A STUDY OF THE EFFECTS OF CONSTRUCTION PRACTICES ON BRIDGE DECK CONSTRUCTION

Philip D. Cady and John C. Theisen, Pennsylvania State University

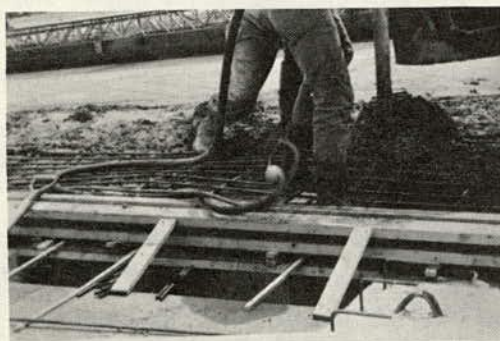
The top reinforcing steel in this bridge deck was not adequately supported (Fig. 1). The weight of the construction crew caused the reinforcing mat to sag. In some areas the mats almost touched the lower reinforcing steel.

Figure 1. Inadequately supported reinforcing steel.

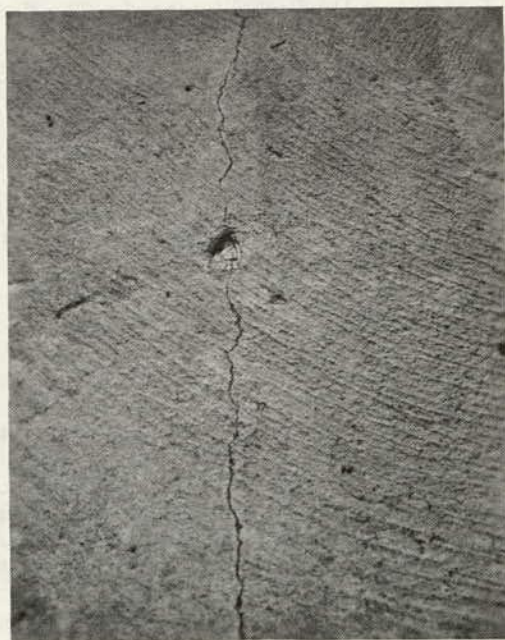
The first survey of this deck revealed a great number of transverse cracks, almost 130 in all, over the 230-ft deck (Fig. 2). It was hypothesized that the cracking was due to the high winds and temperatures during placement. The bridge was 2 years old at the time of the first survey and had experienced 2 winter seasons.

Figure 2. Transverse crack over steel (note pop-out).

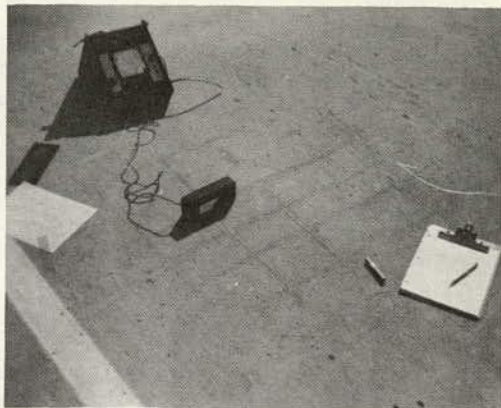
In 1968 the total number of cracks increased to almost 180. Two areas with extensive cracking were found by a pachometer survey (Fig. 3) to have very shallow top steel with average covers of 1.10 and 1.20 in. respectively. A third area, with slight cracking, had an average cover of

1.20 in. but had a wide range of 0.90 to 1.55 in. This indication of bowed reinforcing steel is supported by the original observations during construction. A fourth area, with no cracking, had an average cover of 1.60 in. There was a definite correlation between depth of steel and location of cracks.

Figure 3. Pachometer and reinforcing steel layout.

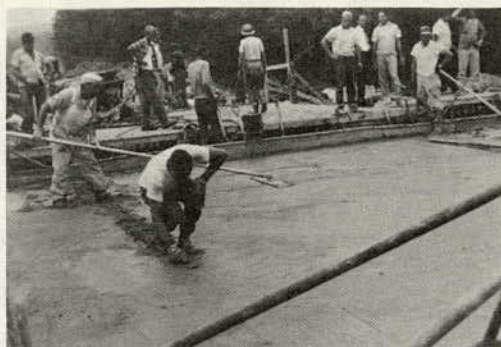
The concrete set up rapidly. This may have been due in part to the 80 F temperatures and high winds present during placement. The individual rail sections used as guides for the screeds were too long, with the result that the first concrete placed in a section developed initial set before the screeding reached the end of a rail section.

These rail grooves were then patched and finished (Fig. 4). The delay caused by the screed rails resulted in more than half of the deck surface being sprinkled to aid finishing. During the early stages of the placement there was a considerable time lapse between completion of finishing and start of curing. Also, the type of initial cure, a single thickness of wet burlap, did not appear to be adequate.

Figure 4. Finishing of void remaining on removal of screed rail (note that concrete has gained initial set).

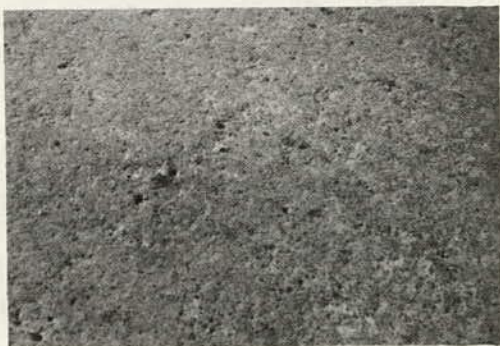
The SMD remained widespread and uniform, but did not appear to increase in depth. The pitting first noticed in 1967 had become severe over the entire deck (Fig. 5). No additional cracks were found. The SMD was concentrated in the wheel tracks; the coarse aggregate, a limestone, appeared to be wearing down as quickly as the cement paste.

Figure 5. Pitting and surface mortar deterioration.

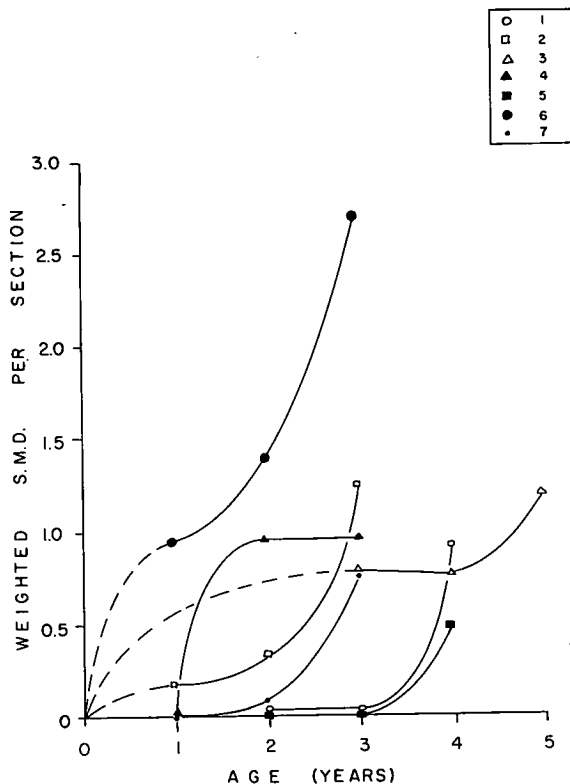
observed previously in studies of bridge deck performance in Pennsylvania. Plots of SMD and transverse cracking versus age are given in Figures 6 and 7. To permit valid comparison, these data have been weighted for severity of SMD and expressed on a unit basis.

Figure 6. Surface mortar deterioration versus age.

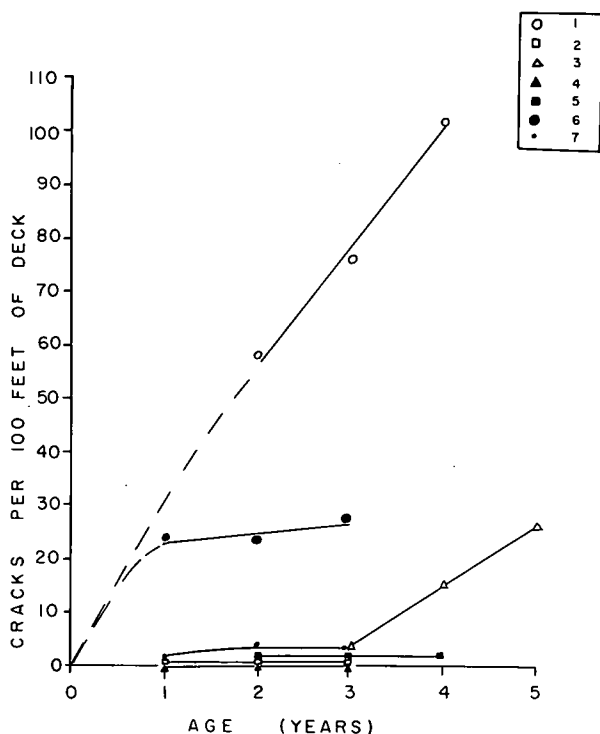
Figure 7. Cracking versus age.
