STUDIES OF THE RELATIONSHIPS AMONG CRACK PATTERNS, COVER OVER REINFORCING STEEL, AND DEVELOPMENT OF SURFACE SPALLS IN BRIDGE DECKS

David Stark, Portland Cement Association

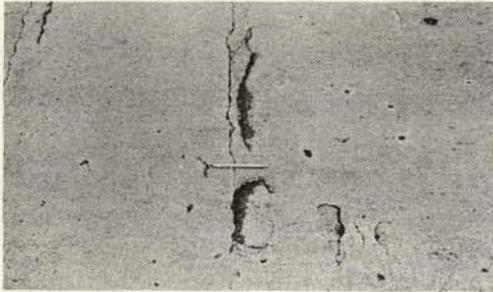
A surface spall is manifested in the removal of an inverted, more or less conical or trough-like piece of concrete, the apex of which extends to the upper surface of the top reinforcing steel, as shown in Figure 1. Numerous cores taken through spalls and incipient spalls revealed the occurrence of a layer of steel corrosion products at the apex of the spall, as shown in Figure 2. In addition, a generally vertical crack was observed that extended from the wearing surface downward to the reinforcing steel. Most commonly this crack passed through aggregate particles and was lined with corrosion products in the vicinity of the steel bar.

Figure 1. Typical surface spall associated with reinforcing steel.

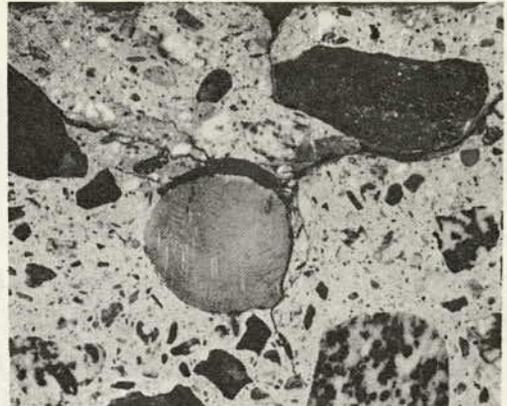
Figure 2. Cross section of reinforcing steel and part of surface spall showing cracking and associated corrosion of steel at upper surface.

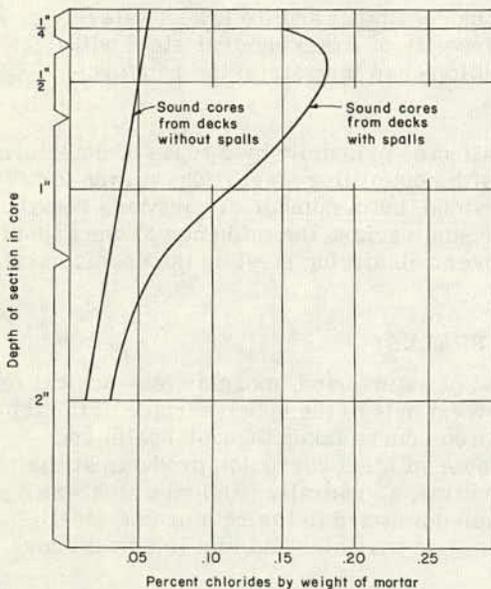
Figure 3. Average chloride distribution for sound cores from spalled and nonspalled decks.

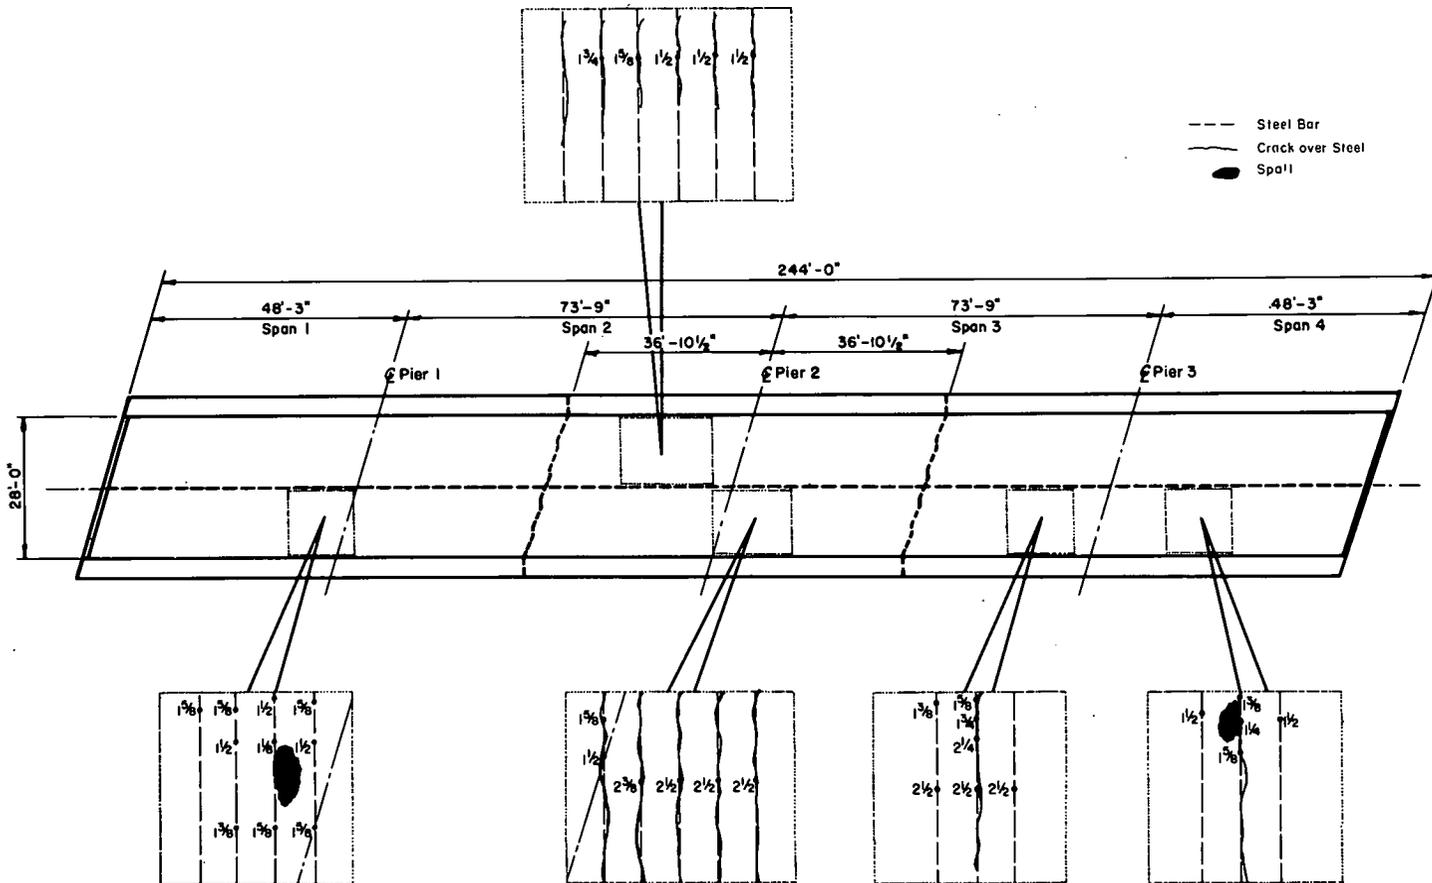
Figure 6. Results of measurements of cover over top steel in 7-year-old bridge deck with specified 1 1/2-in. cover (cover, in inches, is shown adjacent to steel bar).

Figure 6 shows the results for a 7-year-old deck with a specified cover of $1\frac{1}{2}$ in. The actual cover was found to vary from $1\frac{1}{8}$ to $2\frac{1}{2}$ in. Only 2 spalls occurred in this deck, and both were associated with a cover of $1\frac{1}{8}$ to $1\frac{5}{8}$ in. Numerous faint transverse cracks were observed over the entire deck with the cover ranging from $1\frac{5}{8}$ to $2\frac{1}{2}$ in. Also, there were relatively large areas free of visible cracks where the cover ranged from $1\frac{3}{8}$ to $2\frac{1}{2}$ in.

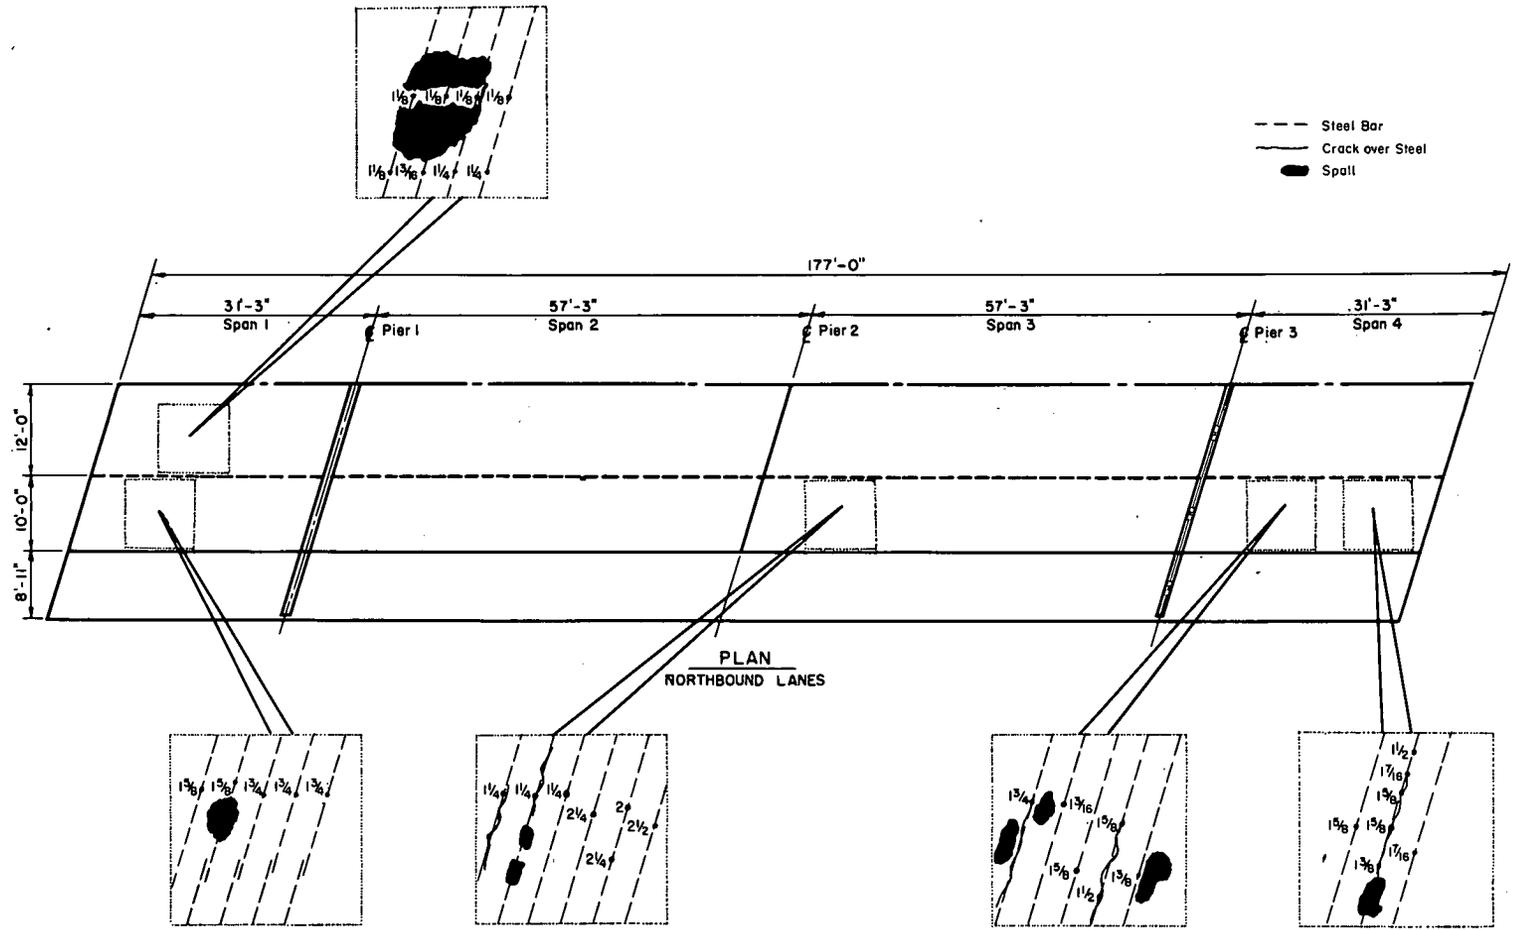
Figure 7. Results of measurements of cover over top steel in 14-year-old bridge deck with specified 1/8-in. cover (cover, in inches, is shown adjacent to steel bar).

Figure 7 shows a 14-year-old deck with a specified cover of $1\frac{1}{8}$ in. Spalling occurred over most of the deck and was located in areas where the cover varied from $1\frac{1}{4}$ to $1\frac{3}{4}$ in. On the bridge as a whole, there was a noticeable lack of vertical cracks directly over steel, but in areas where they did occur spalls and incipient spalls were invariably present. Spot checks in areas where there were no cracks indicated cover of $1\frac{3}{4}$ to $2\frac{1}{2}$ in.

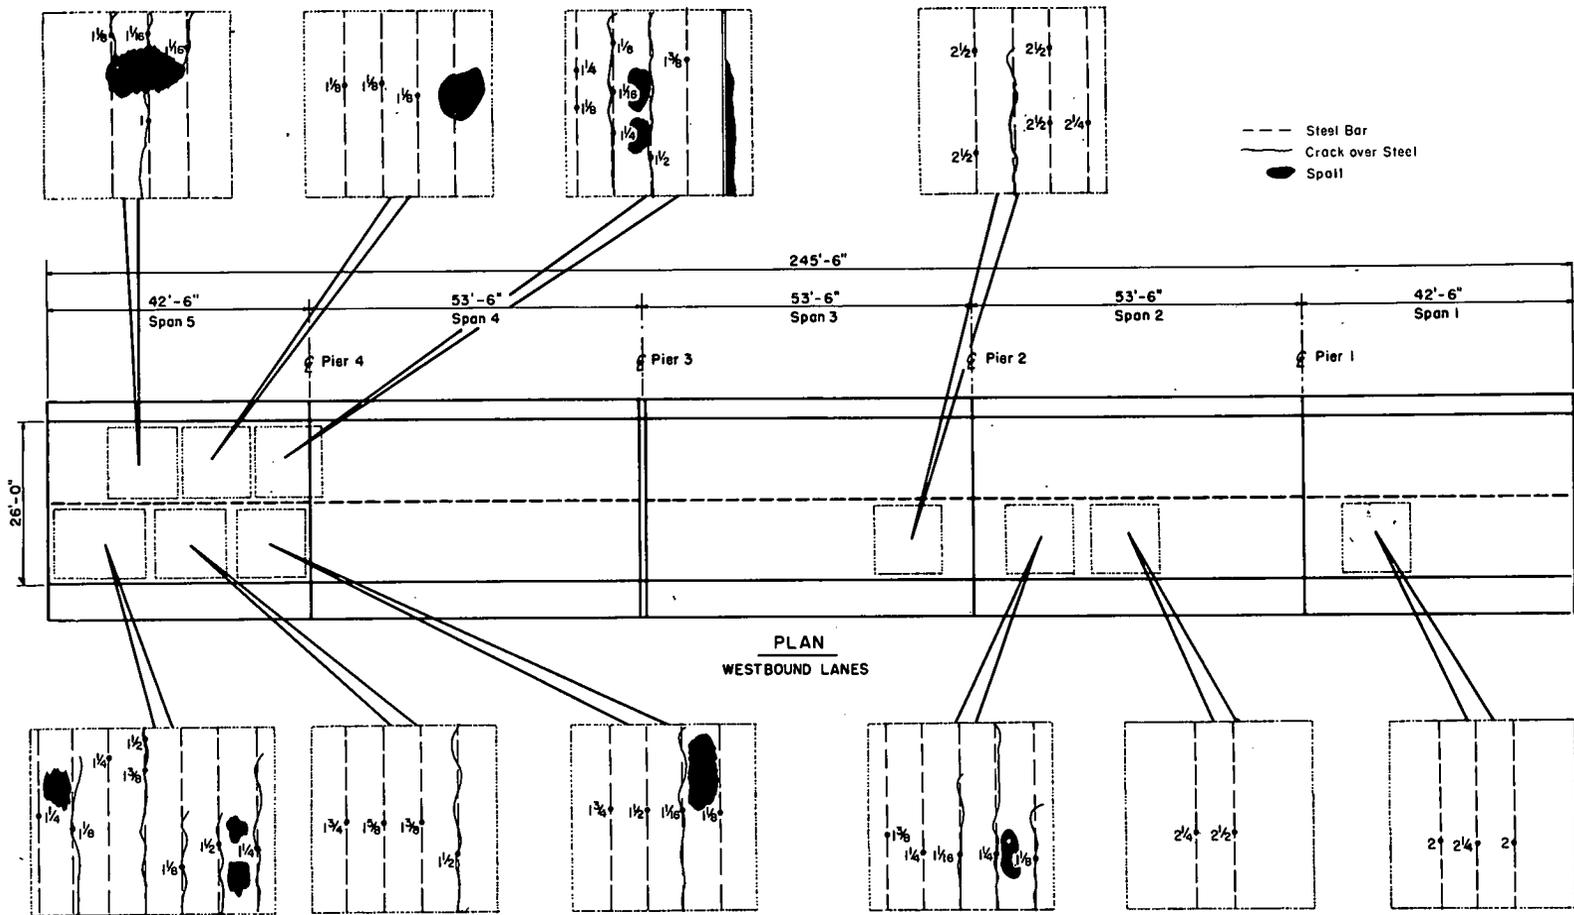
Figure 8. Results of measurements of cover over top steel in 7-year-old bridge deck with specified 1/8-in. cover (cover, in inches, is shown adjacent to steel bar).

Figure 8 shows a 7-year-old deck with a specified cover of $1\frac{1}{8}$ in. Spalls and incipient spalls were found in 3 of the 5 spans in this deck. All spalls were associated with reinforcing steel with a cover ranging from 1 to $1\frac{1}{2}$ in. Transverse cracks occurred over steel with a maximum cover of $1\frac{1}{2}$ in. Many areas of the deck displayed only faint pattern cracking, and in these areas the cover was 2 to $2\frac{1}{2}$ in. Again, there was no progressive deterioration associated with these cracks.
