# **STUDIES OF THE RELATIONSHIPS AMONG CRACK PATTERNS, COVER OVER REINFORCING STEEL, AND DEVELOPMENT OF SURFACE SPALLS IN BRIDGE DECKS**

David Stark, Portland Cement Association

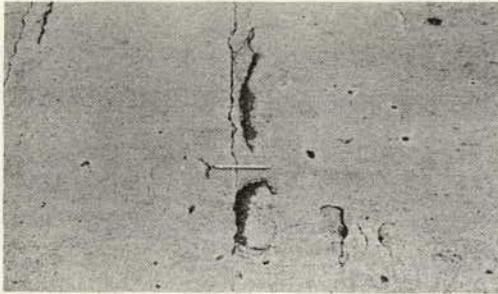
A surface spall is manifested in the removal of an inverted, more or less conical or trough-like piece of concrete, the apex of which extends to the upper surface of the top reinforcing steel, as shown in Figure 1. Numerous cores taken through spalls and incipient spalls revealed the occurrence of a layer of steel corrosion products at the apex of the spall, as shown in Figure 2. In addition, a generally vertical crack was observed that extended from the wearing surface downward to the reinforcing steel. Most commonly this crack passed through aggregate particles and was lined with corrosion products in the vicinity of the steel bar.

Figure 1. Typical surface spall associated with reinforcing steel.

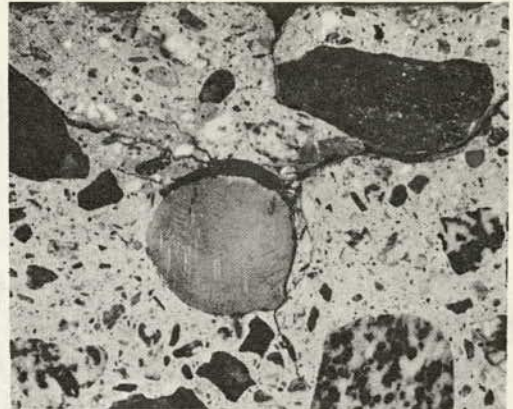
Figure 2. Cross section of reinforcing steel and part of surface spall showing cracking and associated corrosion of steel at upper surface.

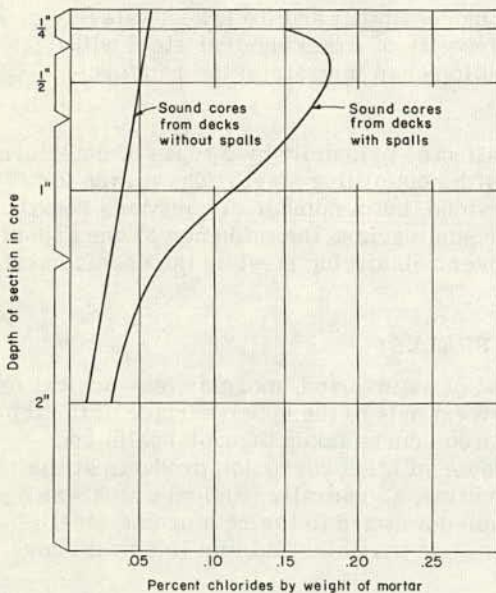
Figure 3. Average chloride distribution for sound cores from spalled and nonspalled decks.

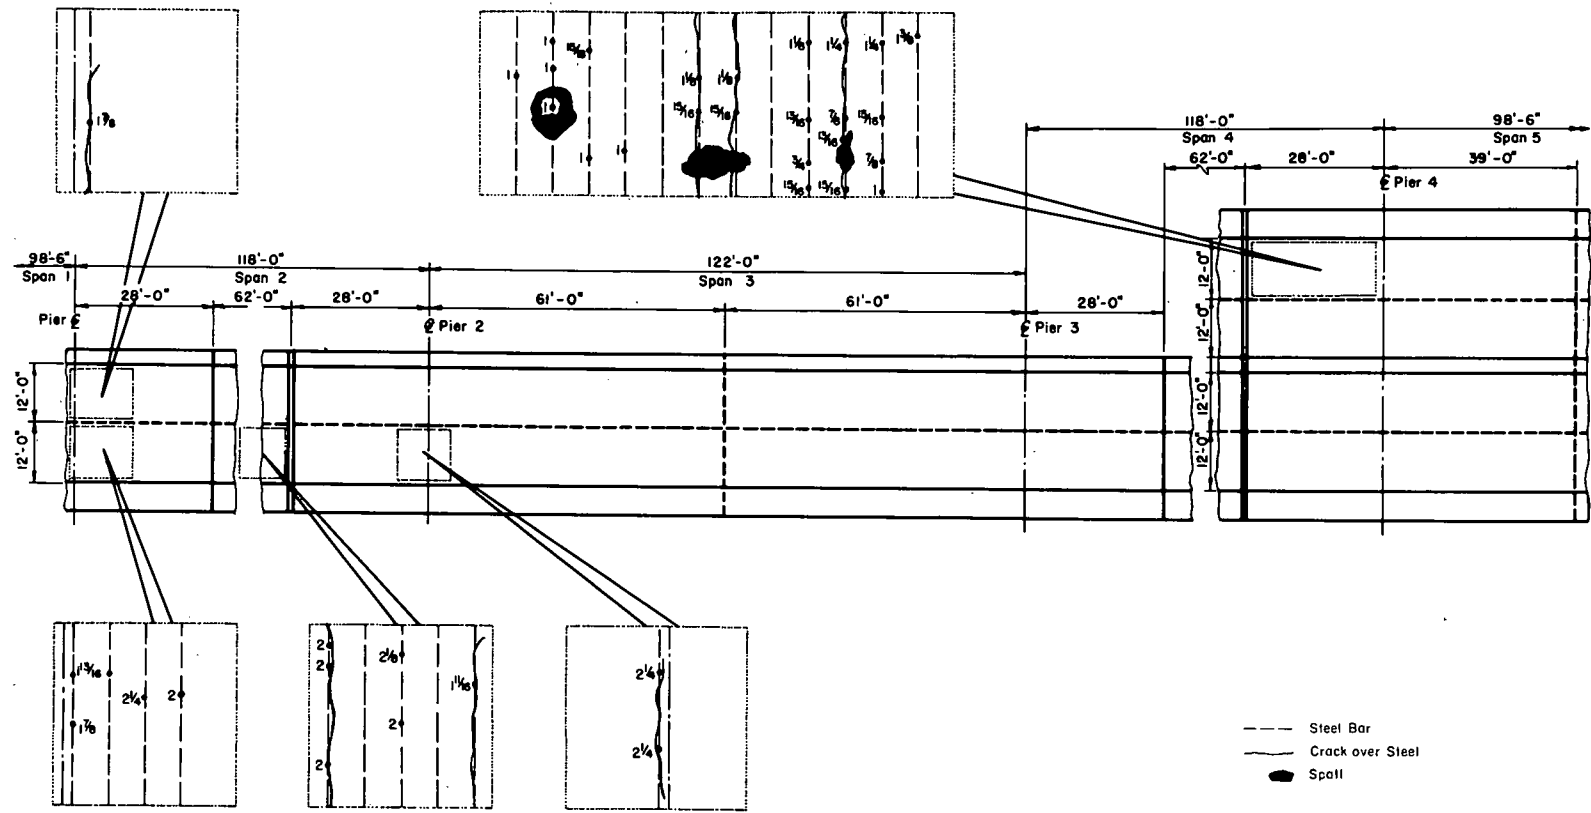
The bridge deck shown in Figure 5 was 11 years old at the time the measurements were made; the specified cover was  $1\frac{1}{8}$  in. Measurements in one of the few spalled areas showed cover ranging from  $1\frac{1}{4}$  to  $\frac{3}{4}$  in. The spalls occurred where the cover was 1 in. or less. Spot checks elsewhere revealed that the cover varied from  $1\frac{11}{16}$  to  $2\frac{1}{4}$  in. In these areas there was a total absence of spalls and incipient spalls

Figure 5. Results of measurements of cover over top steel in 5-year-old bridge deck with specified 1 7/8-in. cover (cover, in inches, is shown adjacent to steel bar).

but a well-developed system of pattern cracks and a few tight transverse cracks. These pattern cracks were not associated with progressive deterioration.

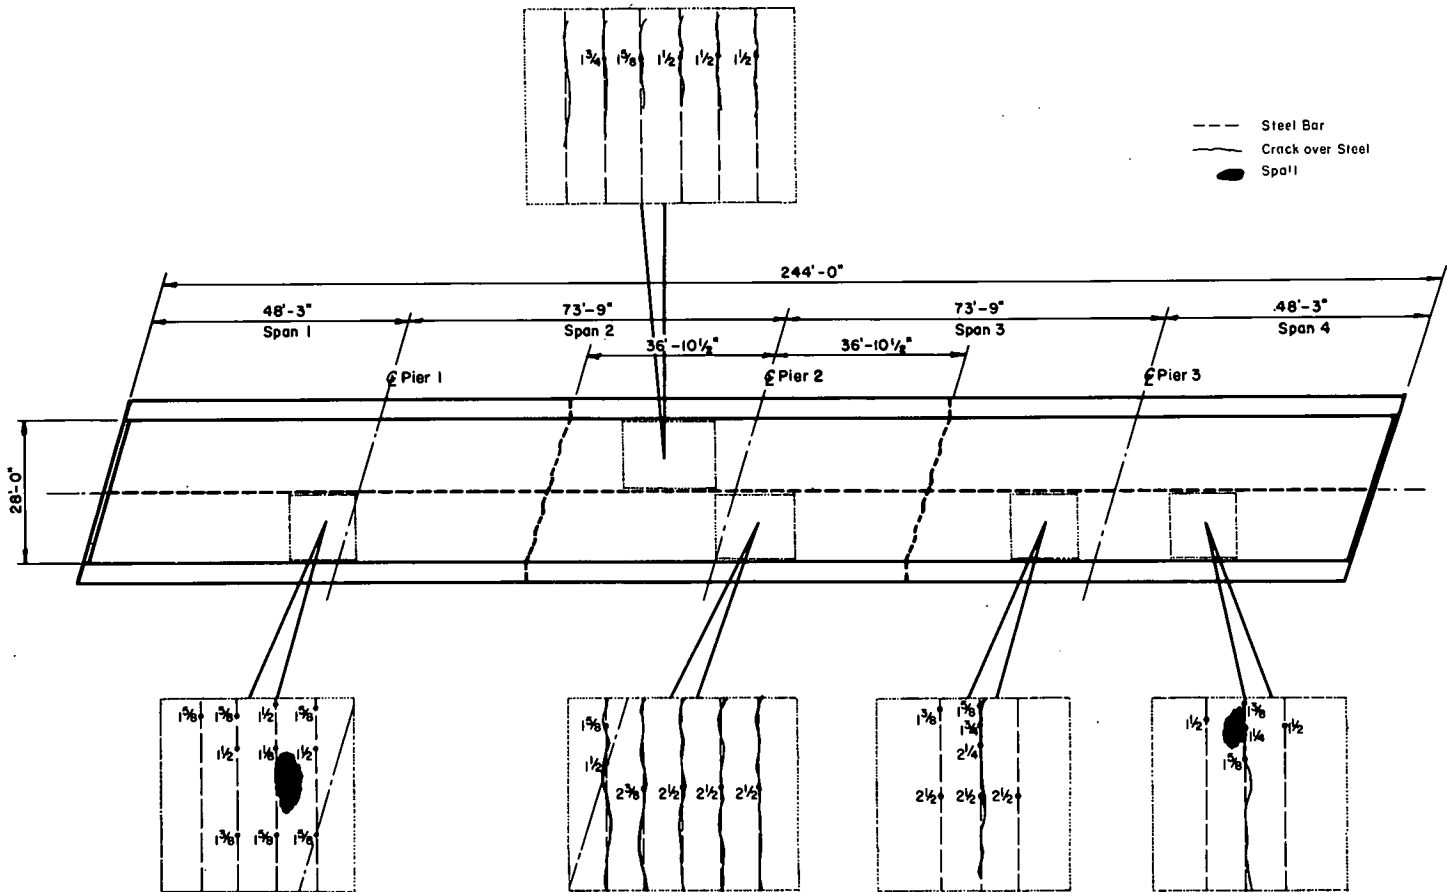
Figure 6. Results of measurements of cover over top steel in 7-year-old bridge deck with specified 1 1/2-in. cover (cover, in inches, is shown adjacent to steel bar).

Figure 6 shows the results for a 7-year-old deck with a specified cover of  $1\frac{1}{2}$  in. The actual cover was found to vary from  $1\frac{1}{8}$  to  $2\frac{1}{2}$  in. Only 2 spalls occurred in this deck, and both were associated with a cover of  $1\frac{1}{8}$  to  $1\frac{5}{8}$  in. Numerous faint transverse cracks were observed over the entire deck with the cover ranging from  $1\frac{5}{8}$  to  $2\frac{1}{2}$  in. Also, there were relatively large areas free of visible cracks where the cover ranged from  $1\frac{3}{8}$  to  $2\frac{1}{2}$  in.

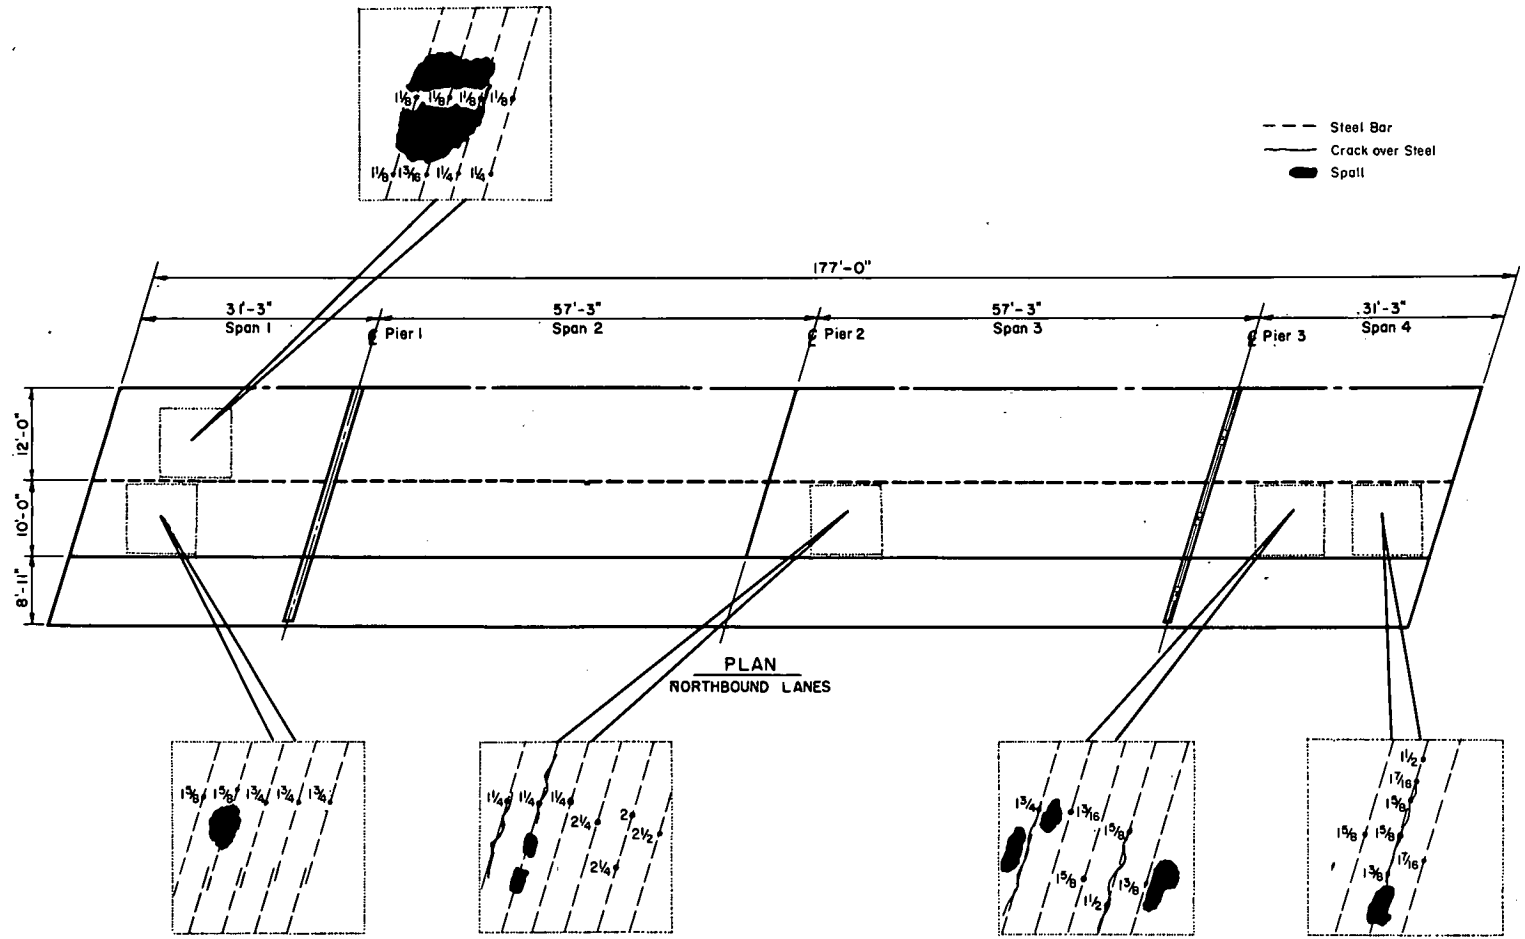
Figure 7. Results of measurements of cover over top steel in 14-year-old bridge deck with specified 1/8-in. cover (cover, in inches, is shown adjacent to steel bar).

Figure 7 shows a 14-year-old deck with a specified cover of  $1\frac{1}{8}$  in. Spalling occurred over most of the deck and was located in areas where the cover varied from  $1\frac{1}{4}$  to  $1\frac{3}{4}$  in. On the bridge as a whole, there was a noticeable lack of vertical cracks directly over steel, but in areas where they did occur spalls and incipient spalls were invariably present. Spot checks in areas where there were no cracks indicated cover of  $1\frac{3}{4}$  to  $2\frac{1}{2}$  in.

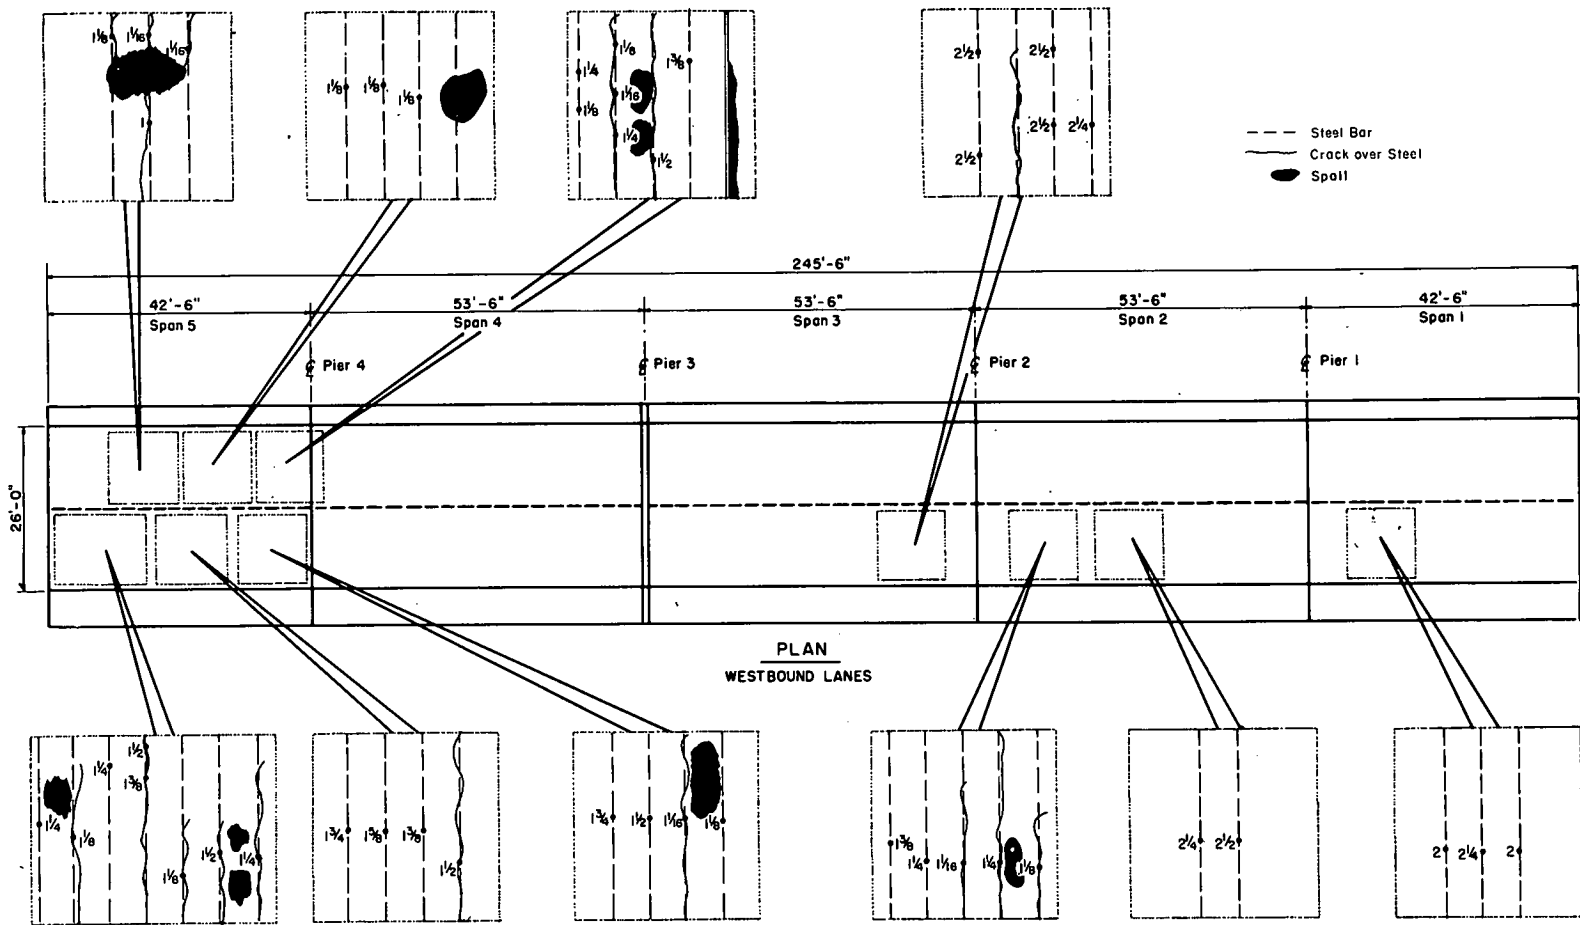
Figure 8. Results of measurements of cover over top steel in 7-year-old bridge deck with specified 1/8-in. cover (cover, in inches, is shown adjacent to steel bar).

Figure 8 shows a 7-year-old deck with a specified cover of  $1\frac{1}{8}$  in. Spalls and incipient spalls were found in 3 of the 5 spans in this deck. All spalls were associated with reinforcing steel with a cover ranging from 1 to  $1\frac{1}{2}$  in. Transverse cracks occurred over steel with a maximum cover of  $1\frac{1}{2}$  in. Many areas of the deck displayed only faint pattern cracking, and in these areas the cover was 2 to  $2\frac{1}{2}$  in. Again, there was no progressive deterioration associated with these cracks.
