## CORROSION OF EPOXY-COATED REBAR IN A MARINE ENVIRONMENT

L. L. Smith, R. J. Kessler and R. G. Powers\*

In 1986 the first signs of corrosion of epoxy-coated rebar were observed in the Long Key Bridge Substructure. Further investigations revealed extensive corrosion of epoxy-coated rebars in four of the five major structures in the Florida Keys. A Task Force was established to investigate the problem by conducting in house research, contract research and a statewide survey of bridges with epoxy-coated rebar substructures. As a result of the investigation it was concluded that epoxy-coated rebar is unsuitable for marine splash zone corrosion protection.

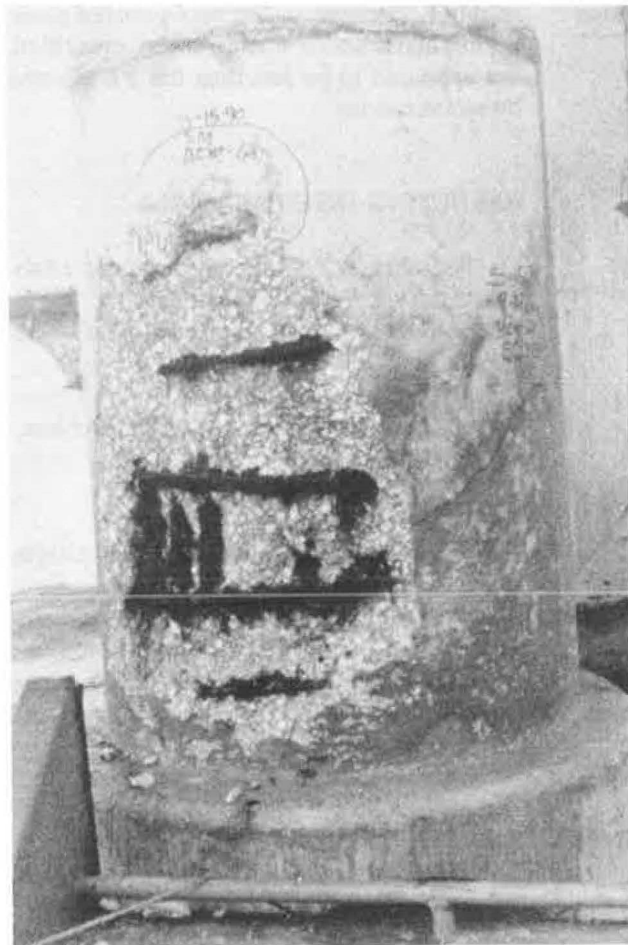
Corrosion was found in both fabricated and straight epoxy-coated rebar, Figure 1. Visual inspection indicated that corrosion may have started in the fabricated rebars and then progressed to the straight bars. Underneath the coating, water with a pH of 5 was commonly found, indicating that acidic conditions had developed. Cores taken from the structures on opposite sides from the corrosion spalls indicate that corrosion had progressed beyond the spalled area into sound

**Figure 1** Typical corrosion deterioration common to Seven Mile Bridge observed in 1987.

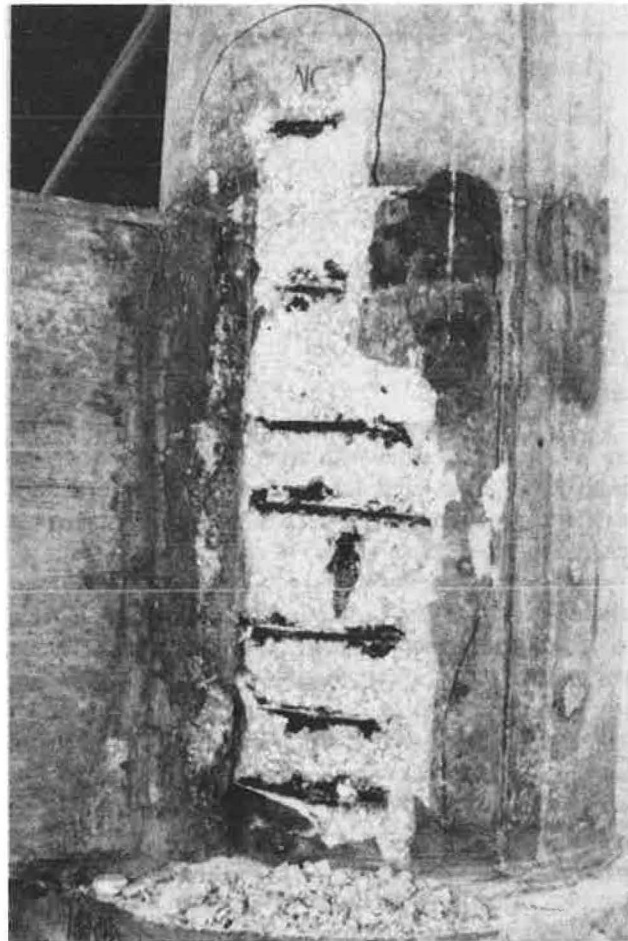
**Figure 2** Typical corrosion deterioration common to Niles Channel Bridge observed in 1987.

The results of this investigation showed that coating after fabrication did not significantly improve corrosion resistance. Disbondment occurred in "perfect" condition bars and in the bars coated after fabrication, Figure 2. Coating disbondment can lead to serious problems since the initial passivating effect of the concrete is isolated from the rebar. The disbondment of the epoxy allows the chloride laden electrolyte to reach and progress along the rebar surface. The corrosion observed in these tests was not as severe as noted in the Florida Keys structures. This is believed to be due to the sample configuration that allowed a large anode to small cathode ratio and the short exposure period.

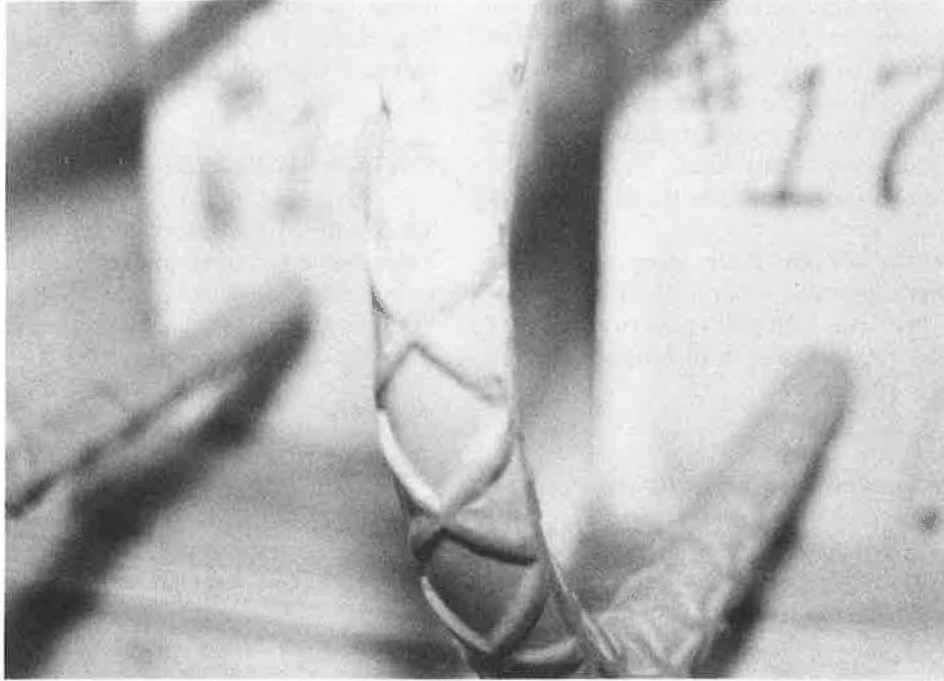
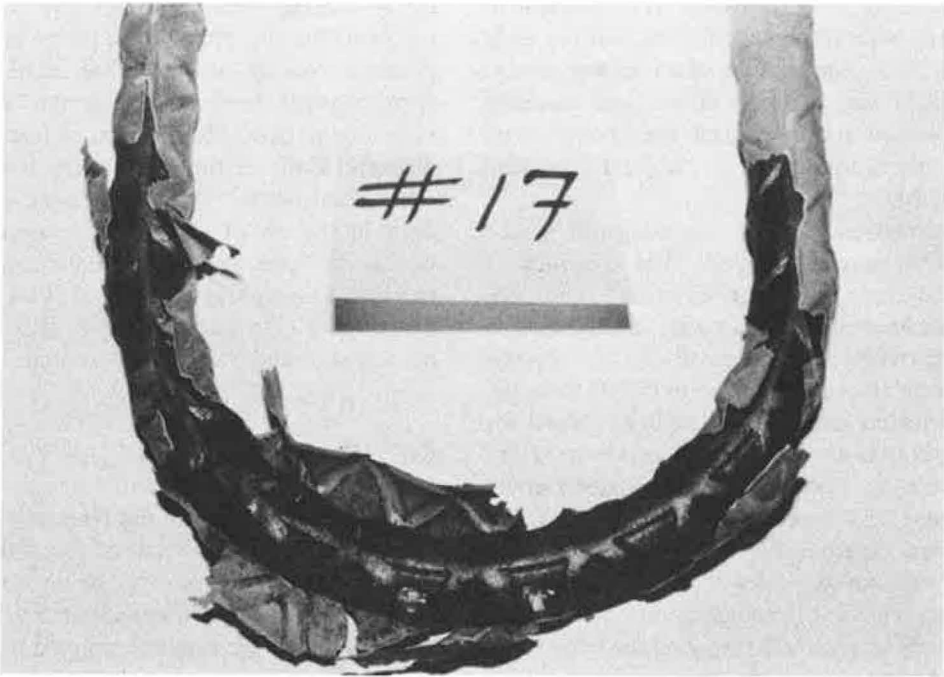
**Figure 3** Sample #17 with small defects present before test (top) and extreme disbonding, localized and general corrosion after test (bottom).

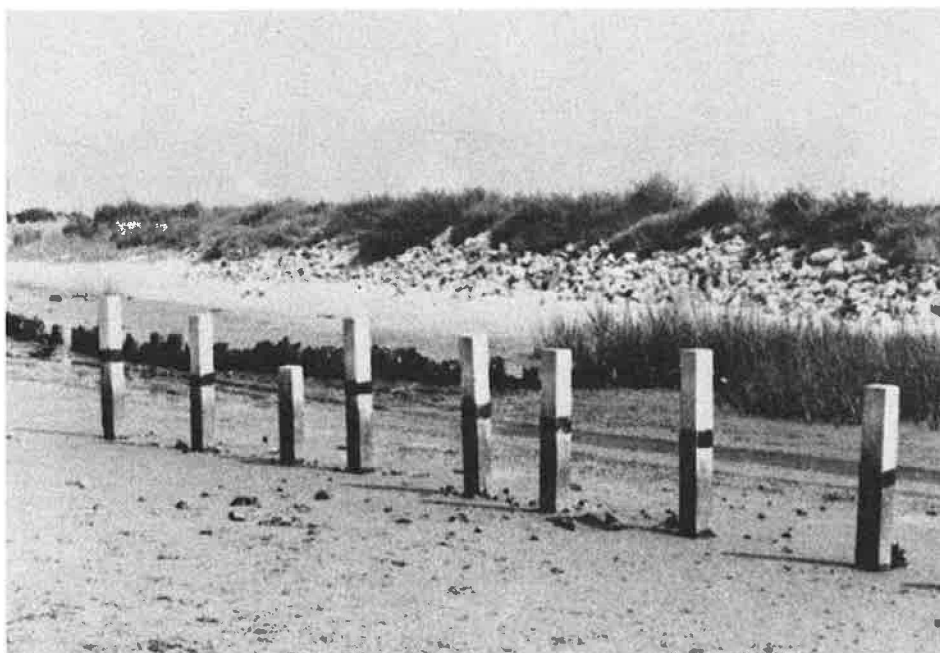
A test site established at Matanzas Inlet (Intracoastal Waterway) on the east coast of Florida was used to evaluate epoxy-coated and bare rebar test piles (9). The test piles were installed in 1979 in the corrosive marine environment, Figure 3. After approximately nine years of exposure, three test piles were removed for examination, one with epoxy-coated steel rebars, one with bare rebars and one with galvanized steel. The epoxy-coated rebar pile outperformed the bare rebar piling. However, the epoxy-coated rebars used in this study were not typical of those supplied to construction projects. The

**Figure 4** Matanzas Inlet test site after placement of test pilings in 1979 with application of coal-tar epoxy bands around areas containing the rebar support chairs.

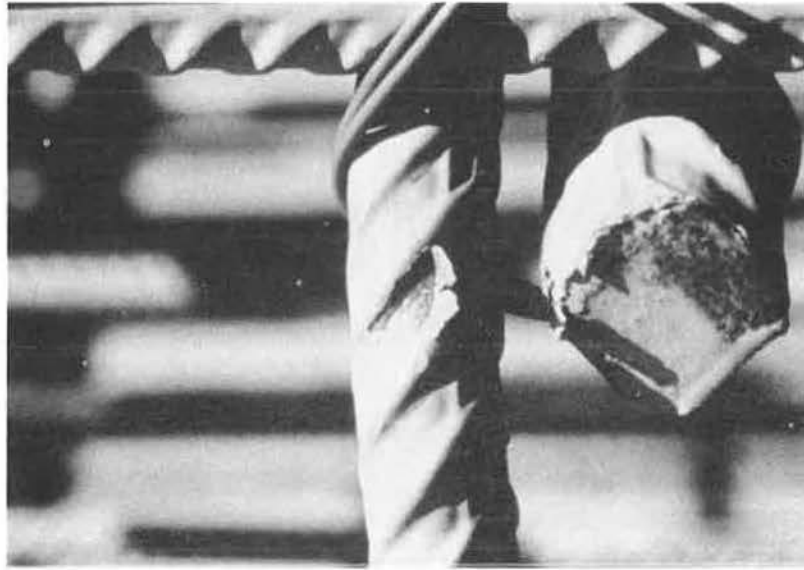
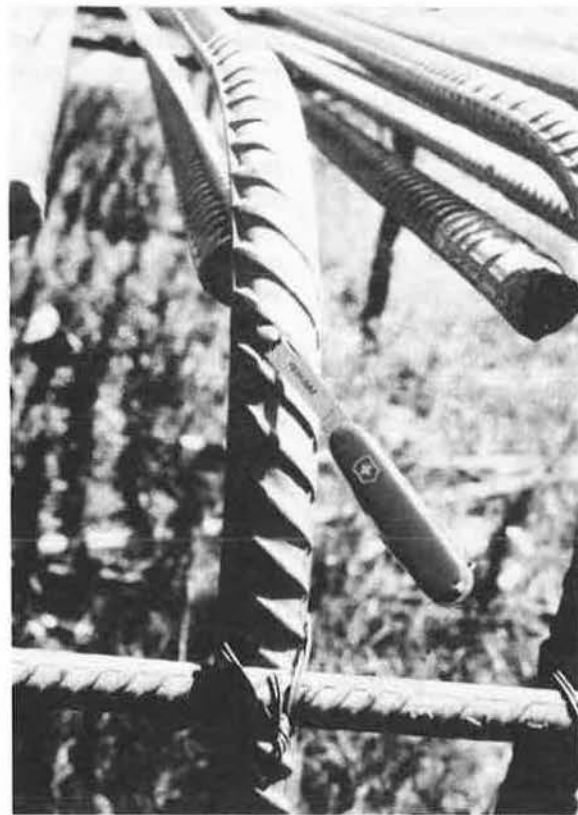
**Figure 5** Epoxy coating easily removed with pocket knife along fabricated (bent) areas.
