In-Depth Inspection of Arizona's Steel Bridges

MARK E. BERNHARDT, P.E.

Burgess & Niple, Ltd.

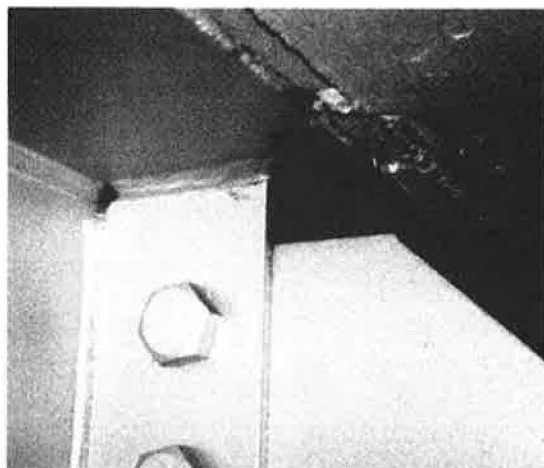
Most of the other significant deficiencies noted were fatigue or impact related. Distress was usually found at the superstructure connection details between transverse diaphragms and girders or beams. Typically, transverse diaphragms were bolted or welded to vertical stiffeners on the girder webs. When cracks were found, they were commonly located in the weld between the vertical stiffener and web or top flange. Figure 3 depicts this type of distress. This type of cracking is commonly caused by out-of-plane forces

Figure 3: Cracked connection weld between girder top flange and diaphragm connection stiffener.

induced in the girder webs by the diaphragms. Differential deflections of adjacent girders during vehicular loading are the source of these forces. On older girder bridges (those constructed around the 1950s), it was typically welds between vertical stiffeners and diaphragms that failed. Often this weld was a field weld of marginal quality. A cracked weld at a diaphragm to stiffener connection is shown in Figure 4.

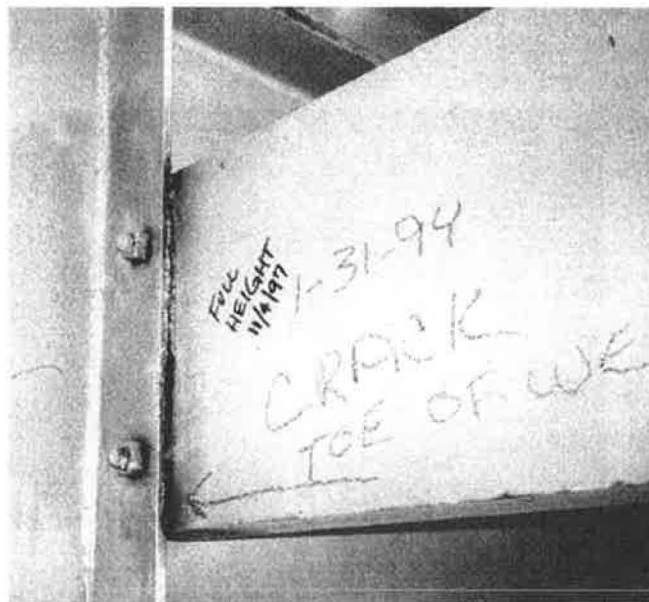
Figure 4: Cracked connection weld between the transverse diaphragm and vertical connection stiffener.

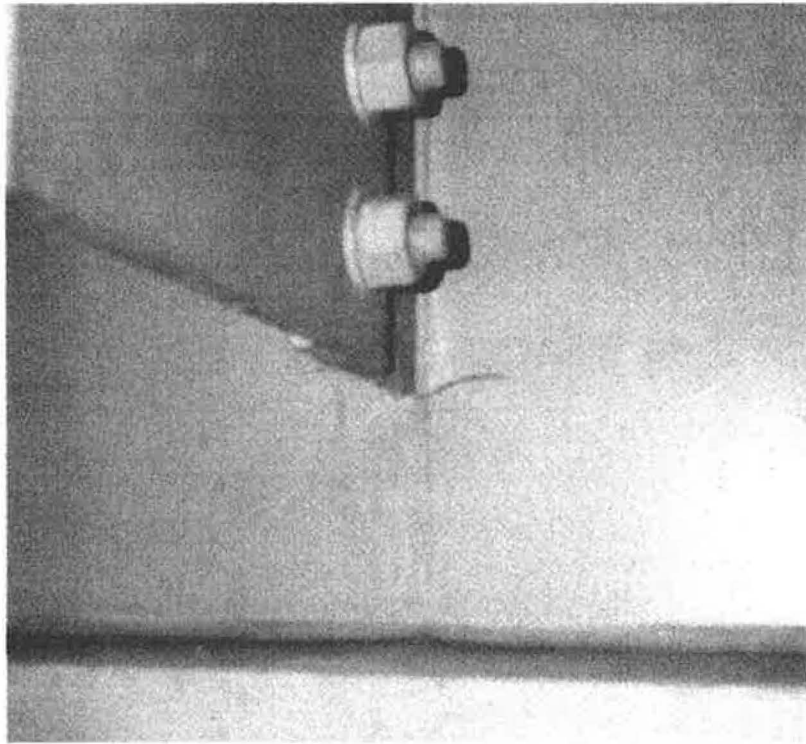
Cracks were also found in girder webs where vertical connection plates at transverse diaphragms terminated a distance above the bottom flange of the girder. This condition is depicted in Figure 5. This particular bridge was also skewed and the diaphragms were perpendicular to the girders. Out-of-plane distortions were induced in girder web plates by diaphragm connection plates. When the bottom flange is relatively thick and stiff, as was the case on this bridge, diaphragm forces are accommodated by the out-of-plane bending of the web plate between the bottom flange and toe of the connection plate. Cracks, such as the one pictured, were found in the girder webs on this and other similar bridges.

Figure 5: Crack in girder web below termination of transverse diaphragm connection plate.

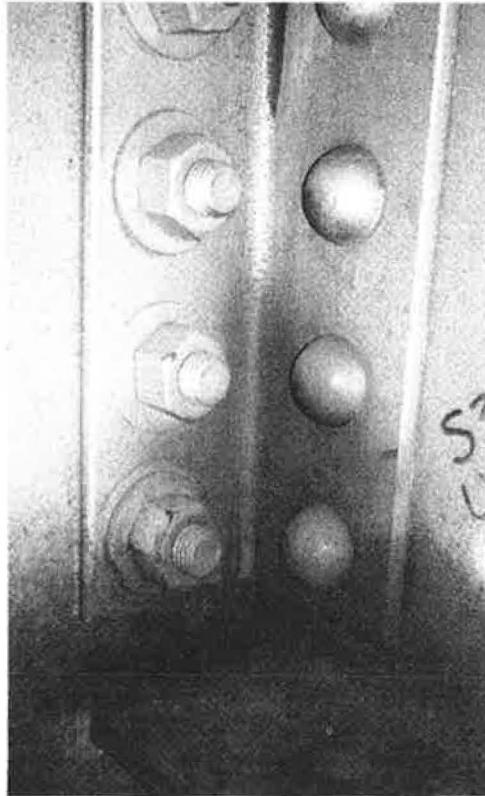
Some of the older riveted bridges inspected contained cracked clip angles at stringer to floorbeam connections. These connection angles are subjected not only to vertical shear forces, but also bending moments. Differential expansion and contraction between continuous deck sections and supporting steelwork appears to be responsible for

the cracked clip angles. A typical distressed clip angle is depicted in Figure 6. The bending axis of this connection is close to the top of the member due to the composite action with the deck. The bottom portion of the clip angle is subjected to the highest stresses. Two parallel cracks have formed near the bottom of this angle.

Figure 6: Distressed clip angle at stringer to floorbeam connection.

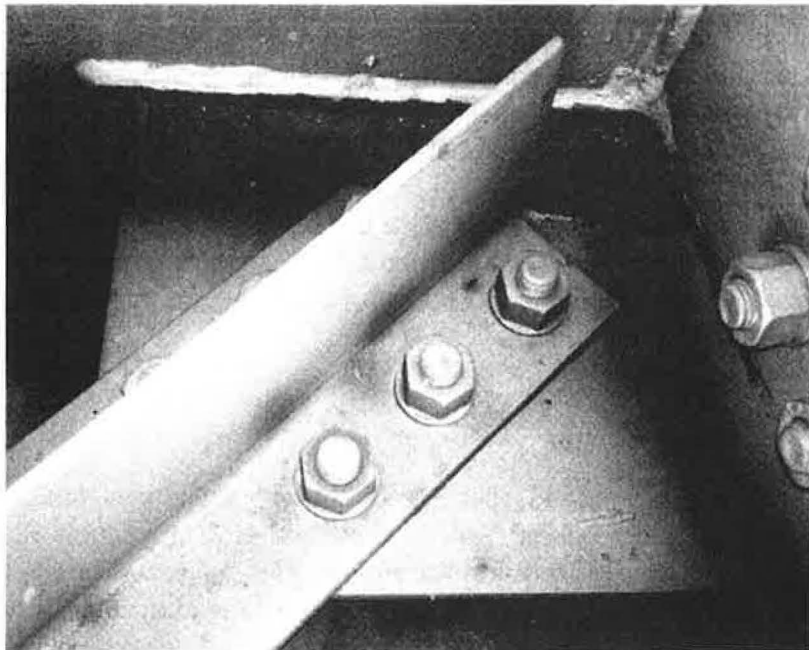
Fatigue related distress was also noted in the lower lateral bracing components of several girder bridges. In Figure 7, a gusset plate at the connection between a lower lateral brace and a girder web is pictured. The gusset plate attachment welds have completely fractured, allowing the gusset plate and bracing to drop and rest on the bottom flange of the girder. This distress can be attributed to secondary stresses induced by dynamic vertical vibrational movement and out of plane distortions caused by vehicular live load on the bridge.

Figure 7: Fractured bottom lateral gusset plate welds.
