Development of Long-Life Overlays for Existing Pavement Infrastructure Projects with Surface Cracking in New Jersey

GEOFFREY ROWE
Abatech, Inc.

ROBERT SAUBER
New Jersey Department of Transportation

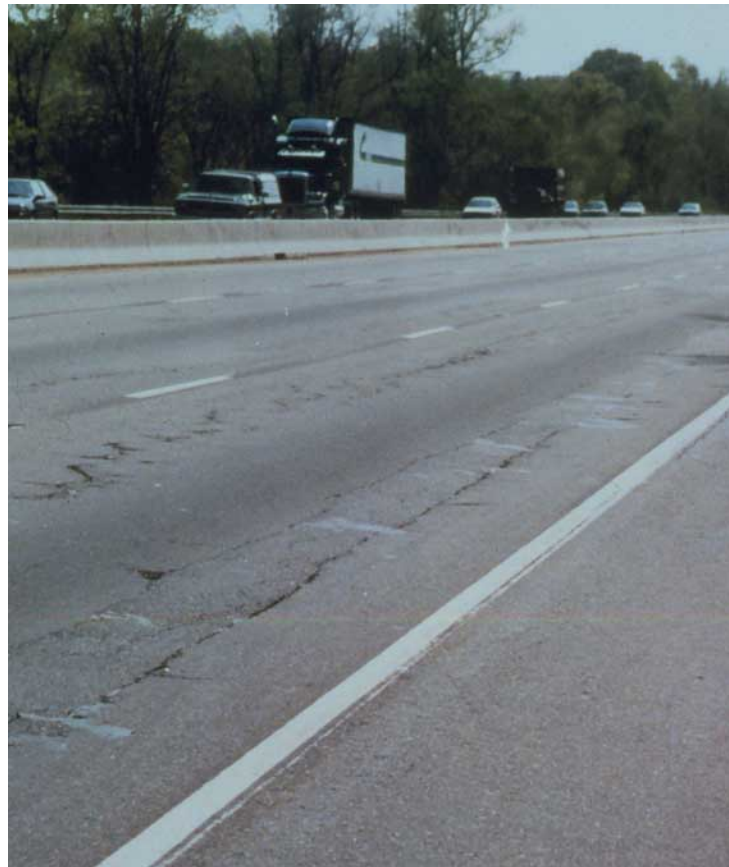
FIGURE 2 Typical surface appearance, 1993.

A visual condition survey of the pavement was conducted during the design phase, concluding that all lanes had cracking, apparently typical bottom-up fatigue cracking (Table 1). The cracking was more evident in Lanes 2 and 3, which carry the higher truck volumes. The typical surface appearance at that time is illustrated in Figure 2.

Lane 1 (Fast Lane)	Lanes 2 and 3 (Middle and Slow Lane)
Low-severity cracking Rutting <1 in.	Moderate- to high-severity fatigue cracking Wheelpath longitudinal cracking Some high-severity patching Rutting > 1 in.

As a consequence of the analysis, a polymer-modified asphalt surface course was selected for the final surface. The surface cracks were removed by milling out the top 3 in. of pavement structure and then laying down two 2-in. layers, consisting of an HMA base course followed by a polymer-modified surface course.

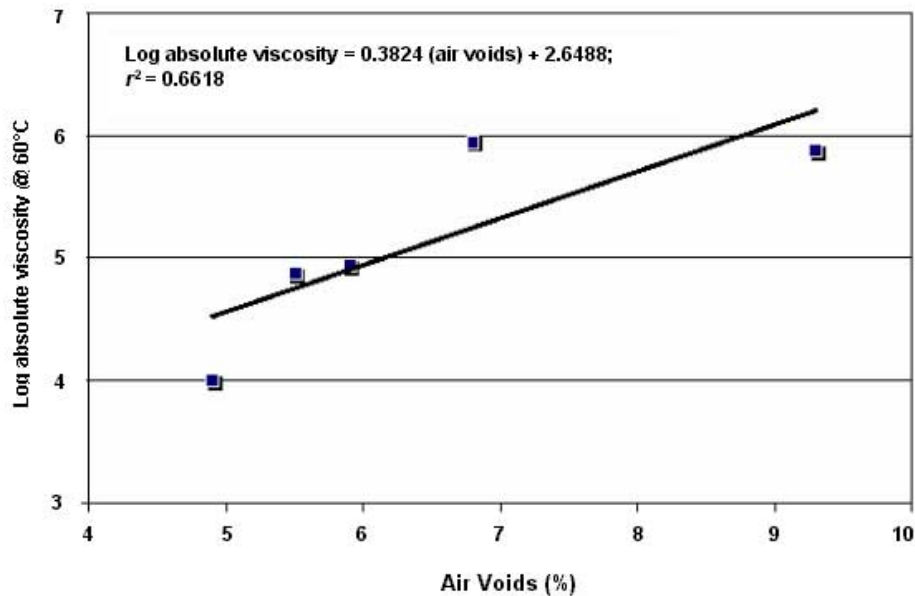
FIGURE 5 Log absolute viscosity versus air voids.

The data from all the testing appeared to suggest that the degree of hardening in the binder (viscosity data) is related to the void content of the mixture with a regression coefficient r^2 of 0.6618. However, it should be noted that this data set is fairly limited with only five test results (Figure 5).

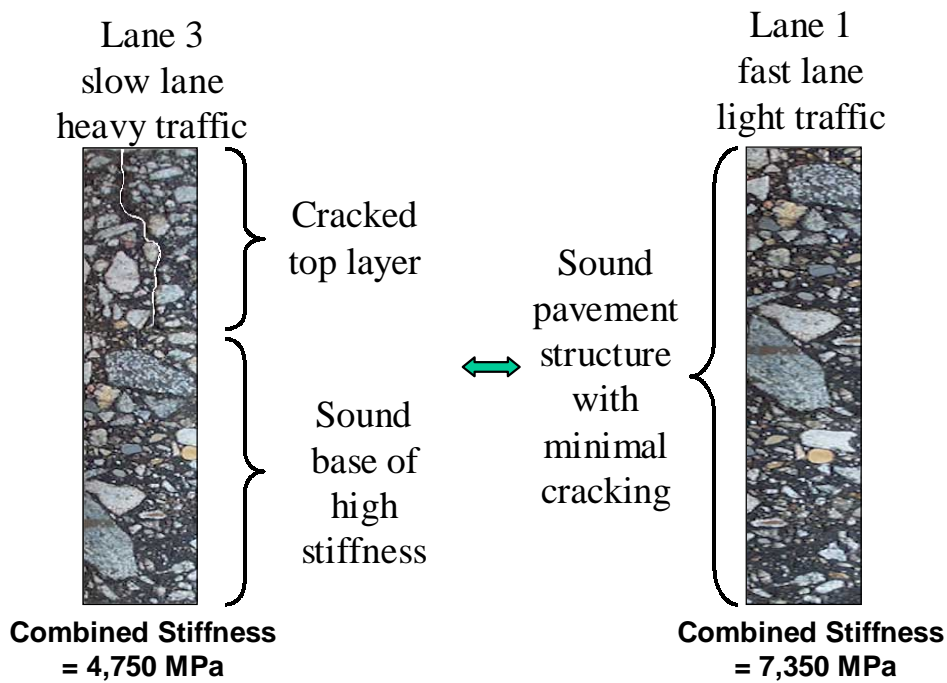
FIGURE 6 Average FWD results. [Combined stiffness refers to the stiffness modulus obtained from back analysis when the asphaltic layers (base and wearing course) have been combined into a single layer.]

The section was tested with the FWD after milling (December 1996) and after the final resurfacing (April 1997). The stiffness modulus values corresponding to the 85-percentile deflection values were the transposed into structural numbers using the procedures contained within the AASHTO Pavement Design Manual. This resulted in structural numbers for the slow lane of 5.7 in. before construction, 4.5 in. after milling, and 7.6 in. after final overlay. The existing structural capacity before overlay, using this approach, is a remaining pavement life of

7,000,000 ESALs compared to the rehabilitated structural capacity of 69,000,000 ESALs. The rehabilitated structure essentially offers an indeterminate pavement life that will need only periodic resurfacing to restore the ride quality.

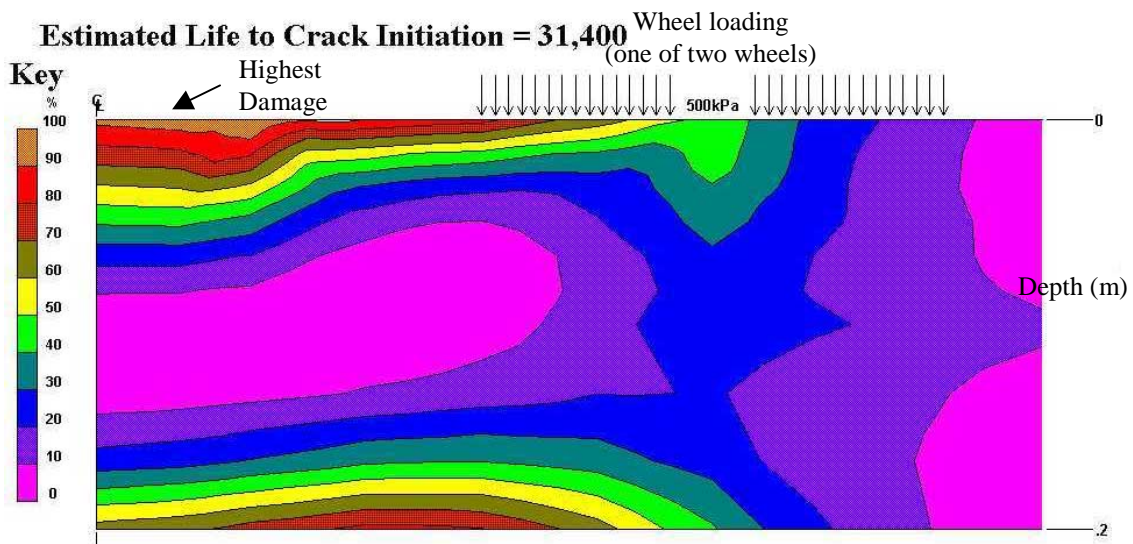
FIGURE 7 Surface-cracking calculations: pavement of 8 in. dense bitumen macadam with applications of a 40-kN duell wheelload; contours of relative (percent) fatigue damage; cross section from center line of loaded area with position of one wheel indicated (3).

With stiff pavement layers, surface cracking can be predicted to occur at the edge of the loaded area using sophisticated pavement models that are based upon dissipated energy or damage mechanics. The example shown in Figure 7 illustrates the case of a thick pavement structure made with a dense asphaltic material similar to that laid on I-287 and for which the highest value of dissipated energy occurs at the top of the pavement structure (3). This type of analysis will show that the dissipated energy will also be highest at the surface for thick pavement even if a wearing course with higher binder content is used. The analysis concluded that to limit cracking in the wearing course it is necessary to design the surface course mixture for high fatigue life, with as little age-hardening susceptibility as possible.

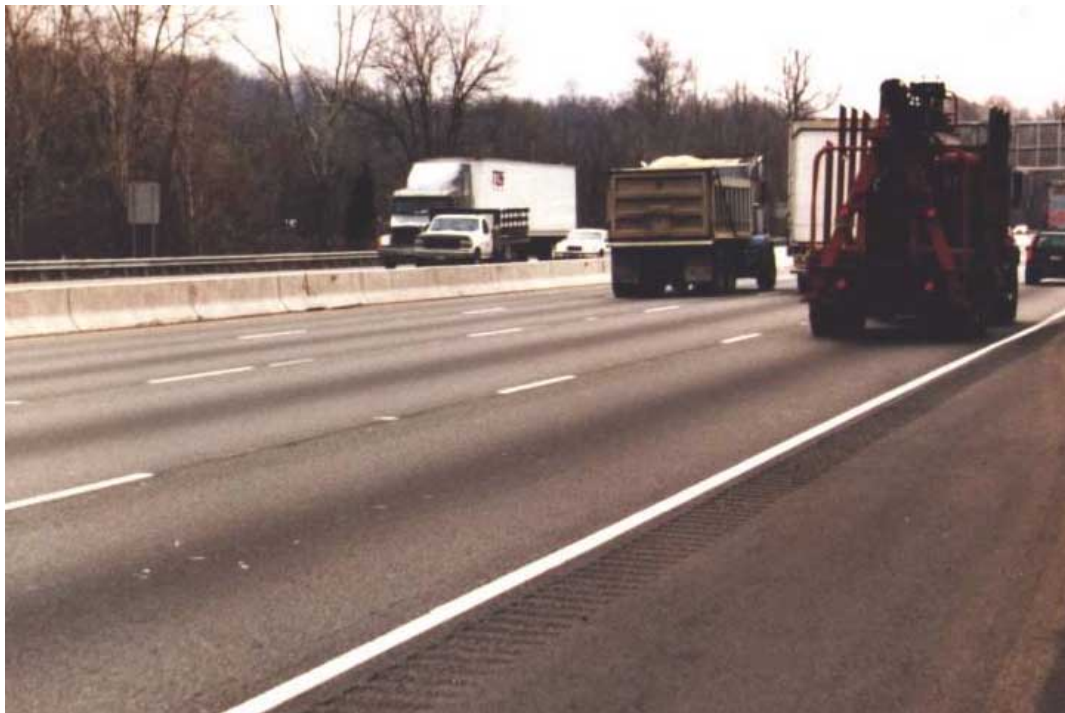
FIGURE 8 Current condition.

The project was inspected in January 2001 and is illustrated in Figure 8. Currently, after 4 years of traffic, the project is performing to acceptable standards with little signs of distress.

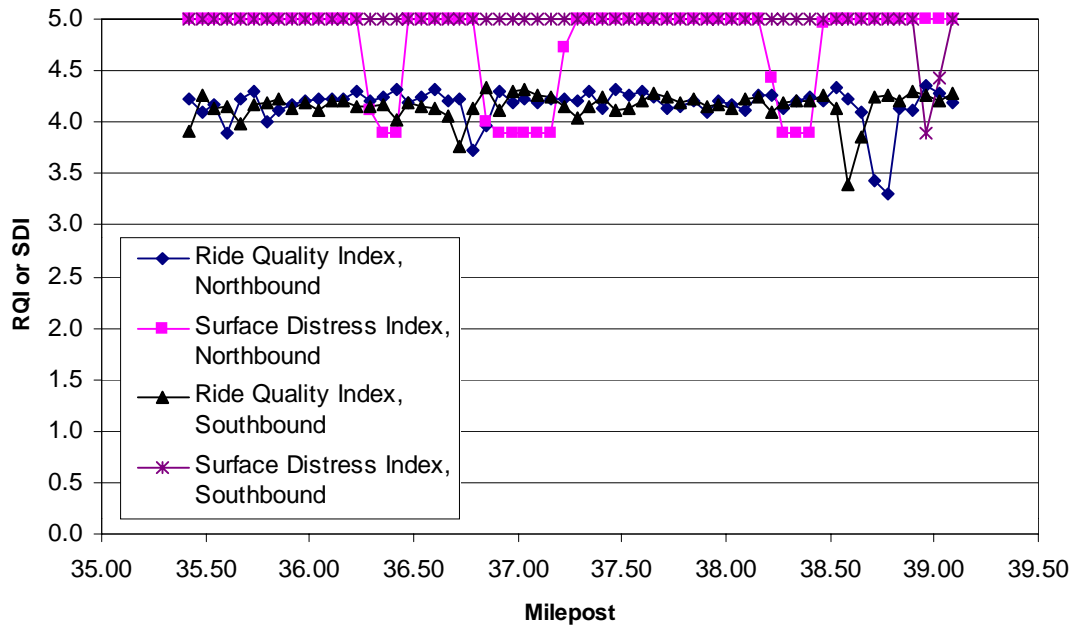
FIGURE 9 Pavement ratings (RQI and SDI) versus Milepost I-287.

The pavement rating data was obtained on December 11, 1998 (approximately 2 years after surfacing). The pavement rating is presented as both a Ride Quality Index (RQI) and Surface Distress Index (SDI) as measured with the ARAN profile device. (ARAN is the trade name for the equipment manufactured by Roadware of Paris, Ontario.) The pavement ratings (RQI and SDI) are related to the condition as indicated in Table 4.

Based on the above definitions the pavement rating is in a “good” to “very good” condition with few (if any) visible signs of deterioration.

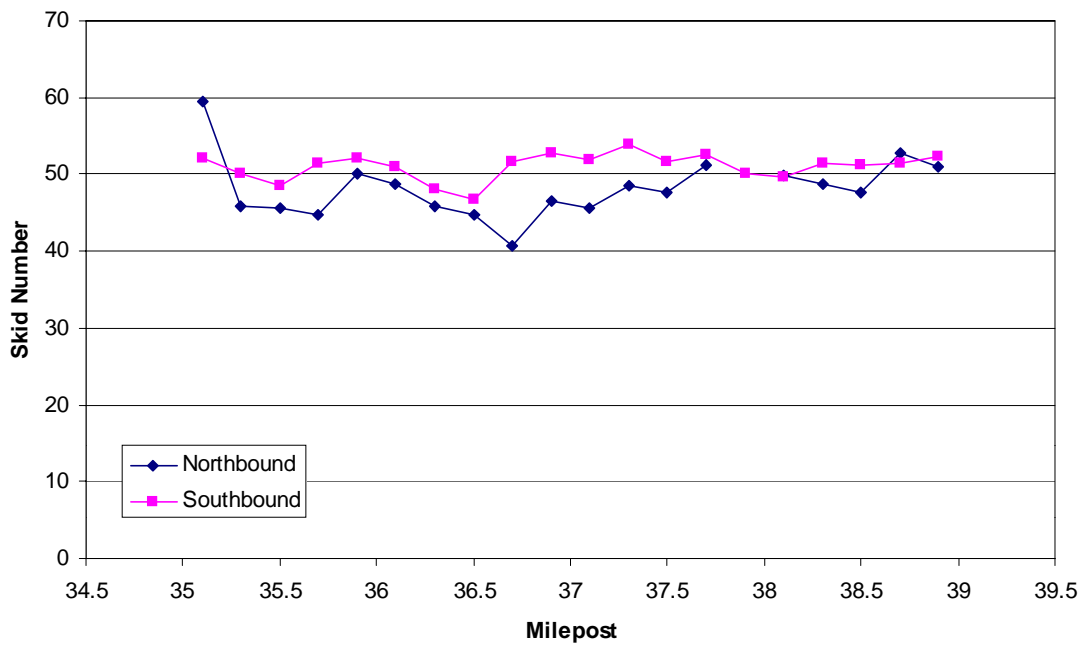
FIGURE 10 Skid numbers versus Milepost I-287.

The average skid number obtained for the site on September 6, 2000, was 49.6 and with a standard deviation of 3.3 (see Figure 10). This would meet the requirements for a traffic speed of approximately 70 mph and is considered acceptable.
