Drilling and Filling is Key to Cheap, Quick, Bridge Repair

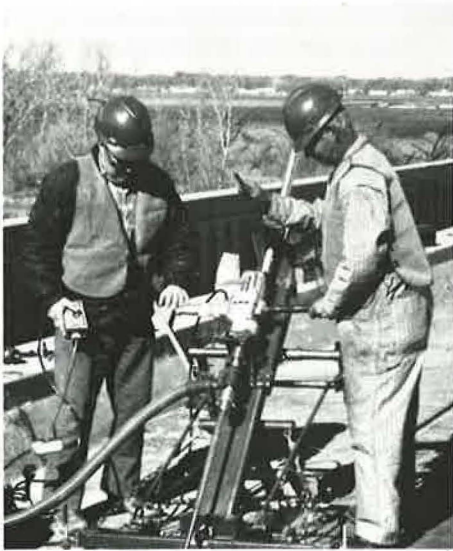
1 Specially built drilling rig was powered by a bumper jack, which reduced the effort needed to penetrate several feet of concrete.

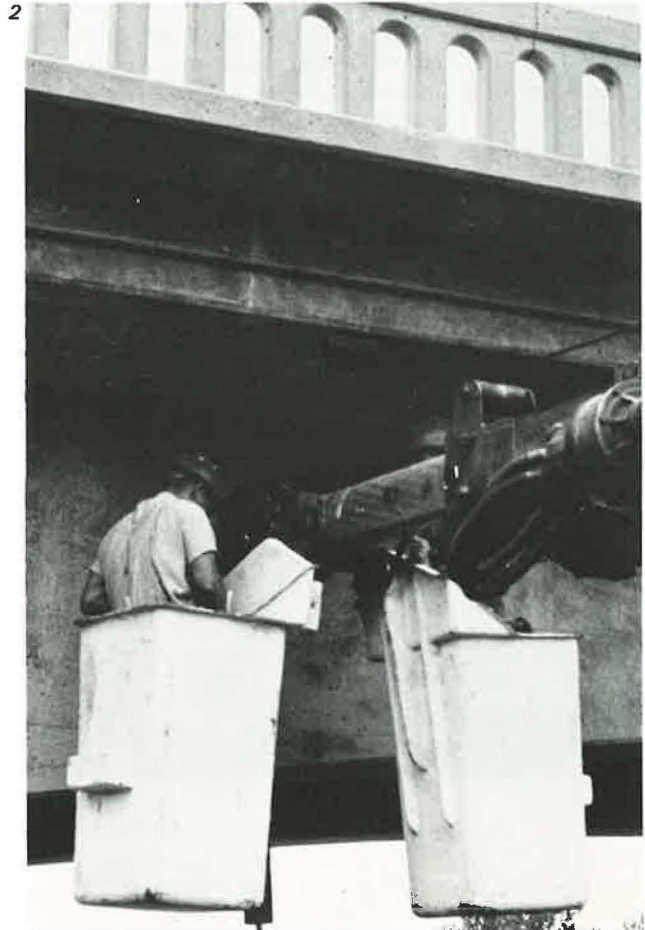
2 Maintenance crew members seal cracks in bridge girders before epoxy is pumped in from bridge deck. Low-modulus gel and silicone gap sealer were used at different stages of the research project.

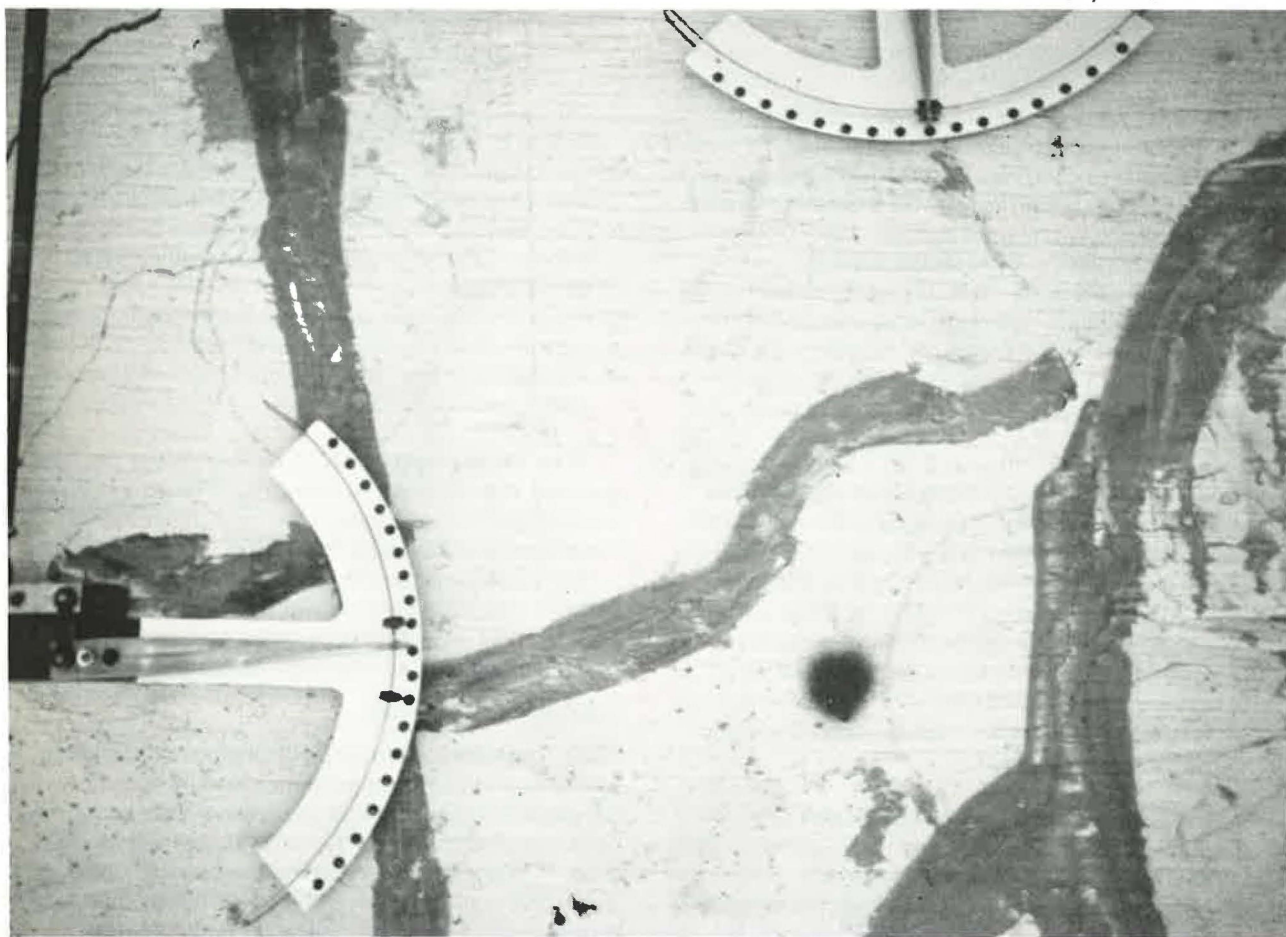
Motion detector firmly fixed to defective bridge girder shows whether the sides of the crack move in relation to each other. No movement was recorded after the epoxy injection and postreinforcement treatment was completed.
