# Impact Performance of the Minnesota 1.5-m-Radius Plate Beam Guardrail

Eugene Buth and Joe W. Button, Texas Transportation Institute, Texas A&M University  
Paul J. Diethelm, Minnesota Department of Transportation

The Minnesota Department of Transportation employs a 1.5-m-radius (5-ft-radius) plate beam end treatment for median rails at twin bridges and piers or divided roadways. The crashworthiness of this end treatment was evaluated in a program that included two full-scale vehicle crash tests. A small-size and a full-size test vehicle were towed head-on into the median rail system at 96.6 km/h (60 mph). Performance of the system was excellent in both tests.

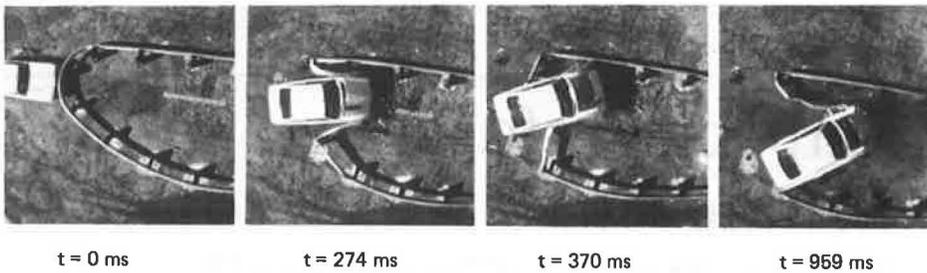
Figure 2. Test B1.

A 1971 Chevrolet Vega weighing 1039 kg (2290 lb) impacted the guardrail head-on at 99 km/h (61.5 mph) (Figure 2). On impact, the foremost post failed at ground level. As the vehicle advanced into the attenuator, the guardrail buckled and wrapped around the front of the vehicle, and posts on each side of the installation were successively broken at ground level. Significant yaw displacement of the vehicle occurred, but pitching

and rolling motions were negligible. After failure of five wooden posts and partial failure of four others, the vehicle came to rest with a yaw angle of 33 deg. The vehicle center of mass penetrated 7.1 m (23.2 ft) into the barrier.

The average deceleration of the test vehicle computed from the impact velocity and the stopping distance of the vehicle center of gravity was 5.3 *g* (1). The highest average deceleration determined over a 200-ms interval was 6.1 *g*, and over 50 ms was 9.1 *g*.

The vehicle received moderate damage in the form of distortion of front frame members and considerable sheet metal deformation. Based on the TAD scale (2), the vehicle damage rating was FD-5. The Society of Automotive Engineers (SAE) collision deformation classification was 12FDEW3 (3).

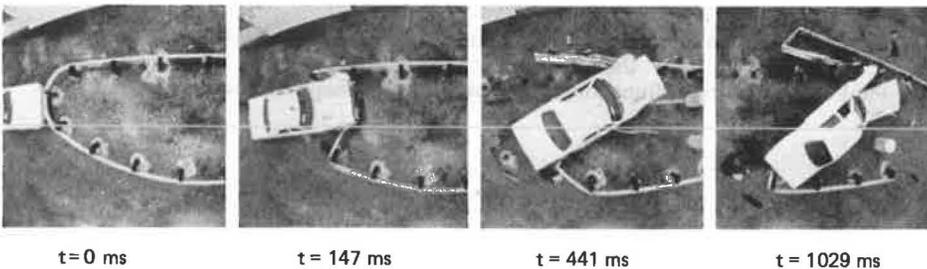
Figure 3. Test B2.

A 1969 Chrysler weighing 2041 kg (4500 lb) impacted the guardrail head-on at 100.26 km/h (62.3 mph) (Figure 3). On impact, the foremost post was broken, and the vehicle began to yaw counterclockwise as it advanced. The rail wrapped around the vehicle, and posts on each side of the installation were successively broken as the vehicle advanced. In the final stages of the collision, the rearward force on the steel guardrail caused the remaining three posts supporting the left side to split, and the guardrail fell to the ground. The test vehicle continued to advance

and yaw counterclockwise until the right front corner impacted one of the simulated concrete piers. During contact with the pier, the vehicle roll displacement reached about 45 deg. The vehicle rebounded approximately 0.61 m (2 ft) and came to rest with a yaw angle of 43 deg. The vehicle center of mass penetrated 11.83 m (38.8 ft) during impact.

Average deceleration of the vehicle computed from the impact speed and stopping distance was 3.8 *g*, which is well below the acceptable limit. The highest average longitudinal deceleration over a 200-ms interval, obtained from the accelerometer traces, was 3.4 *g*; the highest over 50 ms was 4.7 *g*.

At the time of impact with the simulated pier, the forward velocity of the vehicle had been reduced to such a level that the impact was entirely acceptable. Damage to the front of the vehicle consisted of severely deformed sheet metal and somewhat distorted front frame members. Damage to the right rear consisted of minor dents in the sheet metal. The vehicle damage rating was FD-5 and RBQ-3 (2), and the SAE collision deformation classification was 12FDEW1 (3).
