# Vertical Drains for Highway Embankments in Kansas

Paul C. Clark, Carl F. Crumpton, and William J. Gilliland, Kansas  
Department of Transportation, Topeka

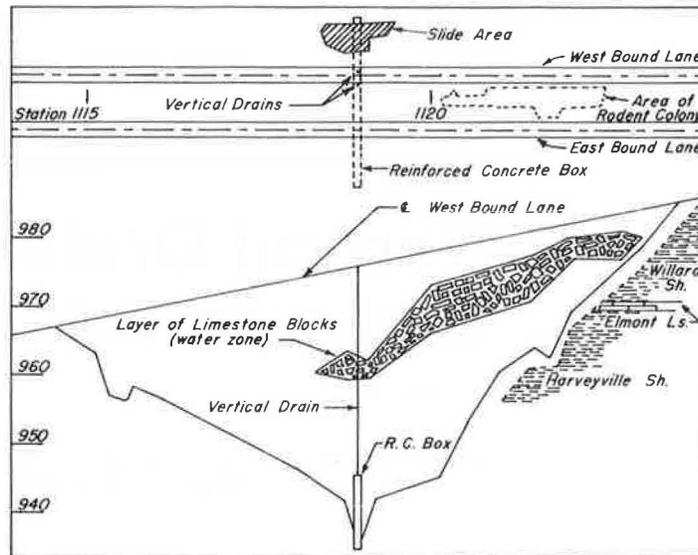
Figure 1. Plan and profile views of the fill.

In the fill discussed here the downslope movement resulted from a number of small incremental slides and has been slow over a long period of time. A row of trees approximately halfway down the fill slope has acted as an anchor and prevented the slide material from moving on down the slope, but a noticeable bulge, easily seen in aerial photographs, reveals its presence.

During the drilling program, a layer of limestone blocks and fragments saturated with water was found in the fill. The water had apparently accumulated over a period of time by the movement of surface water down through joints, cracks, and rodent burrows in the fill section, especially in the median. The water in the limestone layer caused soaking of the fill slope and provided some buoyancy, and hence contributed to the resultant incremental slides.

installed from the road surface down through the top of the reinforced concrete box at the bottom of the fill (Figure 1) and successfully drained trapped water from the fill into the underlying box. One of these drains had a maximum drainage rate of  $0.00189 \text{ m}^3/\text{s}$  (1800 gal/h), and the other of  $0.000063 \text{ m}^3/\text{s}$  (60 gal/h). They have since decreased until at times they only drip. About 8 h after a rain of 2.54 cm (1 in) or more, the flow increases considerably, and they have now drained more than  $7200 \text{ m}^3$  (1.9 million gal) of water from the fill. (Even more was removed from one of the other fills.) With the trees helping to hold the slide and the drains keeping the water from building up, it is believed that this slide will not progress and that no other repair is needed.
