In-Place Roadway Foundation Stabilization

Richard P. Murray

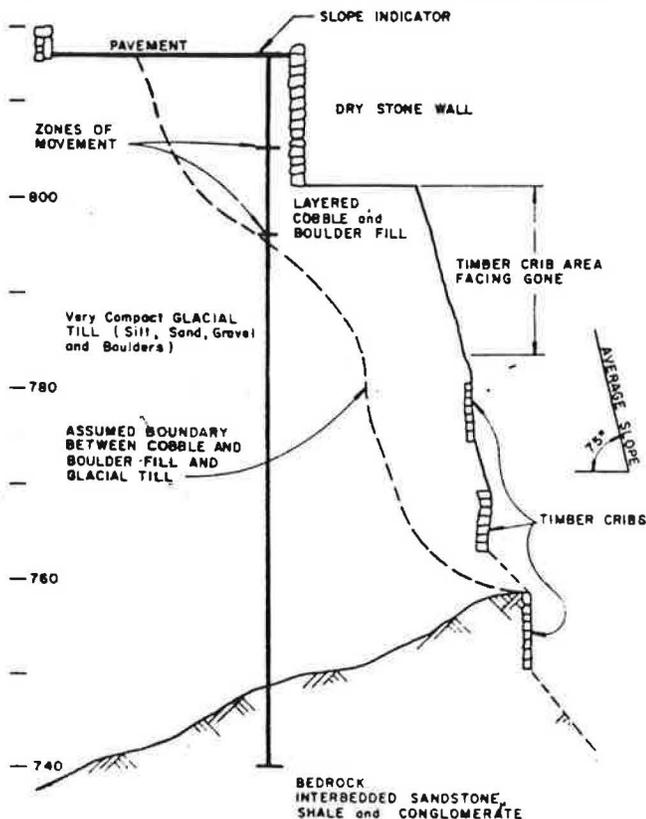
Figure 2. Cross section of critical section showing need for stabilization.

A cross section of the landslide area shows the need for stabilization (see Figure 2). The embankment slope combining the stone wall and the series of timber cribs

has an overall inclination of about 75°. Borings taken adjacent to the dry stone wall showed a layered cobble and boulder fill over very compact glacial till that extends to bedrock. Borings taken on the uphill side of the road did not encounter the cobble and boulder fill.

Slope indicator data showed movements at 3 m (10 ft) and 5.8 m (19 ft) below the roadway surface. The movements at 3 m were related to displacement of the dry stone wall. In 1977, a portion of this wall appeared ready to collapse and was replaced. The continuing movements at 5.8 m were approximately at the interface between the cobble fill and the glacial till (thus reinforcing the failure-mechanism theory that the deterioration of the timber crib facing was the cause of the loss of support for the facilities above). Failure at this level would remove at least half of the roadway and thus close the road.
