## The Malibu Landslide

RAYMOND A. FORSYTH AND MARVIN L. McCAULEY

A case history of one of the most highly publicized landslides in the history of the California Department of Transportation is presented. In the spring of 1979, the recognition of an incipient and potentially dangerous massive slide above steep sandstone bluffs adjoining the Pacific Coast Highway (CA-1) between Malibu and Santa Monica necessitated closure of this vital transportation link. The installation of an extensive and unique warning system plus a rock fall catchment area permitted partial reopening one month later while the slide investigation proceeded. The correction ultimately selected involved a partial unloading and slope reinforcement. The four-way warning system proved to be extremely useful in permitting the partial reopening of the highway while providing for the general safety of the traveling public and adjacent home owners. The use of rock dowels for slope reinforcement reduced the required excavation to achieve stability by more than 1 million yd<sup>3</sup> in extremely difficult terrain.

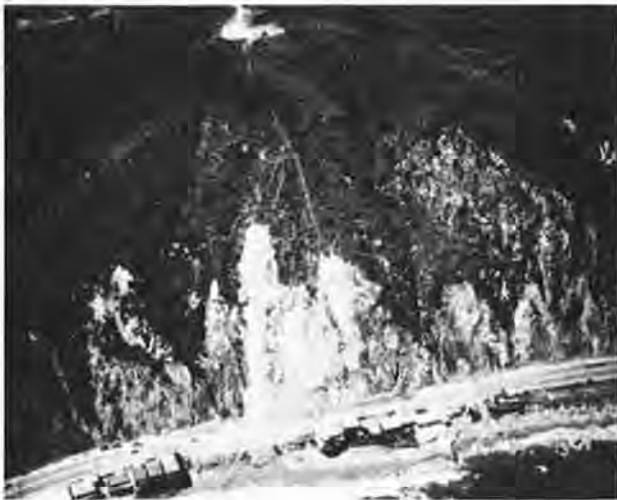
Figure 1. Oblique aerial view of Malibu slide.

bluff that shows the active slide area, the Pacific Coast Highway, and homes on its seaward side.

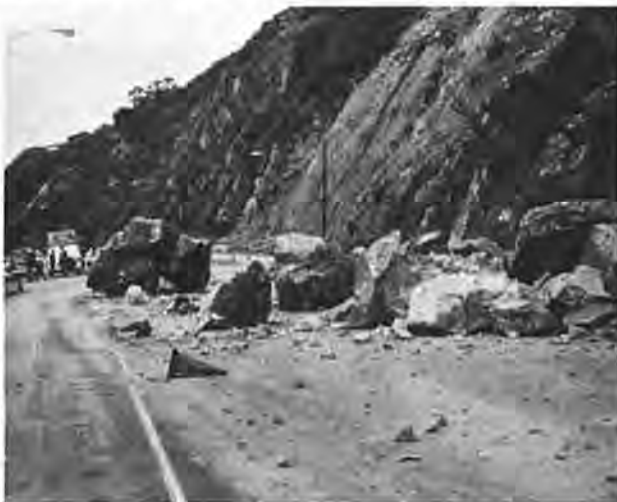
Figure 2. Rock slide on Pacific Coast Highway, April 13, 1980.

In January and February 1979, California Department of Transportation (Caltrans) maintenance personnel observed a significant increase in the number of rock falls along this stretch of the highway. One extremely large rock (>100 tons) appeared to be precariously balanced on the bluff face and was judged to be a menace, not only to the heavy traffic on the highway (average daily traffic = 30 000 vehicles) but also to the homes on its seaward side. Removal of the rock was accomplished on February 16, 1979, by emergency contract. On April 13, 1979, a rock fall occurred that was of sufficient magnitude to warrant closure of the Pacific Coast Highway (see Figure 2).

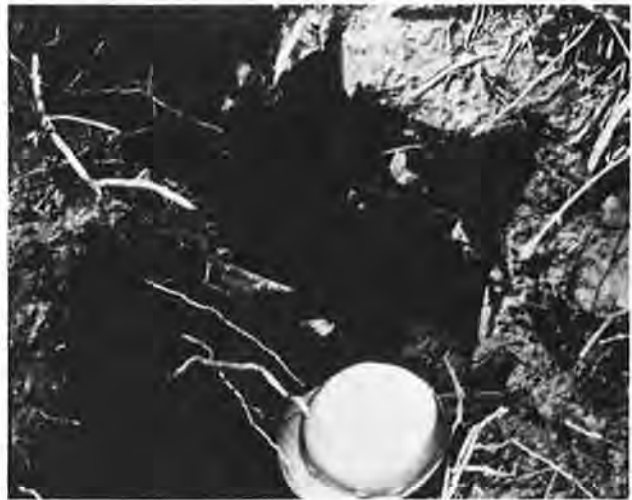
A subsequent field review of the area by Caltrans geologists and engineers immediately above the bluff where the closure had been made revealed an extensive system of cracks and fissures extending as far as 350 ft up slope from the bluff face. The generally geometric pattern of the cracks and the 1.5-ft-wide, 3-ft-deep scarp at the head of the slide, shown in Figure 3, indicated the existence of an unstable mass of up to 60 000 yd<sup>3</sup> of soil and rock

Figure 3. Fissure at head of slide.

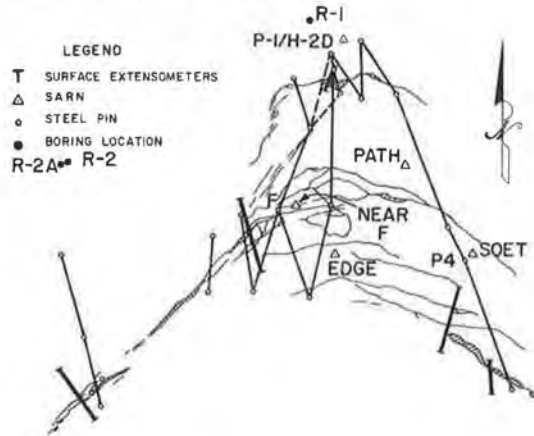
Three "early warning systems" were installed in the badly fissured area above the bluff between mid-April and early May. A plan view of the monitoring system is shown in Figure 4. Steel pins were driven into the slope at various locations, and measurements were taken between them on a daily basis so that the rate of movement across various segments of the hillside could be determined. Beginning April 18, four acoustic emission [subaudible rock noise (SARN)] stations were established for the purpose of obtaining a relative measure of slide activity. These microacoustic devices consist of highly sensitive geophones capable of sensing rock noise well below human acoustic range. Individual clicks or events per minute at a given site are counted by trained personnel (see Figure 5). Having established a background level of activity for a particular site, an increase in events or counts per minute provides warning of mass movement. Eventually, six acoustic emission stations were established and monitored on a near-continuous basis. On the even-

Figure 4. Malibu slide instrumentation.

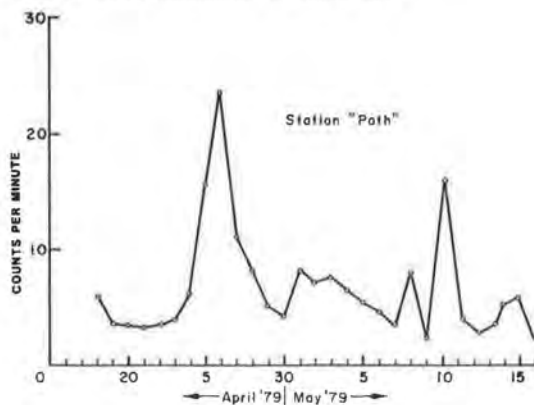
ing of April 25, three of the six stations then in operation indicated a sudden acceleration in count rate, which prompted closure of the pedestrian walkway along the highway. A plot of counts per minute versus time for one such station (PATH) is shown in Figure 6. Three days later, noise levels dropped to the original background level so that reopening of the walkway was permitted.

Figure 6. SARN measurements for Malibu slide.

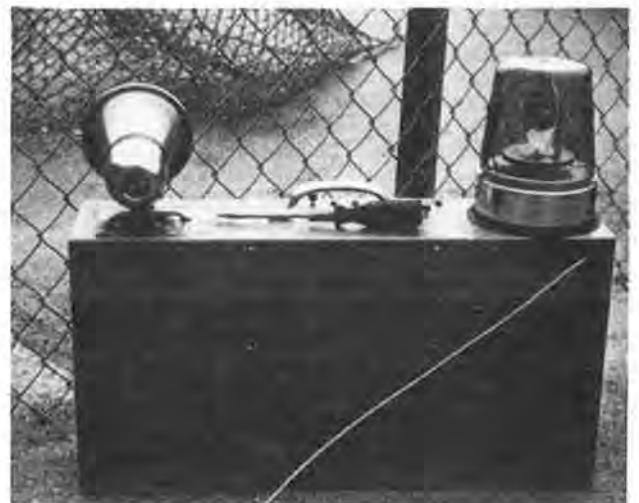
The two monitoring systems described required the presence of surveyors or geophysicists on a continuing basis. It was deemed extremely hazardous for personnel to work on the unstable and very steep bluff at night for monitoring purposes. With this in mind, a third warning system was installed that would automatically trigger an alarm at roadway level in the event of significant slope movement. These devices, designated as "surface extensometers", were installed across selected zones of high activity based on previous survey measurements. They consisted of wire several feet long connected to two steel pins 3-4 ft above the ground surface (see Figure 7). A constant tension was maintained by a spring mounted in a metal housing attached to the system. Movements exceeding 0.15 ft closed an electrical contact, which in turn would trigger a battery-driven alarm system at roadway level. The alarm itself consisted of a flashing yellow light and an air horn (see Figure 8).

Figure 8. Surface extensometer alarm system.

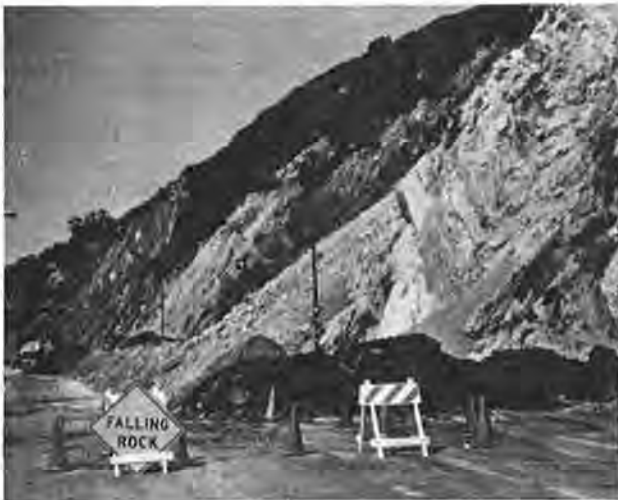
Concurrent with installation of the monitoring systems, a soil-and-rock berm approximately 8-10 ft high was constructed near the toe of the slope. This berm consisted primarily of slide debris that covered the northbound outer lane (see Figure 9). A 10-ft-high chain link fence was installed on top of the berm. The purpose of the berm-fence system was catchment of small earth and rock falls, which would safely permit the opening of the remaining three lanes. Partial opening of the highway occurred on May 6, 1980, after a period of relatively little slide activity. Shortly after the highway was re-opened, however, rock and soil falls increased in frequency and magnitude and quickly filled the

Figure 9. Soil berm catchment system on Pacific Coast Highway.

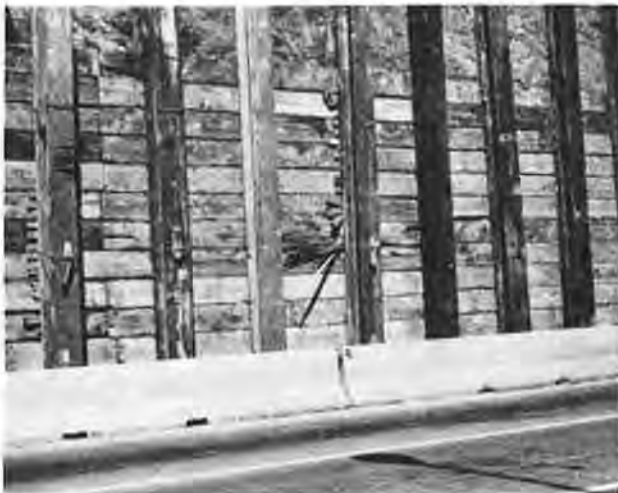
Figure 10. H-pile catchment wall and fence on Pacific Coast Highway.

catchment area. Slide activity precluded the safe removal of debris that collected behind the berm. Consequently, the Pacific Coast Highway was again closed to vehicle traffic on May 8. Construction of an improved catchment system was immediately begun. This consisted of H-beam uprights with heavy timber lagging. Individual H-piles were set in 10-ft-deep predrilled holes and backfilled with lean concrete. The H-pile wall was 12 ft in height from highway profile grade. Secured to the wall was an additional 12 ft of chain link fence for rock catchment (see Figure 10). This system substantially increased the storage capacity for rock and soil fall. On completion of the H-pile timber wall on May 20, three lanes of the highway were again opened. The new system functioned effectively throughout the remainder of the preconstruction phase of the slide.

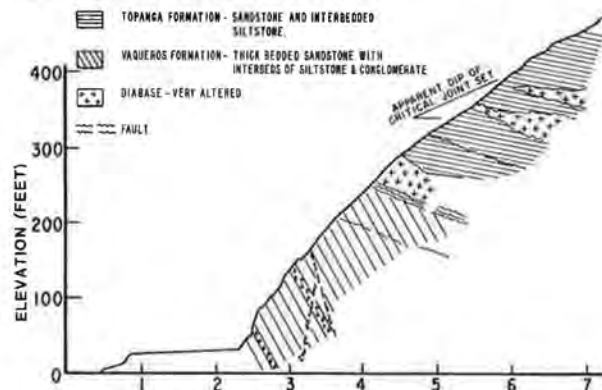
Information obtained from the exploration and monitoring indicated that geological conditions for the slope on which the material was failing differed from conditions exposed in the bluff area. This relation is consistent with geologic mapping by Yerkes and others of the U.S. Geological Survey in 1973. A generalized geologic cross section of the slide is shown in Figure 11.

Figure 11. Generalized geologic cross section.

Based on the inclination of the apparent critical joint set (Figure 11) and the residual shear strength of the dominant material, it was estimated that the flattening necessary to achieve stability without reinforcement would involve removal of from 1.5 million to 3 million yd<sup>3</sup> of material. Because of the extreme expense of the magnitude of unloading under very difficult conditions, plus obvious aesthetic considerations and lack of nearby disposal sites, the basic concept of a combined unloading reinforcement scheme evolved early in the investigation. It was postulated that an unloading of the active slide material, coupled with the use of rock dowels to "knit" or pin remaining material together, could reduce necessary excavation to approximately 150 000 yd<sup>3</sup>, or approximately 10 percent of that necessary without slope reinforcement. Improved stability with dowels was to be achieved in four ways, three of which cannot be quantified but would certainly have a significant effect. These are

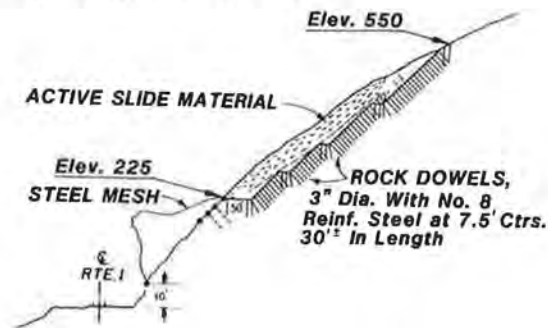
Figure 12. Typical rock dowel section.

The pattern of cracking and the types of failure that were occurring suggested that the depth of failed material was shallow. Drilling and seismic refraction indicated a thickness of about 30 ft of disturbed material. The active slide material is shown in section in Figure 12.

The final design, shown in section in Figure 12, involved unloading to a series of benches 20 ft in width separated by 1:1 slopes. The maximum depth of excavation into the slide mass would be approximately 40 ft, which, based on previous exploration, was judged sufficient to remove the failed material. Rock dowels were to be installed in the configuration shown in Figure 12 on 7.5-ft centers to a

depth of 30 ft. Each would consist of a 3-in-diameter hole in which a No. 8 reinforcing bar would be inserted, after which the hole would be backfilled with neat cement grout. In addition, placement of steel mesh over the active portion of the bluff face, also pinned with rock dowels, was planned.

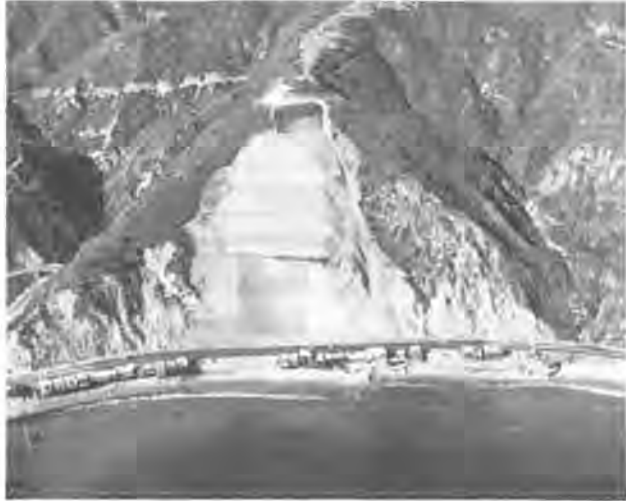
Figure 14. Completed project.

The project was completed and accepted on July 17, 1980. An oblique aerial view of the completed project is shown in Figure 14.
