Evaluation of Two Geotextile Installations in Excess of a Decade Old

BARRY R. CHRISTOPHER

Many erosion-protection installations for roadway embankments were designed and constructed by using geotextiles during the 1960s. Two such installations constructed in 1969 were studied to evaluate the long-term field performance of the facilities and the geotextile material. These projects were the 79th Street Causeway in Miami Beach, Florida, and the Bahia Honda Bridge in Bahia Honda Key, Florida. The 79th Street Causeway was constructed with a woven geotextile as a filter in a rip-rap revetment-type seawall to protect one of the bridge abutments and a segment of the causeway. The geotextile design was used in place of a conventional granular filter design to prevent erosion of the subgrade soils through the rip-rap. The protected section was designed for 3-ft waves and a 3-ft tidal variation. The Bahia Honda Bridge project was constructed with a woven geotextile as a subgrade-protection filter beneath sand-cement rip-rap-constructed bridge abutments, drains, and seawalls at both ends of the bridge. In this system, a geotextile was used to act as a filter between the rip-rap and underlyin

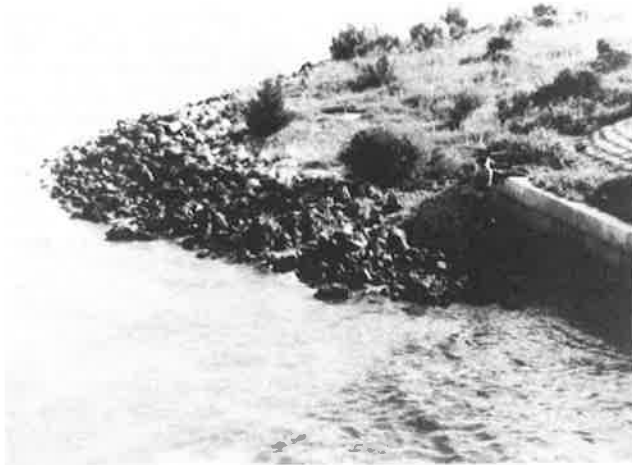
Figure 3. Limestone rip-rap covering fabric at site 1.

At site 1 an area approximately 3x12 ft was excavated with the limestone rip-rap and other materials removed by hand down to the fabric. Figures 3 and 4 show the area excavated. The surface rip-rap consisted of fossiliferous limestone boulders that had a mean diameter of 12 to 18 in. The surface rip-rap used throughout the site was highly weathered limestone, which was rough and had many sharp edges. (As an example of the abrasiveness of the rip-rap, the subsequent excavation of the rip-rap for this project resulted in the destruction of several pairs of work gloves due to abrasion.)

Beneath the large surface rip-rap a 1-ft layer of 6- to 12-in.-diameter rip-rap was encountered. Beneath the total depth of rip-rap a 3-in. layer of coarse sand and gravel was underlain by approximately 0.25 to 0.50 in. of fine to medium sand. Note that the 3-in. cushion layer of sand and gravel was not shown in the proposed design (Figure 2). The sand was located directly on the surface of the geotextile and was probably the result of sand being washed down from the upper slope above the protec-

The exposed surface of the fabric was gently washed with water to remove the sand from the surface. The fabric appeared to be in excellent condition, and no large tears or punctures were observed. Small perforations and punctures were present, which probably resulted from the placement of the rip-rap during construction. On average, two to three 0.125- to 0.25-in.-diameter holes were noted for each square foot of material. Some smaller holes were also observed. Little abrasion from sliding of the rip-rap was apparent, even though the relatively light wave action during the visit was sufficient to move rip-rap as large as 6 in. in diameter.

New fabric was placed over the excavated area with an overlap in excess of 1 ft over the old fabric. Then gravel and rip-rap were replaced in the proper order.

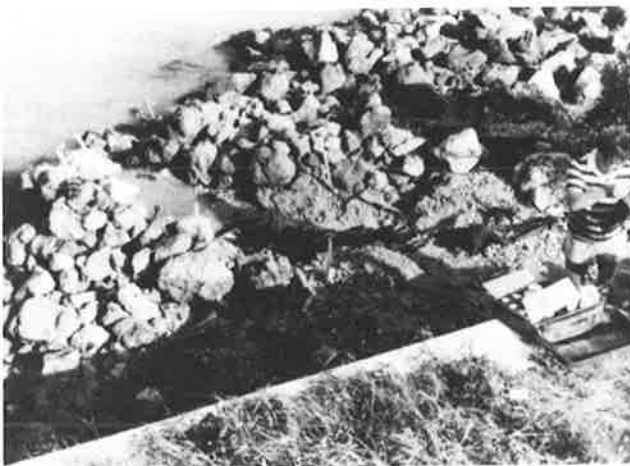
Figure 4. Excavated section at bridge abutment corner at site 1.

The geotextile was cut and carefully peeled off the underlying soils. Light was readily seen through a section of the fabric. Some particle retention was noted in the fabric; however, water was observed to readily flow through the fabric. Samples of the fabric were returned to the STS laboratory for testing.

Directly beneath the exposed section, very fine sand to silt-sized particles were noted, with grain size of the sand increasing with depth. Fine sand with less silt was observed approximately 0.5 to 1.0 in. beneath the fabric. At the lower part of the slope, gravel-sized material mixed with sand was found directly beneath the fabric. Samples of the soils encountered above and below the fabric were returned to the laboratory for further examination and testing.

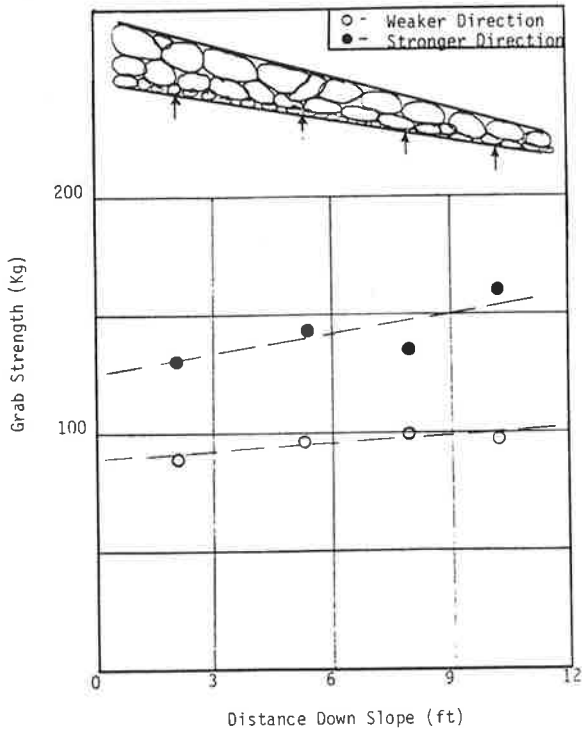
Figure 6. Strength of fabric versus position on slope at site 1.

The data in Figure 6 indicate that strength variations at site 1 may exist due to the location of the test specimens at the site. These data are based on limited testing and may be influenced by nonuniformities in the test specimens (such as perforations). Product variation may also have contributed to the relatively small variations observed. Nevertheless, the grab strength appears to increase with location in the downslope direction. The relation appears to occur for both mutually perpendicular test directions. This general pattern indicates that the observed strength differences are due to tidal fluctuations, which result in differences in exposure to water, air, and temperature.

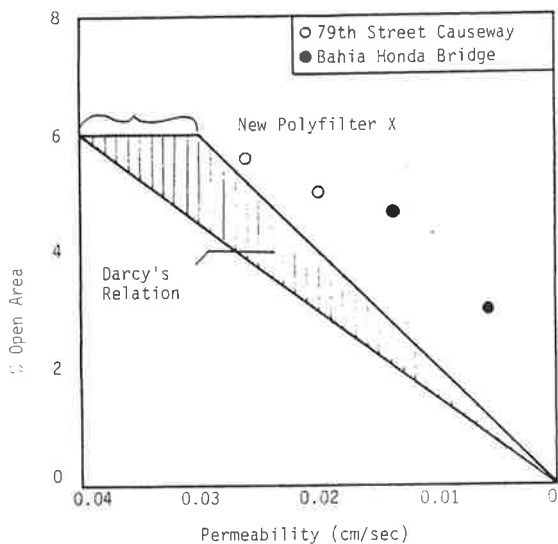
Figure 7. Relation between permeability and percent open area.

The data in Figure 7 indicate the theoretical decrease in permeability of the fabric with a decrease in the percent open area for a gradient of 1. Percent open area is defined as the area of the openings (times 100) divided by the total surface area of the unit of fabric; it is equivalent to the porosity of the soil. Note that the data in the figure are only applicable to the particular material tested; other fabrics may react in a different manner. Permeability values obtained from the field study are included on the graph. (Also included in this graph are the test values obtained from a similar fabric-exhuming project at Bahia Honda Key, which will be subsequently discussed.) Note that the decrease in permeability due to particle retention in the fabric generally follows the relation of

decrease in porosity for a soil filter. The test results do not fall within the theoretical curve, probably because actual tests were performed under a gradient much higher than 1 (10 to 3.7 cm of water over the thickness of the fabric), which probably resulted in turbulent flow.

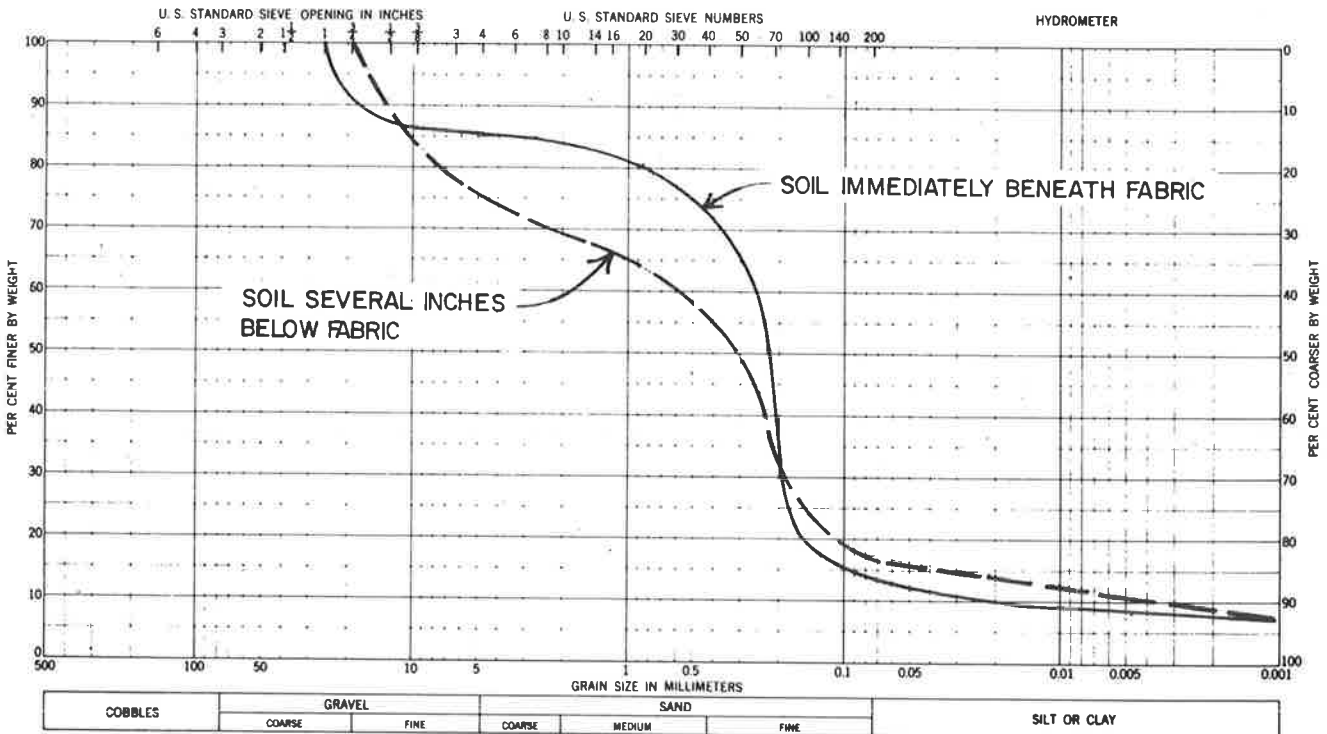
Figure 8. Grain-size distributions for soil immediately beneath and several inches below bridge abutment protection fabric from site 1.

Grain-size distribution curves for the soil from 0 to 0.25 in. below the fabric and soils several inches below the fabric for sites 1 and 2 are shown in Figures 8 and 9. The fabric retained medium to fine sand and silt-sized particles, with up to 20 percent passing a No. 200 mesh sieve. Up to 50 percent of the soil particles directly against the fabric were smaller than the fabric opening. This is in agreement with the work on filter media done by Calhoun (2) and Cedergren (3).

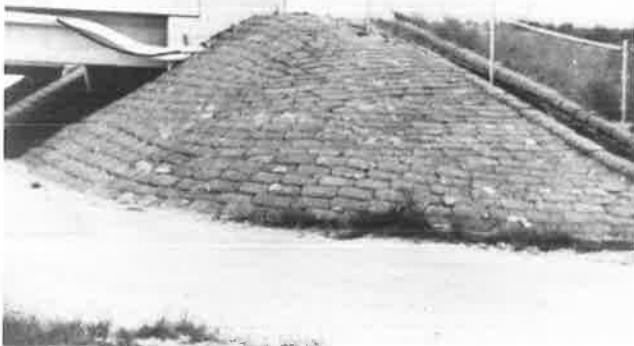
Figure 12. Armoring system: bridge abutment and drain, Bahia Honda Bridge.

stability of the sand-cement constructed facilities, as shown in Figures 12 and 13. No erosion problems were apparent at any of the drains, slopes, and seawalls protected by the sand-cement armoring system, which indicated that the installation was functioning as designed. The armoring, in most cases, has held up completely. Some surface wear was noticeable; however, no washouts of the rip-rap were observed.

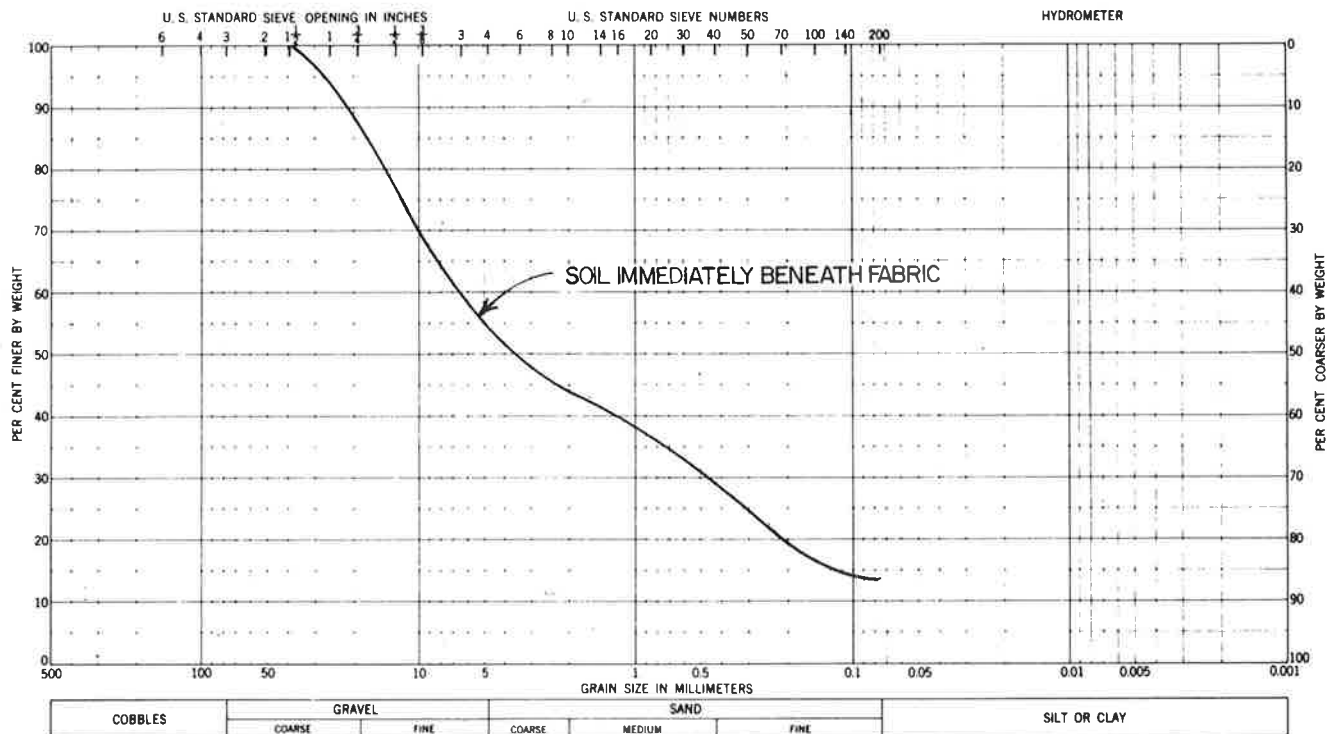
Figure 14. Grain-size distribution of soil immediately beneath fabric in bridge abutment.

The grain-size curve for the material retained by the fabric is shown in Figure 14. The fabric was generally found to retain medium- to fine-sand-sized particles, with up to 15 percent silt. The Poly-

Filter X used in the installation had an opening size equivalent to a No. 70 mesh sieve. The data in the figure reveal that 20 percent of the soil particles directly behind the fabric were smaller than the fabric openings. When used in drainage applications the fabric has been able to retain particles in which the equivalent opening size of the fabric is less than or equal to the D85 (mean particle diameter of 85 percent of the material) size of the protected soil. However, for wave action problems, model studies should be performed to analyze cyclic gradients.
