## Field Tests of Rapid Repair Methods for Bomb-Damaged Runways

A.H. MEYER, D.W. FOWLER, AND B. FRANK McCULLOUGH

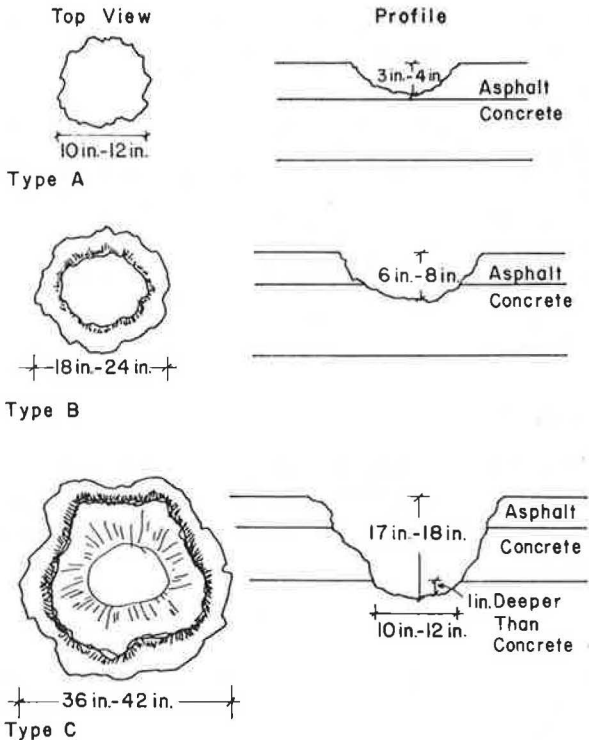
Figure 1. Typical spall repair sections.

The series was made up of five sets of three spalls, each set having a small, medium, and large spall. Type A spalls were small, type B were medium, and type C were large (Figure 1). Three sets were repaired by using the user-formulated (UF) system and an in-line mixing gun. From this series of tests, the concept of the in-line mixing gun was verified. This concept allows the chemicals to be mixed at the point of application and minimizes exposure of personnel to the chemicals. The tests also verified that debris can be used for at least part, if not all, of the aggregates required, provided some select material is available for finishing. It should be noted that the debris used did not contain large chunks or a significant amount of asphaltic materials.

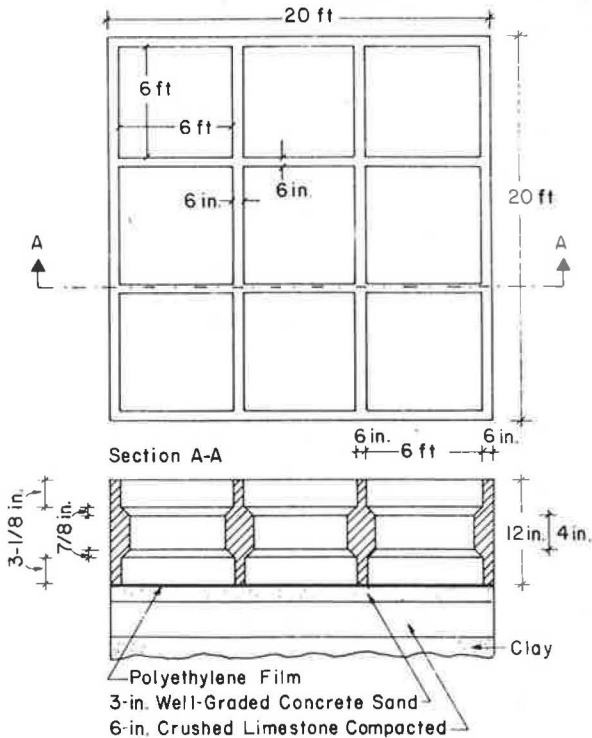
Figure 2. Pit 2.

Pit 2 was repaired by using the at-grade precast slab method. The base of the pit was a clay layer some 21 in. below the grade surface. A 6-in. layer of crushed limestone was compacted over the clay, and a 3-in. sand leveling course was placed over the crushed limestone. Figure 2 gives a plan view and a cross section of pit 2.

Pit 2 was then tested with the load cart; 150 coverages of the F-4 load cart and 70 coverages of the C-141 load cart were used. A coverage is a function of the number of operations at full load, configuration of the wheels, and wander of the aircraft. One coverage of the F-4 load cart is roughly equivalent to 50 passes of the aircraft and one coverage of the C-141 load cart is roughly equal to 10 passes. The repair showed no visible signs of deterioration. The profile of the repair remained virtually unchanged from the beginning to the end of load-cart testing, and from the profile data the riding quality was excellent, because there was little change in elevation across the slab.

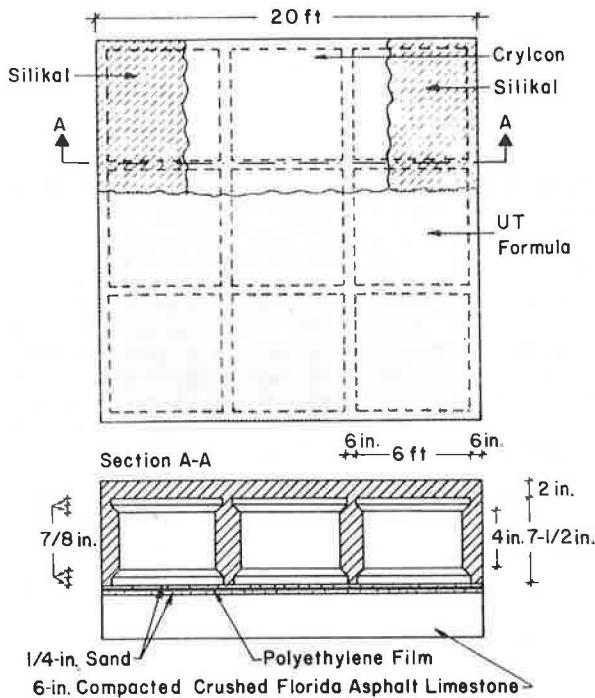
Figure 3. Pit 3.

Pit 3 was repaired by using a combination of the precast slab and the cap methods of repair. The base of the pit was a clay layer [California bearing ratio (CBR) = 4] covered with 6 in. of compacted,

crushed limestone. The 8-in. precast slabs were then placed on the crushed limestone. Polymer concrete was placed around and over the slabs to bring the repair to grade. The PC cap over the slab was nominally 2 in. thick (Figure 3).

Pit 3 was load-cart tested in the same manner as pit 2, and analysis of the profile data revealed essentially no change in profile from beginning to end of load-cart tests. The profile data also illustrate excellent riding quality in that the maximum change along any profile line was 0.09 ft (1.08 in.) in 20 ft.

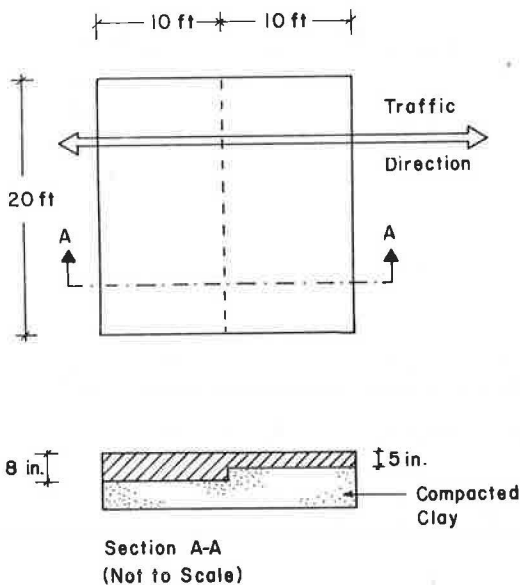
Figure 4. Pit 1.

Pit 1 was repaired by using UF polymer concrete. The base of the pit was clay. The repair consisted of two parts; half of the PC cap was nominally 8 in. thick and half of the repair was nominally 5 in. thick (the actual average thickness was 4.5 in.). A cross section of pit 1 is shown in Figure 4. The clay under the 8-in. section had a CBR of 6, and the clay under the 5-in. section had a CBR of 3.

The UF polymer concrete was placed in pit 1 by using the concrete mobile as in pit 3. After placement, the polymer concrete was screeded and finished. Thermocouple data from both the 5-in. and the 8-in. sections revealed expected values for both peak temperature (approximately 80 to 90°C) and time to peak exotherm (approximately 30 to 35 min).

The repair was load-cart tested with 150 coverages of the F-4 load cart and 70 coverages of the C-141 load cart. Analysis of the profile data reveals no significant changes in elevation from beginning to end of load-cart testing. The average change in elevation is 0.002 ft (0.03 in.); the maximum difference at any location is 0.03 ft (0.4 in.). Analysis of the profile lines reveals a maximum change of 0.08 ft (0.96 in.) in 20 ft. This indicates that the riding quality would be adequate for air traffic.
