Durability of Drainage Structures

KENNETH M. JACOBS

ABSTRACT

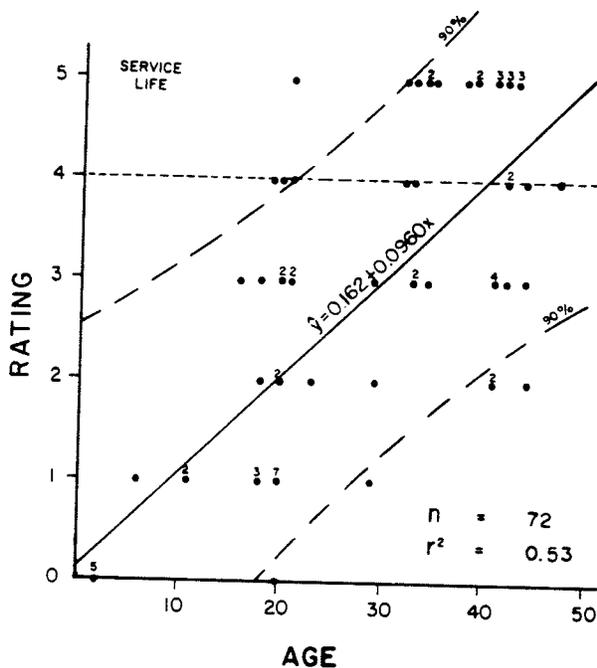
FIGURE 3 Condition versus age for BCCMP, 14 gauge.

An evaluation of 103 BCCMPs, ranging in age from 2 to 44 years, was completed. An approximate service life of 40 years was determined based on a sample size of 72 BCCMPs that were 14 gauge. The r^2 for the linear regression was found to be 0.53. The confidence limits for BCCMP are quite wide (see Figure 3). This value (40-year service life) was in close agreement with results of a study by Jacobs (2), which estimated a 42-year service life for 14-gauge BCCMP (see Figure 3).

If the bituminous paved invert adhered to the corrugated metal pipe, it provided the added service life anticipated. However, in many instances there appeared to be delamination of the paved invert after only a short period, whereas other installations with 20 years or more of service were completely intact. This inconsistency of performance for the paved invert is somewhat reflected in the low r^2 value for the BCCMP. A multiple regression was computed to determine what influence resistivity, pH, stream flow, and age had on the dependent variable condition and to determine if these variables were statistically significant. Resistivity was found not to have a significant effect on condition, whereas pH and age did have a significant effect at the 1 percent level and stream flow was significant at the 5 percent level. The reason resistivity may not have had a significant effect on condition was that resistivity values were generally quite high.

Based on service life values for CMP and BCCMP, it appeared that bituminous coating added approximately 7 to 8 years to the service life, allowing for gauge difference (see Figures 3 and 4).

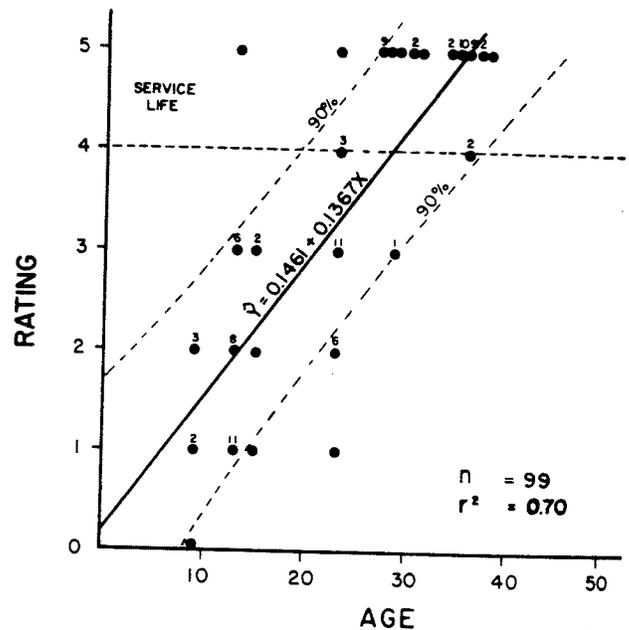
FIGURE 4 Condition versus age for CMP, 16 gauge.

The evaluation of CMP consisted of 99 structures ranging in age from 9 to 45 years. The estimated service life for CMP was found to be approximately 28 years for 16 gauge. The estimated service life was determined from the data by using a weighted value of 0.81 for the 14-gauge culvert pipe and the linear regression computed as shown in Figure 4. For those culverts cored, the average metal loss per year was 0.0021 in., with a standard deviation of 0.0006 in. The linear regression was found to have an r^2 of 0.70. The confidence band for CMP was considerably narrower than for BCCMP (see Figures 3 and 4). Thus the estimated service life by the condition rating was within approximately 7 percent of that for the average metal loss per year (i.e., a 16-gauge pipe had an estimated average service life of 30 years based on an average metal loss of 0.0021

in. per year). The rate of deterioration was somewhat less for the 14-gauge culverts than for 16-gauge culverts. This may be the result of the scale providing protection for a period of time.

The analyses of the multiple regression, as in the BCCMP analysis, indicated that resistivity did not have a significant effect on condition, whereas pH and age did have a significant effect on condition at the 1 percent level. Stream flow had a significant effect on condition at the 5 percent level.

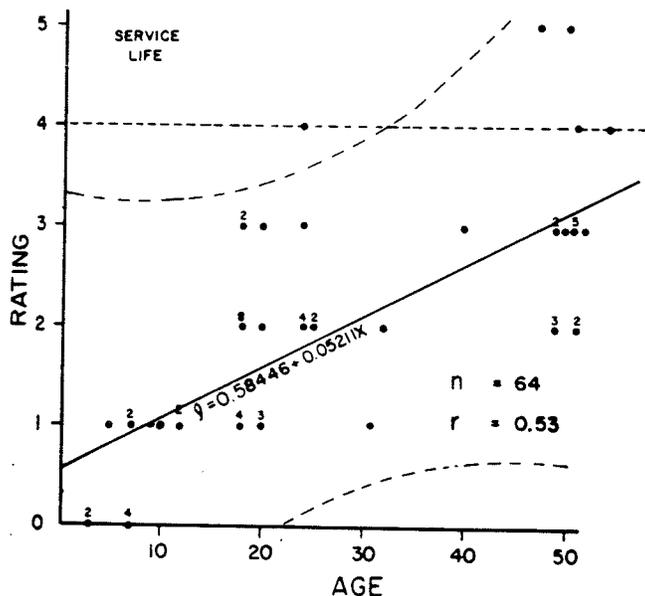
FIGURE 5 Condition versus age for RCP.

The evaluation of 64 RCPs indicated a service life of 65 to 70 years (see Figure 5). The r^2 for the linear regression was found to be 0.53, and it had a wide confidence band, as shown in Figure 5.

The independent variables pH, stream flow, and age all had a significant effect on condition at the 1 percent level.

Only two RCPs were rated as condition 5. This does not mean that RCPs that rated below 4 or 5 have not been replaced. However, the replacements for many sites were the result of frost action on the end sections or barrels of the culverts. It should be noted these older RCPs were 4-ft sections, and this may explain why the frost action destroyed the mechanical integrity of these structures.

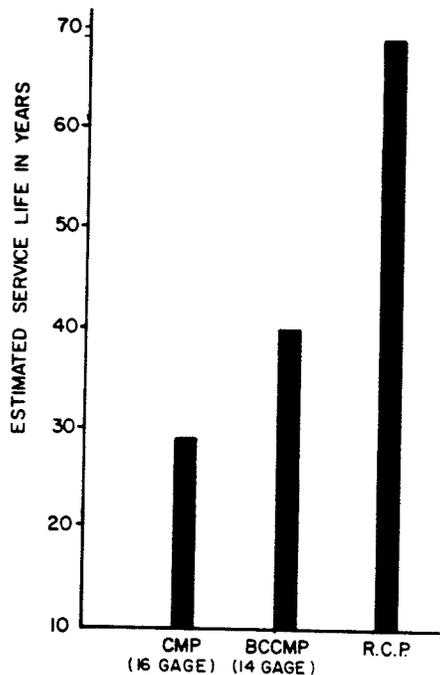
FIGURE 6 Estimated service lives for various culverts for inland waters in Maine.

A comparison of estimated service life for the various culvert materials and coatings is shown in Figure 6. Aluminum alloy and asbestos-bonded pipes

were not included in Figure 6 because of a limited data base and a limited time in service. These estimated values of service life should be reasonably accurate for Maine. The pH levels for the inland waters of Maine generally range from 5.0 to 7.5, with 6.5 to 7.0 being the more normal readings. The resistivity values for the soils adjacent to the culverts were generally 10,000 ohm-cm or greater. In reviewing the effects of resistivity early in the study, little or no correlation was found with condition. This may have been the result of higher readings, with most readings being greater than 10,000 ohm-cm.
