Overview of Polymer Coatings for Corrugated Steel Pipe in New York

ROBERT M. PYSKADLO and WALLACE W. RENFREW

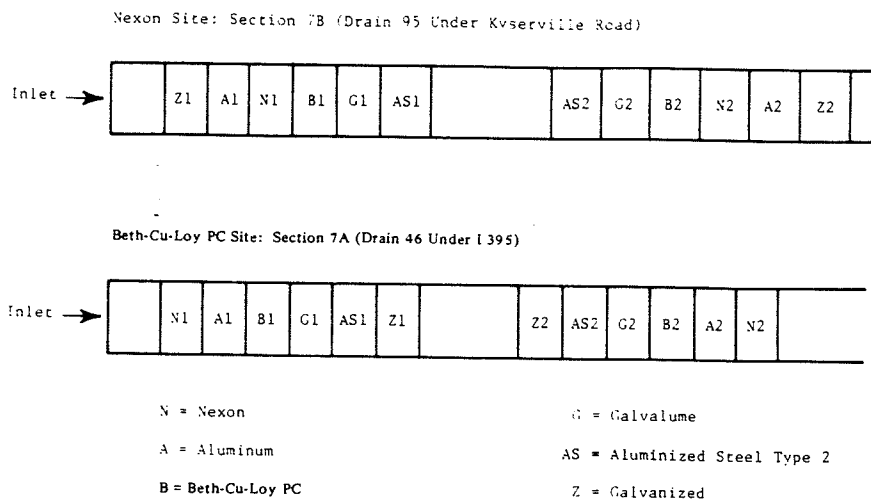
1. Section 7B (Nexon site): Nexon plates: number 1 plate--middle 12-in. path rated 3, 6-in. path on both sides rated 2, and one lock-seam rated 4 (16-by 0.5-in. peel-back); number 2 plate--20-in.-wide

FIGURE 3 Experimental plates installed in October 1981.

path rated 3.5, two crests rated 4. Beth-Cu-Loy PC plates: number 1 plate--20 in. wide rated 2; number 2 plate--18 in. wide rated 2 with slight peel-backs (8 by 0.25 in.) on two lock-seams.

2. Section 7A (Beth-Cu-Loy PC site): Both sets of polymers rated 0.

1. As expected, the 7B site is much more aggressive than the 7A site;
2. The Nexon plates are performing the same as the Beth-Cu-Loy PC plates at the 7A site, where presumably no shale is going through the pipe;
3. At the 7B site the Beth-Cu-Loy PC plates are performing better than the Nexon plates; and
4. The Beth-Cu-Loy PC plates at the 7B site are worse than any of the Beth-Cu-Loy PC pipes at the 7A site; even though the plates and the worst 7A pipe are rated 2, there are no peel-backs in the 7A pipe.
