Galvalume Corrugated Steel Pipe: A Performance Summary

A. J. STAVROS

ABSTRACT

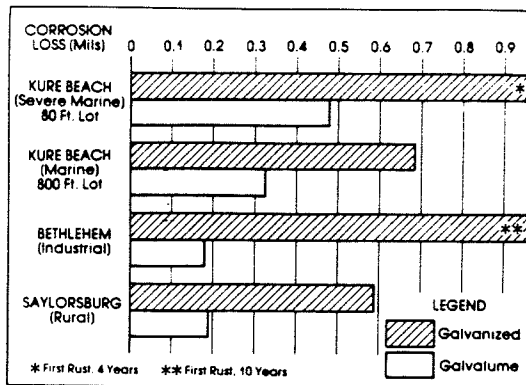
Based on 13-year exposure test results of sheet samples in severe marine, marine, industrial, and rural atmospheres, 55 percent Al-Zn coating is 2 to 4 times more durable than a galvanized coating of the same thickness [see Figure 1 (1)].

FIGURE 1 Corrosion losses of Galvalume and galvanized sheets after 13 years of exposure in the atmosphere (average top and bottom surfaces) (1).

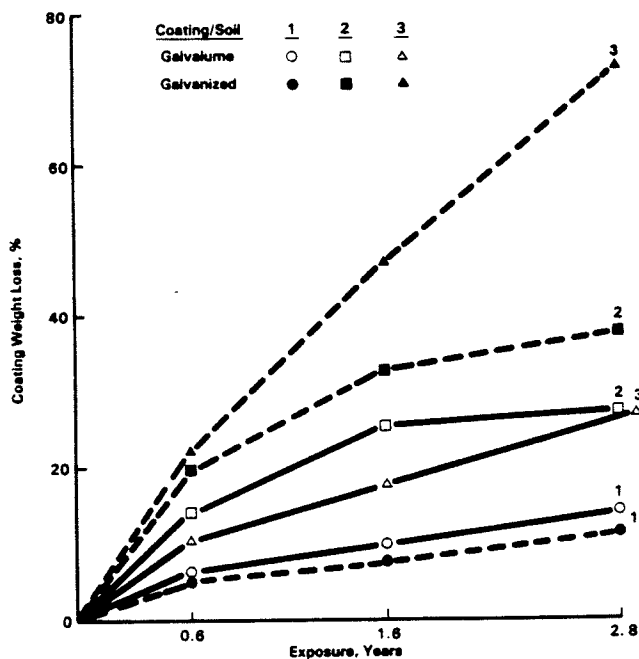
Corrosion data have been compiled for test panels removed at 0.6, 1.6, and 2.8 years (Figure 4). In the mildest Soil 1, the percent coating weight loss for the galvanized panel is less than that for the Galvalume panel, but both are low and nearly identical.

Galvanized and Galvalume panels buried in the more aggressive Soils 2 and 3 have much higher weight losses. In both soils the losses for Galvalume panels are much less than those of galvanized panels.

FIGURE 4 Coating loss in burial tests.
