## Post-Construction Evaluation of the Fremont Bridge

MICHAEL J. KOOB, JOHN M. HANSON, and JOHN W. FISHER

#### ABSTRACT

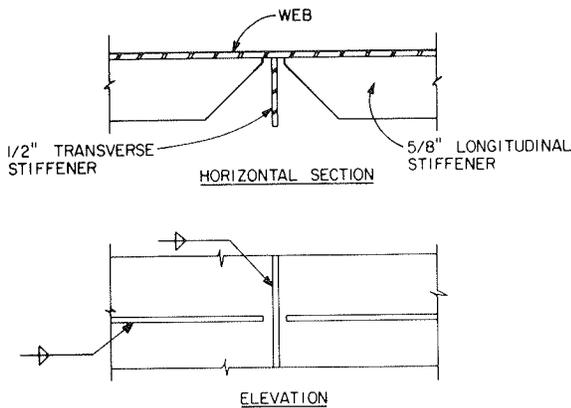
Several fatigue-sensitive conditions occur repeatedly in the tie girders. These conditions are shown in Figure 4a--the junction of the longitudinal and transverse stiffeners; Figure 4b--cover plates adjacent to vent openings; Figure 4c--slots in the bottom flange for lower deck hangers; and Figure 4d--the junction of deck beams and side plates. Terminations of fillet welds, which are parallel to the axis of the tie girder in Figures 4a, c, and d, are classified as category E by AASHTO specifications (5,6). Overlapping welds at the junction of longitudinal and transverse stiffeners and the heavy welds of the thick cover plates at the vent openings are particularly severe conditions.

(a) Junction of longitudinal and transverse stiffeners.

of all potentially critical fatigue and fracture conditions, including grinding severe gouges in all of the flame-cut openings and shot-peening weld terminations. The weld around the junction of the arch rib and exterior flange surfaces was to be removed by grinding or milling. The exterior arch rib straps are to be bolted to the webs of the girder to offset the removal of the weld around the junction. An in-depth visual inspection with non-destructive testing was recommended along with work to reduce the severity of the critical conditions.

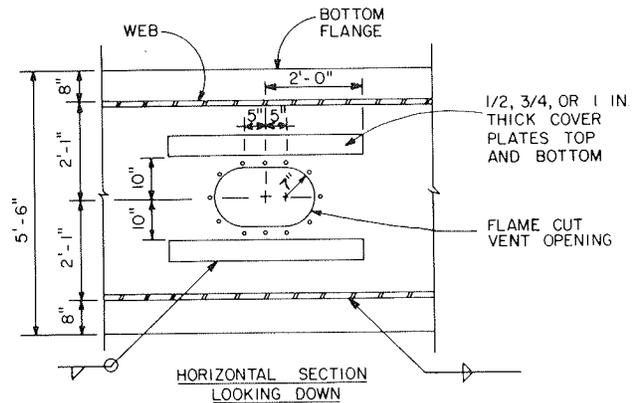
(b) Cover plates at vent opening.

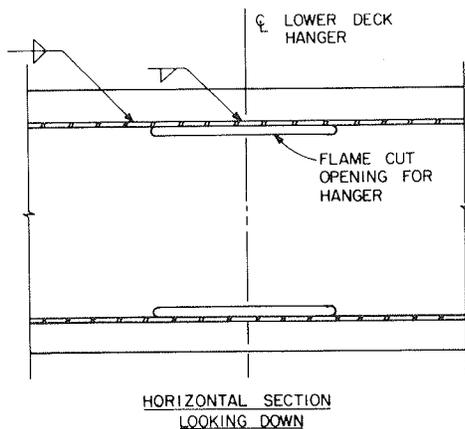
(c) Slots in bottom flange for deck hanger.

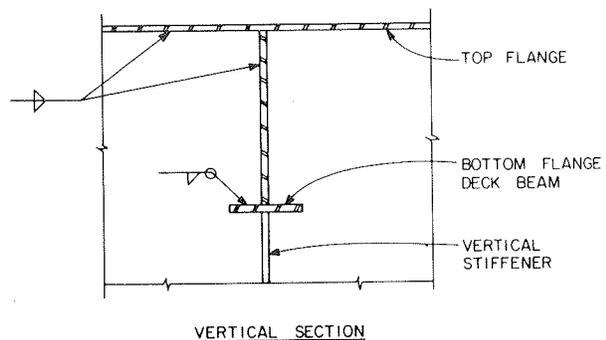
(d) Junction of deck beam and web plate.

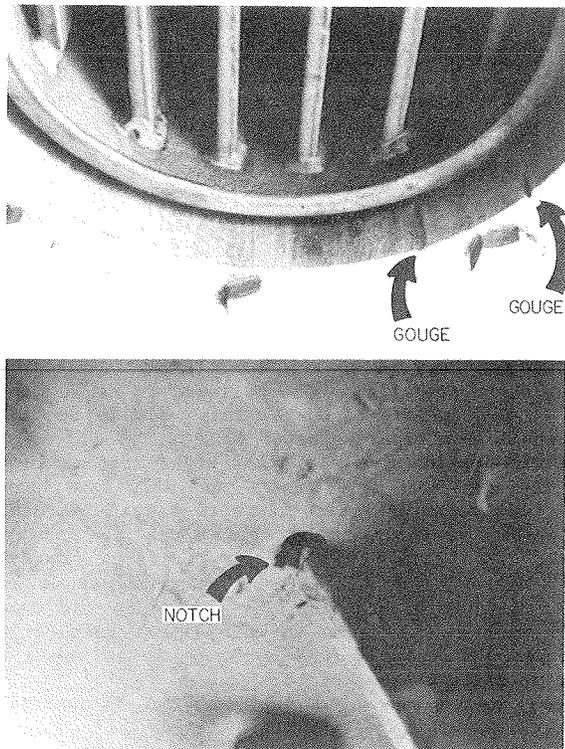
Vent and slot openings in the bottom flange were made by flame cutting. A number of these openings contained severe notches and gouges, as shown in Figure 5. These conditions do not meet the workman-

ship requirements of the AASHTO Standard Specifications for Welding of Structural Steel Highway Bridges (7).

FIGURE 5 Notches and gouges on flame-cut openings: (top) vent opening in bottom flange, and (bottom) end of hanger slot.

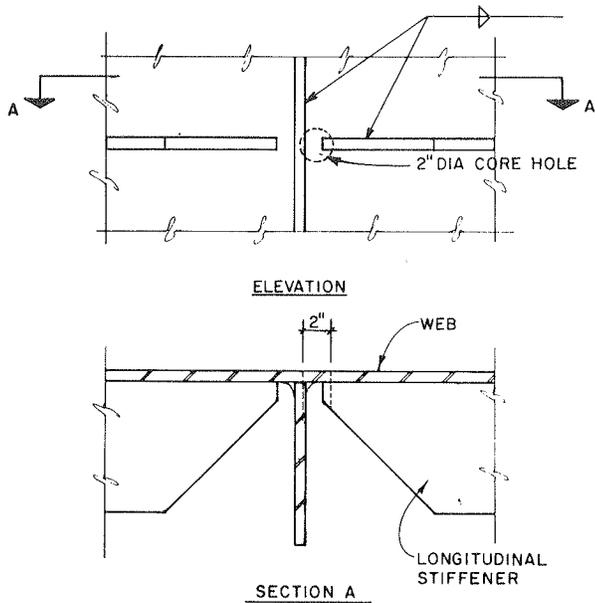
(a) C1 cores at ends of horizontal stiffeners.

Four cores were removed from the junction of longitudinal and transverse stiffeners, cut into segments, and examined. The only significant defect was found at a weld overlap, where there was entrapped slag and a small crack, which may have occurred during fabrication or handling. This condition is shown in Figure 9. No evidence of fatigue crack propagation was detected when the crack was split open for examination.

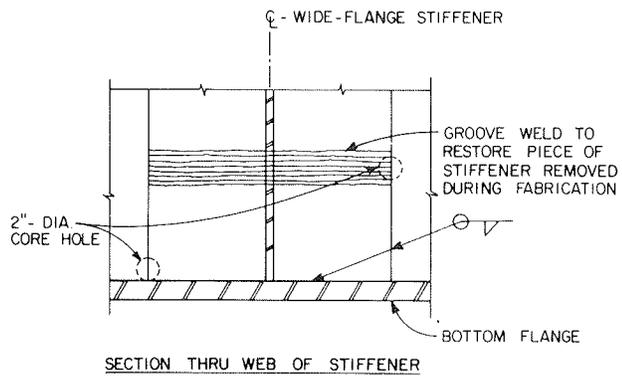
(b) C2 cores at base of wide flange stiffeners.

These cores were also cut into segments. Significant root cracking was present in all four cores, where the fillet welds connected the stiffener flange to the girder web. A typical root crack is visible in Figure 10. This crack originated from the sharp slag pocket at the vertical weld root.

It was evident that cracking at wide flange stiffener connections had developed at the time of fabrication. Two out of the four cores exhibited fatigue crack growth with a striation spacing of about  $10^{-6}$  in. per cycle. This striation spacing indicated that the crack growth rate was near the lower limit detectable by fractographic examination. These cracks were not considered to be significant. Growth was the result of stress passing from the web plate into the stiffener through the vertical fillet

welds, promoted by the existence of extensive weld root cracking. However, the crack propagates along the leg attached to the stiffener, and the lack of fusion gap between the web and stiffener flange prevents it from moving into the girder web and creating a more serious crack condition.

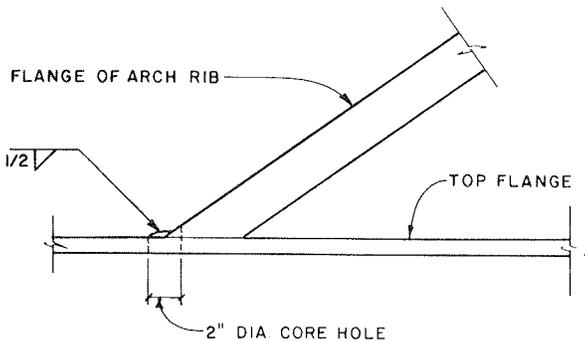
(c) C3 cores through welds at the junction of the arch rib and top and bottom flanges of the tie girder.

Four cores were extracted and cut into segments for examination. There was no evidence of cracking in any of the weldments, although it was visually apparent that sharp notch conditions exist at the weld roots. A substantial gap was present in all of the core samples between the flange and the arch rib plates. In one sample a 0.3125-in. plate was found to have been inserted to fill part of the gap between the arch rib and top flange before welding. The weld fused the insert plate and the arch rib and tie girder flanges, as shown in Figure 11. However, sharp notches were found at two locations. Slag was also apparent at the root of the weldments that connect each plate. Although no sign of cracking was detected at the weld root, the distance between the root and the outside surface was only 0.3125 in. in this core. This small ligament may be susceptible to cracking.

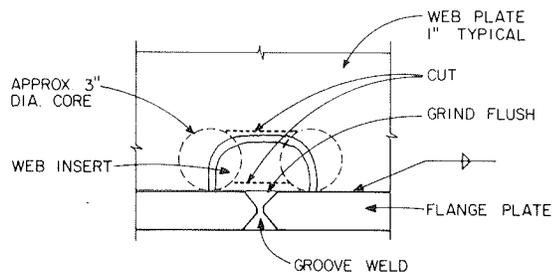
(d) C4 cores through welded inserts in web plate.

Two pairs of cores were removed from small insert plates welded into cope holes in the web, as illustrated in Figure 8d. These holes were made during

fabrication of the groove welds in the flange. The cores were sliced into segments for examination. It appeared that the welds were intended to be double V-grooves, but the root pass was not back-gouged. There was evidence of some fatigue crack growth from the larger defects. The striation spacing suggested that fatigue crack propagation was near the crack growth threshold.

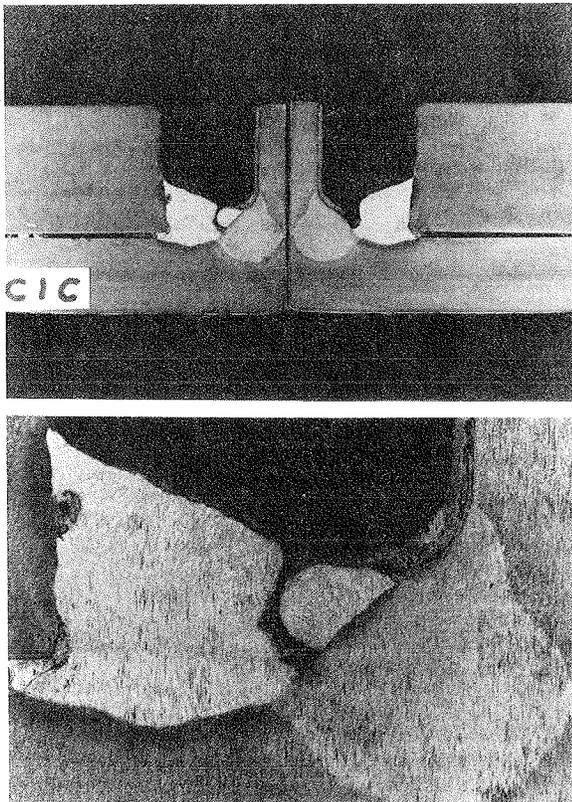
FIGURE 9 Split segments from core C1C: (top) etched cross section showing lack of fusion, and (bottom) close-up showing slag and crack in weld overlap.

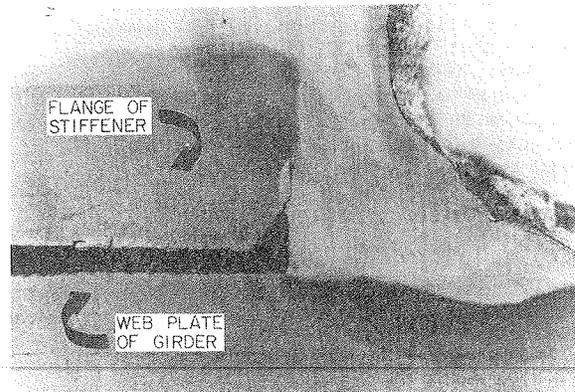
FIGURE 10 Etched surface of split segment of core C2D showing root crack from slag pocket.

Fatigue cracks that grow from fillet welds usually have a semielliptical-shaped crack front. This condition is shown in Figure 12b, where  $K_I$  is the stress intensity factor for mode I behavior. Assuming as an example that  $a$  equal to 0.20 in. and  $a/2c$  equal to 0.25 represent a small semielliptical surface crack, and taking  $Q$  equal to 1.25,  $K_I$  is approximately 0.8  $S_r$ , or  $S_r$  is approximately 3 ksi for for  $\Delta K$  equal to 2.5 ksi  $\sqrt{\text{in.}}$  Assuming larger and less tolerable defects leads to lower values of  $S_r$ . Recognizing that these stress ranges are comparable to the maximum values measured under traffic in the bridge, it is not likely that crack growth will occur from the observed defect conditions that existed in the girders. The only observed crack propagation was at larger cracks, such as shown in Figure 10.

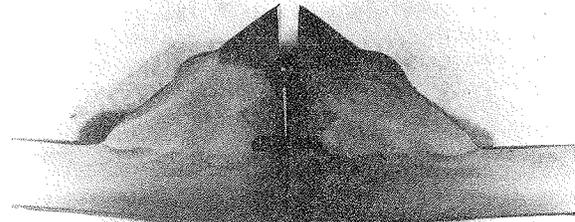
FIGURE 11 Etched sections of sample core C3C showing insert plate and notches at weld roots.
