# Kansas' Experience with Interlayer Membranes on Salt-Contaminated Bridge Decks

JOHN E. BUKOVATZ and CARL F. CRUMPTON

## ABSTRACT

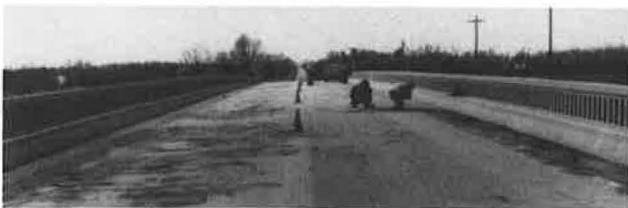
The 1967 membrane test section, membrane type 52a (Tables 1 and 2), showed a great contrast in condition between the covered and uncovered parts of the deck in 1983 (see Figure 1). (Note in Figure 1 that the deck under the membrane is in far better condition than the bare deck on the left.) All of the corrosion potentials on the uncovered deck measured more negative than -0.35 V. No measurements were made through the membrane. One-third of the resistivity readings on the membrane were more than 500,000 ohms/ft<sup>2</sup>. Patches, spalls, and hollow planes were present on 91 percent of the uncovered deck area. Only 6.5 percent of the deck in the membrane area experienced delaminations, and they were all at the edges of the membrane adjacent to the uncovered deck or along the curb. There were no spalls or patches in the membrane area. The uncovered part of the deck contained from 6 to 16 lb of chloride per cubic yard of concrete, whereas the concrete under the membrane contained only 1.5 to 3 lb Cl<sup>-</sup>/yd<sup>3</sup>. The bridge had been salted for 6 years before the membrane was placed. It is possible the deck already had as much as 3 lb of chloride per cubic yard of concrete in 1967 when the membrane was placed. The salt content was not determined at that time, however. Total traffic over the membrane had been about 3 million vehicles up to the time of the 1983 evaluation.

FIGURE 1 A 16-year-old polypropylene fabric membrane covering part of the deck in right foreground.
