Monitoring and Evaluation of High-Type Railroad Crossing Surfaces

DEAN A. MAURER

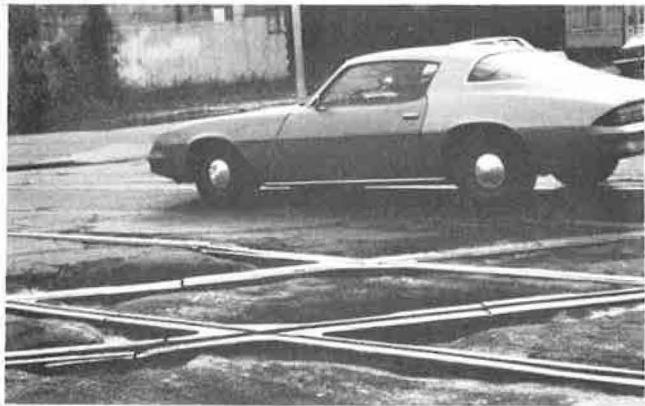
A common problem that has occurred for many years on highway systems universally has been the existence of rough and dangerous railroad crossings (Figure 1). Even though the predominant causes for the problem--excessive loading of the subgrade and inadequate drainage--have been recognized for a long time, only a limited effort has been made to correct the situation until the past decade. Starting in 1973, Section 203 of the Federal Highway Safety Act provided special funding for the construction of high-type surfaces at selected railroad-highway grade crossings. This was the start of a comprehensive program to improve grade crossings across the United States. Other improvements funded by the program include provisions for upgrading protective or warning devices and the elimination of crossings where abandonment of rail service has occurred.

FIGURE 1 A high-type crossing surface is desirable for a rough and dangerous crossing such as this.

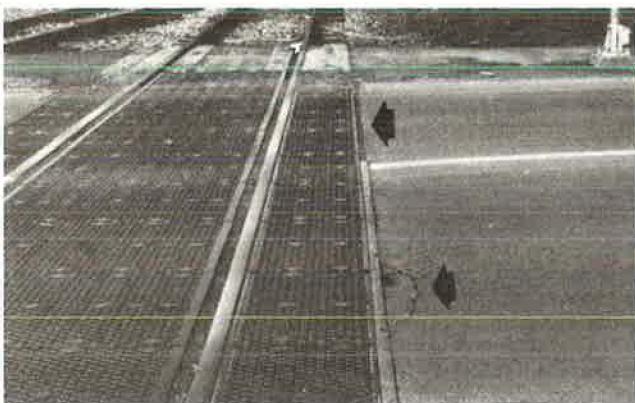
1. Inadequate compaction of subgrade, ballast, and pavement material in the area from the end of tie to the existing pavement
2. Failure to install header board
3. Misaligned and damaged header boards
4. Failure to seal or maintain pavement-crossing joint with rubberized asphalt sealant (see Figure 2)

FIGURE 2 Failure to seal joint resulted in pavement cracking. Note that one-half is sealed but has no header board and is performing better.

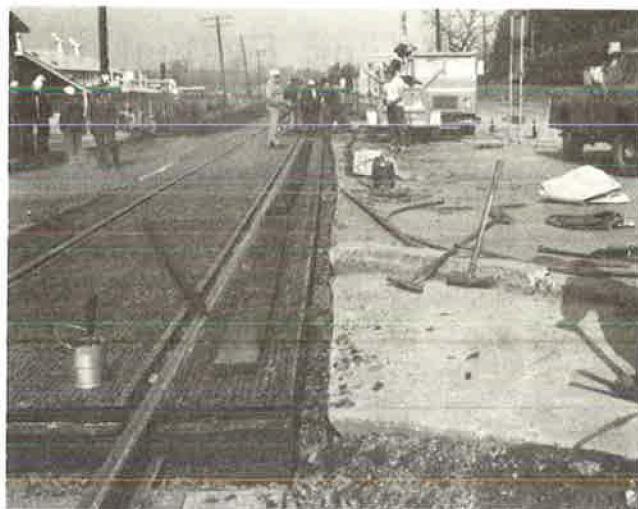
5. Inadequate existing pavement removed for crossing installation, creating a space too narrow to properly compact replacement materials (see Figures 3 and 4)

FIGURE 3 When insufficient pavement is removed for construction, it is improbable that the replacement material will be thoroughly compacted.

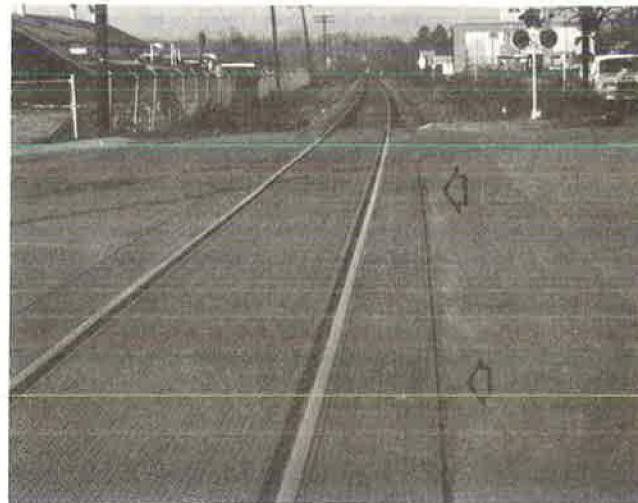
FIGURE 4 Condition of joint shown in Figure 3 after 3 years.

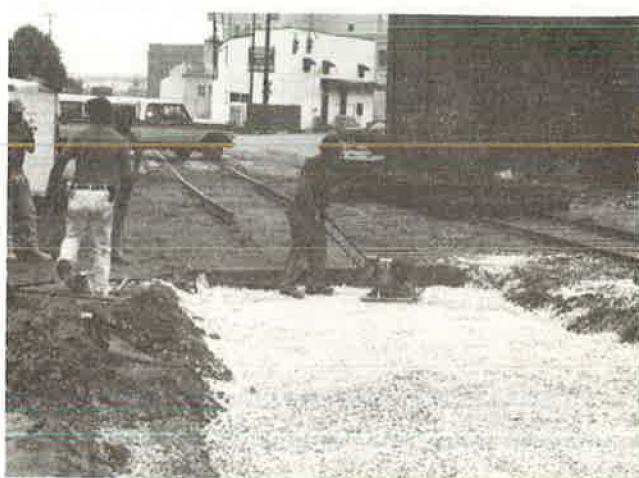
1. Inadequate ballast depth or compaction or both under rails (see Figure 5)
2. Unstable subgrade (inadequate preliminary investigation by soils engineer)
3. Inadequate or improperly installed drainage system (see Figure 6)
4. Improper establishment of highway crossing elevation

FIGURE 5 This method of compaction will not prevent settlement of track structure.

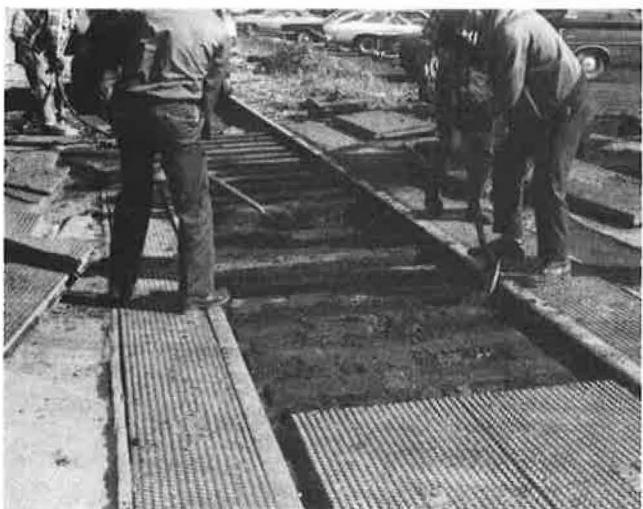
FIGURE 6 Because of a high water table and poor drainage design, crossing was completely clogged with saturated fines after only 3 years.

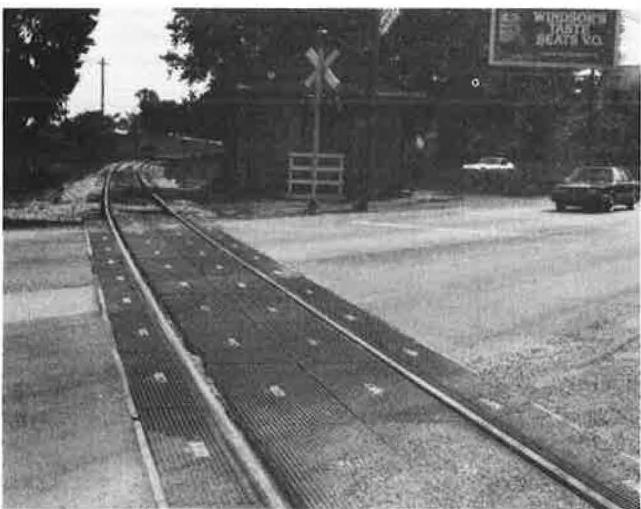
- 3. Pipe improperly sloped
- 4. *Heat-bonded geotextiles often chosen to wrap trenches, which trap water and do not provide planar flow
- 5. *Excess flow into crossing area when excessive debris and road dirt accumulate along the flange way; need for routine cleaning to maintain seal of high-type surface (see Figure 7)

FIGURE 7 Without routine cleaning, excess highway anti-skid material has accumulated in shoulder area and in flange way.
