Pavement Failure Investigation: Case Study

VISHNU A. DIYALJEE

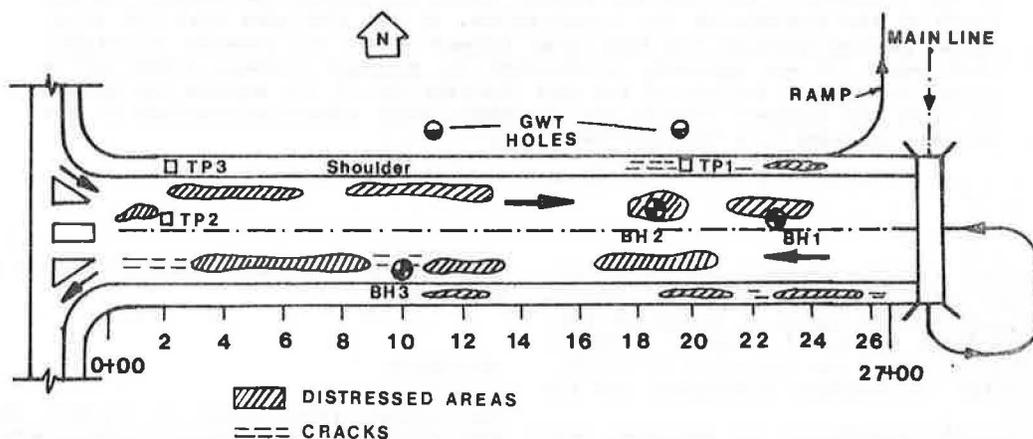
FIGURE 1 Plan of connector road.

Five boreholes, including two groundwater observation holes, and three test pits were sunk at locations shown in Figure 1. During the drilling, the following were observed:

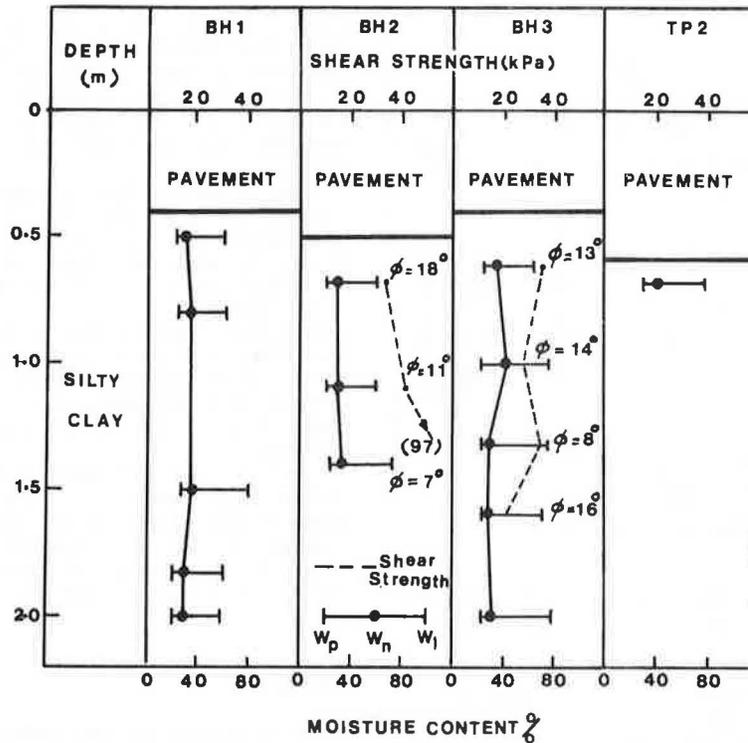
FIGURE 2 Moisture content and shear strength versus depth.

Atterberg limits, shear strength, and standard Proctor compaction results for the subgrade soil are shown in Figures 2 and 3, and California bearing ratio (CBR) test results are summarized in Table 1.

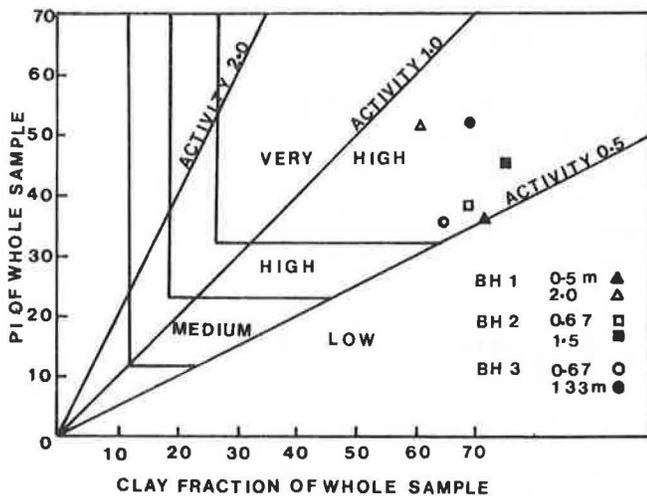
FIGURE 4 Plasticity index versus minus 2μ fraction.

The subgrade soil was mainly of the CH type and exhibited very high potential expansiveness (Figure 4) as determined from Williams' chart (2).

Although swelling of the subgrade soil can contribute to pavement failure, there was no consistent evidence from the condition survey and the soils investigation that the distress along the carriageway was caused by subgrade volume change.
