# New Mexico Study of Interlayers Used in Reflective Crack Control

VIRGINIA M. LORENZ

The objective of this study was to finalize the evaluation of several New Mexico experimental projects that were established under Category 2 experimental construction and to provide an overall evaluation of several interlayer systems that New Mexico has implemented for the purpose of retarding reflective cracking. Only the first four of the original six reported projects are discussed.

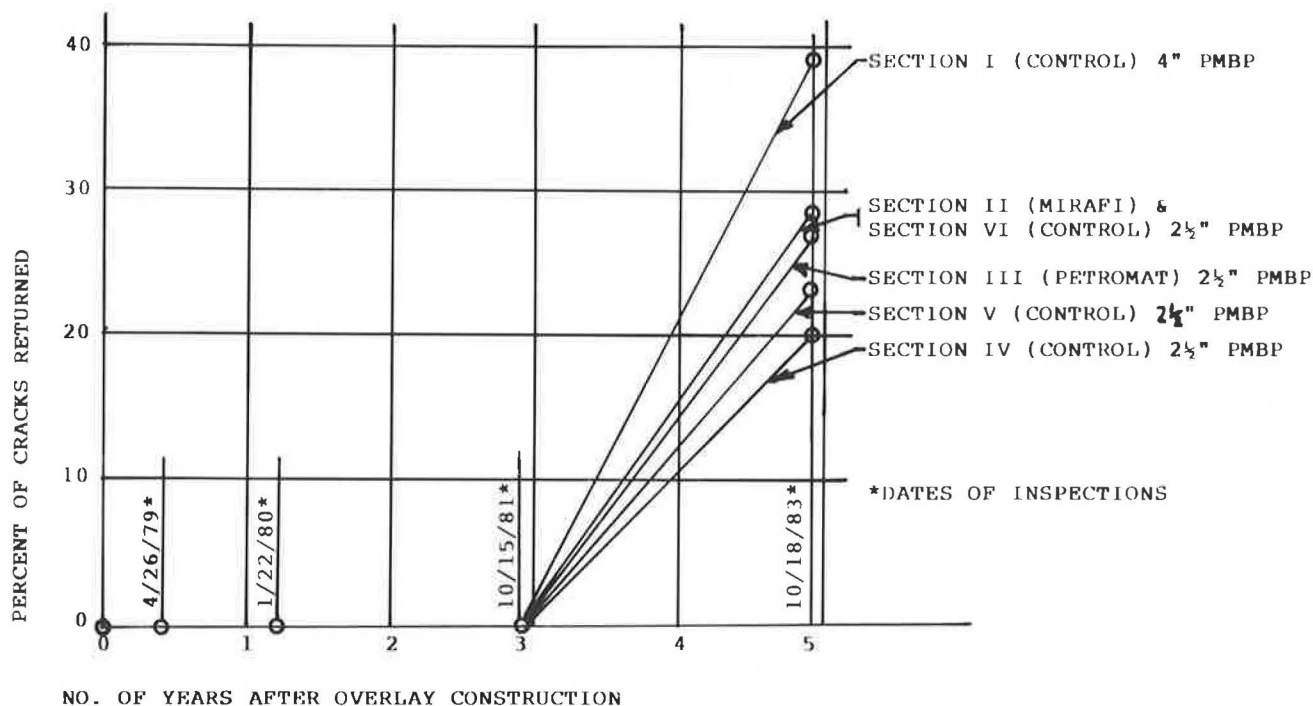
FIGURE 2 Reflective cracks versus overlay life, I-27, 7.0 mi south of Raton.

took place almost 5 years after the overlay construction. The two monitor sections with 4 in. of PMBP and no interlayer have both the greatest percentage (39 percent) and the smallest percentage (20 percent) of reflective cracks. The section using Mirafi 140 fabric had 28 percent of the cracks return. The section constructed with Petromat fabric had 27 percent of the original cracks return. Where a 2½-in. layer of PMBP was built without an interlayer, 23 percent of the original cracks reflected through in one section and 28 percent occurred in the

other section. Figure 2 is a graph of the percent of cracks returned versus the number of years since the overlay was constructed. As shown, after almost 5 years of service, fewer than 30 percent of the cracks reflected through the overlay in five out of the six sections. The pavement distresses that developed indicate that the reflective cracks could be caused by repeated traffic loads. The Petromat section and two control sections had the best performance of all the experimental sections in reducing reflective cracking.

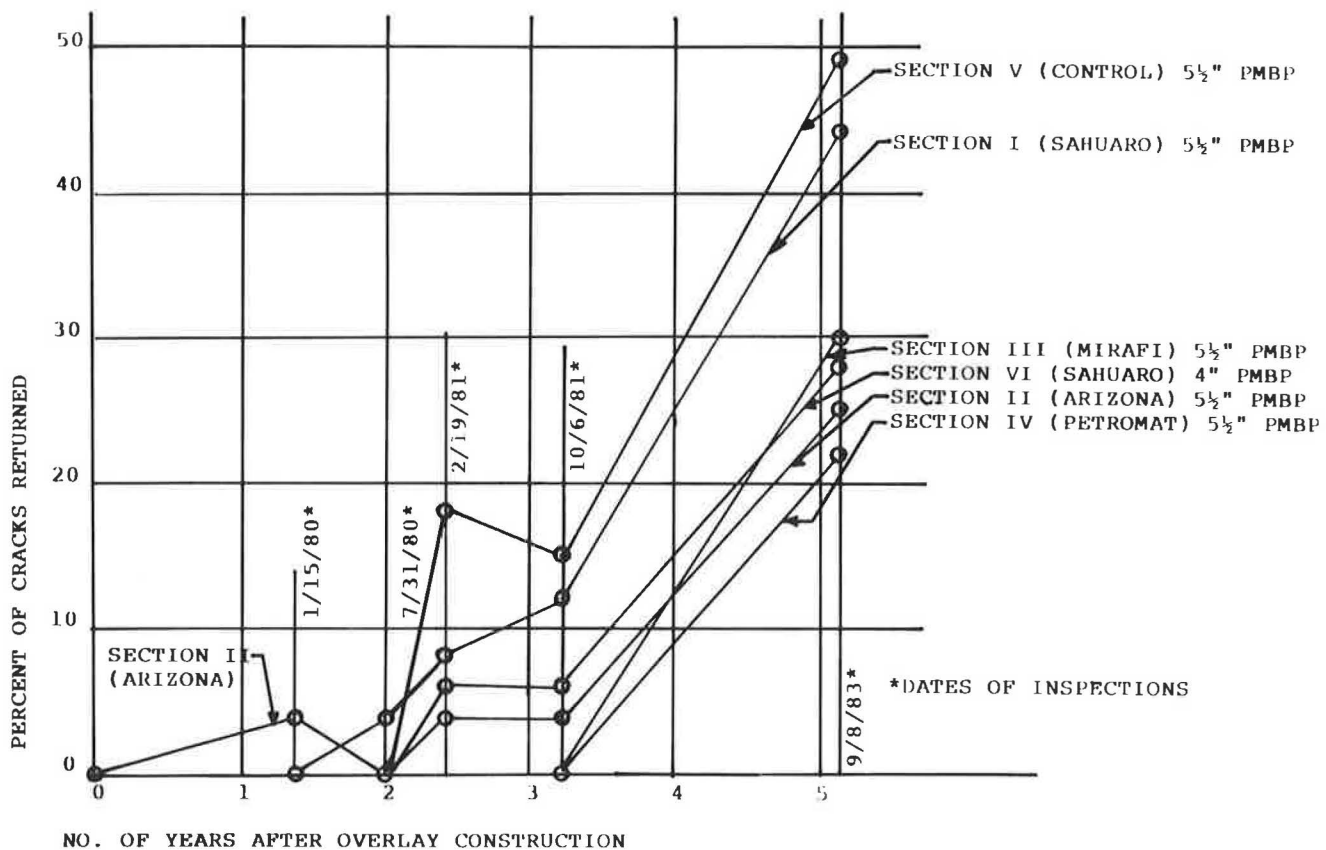
**FIGURE 3 Reflective cracks versus overlay life, I-40, 4.5 mi east of Clines Corners.**

Cracks began appearing as early as 19 months after the overlay construction in the Arizona rubberized asphalt section. After 2 years, cracks were observed in the first Sahuaro rubberized asphalt section. Cracks appeared in the control section and the second Sahuaro rubberized asphalt section after almost  $2\frac{1}{2}$  years. After more than 5 years, cracks were observed in all sections. The greatest percentage (51 percent) of reflective cracks that were observed during the final inspection occurred in the control section where no interlayer was used. The smallest percentage (22 percent) of cracks that returned was observed in the Petromat section. The percent of cracks in the remaining sections ranged from 25 to 44 percent. Figure 3 is a graph of the percent of cracks returned versus the number of years since the overlay was constructed for each monitor section. After more than 5 years of service, less than 30 percent of the cracks returned in three out of the six sections. The pavement distresses observed indicated that repeated traffic loads and temperature and moisture changes possibly aided in the development of the reflective cracking. The Petromat, Sahuaro, and Arizona sections performed the best in reducing the number of reflective cracks.

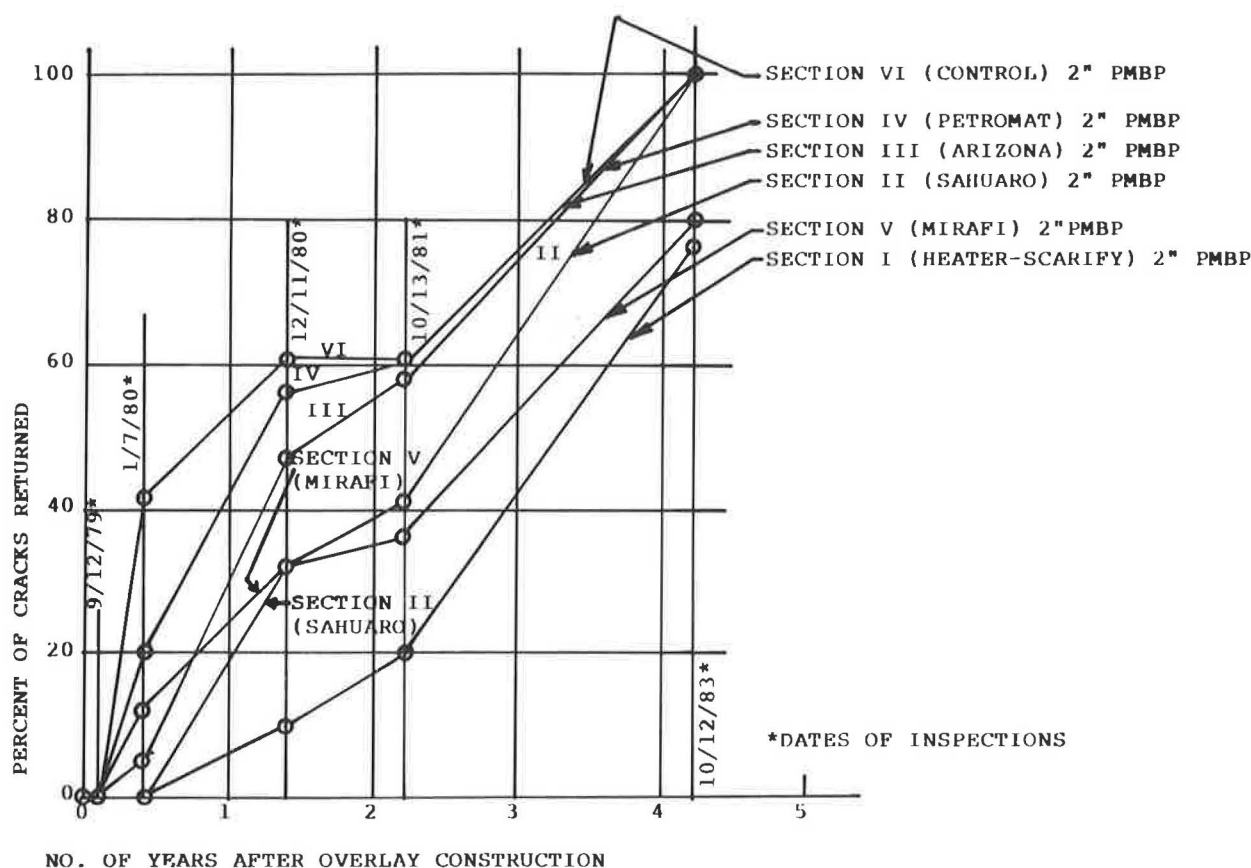
FIGURE 4 Reflective cracks versus overlay life, I-25, 8.2 mi north of Truth or Consequences.

The data in Table 3 show the number of cracks and the percent of original cracks observed during all reported inspections. Figure 4 shows the increase of percent of cracks returned versus the age of the overlay construction.

Cracks began to appear within the first year after the overlay construction in four of the six monitor sections. Cracks appeared in the remaining two sections within the next 6 months following that first year. The pavement distresses indicate that both vertical and horizontal movements possibly contributed to the development of reflective cracking. The heater-scarification section and the Mirafi 140 section had the best performances for reducing reflective cracking after 4 years with cracks returning at 77 and 80 percent, respectively.

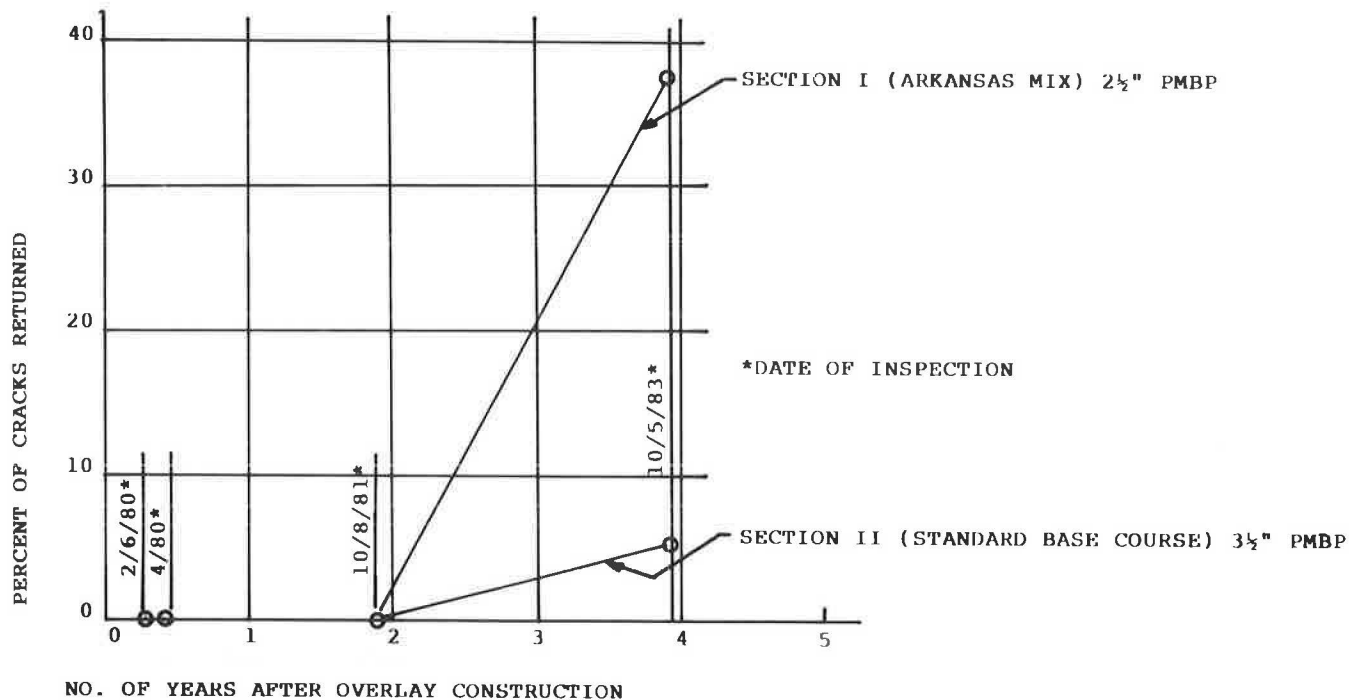
FIGURE 5 Reflective cracks versus overlay life, I-40, Mileposts 70.15 to 79.00, west of Grants.

Table 4 presents the number of cracks returned for each inspection and the percent of the original cracks. Figure 5 is a graph showing the percent of reflective cracks versus the time in years after the overlay construction.

Cracks first began appearing in each section after slightly less than 4 years. Pavement distresses indicate that the reflective cracks were possibly developed by repeated traffic loads. A total of 37 percent of the cracks had returned in the Arkansas mix section. The standard base course performed better with only 5 percent reflective cracks.
