Long Island Rail Road Bridge Infrastructure

MOHAMMAD S. LONGI

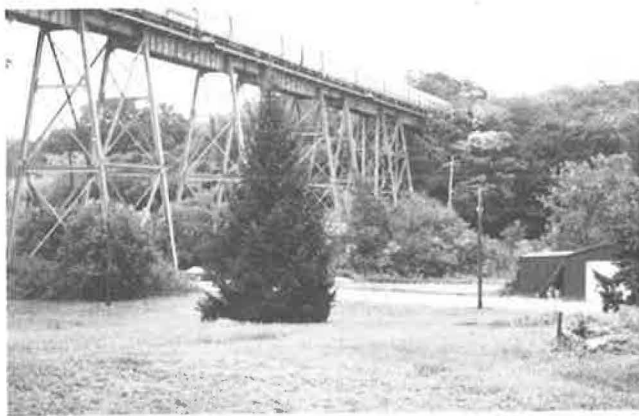
FIGURE 2 View of Manhasset Viaduct.

Girders The girders had corroded significantly along the top and bottom flanges and on the upper surfaces of lateral connection plates. Webs of the girders were generally in good condition, although some localized rusting was present in areas where paint was not adhering tightly.

The amount of deterioration varied widely from point to point, but all girders had areas where the top cover plate was significantly reduced. At locations on the girders where the timber ties had previously been shifted, conditions were also variable. In the worst cases, the deterioration under the ties was considerably more extensive than in the adjacent spaces; there were deep craters around the rivet heads.

Towers The bent caps between girders were generally deteriorated at the outstanding leg of the bottom flange angle. However, previous maintenance repairs has remedied the deficiency by the addition of plates welded and spliced across the bottom of the cap beam.

Columns were in excellent condition and are stronger than originally built because of the addition of cover plates.

Footings and Abutments Footings for Bents 13 and 14 were badly deteriorated. At the east abutment, the girder ends were recessed into the backwall. The girder is intended to be free to expand and contract at the abutment. However, the backwall was restricting that movement, forcing both expansion and contraction to occur at the expansion end of Span 13-14.

Scheme 3 was the recommended scheme, and design documents were prepared and contracts awarded for construction in late 1987.

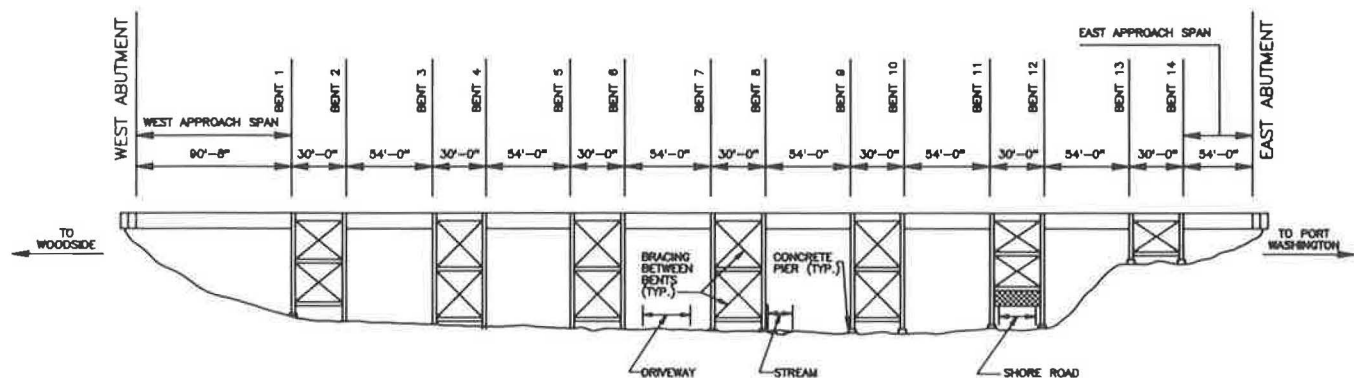
FIGURE 3 Elevation of Manhasset Viaduct.

The as-inspected ratings were governed by the 30-ft spans with ratings as low as E-51, followed by the 54-ft spans with a lowest rating of E-63. The 90-ft span and columns all rated higher than their as-built conditions. The 30- and 54-ft spans

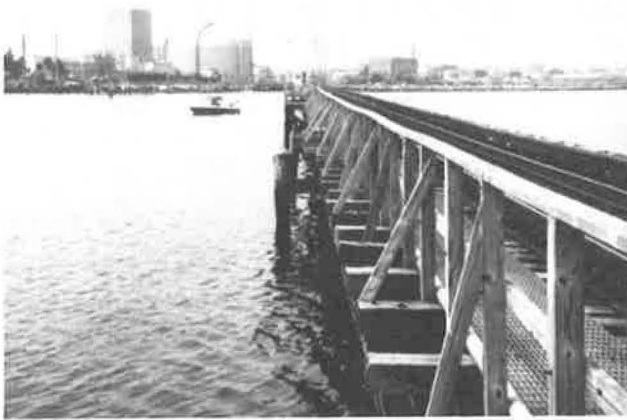
FIGURE 4 Reynolds Channel timber trestle.

1. The most serious deterioration of the trestle structure was observed in the piles. During underwater inspection of piles, including probing, dry rot was observed in almost one-half of all piles. This deterioration is generally confined to the tidal zone (+2.1 to -1.8 ft above and below Mean Sea Level); the daily cycle of immersion and drying promotes the incidence of dry rot. Fortunately, the piles incapable of supporting a full or even a partial load were randomly distributed throughout the structure.

2. The pile caps are subjected to partial submersion on a daily basis.
3. Portions of the trestle appear to have sustained surface damage from fire.
4. Rotting, deterioration, and absence of lateral bracing were prevalent. A total of 152 of the possible 224 cross braces are missing, loose, split, or rotted.

5. The prevalence of dry-rotted piles suggests that the cut ends of these piles were either not treated or inadequately treated.
6. Numerous instances of out-of-alignment failed piles missing a "V" section were noted. No significant instances of marine borer damage were observed.

The field investigation, test results, and design analysis indicated that the substructure required extensive rehabilitation. The rehabilitation scheme entailed driving new piles and replacing existing pile caps and stringers with new members. It was estimated that this scheme would cost \$550,000 in 1984 dollars.

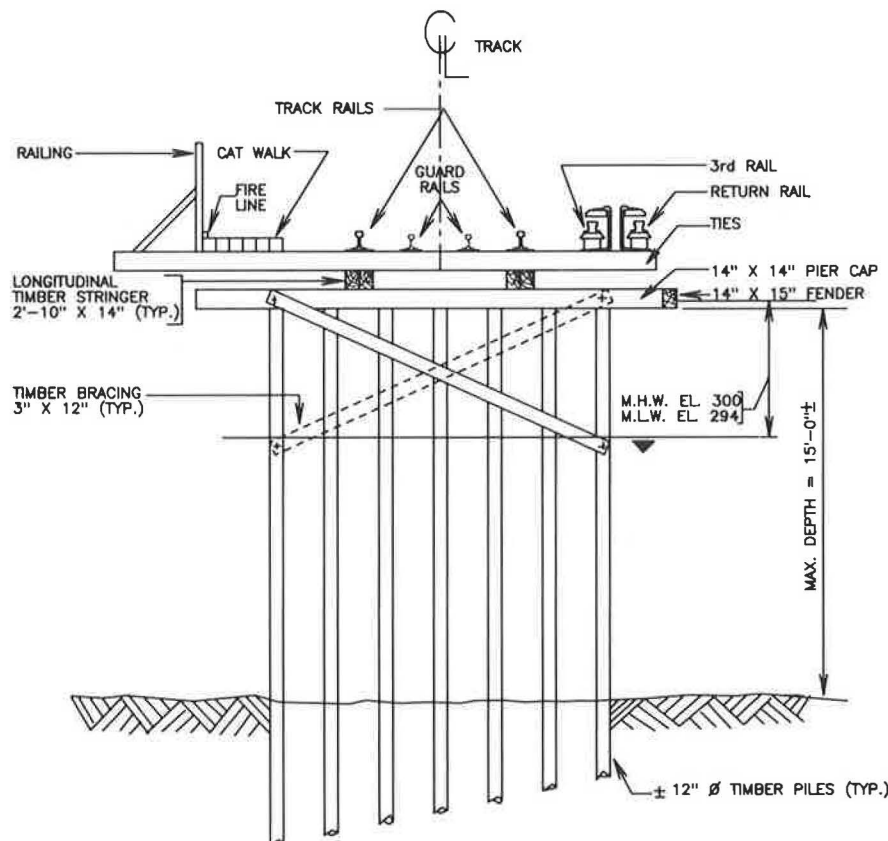
FIGURE 5 Cross section of timber trestle.

The stringer analysis was completed using the assumption that the stringers have partial continuity over the support. Given this assumption, based on field observation, the stringers can support approximately Cooper E-33 loading.

In summary, the timber trestle superstructure, which was rehabilitated during 1971–1980, was found to be in good shape.

However, in the vicinity of those bents rated below Cooper E-12, there were signs of structural damage to the stringers and the pile caps. In these instances, both needed to be replaced with new members. The substructure needed extensive rehabilitation to bring it up to a rating for a Cooper E-25 loading. This involved a majority of the bents. However, the absence of foundation data dictated caution in relying on the ratings obtained. Therefore, even after the trestle was rehabilitated, it was recommended by the consultant that the LIRR not use this trestle for loads greater than E-20 loading. The trestle was restricted to light electric trains and speeds not to exceed 5 mph.
