A Bridge Field Inspection Procedure To Check the Integrity of Pins in a Pin and Hanger Strap Connection

FRANK L. CARROLL, FRED A. MARTIN, AND STEVEN A. McDONALD

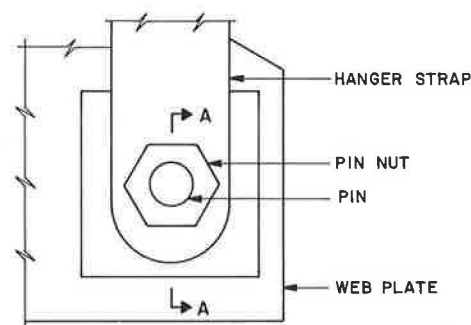
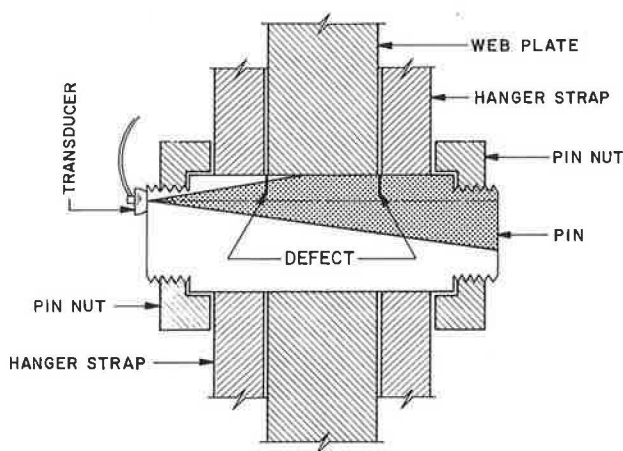
FIGURE 1 Part elevation of pin-and-hanger detail with enlarged section A-A.

The design parameters for this pin and hanger strap connection (Figure 1) as an expansion device assumed that the pin would be free to rotate in the web as the girders

expanded and contracted in response to temperature changes. The pin was designed to resist the shear and bending forces resulting from dead load, live load, and impact forces. Torsional forces were not considered. This design assumption has been proven to be invalid because it has been found that the joint was frozen as a result of corrosion between the pin, the straps, and the web. Consequently, torsion forces exceeding the pin strength were developed.

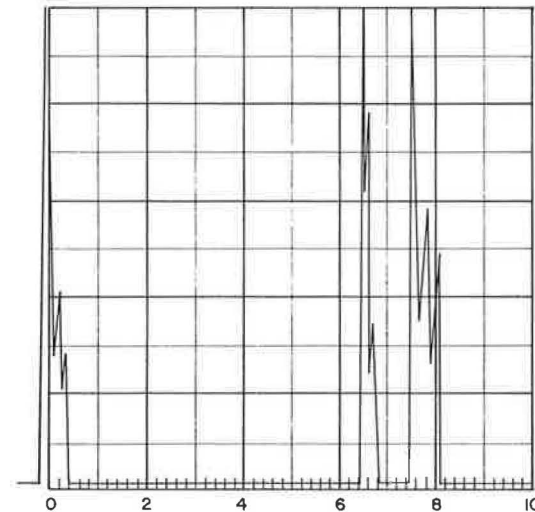
FIGURE 5 Screen of good pin.

The reading on the scope of the machine for a good pin (Figure 5) shows an initial spike, a spike representing the far shoulder at the threaded end of the pin, a spike representing the end of the pin, and a flat line between the initial spike and the shoulder spike.

NOTE: Screen shows initial spike and reflections from thread reduction shoulder and end of pin.

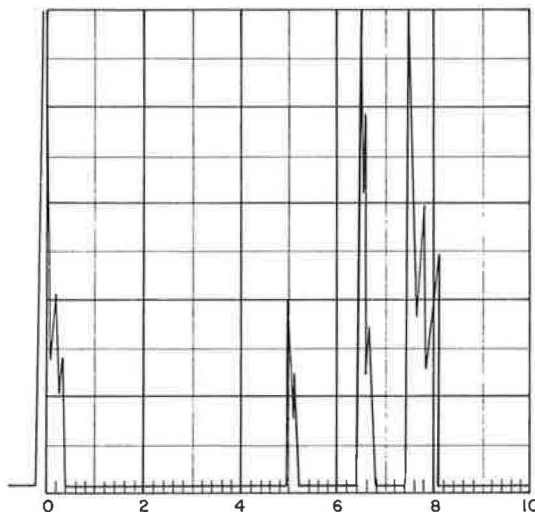
FIGURE 6 Screen of pin with defect.

The reading for a defective pin (Figure 6) shows an initial spike, a spike on the scope at the location of the defect, a spike representing the far shoulder at the threaded end of the pin, and a spike representing the end of the pin. The reading for a pin with total failure shows an initial spike, a tall spike at the defect location, and that the spikes representing the far shoulder and the end of pin are gone. The location of the spike on the scope that indicates a defect will correspond to the distance of the defect from the end of the pin. The height of the spike is related to the size of the defect. A very shallow defect will produce a very short spike whereas a deeper defect will produce a higher spike.

NOTE: Screen shows same indications as good pin plus a spike from a defect at 5 inches.
