Shoreline Stabilization To Protect Louisiana Highway 82

BABAK NAGHAVI AND PETER A. ALLAIN

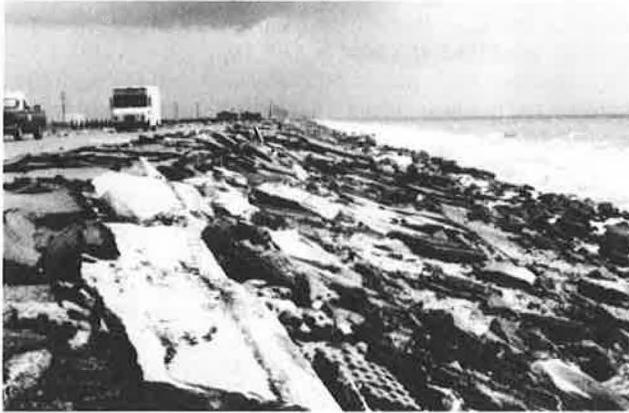
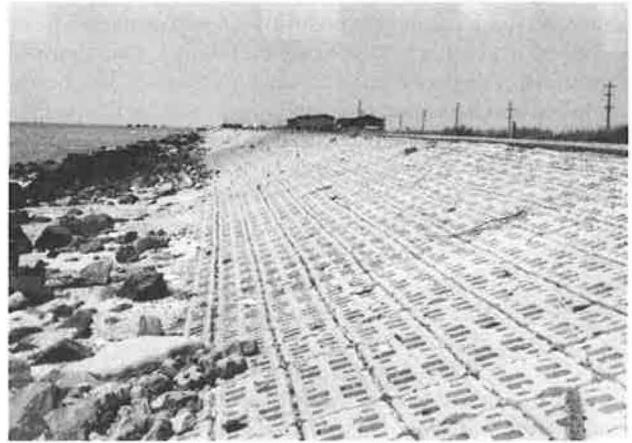
FIGURE 1 *Left:* A section of LA-82 after tropical storm Chris in 1982, and *Right:* one of the several revetment projects along LA-82.

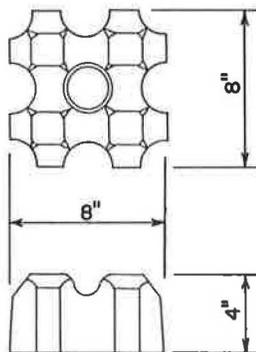
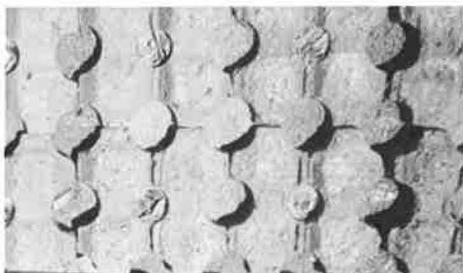
FIGURE 5 Type A revetment used on the experimental, the 1970, and the 1977 revetment projects.

Departure of concrete block from the slope because of being too light is the main reason suspected for the failure of the 4-in.-thick Type A revetments installed in 1970 and 1977. The larger 8-in.-thick Types B, C, D, and E revetment blocks installed in 1984 provided far more weight. As indicated in Table 3, these larger blocks provided at least 67 lb/ft², in comparison to the 29 lb/ft² of the 4-in.-thick revetment. To further reduce the chance of loss of individual blocks, only cabled revetments were considered for the 1988 8-in.-thick revetment project. Corrosion-resistant polyester cables were used to tie the blocks. The use of heavy blocks that are cabled together and anchored with an anchoring mechanism at the top of the mat should provide significant stability, and therefore reduce the chance of failures. Tables 3 and 4 present the physical characteristics and the amounts installed and cost, respectively, of the individual revetments.

The 4-in.-thick revetment installed in 1970 and 1977 did not have the weight necessary to resist uplifting forces. Although failure of this revetment system required the use of heavier blocks on the 1984 project, sections of the original 1970 projects were still functioning, and were simply covered over during the 1988 revetment project.

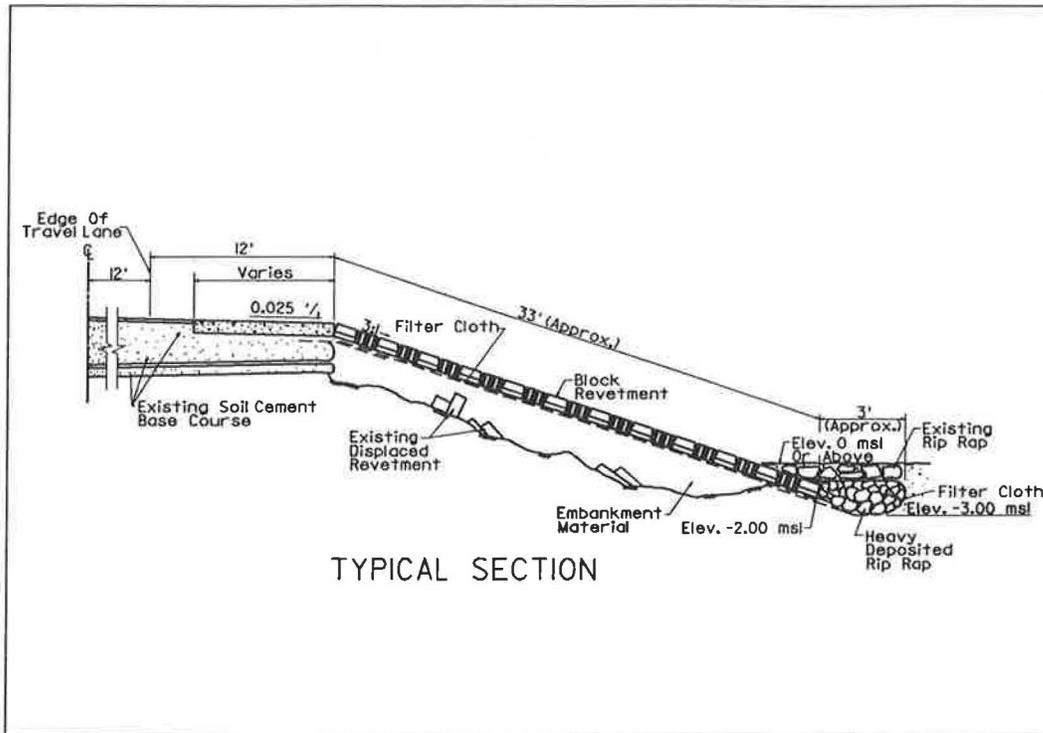
FIGURE 10 Typical section for 1988 8-in. revetment project.

Scour at the toe of the revetment structure is another reason for the failure of revetments. A protective apron or placing heavy riprap at the toe of the structure will minimize the risk of such failures. Figure 10 shows the typical section, with toe wall, used for the 1988 revetment project. A similar toe wall was installed for the 1977 and 1984 revetment projects. Table 6 presents specifications and amounts of the rock used in the toe wall for the revetment projects along LA-82. The amount of rock for the latter revetment project was small, because

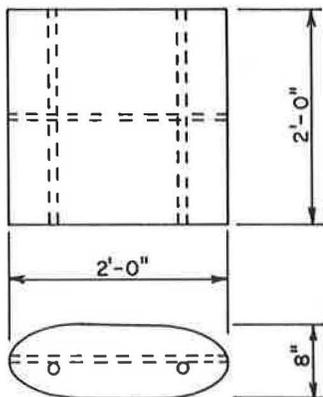
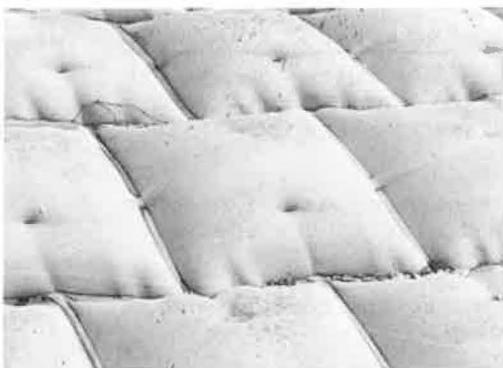
FIGURE 11 Type F cast-in-place cellular concrete revetment.

Heavy construction equipment is not needed with Type F cast-in-place cellular revetment. This fact makes this type of revetment more economical, as reflected in Table 4.

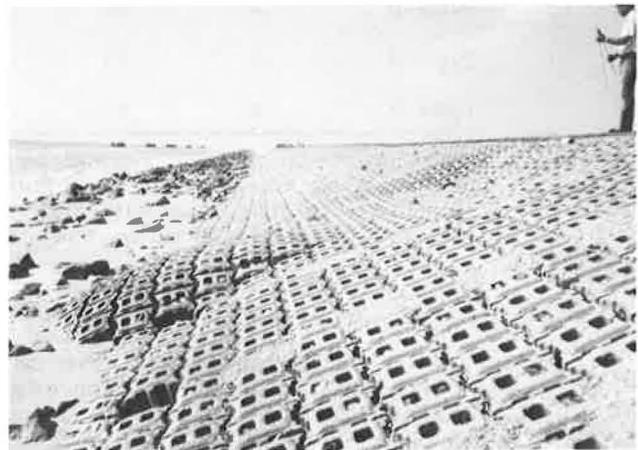
FIGURE 12 Revetment displacement caused by slope instability.

hydrostatic pressure was created in the slope, resulting in displacement of the underlying sand as well as the revetment. The revetments and underlying geotextiles installed in the 1984 and 1988 projects provided adequate porosity. The experience at Holly Beach also proved that the geotextile with 300- μm openings had a high retention for the fine sand (10). The D_{50} size of 150 μm was reported in the U.S. Army Corps of Engineers Report (5). However, the D_{50} size for the five samples (of 0- to 1-ft depth) collected and analyzed in 1989 ranged from 160 to 285 μm , with an average of about 205 μm . The Geotextile Engineering Manual (11) prepared for the FHWA contains a comprehensive guide for the design and selection of geotextiles. Another cause of potential failure is associated with the deterioration of the geotextile because of adverse environmental conditions, including ultraviolet exposure, abrasion, etc. Table 5 presents the properties of the geotextiles used for revetment projects along LA-82. Contrary to previous indications that a high degree of permeability is required for a stable revetment, the cast-in-place concrete revetment installed in 1984 has performed without failure, probably because the revetment is heavy enough to resist the hydrostatic pressure.
