Field Performance of Large-Stone Hot Mix Asphalt on a Kentucky Coal Haul Road

KAMYAR MAHBOUB, AMY SIMPSON, PAUL ODUROH, AND
JOHN FLECKENSTEIN

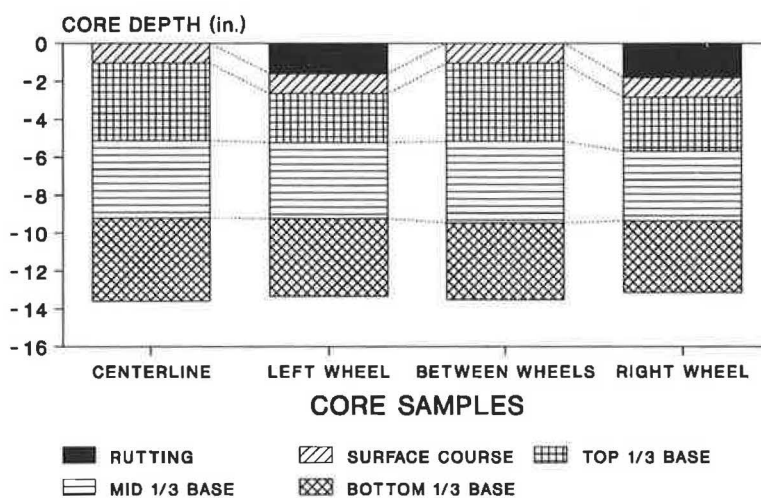
FIGURE 3 Reconstructed view of the pavement cross section based on pavement core data, US-23-Louisa Bypass.

was 1.8 and 1.2 in. under the right and left wheelpaths, respectively. Figure 3 shows a reconstructed view of the pavement cross section at Milepost 17.46 on the basis of data from pavement cores.

Northbound driving lane; M.P. 17.46

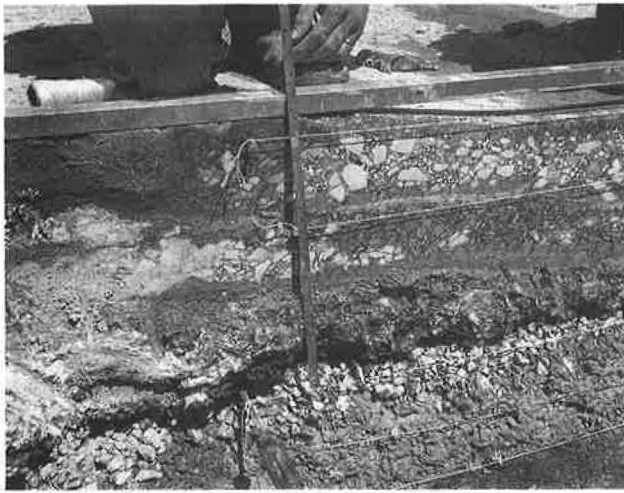
FIGURE 4 Pavement trench at Milepost 17.46, US-23–Louisia Bypass.

The following sections present an analysis of data based on a pavement trench (Figure 4) and pavement cores at Milepost 17.46, where the greatest amount of rutting on this project was developed. All statistical comparisons were conducted using an analysis of variance technique and a least significant difference procedure when needed (3) at 95 percent level of significance (i.e., alpha error = 5 percent). In the analysis of pavement cores, the assumption was made that quality control measures during the construction of this project, as reported by Williams (4,5), produced a uniform quality mixture (in terms of mixture air voids and density) within each lane and within each lift at any given milepost. That is, it was reasonable to assume that before traffic was allowed on this roadway, there were no significant differences in large-stone HMA air voids and densities at locations corresponding to future under- and between-the-traffic wheelpaths for any given milepost within each lane and within each lift. Examination of the postconstruction data, and specifically the relative coefficient of variability for the air voids and the density of each lift, as a measure of data dispersion, revealed that this assumption was reasonable. The quantitative justification for this as-

The data from the pavement trench did not indicate any distinguishable shear planes within the large-stone base layer. The fact that shear planes were not visually detectable in the trenched cross section does not diminish the possibility of shear deformations. If oblong-shaped aggregate particles are present in the mix, they often align themselves along the direction of shear flow patterns. The large-stone aggregate in this project did not include a large percentage of oblong particles; hence, the existence of shear flow patterns was not visually verifiable.

A 1-in.-thick, dense-graded conventional surface wearing course having a construction variability of $\frac{1}{8}$ to $\frac{1}{4}$ in. throughout the project was used to provide a smooth riding surface. An examination of the pavement trench where rutting was maximum indicated that the surface wearing course was by and large stable, and no measurable amount of rutting was detected in that layer. The 1-in. surface layer conformed to the rutting contour of the large-stone base layer. Data will be expanded to include the long-term performance of the polymer-modified wearing course.

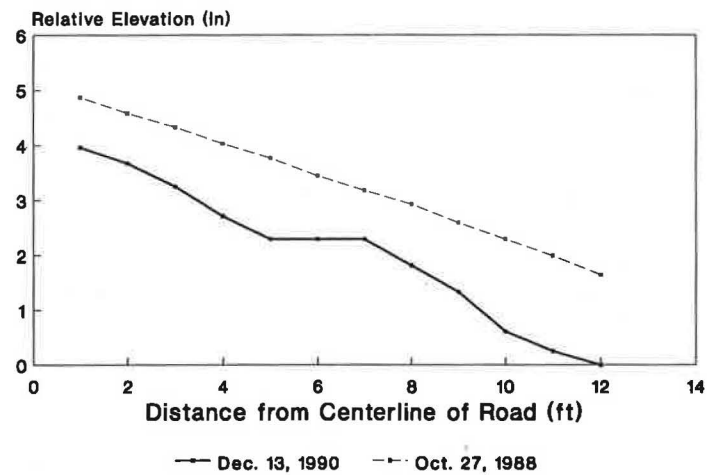
FIGURE 6 Roadway elevation data, US-23-Louisa Bypass.

Northbound driving lane; M.P. 17.46

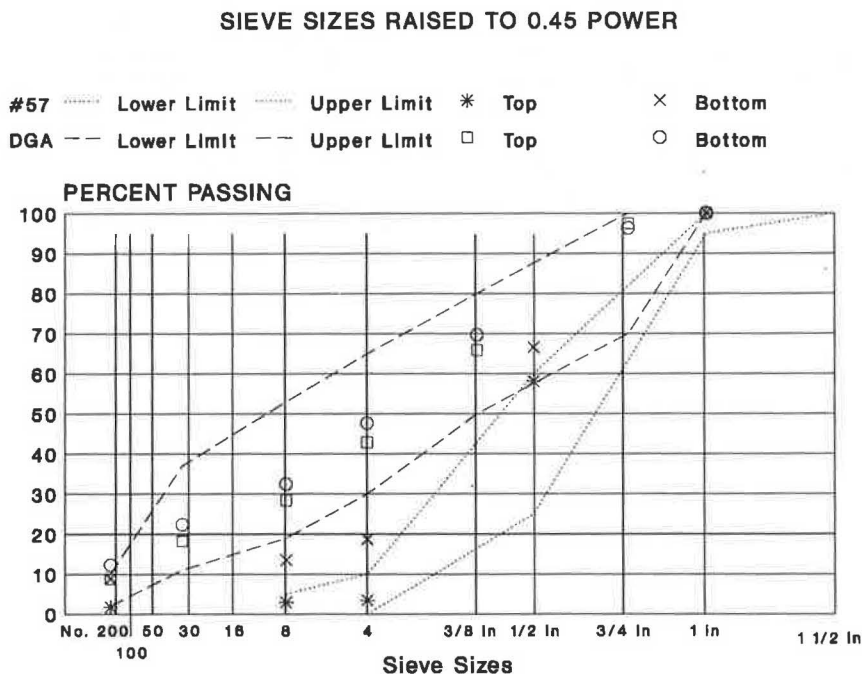
FIGURE 8 Gradation distributions for under-the-right-wheel samples.

there has been some intrusion of small particles into the No. 57 layer, pushing parts of the gradation distribution of the No. 57 materials outside of the specification limits (Figures 8 and 9). This phenomenon was more severe at the under-the-wheel location. Water-associated migration of DGA fines into the No. 57's is possible. Load-associated forcing of the No. 57's into the DGA may also cause the thinning. This seems plausible because of the gradation differences of the between-the-wheel and under-the-wheel samples. Obviously, more work is needed before the actual cause is determined.
