# Slope Failure Risk Mapping for Highways: Methodology and Case History

ROY E. HUNT

**CASE STUDY: HIGHWAY BR 116, BRAZIL**

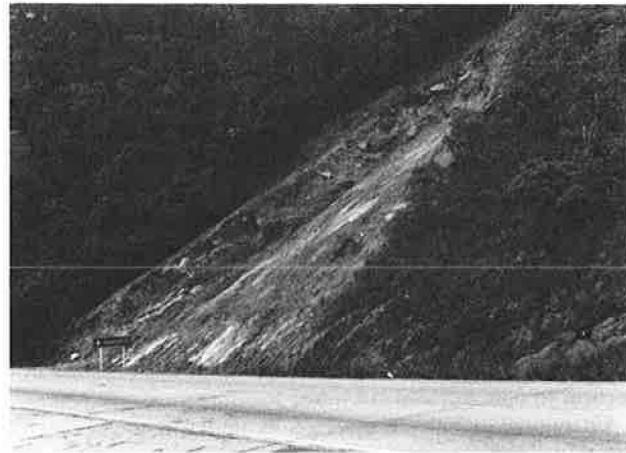
Planar or translational slides, involving masses of residual soils moving along a rock surface dipping downslope, are the dominant form of slope failure along the roadway. The common cause is a cut that extends into rock, exposing a face of overlying soils (see Figure 3). Failure is sudden, occurring during or immediately after heavy rains. Sufficient material is usually displaced to either partially or completely close the roadway. Additional failure will not occur if the slide reaches the crest of the hill, because it is self-corrected. The scar of a planar slide is shown in Figure 4.

**FIGURE 4** Scar of planar slide that partially closed BR 116.

For the dominant case of a soil cap over a rock surface, retention with an anchored curtain wall (5) was recommended. For other soil slopes, recommended treatments

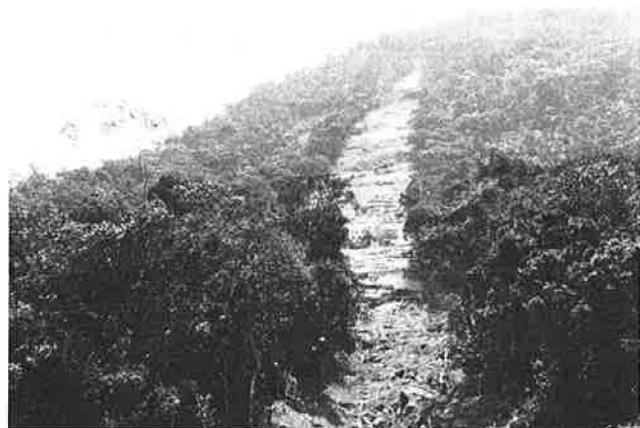
Debris avalanches can completely or partially close the roadway. Occurring during heavy rains, they develop along the hillsides at the higher elevations where residual soils are not thick and overlie a rock surface dipping downslope. Large quantities of runoff move masses of soil and rock fragments downslope at high velocities. Figure 5 shows the scar of a

**FIGURE 5** Scar of debris avalanche that partially closed BR 116 near Km 89.

debris avalanche that occurred along the upper reaches of the roadway.

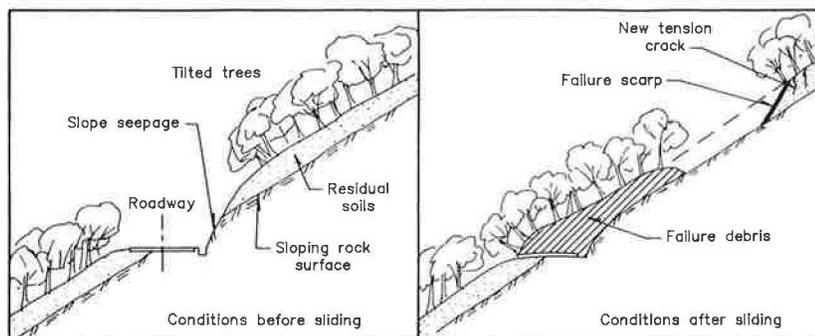
**FIGURE 3** Typical planar slide occurring in residual soil cap over sloping rock surface in cuts along BR 116.

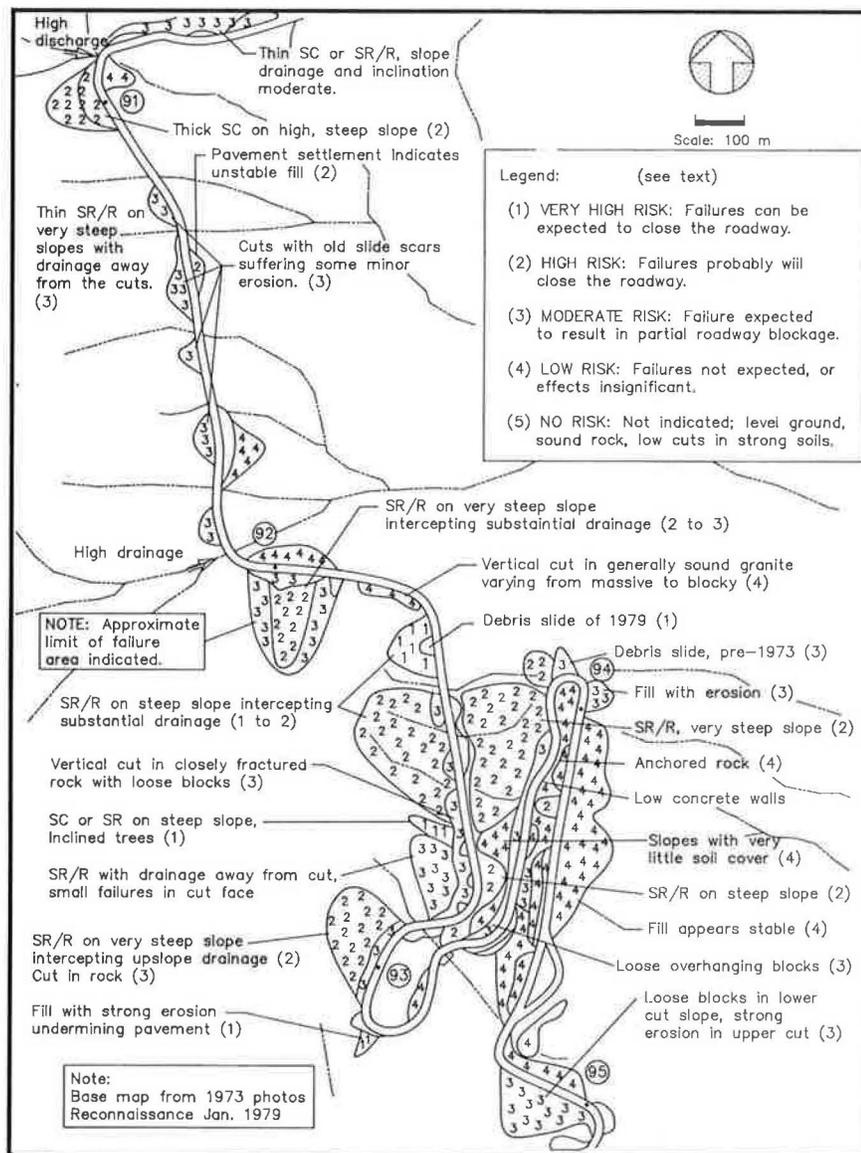
FIGURE 6 Slope failure risk map, BR 116, Km 91-95.

The slopes along the roadway were evaluated on the basis of the assessment factors, and judgments were made regarding the hazard degree and the failure risk. Slope failure risk maps were prepared for five levels of risk incorporating the hazard

1. Very High Risk: High slopes where relatively large failures will close the roadway are considered Level 1. Natural drainage permits substantial water to enter the area, and failures have already occurred. Conditions include steeply inclined cut or uncut slopes, generally greater than 30 degrees, with a layer of SR or SC over a rock surface inclined downslope or SC intercepted in the cut; fills subjected to severe erosion with danger of pavement undercutting causing loss of support; and culverts beneath fills in locations with potentially very high runoff.

2. High Risk: Relatively large failure probably will close the roadway. Conditions are similar to those for very high

risk except that the slope is generally less steeply inclined and natural drainage is more favorable. The risk is judged to be only somewhat less than that in Level 1, and in many cases it is difficult to differentiate between these two levels. Failures have not necessarily occurred in areas assigned Level 2. Fills have consolidated or displaced, or both, causing pavement settlement and cracking.

3. Moderate Risk: Slope heights are moderate. Failures are likely to be small in volume and not likely to close the roadway or severely affect its performance. Conditions include shallow cuts in steep slopes of SR or moderate slopes with SC, very steep cuts in fractured rock with a risk of falling blocks, slopes and fills with erosion, and areas with a layer of soil overlying rock that has already been subjected to sliding, which removed most of the overburden.

The risk maps provided the basis for recommending slope treatments. To establish budget priorities, immediate treat-

ments were recommended for areas with high or very high risk, since these conditions were expected to close the roadway to traffic. High priorities were given also to unstable rock cuts and erosional features, but the large rotational slide at Km 101 was assigned a lower priority. A section of roadway with suggested treatments is shown in Figure 7. Stabilization work should be performed during the dry season, beginning in April or May.
