# Partial Landslide Repair by Buttress Fill

ALAN L. KROPP AND MICHAEL R. THOMAS

Two residences in Orinda, California, were threatened by the enlargement of an existing landslide area. Published geologic literature described the characteristics of landsliding in the geologic materials present in the Orinda formation. Site specific studies were performed using aerial photographs, small and large diameter exploratory borings, and laboratory testing. The studies indicated that the previous landslide was massive in character and that complete repair was probably economically impossible. However, buttress-fill grading could be performed at the rear of the two properties to stabilize those areas and leave the remaining portions of the landslide unchanged.

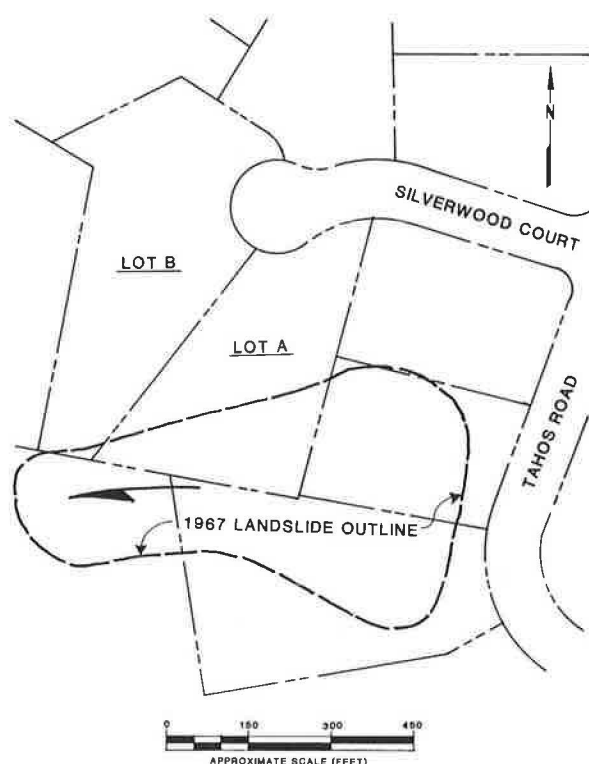
FIGURE 2 Lot plan.

A major landslide occurred in the former swale area during the heavy winter rains of 1967 as shown in Figure 2. The homes previously on the two lots next to Tahos Road were either destroyed or removed from the property. The lateral scarp along

the northern edge of the slide extended very close to the rear of the home on Lot A. This lateral scarp was about 10 ft in height, and the main head scarp adjacent to Tahos Road was approximately 20 to 25 ft in height. The overall dimensions of the landslide were approximately 250 by 400 ft.

The home on Lot B was built in the late 1970s. From 1967 to the late 1980s, there was a slow sloughing and lateral migration of the head and lateral scarps of the landslide, which led to the concern of the two homeowners on Silverwood Court that their houses or improvements might ultimately be threatened by future landslide movement or continued sloughing of the landslide margins.

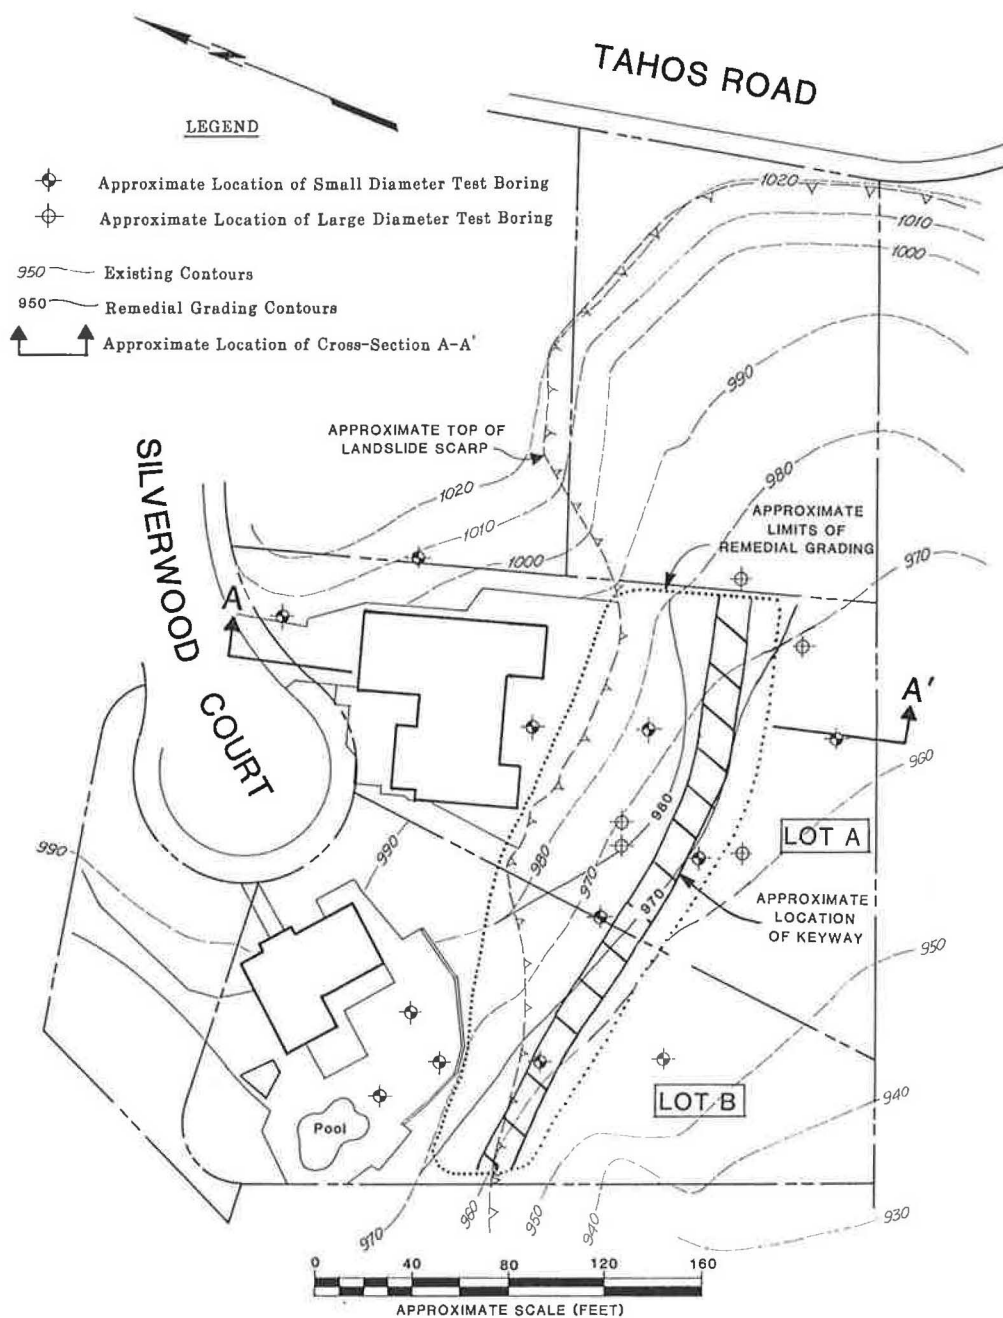
FIGURE 3 Site plan.

types of drilling equipment, depending on access requirements. Selected samples from these borings were taken to the laboratory for testing. These borings were generally extended to depths of 10 to 60 ft. To further define the subsurface geologic environment, five 24-in. borings were drilled and downhole-logged by the engineering geologist. These borings generally extended to depths of approximately 15 to 30 ft. The locations of both the small- and large-diameter borings are shown on the site plan in Figure 3.
