Case Histories of Landslide Stabilization Using Drilled-Shaft Walls

KYLE M. ROLLINS AND RALPH L. ROLLINS

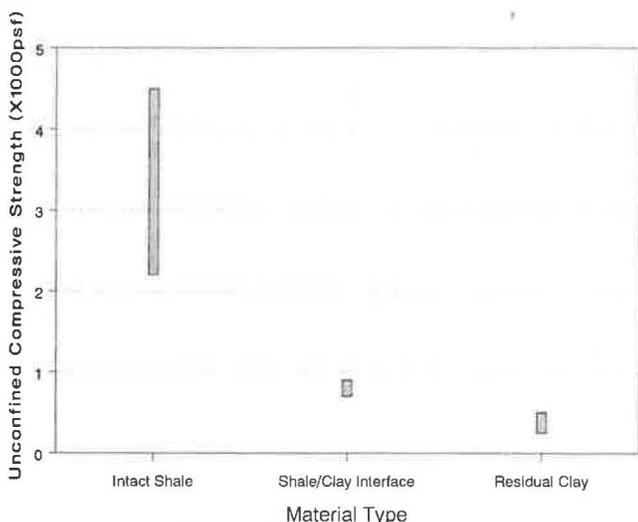
FIGURE 1 Comparison of undrained strength of various materials under saturated conditions.

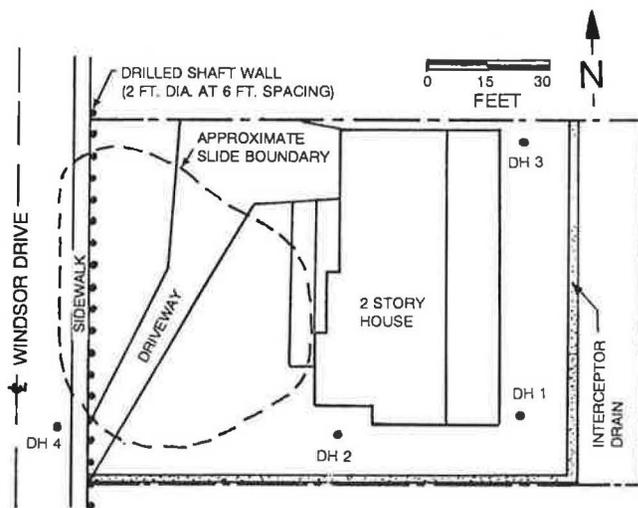
A plan view of the slide mass in relation to the house and Windsor Drive is shown in Figure 2. The house is on a hillside approximately 20 to 25 ft above the elevation of Windsor Drive. A steep slope extends from the front of the house to the east side of Windsor Drive. Above-normal precipitation and poor drainage allowed the subsurface soils to become wet, and a slide occurred in the slope immediately in front of the home. The head of the slide in front of the house was well defined and the toe of the slide intersected the asphalt paving on the east side of Windsor Drive. As a result of the slide, the southwest corner of the house settled several inches and caused a large crack in the basement floor. The outside edge of the front porch settled and pulled away from the house. The driveway, which extended diagonally up the hill in front of the house, was displaced and broken, and a cinder block retaining wall was sheared in two and carried down the hillside.

FIGURE 2 Plan view of Windsor Drive Slide 1 and drillhole locations.

Additional stability analyses were conducted for potential failure surfaces through the reconstructed slope to determine the horizontal force necessary to stabilize the slope. It was determined that a horizontal force of 7,000 lb/ft of wall applied at the location shown in Figure 2 would bring the factor of safety up from 1.0 to 1.5. Based on Broms' method (5,6) it was determined that the shafts should extend to a depth of 15 ft in the intact shale a center-to-center spacing of 6 ft. On the basis of shear and moment requirements, 2-ft-diameter shafts and four #10 steel reinforcing bars were specified. The locations of the drilled-shafts in plan and profile are shown in Figures 2 and 3. The cost of the wall was estimated at about \$160/ft of wall, a total cost of about \$14,400. Because the cost of the wall was a small fraction of the total value of the house and few other alternatives for stabilization were available, the drilled-shaft wall was constructed.

intended to prevent surface erosion that might not be controlled by soil arching. In addition to the shaft wall, a 10-ft-deep interceptor drain was constructed across the back side of the house as shown in Figure 2. A perforated 4-in. PVC drainpipe was placed at the bottom of the trench and extended to the roadway at the base of the slope. A photograph of the completed wall is shown in Figure 4.

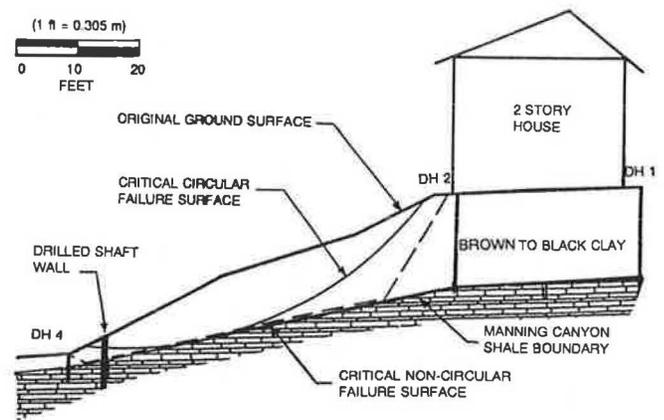
Four boreholes were drilled into the bedrock at locations shown in Figure 2. A cross section through Boreholes 1, 2 and 4 is shown in Figure 3. The subsurface profile generally consisted of a brown to black clay that graded into a dark brown to black Manning Canyon shale. The clay material above the shale has principally been derived from the weathering of the parent material. The clay classified as a CL material using the unified soil classification system, and the plastic index ranged from about 15 to 30 percent. No static water table was encountered in any of the test holes; however, the clays were very moist, and experience has shown that seeps frequently occur in the fractures of the Manning Canyon shale.

FIGURE 3 Profile through Windsor Drive Slide 1.

The shear strength of the shale layers consistently exceeded 2,500 psf, the strength of the clay was fairly erratic and varied from 200 to 2,000 psf. Because the failure surface was approximately known, it was possible to estimate the shear strength corresponding to a factor of safety of 1.0. For an assumed shear strength, the critical factor of safety was determined for potential circular surfaces passing through the toe of the slide. The safety factor became equal to 1.0 when an undrained shear strength of 270 psf was specified.

For the same strength values, a search was made for the critical noncircular failure surface, assuming that the failure occurred along the clay-shale interface. The search procedure employed the method proposed by Celestino and Duncan (7). The safety factor for the noncircular failure case was 20 percent higher than that for the circular failure case, so it was concluded that a circular failure mode was more critical. This finding also agrees with the shape of the slide.

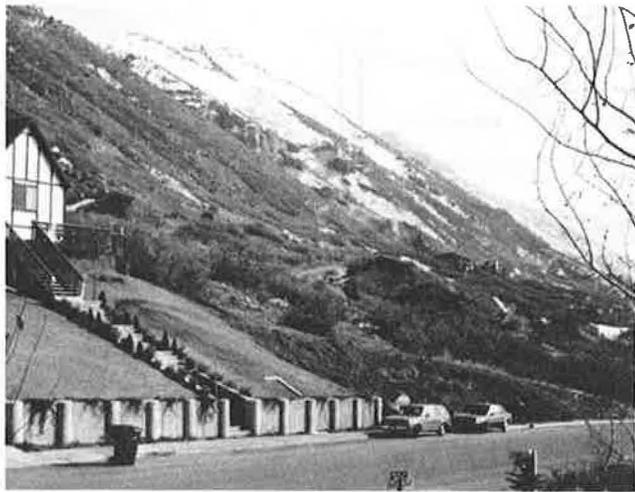
FIGURE 4 View of completed drilled-shaft wall with landslide developing immediately adjacent to it.

The success of the stabilization procedure was recently proved when the slope behind the drilled-shaft wall became wet because of heavy spring rains and a leaky sewage line that had not been completely repaired in the reconstruction of the hillside. A slide similar in magnitude to the original slide developed in the slope immediately adjacent to the wall and moved onto the street. The stark contrast in the hillside performance at the interface between the slide mass and the wall is shown in Figure 5. Clearly, without the presence of the shaft wall, the slope in front of the home would have once again failed. Although the soil behind the wall became nearly saturated, the slope has remained stable and there are no signs of distress in the shafts. Structural damage to the home because of movement of the slide has been arrested since construction of the shafts.

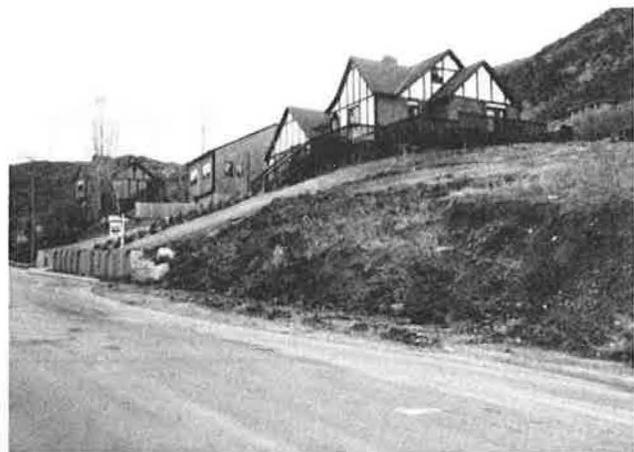
FIGURE 5 View of slide mass with drilled-shaft wall in background.

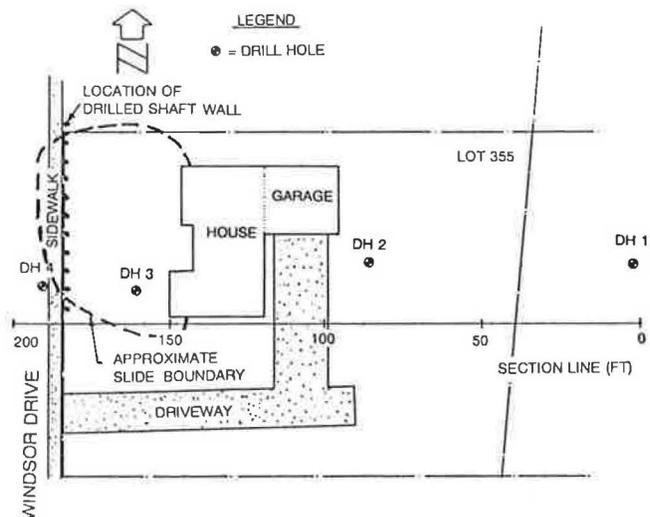
Within a year of the original slide described in Case History 1, a similar slide began to move in front of another house several hundred ft away. A plan view of the slide mass in relation to the existing house is shown in Figure 6. The house consists of a basement and two levels above the ground surface. The topography in this area slopes steeply toward the west; a level site for the facility was developed by cutting into the hillside. A profile showing the original ground surface and the ground surface prior to slope failure is shown in Figure 7.

and south side. A major north-south crack developed along the basement floor directly behind the western wall and exhibited considerable vertical displacement. Differential movement between the north and south corners at the first-floor level was more than 3 in., and cracking of the basement walls was also evident. Cracking of the brickwork was also observed in front of the house and on the north and south sides. Slide movements in front of the house had significantly disrupted sidewalks, steps, and a retaining wall made from wood railroad ties. Bulging of the asphalt pavement on Windsor Drive directly adjacent to the easterly curb of the street suggested that the slide terminated in this area.

FIGURE 6 Plan view of Windsor Drive Slide 2 and drillhole locations.

The undrained cohesion of 300 psf was subsequently used in stability analyses to calculate the magnitude of the lateral force acting on the downhill face of the slide necessary to increase the factor of safety from 1.0 up to 1.5. It was determined that a force of 8,100 lb/linear-ft of wall would be required. On the basis of horizontal force, 2-ft-diameter shafts spaced at 6 ft on centers were specified. The shafts extended 12 ft into the subsurface profile at the location shown in Figure 7. This embedment depth was beyond the observed failure surface at the base of the slide. The investment in the drilled-shaft wall was considered worthwhile because it restored the original value of the property at a small fraction of the original cost of the structure.

In addition to the drilled-shaft wall, other measures to improve stability included channeling runoff from roof drains into pipes that were carried to the street level and the installation of a shallow interceptor drain along the front of the house. The house itself was then repaired, and no additional distress has been observed even though slides in the immediate vicinity of the house have occurred.

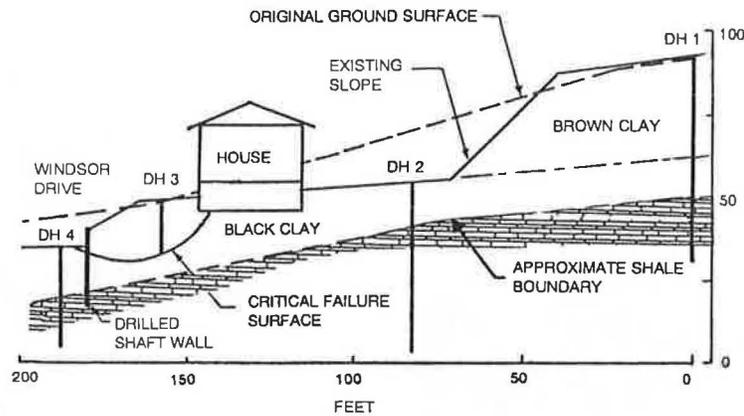
FIGURE 7 Profile through Windsor Drive Slide 2.

at the site are shown in Figure 7. The subsurface profile generally consisted of gray to black clay that graded into Manning Canyon shale. However, the steep slope behind the house was composed largely of a brown clay with a markedly lower plasticity index.

Although groundwater was not encountered in any of the boreholes, the black clay in the vicinity of the slide was 80 to 90 percent saturated. The undrained strength generally varied from around 400 psf near the ground surface to about 1,200 psf at a depth of 20 ft; however, samples obtained near the failure surface had undrained strengths of about 300 psf. Slope stability analyses determined that a factor of safety of 1.0 was obtained for an average shear strength of 300 psf. The location of the critical failure circle is shown in Figure 7; it may be seen that it closely approximates the observed failure surface. It is interesting to note that the undrained strength and failure mode in this case are very similar to the previous case history.

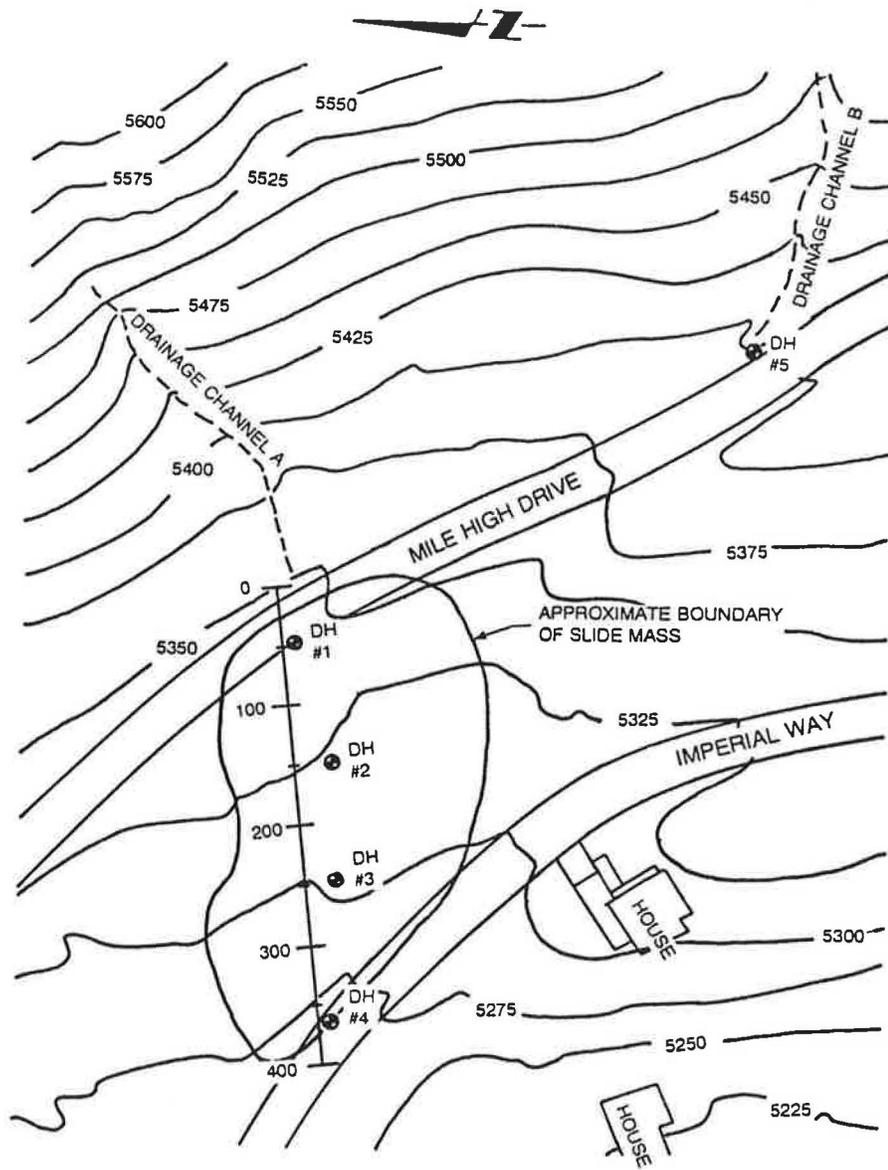
The general location of the slide area between Mile High Drive and Imperial Way is shown in Figure 8. The head of the slide intersects nearly all of Mile High Drive, and the toe of the slide is located on the easterly edge of Imperial Way. Both roadways were closed because of the slide. The topography of the slide area is also shown in Figure 8, and a profile through the center of the slide is shown in Figure 9. The location of two small drainage channels east of Mile High Drive, designated as "A" and "B," are also shown in Figure 8. Before construction of the roadway, water from these drainage channels flowed down a depressed area to the south of the slide and was carried downslope. With the construction of the roadway, the drainage path was interrupted and water from both drainages seeped into the subsurface material in the general slide area. Following heavy runoff the slide moved downslope about 15 ft.

FIGURE 8 Plan view of Mile High Drive–Imperial Way landslide and drillhole locations.

The stabilization measures for this slide called for (a) installation of a 24-in.-diameter storm drain to carry the flow from the drainage channels away from the slide, (b) a 3-ft-wide interceptor drain back-filled with coarse concrete aggregate to a depth of 10 ft, and (c) a line of drilled shafts extending across the slide zone on the west side of Mile High Drive. Stability analyses indicated that a drilled-shaft wall near the toe of the slide would produce an increase in the factor of safety of less than 10 percent for the entire slope; however, a drilled shaft wall at the top of the slope could provide significant resistance and protect the upper roadway from future sliding. Based on the back-calculated strength values, stability analyses indicated that the drilled shafts adjacent to the roadway would need to provide a resistance of 7,000 lb/linear-ft to provide a factor of safety of 1.5 against sliding of the upper wedge of the slide.

The shafts were designed to penetrate through approximately 30 ft of overburden and 15 ft into the shale itself. The concrete shafts were 2.5 ft in diameter and were spaced at 5 ft on centers. Reinforcing consisted of four #11 bars. Movements of the slide have been minor since the construction of the stabilization measures.

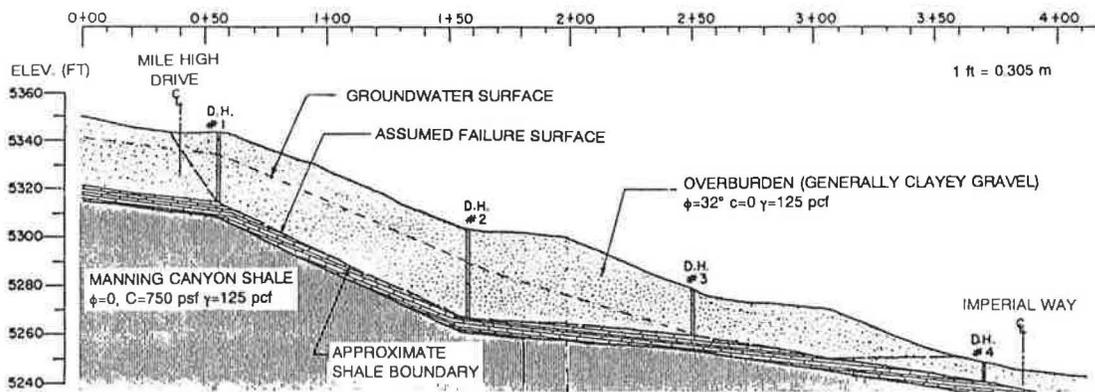
The characteristics of the subsurface material throughout the slide area were defined by drilling four test holes to depths varying from 14 to 40 ft as shown in Figures 8 and 9. It should be noted that the Manning Canyon shale was encountered in each of these test borings at depths varying from 9 to 36 ft below the ground surface. The location of the overburden and shale materials are shown in Figure 9. The overburden generally consisted of gravelly sand and clayey gravel overlying a 6- to 8-ft-thick layer of residual clay above the shale. Groundwater was encountered in every boring. The water table was typically 25 ft above the shale interface near the

FIGURE 9 Profile through Mile High Drive–Imperial Way landslide.

The location of the shale surface along with the groundwater conditions and the characteristics of the overburden material strongly suggest that the failure surface is in the vicinity of the interface between the overburden and the shale. Assuming that the failure surface lies near the clay-shale interface and that the factor of safety against sliding is equal to 1.0, a stability analysis was performed to determine the average shear strength along the failure surface. Assuming undrained conditions in the clay-shale, the results of the stability analyses indicate an undrained shear strength of about 750 psf. At the head and toe of the slide the failure surface passes through the overburden material. The groundwater level shown in Figure 9 was taken as the piezometric surface for the granular soils. The unit weight and strength parameters used for the overburden material are shown in Figure 9. The results were not highly sensitive to small variations in these properties.

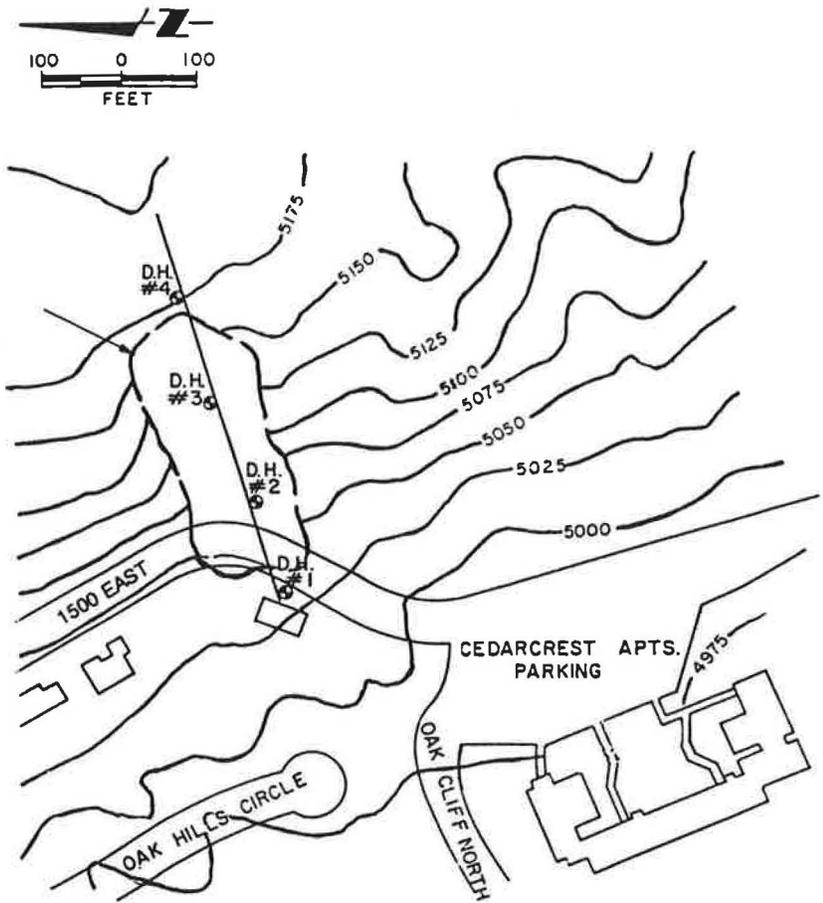
A plan view of the Oak Hills slide is shown in Figure 9. This slide is located at the toe of a large ancient landslide near the base of Provo Mountain. Although the topography next to the slide is shown in Figure 10, the topography of the slide zone immediately before the slide occurred is uncertain. Construction was under way to prepare a level pad for a house and an access road up to the house. On the basis of photographs, eyewitness accounts, and volume comparisons with the slide debris, the best estimate of the original profile through the slide is shown in Figure 11. The slide was about 400 ft long and 100 ft wide. The scarp formed by the slide was more

FIGURE 10 Plan view of Oak Hills slide and drillhole locations.

The stabilization evaluation assumed that the slide mass would be removed from the roadway and that the slope would be cut back from the edge of the roadway to provide a stable slope. A number of alternatives were investigated and stability evaluations made for both circular and noncircular failure surfaces. The strength of the shale interface was assumed to have a value of 800 psf, which was based on back calculations and laboratory test results. For the case with the slope cut back to an inclination of about 1.75 H to 1.0 V, the factor of safety was 1.35. The addition of a horizontal force of 10,000 lb/linear-ft increased the factor of safety to 1.5. This force could be provided by using 3-ft-diameter shafts spaced at 6 ft on centers. The shafts would need to extend to a depth of 15 ft into the shale at the base of the slide. An interceptor drain was also recommended for the uphill side of the slide. It should be noted that because of the volume of the slide mass involved, the drilled-shaft wall, in this case, produced

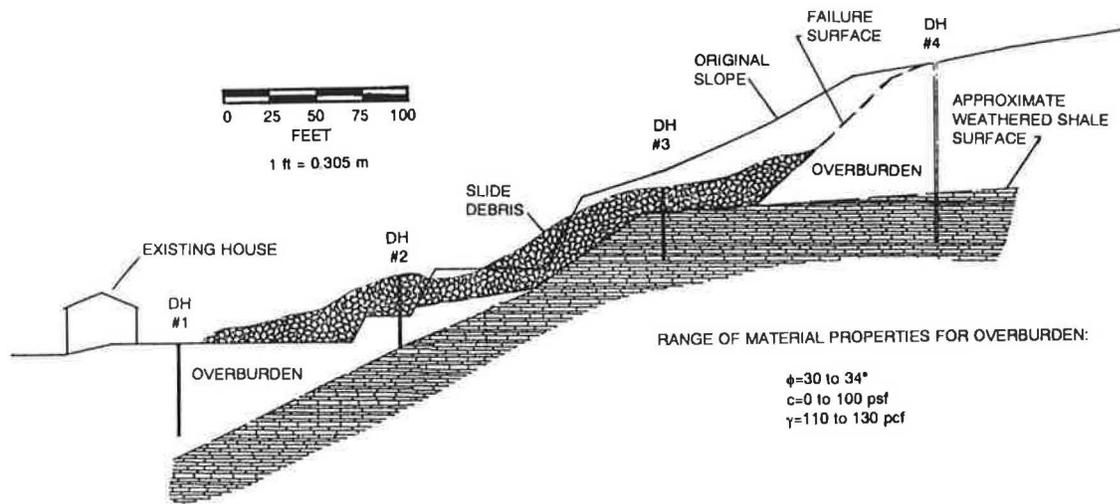
To define the soil profile and the probable location of the failure surface, it was necessary to drill four borings at the locations shown in Figure 11. Three of the borings penetrated the intact Manning Canyon shale, and the fourth boring, located at the bottom of the slide, did not. On the basis of the borings, the approximate location of the shale boundary is shown in Figure 11. It should be noted that the shale boundary is not a simple linear feature because previous landslides have displaced the shale. The material above the shale generally consists of low-plasticity gravelly silt and silty gravel. In addition to the intact shale zone, photos taken by a geologists before the slide showed a mass of shale with granular material above and below it was exposed in one of the lower cuts. It is theorized that the failure surface followed this detached shale layer and then ran along the shale interface and finally ruptured through the overburden as shown in Figure 11. No groundwater was encountered in any of the holes, but the soils were approaching saturation.

An examination of the cores in the shale indicated that they were highly fractured with zones of relatively hard shale interbedded with relatively soft layers. The plastic index of the shale ranged from 5 to 18, and the unconfined compressive strength varied from 1,500 to 4,900 psf. Thus, if the failure plane moved through the weakest zones, the shear strength would be about 750 psf. Stability analyses were conducted to determine the strength of the shale interface that was required to produce a factor of safety of 1.0. Assuming a reasonable range of values for the strength and unit weight of the granular zones above the shale (see Figure 11), the back-calculated strength of the shale interface was found to be between 700 and 900 psf. This strength is in good agreement with laboratory results and the interface strength that was determined for the Mile High Drive slide.

FIGURE 11 Profile through Oak Hills slide.
