# Remedial Treatment of a Slab on Clay Using a Lime–Fly Ash Curtain

THOMAS M. PETRY

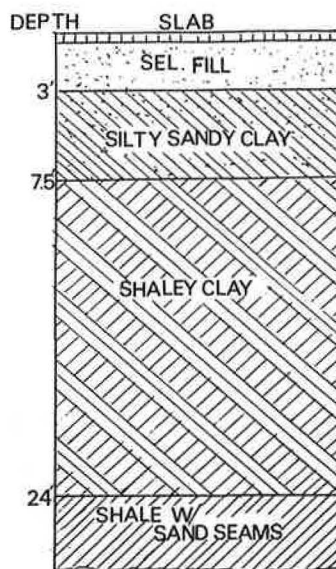
FIGURE 1 Cross section of slab and soil profile.

They were placed there to reduce significantly the swell potential of the subgrade and provide a place for misdirected drainage to accumulate. This select fill and the slab are shown in Figure 1, which includes the soil profile under them.

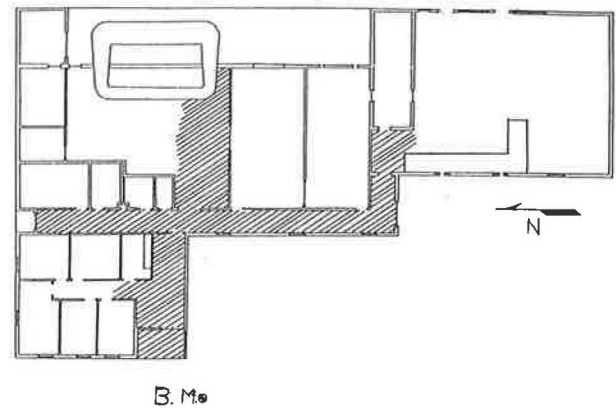
FIGURE 2 Plan view of slab on grade and building.

Construction of the building began late in 1985, before the wetter portion of the year. The structure was complete and occupied by December 1986. A plan view of the facility is given in Figure 2. The first cracks were noted in interior sheetrock walls in February 1986. The first area affected was near the north end of the building and in the room just west of the north-south hallway. One of the possible problems

noted, as part of the early analyses, was poor drainage on the west side of the building from the north end and especially in the flower bed south of the part of the building west of the north-south hallway. In these areas, sprinkling systems and poor drainage caused concentrated wetting of foundation soils, as indicated by laboratory personnel. Even though the use of sprinklers was eventually stopped, the foundation movements continued. In April 1988, the Civil Engineering Department was notified of the problem and the author became involved in surveying the situation and recommending remedial actions to be taken.

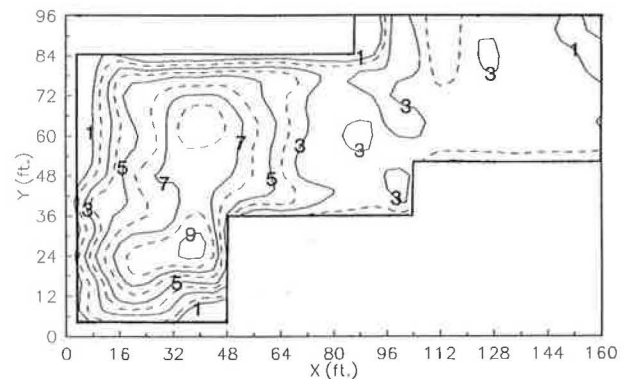
FIGURE 3 AE building elevations, May 5, 1988.

The first survey of relative differential elevations and damage was taken in May 1988. It is important to note that at this time no deep benchmark existed at the site. Using a water-level system, the geotechnical engineering group measured the relative levels of 270 positions of the slab. The results of this survey are shown in the topographic map in Figure 3. The contour interval is 0.3 in. The odd contour lines, representing differentials of 0.3, 0.9, 1.5, 2.1, and 2.7 in., are solid, and the even ones, for 0.6, 1.2, 1.8, 2.4, and 3.0 in. of differential, are shown as dotted lines. At that time, the maximum differential elevation in this slab was nearly 3 in. The largest slopes in the slab can be seen to be in the area where damage was first noted, whereas the south end of the building appears to have few and small differentials. As a part of this survey, holes were cut through the slab and samples were taken.

The materials found during this sampling were as expected and in accordance with the design. The top 2½- to 3-ft layer was made of select sandy fill materials with very low plasticity; the rest was nearly as described in the preceding paragraph. These materials, however, still had a swelling potential of about 1 in., according to swelling tests performed. One of the most significant findings was that the select fill materials were saturated to significant heights above the natural clay subgrade. There was, therefore, much concern that not only the near-foundation materials, but also those materials at greater depths would swell. This potential deep-seated swell, which would not be expected unless water ponded in the select fill could reach materials over time, was sure to be very damaging.

A further cause for concern was that the swell happened so quickly after construction. This was probably due to the relatively high soil mass permeability of the fissured sandy soils; it was also a forewarning that more-damaging swell could occur sooner than expected. For these reasons, it was deemed necessary for remedial actions to be taken as soon as possible.

The remedial actions recommended by the geotechnical engineering group of the Civil Engineering Department included correction of the remaining, concentrated wetting activities; establishment of a permanent benchmark on the property; monitoring of slab levels on a continuing basis; installation of a lime-fly ash grout curtain where needed; installation of a permanent drain system for the select fill; and eventual repair of the structure. The first of these was completed fairly quickly and included correcting drainage, where needed, to carry all surface waters away from the building. There were driveway slabs all along the back or east side of the building that acted as horizontal moisture change barriers. Monitoring of elevations began as soon as the benchmark was placed in the spring of 1990. The intervening years had gone by because UTA wanted not only to see what would happen but also to give the drainage corrections a chance to work. UTA authorized further remedial activities, since the problem seemed to be worsening.

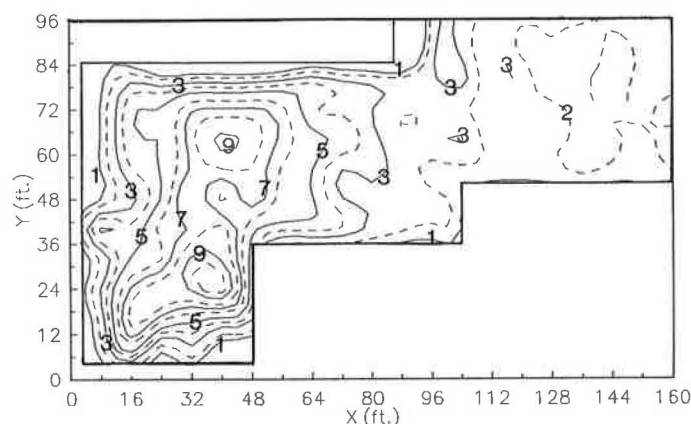
FIGURE 6 AE building elevations, June 11, 1991.

The second type of information was determined during a level survey of the whole slab done in June 1991. The results of this survey are given as a topographic map in Figure 6. The contour intervals shown in Figure 6 are the same as those in Figure 3. It can be seen that some additional differential movements have occurred, but the shape of the slab is nearly the same as in 1988. The maximum differential is still 3 in.,

the major differentials are found in the same places, and the south end of the building has remained relatively level.

When considering both types of elevation survey information, it can be determined that the slab in consideration has not moved in any significant way since the injection of the lime-fly ash grout curtain and that this curtain has assisted in maintaining stable moisture levels in foundation soils. The history of movements in this slab was one of large-scale differentials during the first year of the structure life and less damaging ones up to injection of the stabilizing curtain. The deflected shape of the slab on grade has remained nearly as it was before injection, and this may well provide the opportunity for repair in the near future.
