Pavement Evaluation and Development of Maintenance and Rehabilitation Strategies for Illinois Tollway East-West Extension

ELIAS H. RMEILI, KURT D. JOHNSON, AND MICHAEL I. DARTER

The procedures used in the field evaluation and development of maintenance and rehabilitation strategies for the Illinois Tollway Authority's 70-mi, four-lane East-West Extension are presented. The extension consists of 14-in. portland cement concrete (PCC) placed directly on the silty clay subgrade with random joint spacing varying between 12 and 17 ft. Although the pavement is only 17 years old, it is experiencing rapid decrease in serviceability. The field evaluation consisted of a visual condition survey, non-destructive deflection testing including void detection and transverse joint load transfer efficiencies, coring, soil evaluation, determination of slab and soil properties, and petrographic analysis of the PCC. After the pavement evaluation was completed, several maintenance and rehabilitation strategies were developed for different life expectancies varying from 2 to 20 years. All of the strategies were evaluated using EXPEAR (EXpert system for Pavement Evaluation And Rehabilitation).

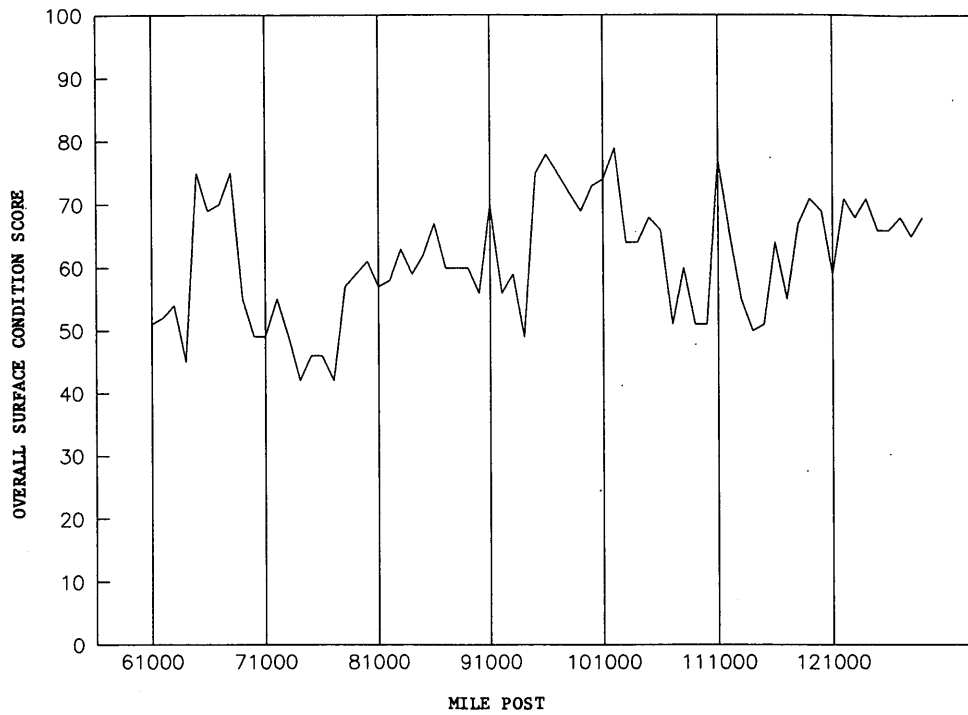
FIGURE 1 Eastbound visual rating.

Several types of distress were present with the extent and severity varying significantly throughout the entire area. The predominant types of distress present were spalling of the transverse joints and spalling and cracking of the longitudinal joints in the driving lanes and on the shoulders. The overall condition scores for each direction are shown in Figures 1 and 2. A score of 100 means the pavement is in excellent condition, a score of 50 means the pavement is in fair condition, and a score of 0 means the pavement is failed.

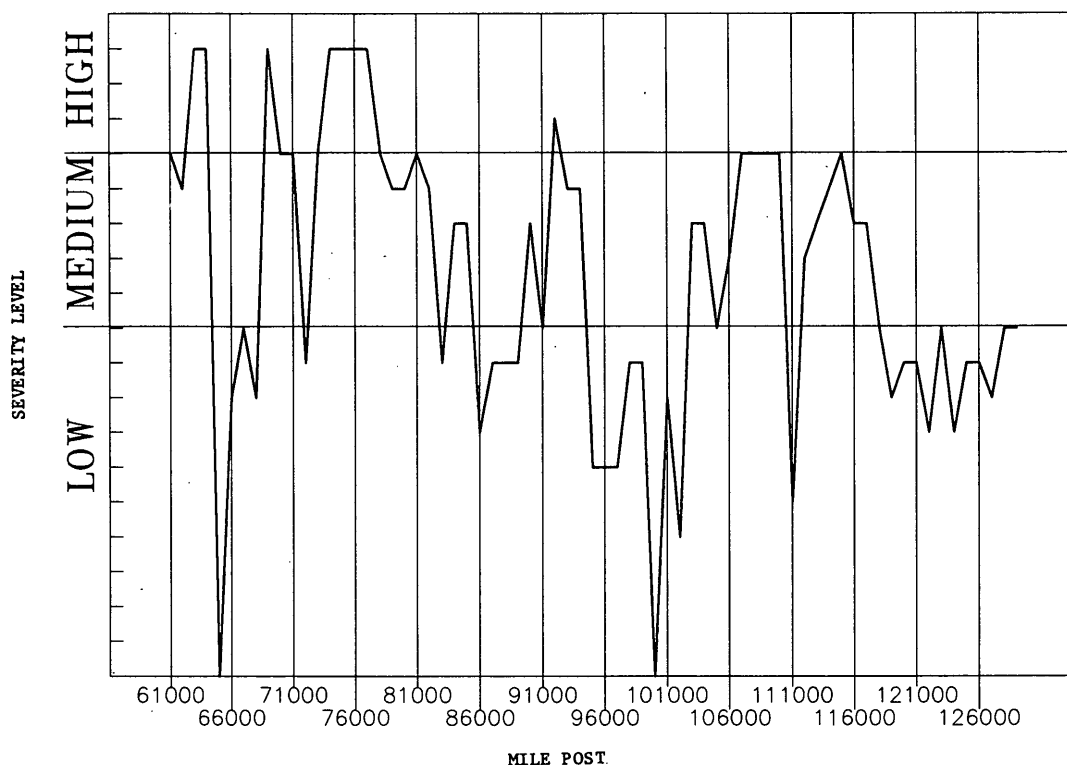
FIGURE 3 Eastbound visual rating of joints.

Another major problem with the pavement was the spalling of the transverse joints. The severity varied from low to high, and in some locations the spalling was as wide as 12 in. on either side of the joint and as deep as 8 in. Figures 3 and 4 show the combined condition of the longitudinal and transverse joints throughout the project.

The entire pavement structure exhibits a nearly total failure of the transverse and longitudinal joints sealant.

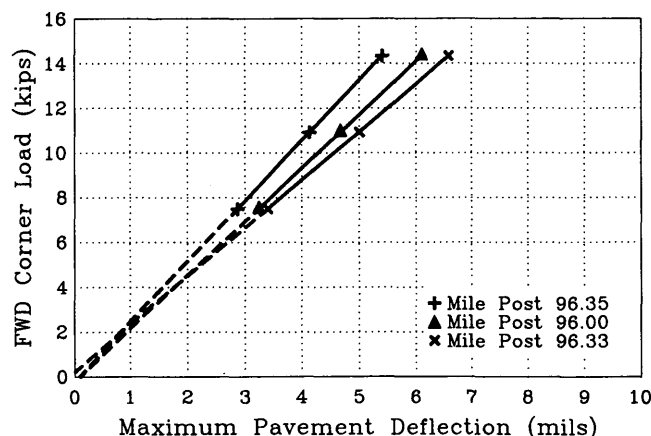
FIGURE 8 Actual load versus deflection detection plot.

A void can be described as an area of loss of support beneath the slab corners. This occurs because of heavy loads deflecting the slab corners, causing some pumping of fines with impulse water pressure. Any loss of support, even less than 0.10 in. thickness beneath the slab, will result in greatly increased slab stresses, causing corner breaks or diagonal cracks. The most common location for these voids is slab corners along the lane/shoulder joints. The loss of support can be determined using a procedure developed at the University of Illinois for the FWD (3). An examination of the load versus deflection at a slab corner can provide a rapid and simple indication of the existence of a void beneath the slab corner. The corner of each slab tested was loaded at three load levels and the corresponding deflections measured. Corners that have a load versus deflection plot that crosses the deflection axis near the origin of zero deflection, such as Line A in Figure 7, do not have voids beneath the slab. However, a line that passes significantly to the right of the origin, such as Lines B and C in Figure 7, is indicative of a void or loss of support beneath the slab corner. Figure 8 shows actual data from the East-West Extension.

After reviewing all of the load versus deflection plots, it was concluded that no voids or loss of support existed beneath the slabs tested except at Milepost 62.0153 eastbound. This was probably caused by the full-depth asphalt patch of the shoulder across the joint. Most likely the subgrade soil was disturbed during patching.
