Performance Monitoring of Joint Load Transfer Restoration

KATHLEEN T. HALL, MICHAEL I. DARTER, AND JAMSHID M. ARMAGHANI

The most comprehensive load transfer restoration experiment currently in service was constructed on Interstate 10 near Tallahassee, Florida, in 1986. The performance of this experiment has been monitored continuously by the University of Illinois and the Florida Department of Transportation between 1986 and 1992. Fourteen different load transfer restoration treatments were studied. Retrofit dowel factors studied included number of dowels per wheelpath, dowel length, and dowel diameter. Double-V shear device factors studied included core wall grooving and number of devices in the outer and inner wheelpaths. The results of condition surveys, faulting surveys, and falling weight deflectometer deflection load transfer testing of the project are reported. All of the treatments were effective in limiting faulting increases to much lower levels than the faulting increases of the control sections. In addition, they all improved deflection load transfer significantly, and after 5 years in service, deflection load transfer percentages are still similar to initial postcons

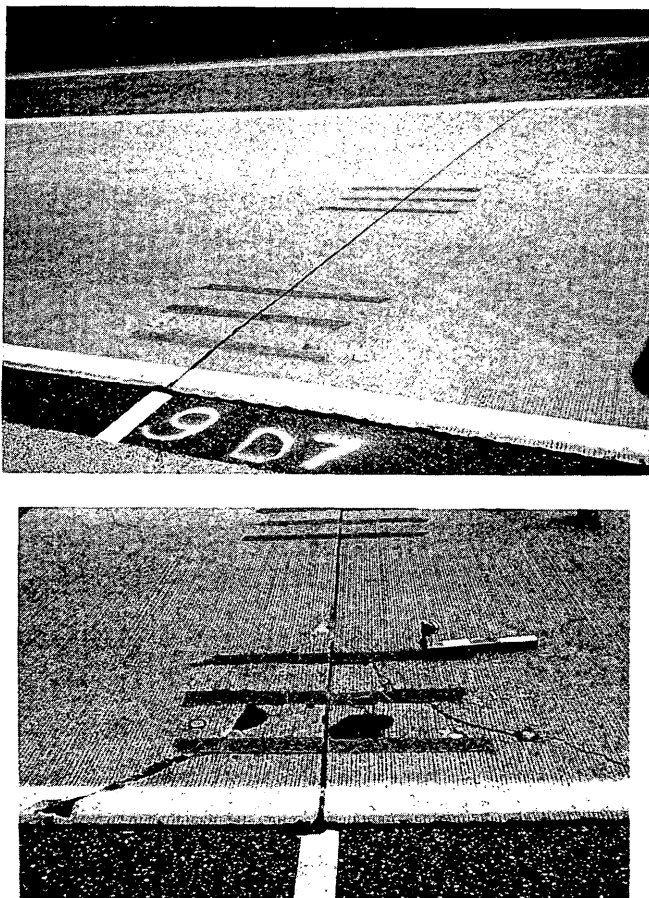
Between 1988 and 1991, however, the project developed considerable distress, particularly at the retrofit dowels. At many locations, a series of horizontal cracks was observed between the dowel slots, parallel to the joint. Often one or more cracks ran along the side of a dowel slot, and from there extended back into the slab. Some of these slab cracks extended straight from the dowel slot, parallel to the wheelpath, but most of the slab cracks that emanated from dowel slots run diagonally across the slab and intersected the lane edge a few feet from the transverse joint. This type of cracking occurred at dowel installations in both wheelpaths of the traffic lane.

Figure 5 shows Joint 9 in the eastbound D7 test section in 1988 (*top*) and in 1991 (*bottom*). The cracking, which is barely visible in 1988, reached medium severity by 1991.

FIGURE 5 Cracking at D7 dowel section, Joint 9 eastbound, 1988 (*top*) and 1991 (*bottom*) surveys.

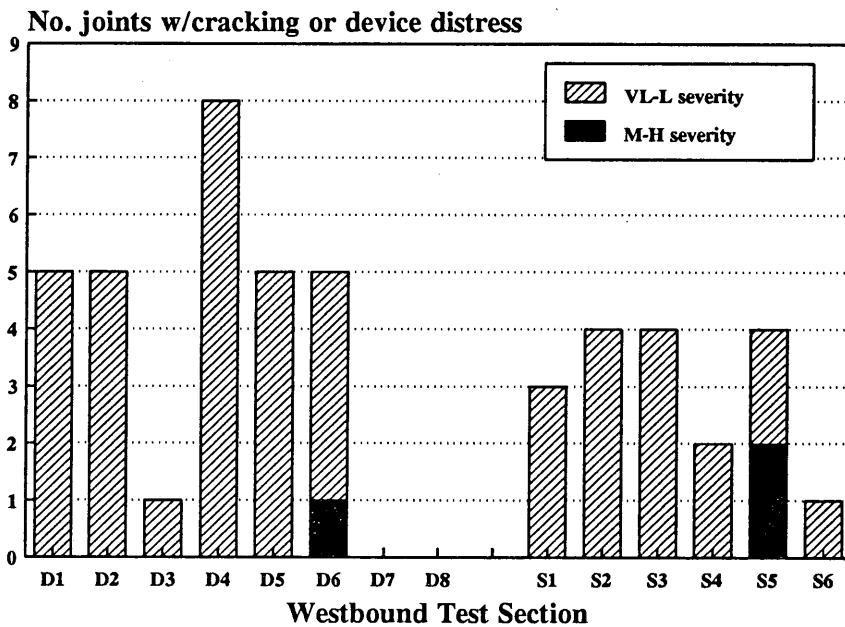
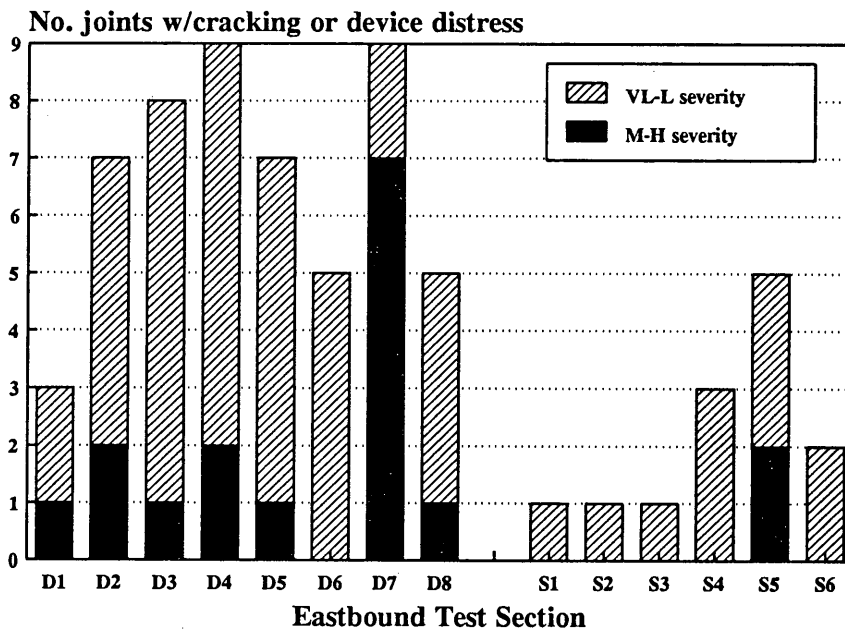
The number of joints in each section affected by slab cracking or device distress in 1991 is illustrated in Figure 6. For most of the retrofit dowel sections, the slab cracking in the vicinity of the retrofit dowels is more prevalent and more severe in the eastbound direction than in the westbound direction. A striking contrast, for example, is seen between the eastbound and westbound D7 sections. All nine of the eastbound D7 joints have cracking, and this cracking was rated medium or high severity at seven of the nine joints. None of the westbound D7 joints have any cracking. It is worth noting that the eastbound D7 section was one of the first test sections to be constructed (see the test section layout in Figure 1).

For the three shear device treatments without core wall grooving (S1, S2, and S3), slab cracking or device distress is more prevalent in the westbound sections than in the eastbound sections. For the remaining three shear device treatments, the distress levels in the two directions were very similar.

FIGURE 6 Number of joints with slab cracking or device distress.

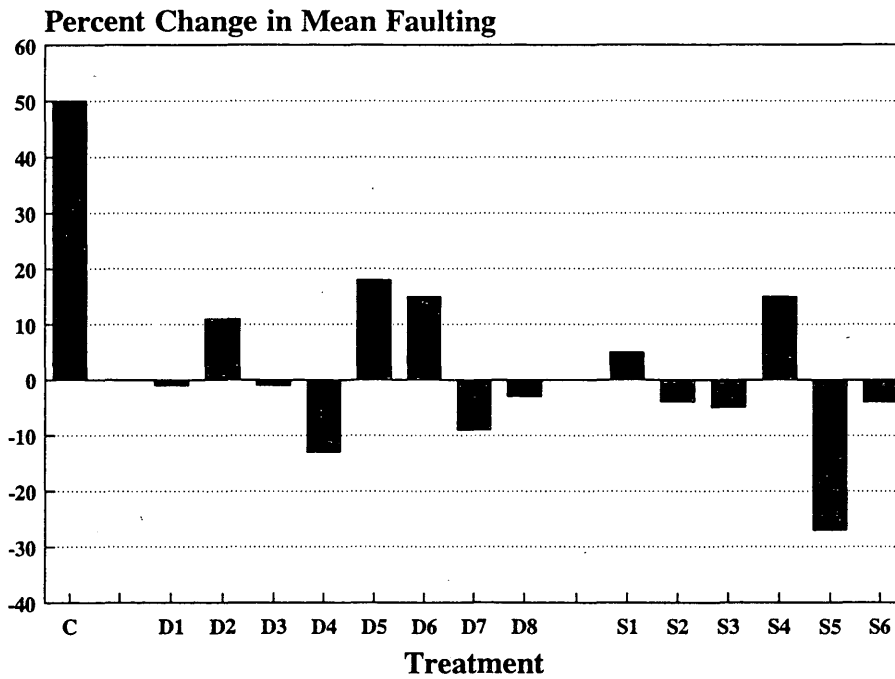
The percent change in average faulting between 1986 and 1991 is illustrated in Figure 7. The 50 percent change for control joints represents the average for all joints in the project's four control sections (36 joints total). The percent changes shown for the various load transfer treatments represent the average of the percent changes for the treatment sections in both directions (18 joints total). The percent change in control section faulting has been much greater than that in any of the load transfer treatments.

FIGURE 7 Percent change in mean faulting of control sections and load transfer and restoration treatments.

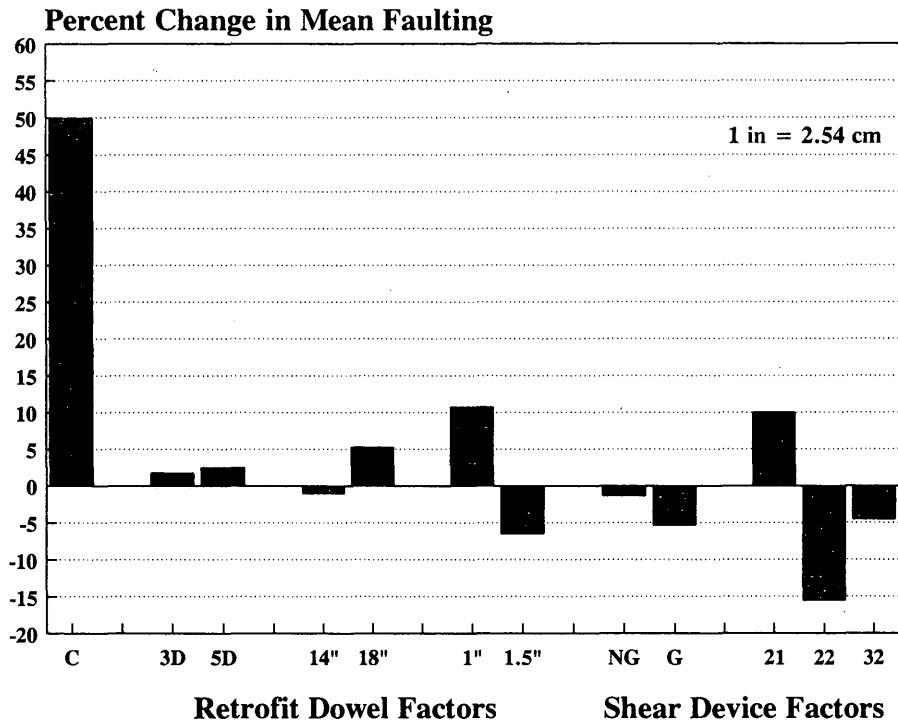
Figure 8 illustrates the effects of the retrofit dowel factors and shear device factors studied on faulting performance. In each category the percent change in faulting is much less than the 50 percent change in control section faulting.

Figure 8 suggests that dowel length may have been significant: the average faulting change of sections with 45.7-cm (18-in.) dowel bars was positive, whereas the average faulting change of sections with 35.6-cm (14-in.) dowel bars was negative. However, these results were actually mixed by section. Of the treatments with 35.6-cm (14-in.) dowels (D1, D2, D3, and D4), one of four showed a percentage increase in mean faulting, and two of four showed a positive average increase in faulting. Similarly, of the treatments with 45.7-cm (18-in.) dowels (D5, D6, D7, and D8), two of four showed a percentage increase in mean faulting and two of four showed a positive average increase in faulting.

The most significant factor in retrofit dowel faulting performance appears to have been dowel diameter. All of the sections with 2.5-cm (1-in.) dowels (D1, D2, D5, and D6) showed a percentage increase in mean faulting and a positive average increase in faulting. All of the sections with 3.8-cm (1.5-in.) dowels (D3, D4, D7, and D8) showed no positive percentage increase in mean faulting, and only D3 showed a slight positive average increase in faulting.

FIGURE 8 Effect of retrofit dowel and shear device factors on faulting.

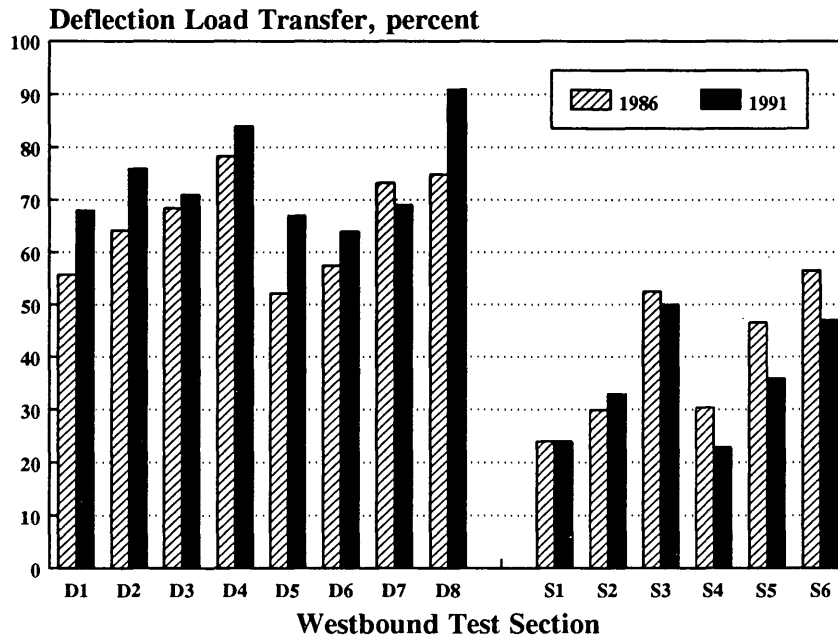
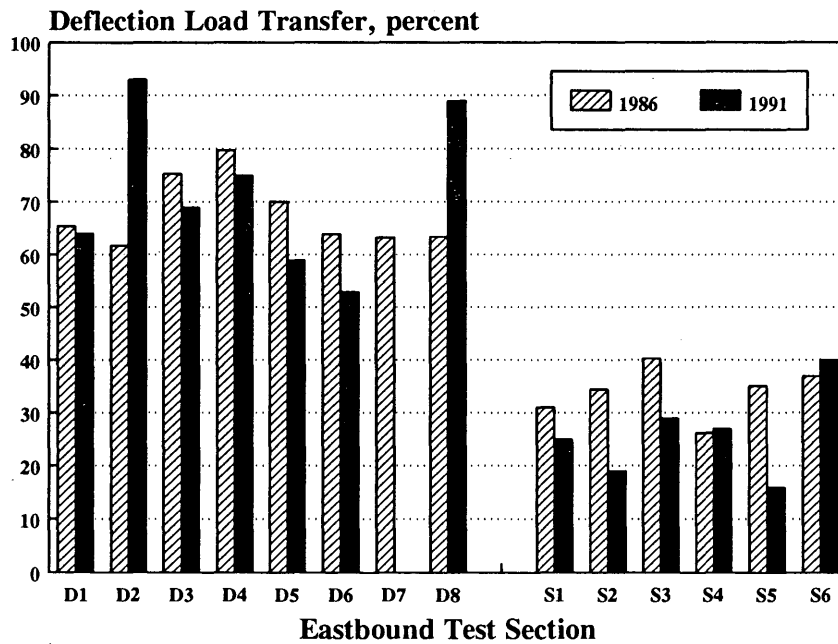
Deflection testing was conducted again by the Florida DOT in early 1992. The load transfer efficiencies of the various test sections are compared with the load transfer efficiencies in 1986 in Figure 9. In general, the results are similar.

The load transfer efficiencies of most of the retrofit dowel sections in 1992 are within 15 percent of their 1986 values. Most of the westbound dowel sections actually have higher mean load transfer efficiencies now, whereas most of the eastbound dowel sections have lower load transfer efficiencies now. In one eastbound dowel section (D7), joint load transfer measurements were not taken, presumably because of excessive joint deterioration.

The load transfer efficiencies of most of the shear device sections in 1992 are within about 10 percent of their 1986 values. Two eastbound sections (S2 and S5) appear to have dropped to fairly low load transfer levels (less than 20 percent). Sections without grooved core walls do not have significantly different load efficiencies than corresponding sections with grooved core walls. In the westbound direction, the load transfer efficiency improves with increasing number

FIGURE 9 Comparison of 1986 and 1991 deflection load transfer efficiencies in test sections.

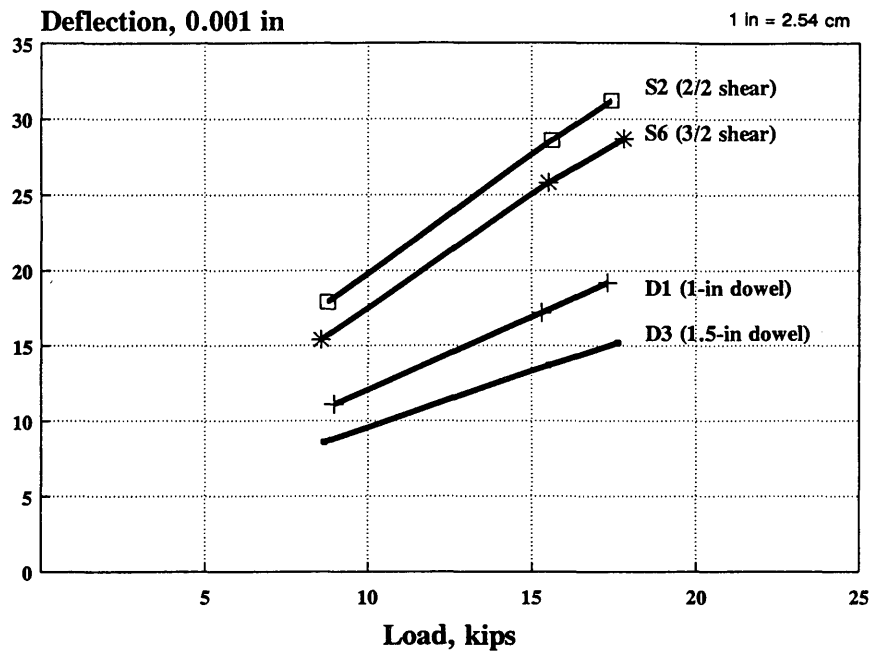
Figure 10 illustrates sample load versus deflection plots for representative joints in two dowel sections and two shear sections. The dowelled joints show lower deflections at each load level than the shear joints. Between the two dowelled joints shown, the joint with 3.8-cm (1.5-in.) dowels shows lower deflections than the joint with 2.5-cm (1-in.) dowels. Between the two shear device joints shown, the one with three devices in the outer wheelpath shows lower deflections than the one with two devices in the outer wheelpath.

The trends illustrated in Figure 10 are typical of the load-versus-deflection behavior of joints throughout the project, although there is significant variation from joint to joint within each test section. In general, joints with 3.8-cm (1.5-in.) dowels had about 30 percent lower corner deflections than joints with 2.5-cm (1-in.) dowels. Other retrofit dowel factors did not have any significant effect on corner deflections. Overall, dowelled joints had about 30 percent lower corner deflections than joints with shear devices. Joints with 3.8-cm (1.5-in.) dowels had about 38 percent lower corner deflections than joints with shear devices.

FIGURE 10 Example of load-versus-deflection results at slab corners for dowels and shear devices.
