Liquefaction-Induced Damage to Bridges

T. LESLIE YOUD

Liquefaction-induced lateral spread is a major cause of earthquake damage to bridges built across streams and rivers. Lateral spreads are characterized by horizontally displaced ground with extensional deformations at the head of the feature, shear deformations along the margins, and compressed ground at the toe. Displacements generally range from a few centimeters to several meters and are directed down mild slopes or toward a free face, such as an incised river channel. Such displacements thrust bridge abutments and piers riverward, generating large shear forces in connections and compressional forces in the superstructure. These forces have sheared connections, allowing decks to be thrust into, through, or over abutment walls or causing decks to buckle. In other instances, connections have remained intact with the deck acting as a strut, holding tops of piers and abutments in place while the bases of these elements are displaced toward the river. These actions have inflicted severe damage and even bridge collapse. The performance of bridges during past earthquakes is reviewed to illustrate types of damage as a consequence o

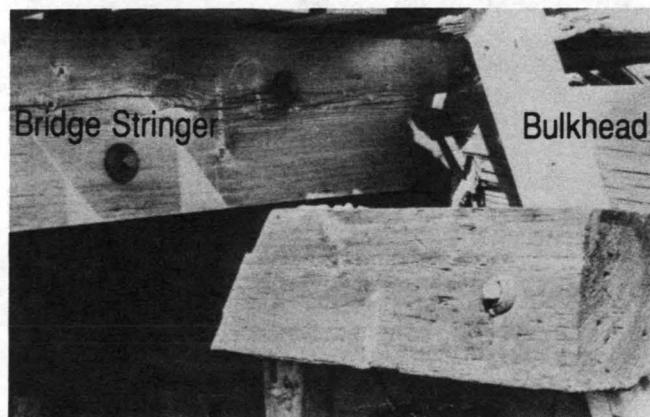
The following examples of damaged railway bridges illustrate these effects. The damage to the bridge at Milepost 61.9 is representative of stringers thrust through bulkhead walls (Figure 3). This bridge consisted of seven 4.5-m long spans supported on interior timber pile bents with timber bulkheads at either end. About 0.5 m of streambank convergence compressed the bridge structure, tearing stringers from their seatings and thrusting the loosened stringers through the bulkhead walls.

FIGURE 3 Stringers of Bridge 61.9 that were driven through the bulkhead wall by convergence of the stream banks during the 1964 Alaska earthquake [after McCulloch and Bonilla (4)].

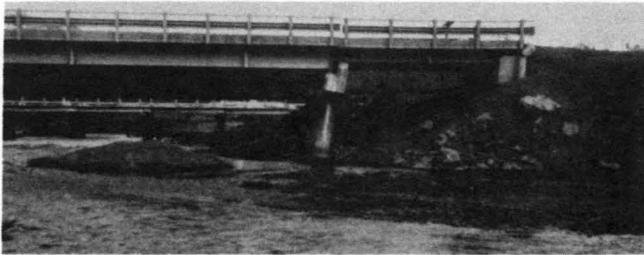
A similar type of failure occurred to a highway bridge over one of the channels of the Resurrection River near Seward. The banks of the river spread into the channel, causing more than 0.3 m of convergence between bridge abutments (Figure 4). The narrowing of the channel thrust the bridge girders and deck into the abutment wall, which fractured and rotated under the impact, allowing the deck to penetrate about 0.3 m into the adjacent fill. The ground displacement carried the adjacent bridge pier about 0.3 m toward the channel, with the top of the pier remaining attached to the deck. As shown in Figure 4, this displacement fractured the pier at the ground line and tilted the upper part of the pier outward, away from the river.

FIGURE 4 Highway bridge over Resurrection River that was compressed by lateral spreading during the 1964 Alaska earthquake. The compression thrust the deck into and fractured the abutment wall, and ground displacement carried the adjacent pier streamward, fracturing that element at the ground line [after McCulloch and Bonilla (4)].

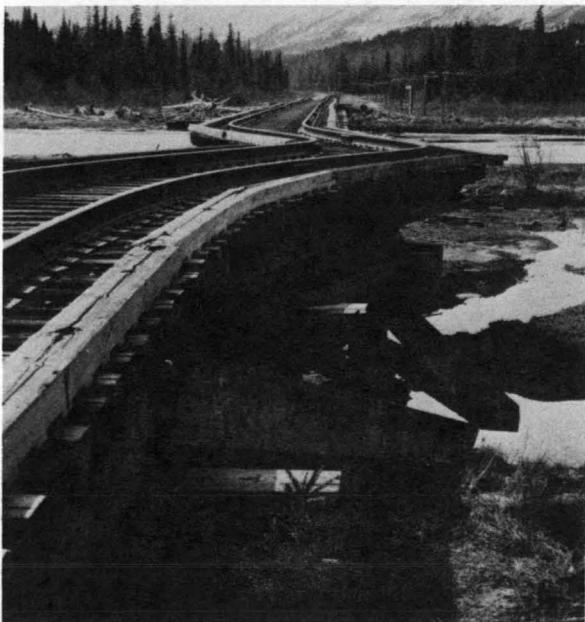
The bridge at Milepost 37.3 is representative of a structure that fractured and buckled because of compressional forces applied by the converging stream banks (Figure 5). This bridge was composed of five 4.5-m long spans. The stream banks

FIGURE 5 Deck of the Alaska railway bridge at Milepost 63.0 buckled by stream bank convergence of about 0.18 m [after McCulloch and Bonilla (4)].

converged about 0.18 m, causing the deck to buckle horizontally by about 1.2 m (4). A few similarly stressed bridge decks buckled upward rather than laterally.

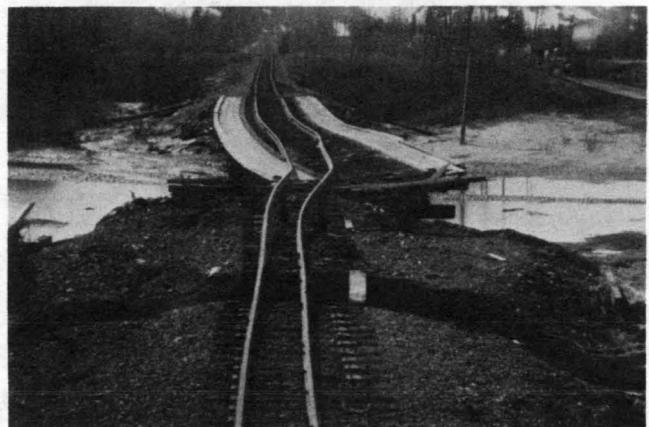
Bridges that crossed streams at oblique angles commonly skewed, rather than buckled, under ground-induced compressional forces. For example, the railway bridge at Milepost 63.0 (Figure 6) skewed horizontally as a consequence of about 2.8 m of stream bank convergence. The bridge was a 58.4-m long structure supported by 14 pile bents. The convergence of the stream banks shifted the pile bents streamward on both sides of the channel. Because the direction of ground displacement was at an angle to the longitudinal axis of the bridge, the compressional forces generated horizontal forces between the deck and the southern bulkhead. These forces fractured the stringer connections at the bulkhead and deflected the deck 2.4 m eastward (to the right in Figure 6). The deck rotated and bowed horizontally as a unit, breaking connections between some pile caps and stringers and dragging others laterally with the displaced deck.

FIGURE 6 The Alaska railway bridge at Milepost 63.0 that was compressed by lateral ground displacement, causing near end of the bridge to shear connections with the bulkhead and skew to the right [after McCulloch and Bonilla (4)].

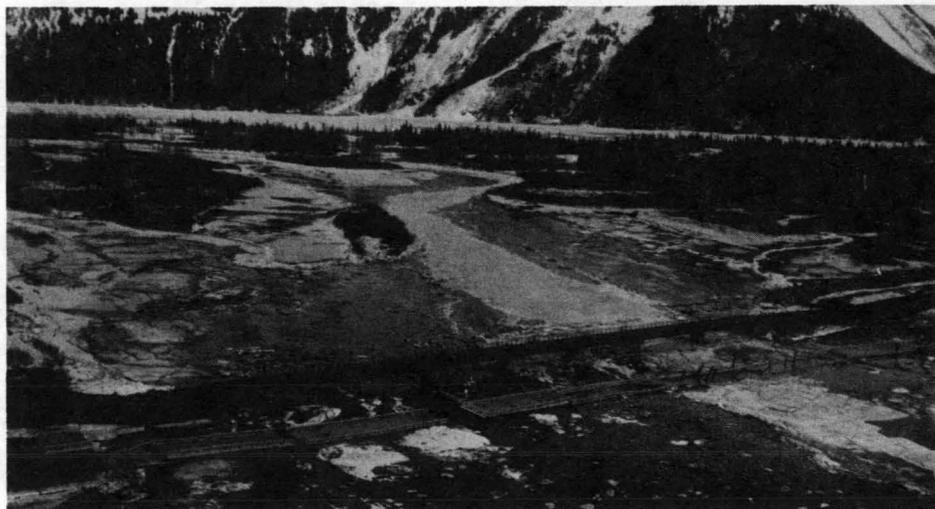
broke connections with the superstructure, leaving decks unsupported. One collapsed bridge—the structure over Twentymile River—is shown in Figure 7. This and other severely damaged bridges were at localities of intense liquefaction effects—including ground oscillation and lateral spread—as described by Kachadoorian (5):

The seismic shaking and lateral displacement of the sediments pulled the wood ties off the caps, and the superstructure became independent of the substructure. The deck or superstructure had a vertical as well as a horizontal component of movement during the earthquake. Eventually the wood bents failed beneath the superstructure and the bridge collapsed. In many bridges the wood piles were driven through the reinforced concrete deck [Figure 7]. Eye witness reports show that the decks had an up-and-down motion period of about 1 second. That is, a wave apparently passed through the deck, and, as it passed through, the superstructure moved up and down in about a 1-second cycle. (5)

This description of bridge failure indicates that seismic shaking liquefied the underlying soils, which in turn spread laterally toward the river channel. That ground movement pushed the pile bents riverward, shearing connections with the superstructure. The ground apparently did not move in a single uniform motion, but oscillated back and forth and up and down in waves as it migrated toward the river. This oscillatory movement caused the bridge deck to vibrate vertically—and apparently out of phase with the underlying ground—generating intense impacts between the deck and the detached piles, with the piles eventually punching through the paved surface as the deck fell to the ground.

FIGURE 7 Collapsed highway bridge across Twentymile River (bridge nearest camera); a damaged but intact railway bridge is behind highway structure [after McCulloch and Bonilla (4)].

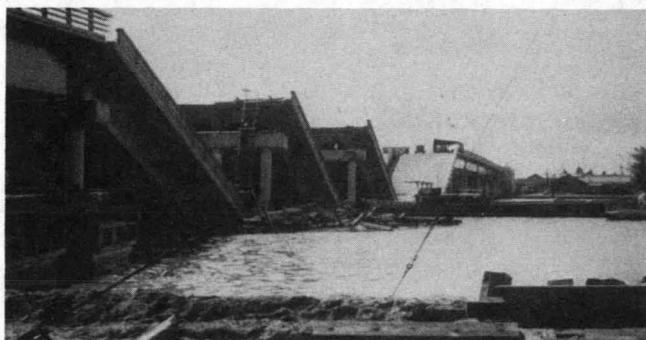
bridges. For example, several deck segments of the Showa highway bridge collapsed into the river as a consequence of ground displacement (Figure 8). Hamada and others (6) give the following description of that collapse:

There were obvious signs that a violent collision had occurred between the girders themselves and the abutment on the left bank. From the above, it can be conjectured that a large horizontal force had been exerted on the girder from the abutment on the left bank, and this is considered to have been one of the causes of the collapse. There were also signs that the bridge pier foundations on the left bank had moved toward the center of the river. In particular, pier P_6 had tilted considerably toward the right bank. It may be considered that such movement of the bridge pier foundations also contributed to the collapse. (6)

FIGURE 8 Showa highway bridge that collapsed into the Shinano River during the 1964 Niigata, Japan, earthquake (photograph by T. L. Youd).

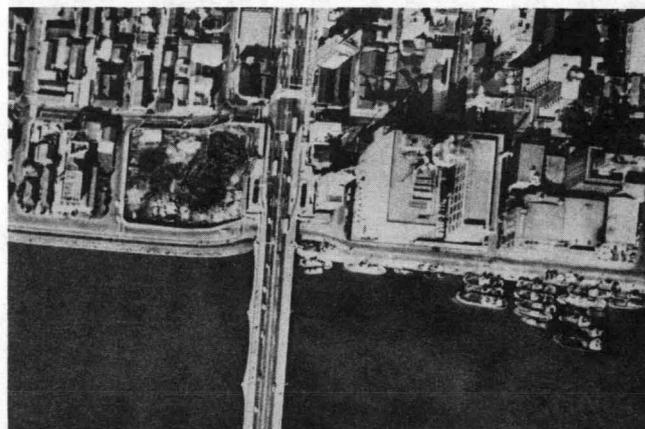
As noted by Hamada and others, horizontal displacement of the piers supporting the Showa bridge was much less than displacement of the ground a short distance either upstream or downstream from the bridge. This reduced displacement indicates that the bridge restrained ground deformation. Other bridges across the Shinano River impeded lateral ground movements as well. In the latter instances, the decks remained attached to the piers and acted as struts or braces, increasing resistance to ground displacement. For example, a postearthquake aerial photograph (Figure 9) shows reconstructed river revetments above and below the Bandai Bridge. Those revetments formed a straight line before the earthquake. The revetments were pushed toward the river during the earthquake and then reconstructed in their postearthquake position. The reduced ground displacement near the bridge is graphically illustrated by the landward curvature of the reconstructed revetments. Further evidence that the bridges restricted bank displacements is given by Hamada and others (6), who calculated vectors of ground displacement from photogrammetric analyses of pre- and postearthquake aerial photographs. Those vectors indicate that river bank displacements were about 8 to 9 m upstream from the Bandai Bridge,

but only about 4 to 5 m near the bridge. Thus the bridge apparently restrained lateral ground movements by about 4 m.

FIGURE 9 Aerial view of Bandai Bridge showing curved revetments along water-bank interface. The curvature was caused by lateral ground displacements during the 1964 Niigata earthquake [after Hamada et al. (6)].

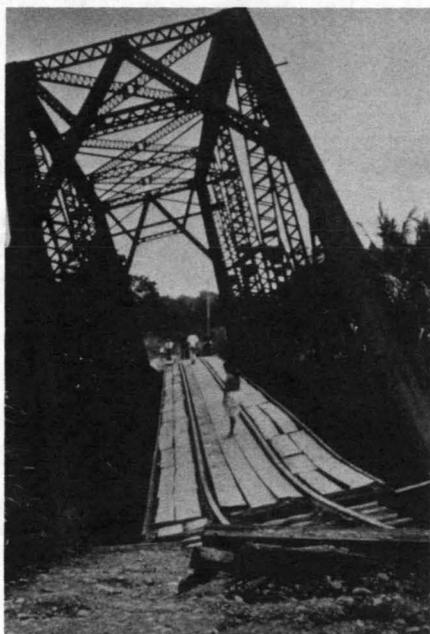
The modes of bridge damage in Costa Rica were generally similar to those described above; that is, lateral displacement of floodplain deposits pushed abutments and piers riverward, shearing connections and causing other damage. In several instances, however, the connections between the foundation and the deck sheared readily, preventing the deck from acting as a strut or brace. The connection failures allowed the abutments and piers to readily shift or tilt toward the river channel, removing support from the superstructure. An example of this type of failure is illustrated by the tipped railroad bridge over the Rio Bananito near Bananito Sur (Figure 10). The steel-truss single-span bridge was supported by four 1.5 m by 2.1 m oval-shaped concrete caissons, one placed under each corner of the truss. Liquefaction and lateral spread on both sides of the river pushed the tops of the caissons inward (Figure 11), removing support from the truss, which then dropped and tilted downstream. Displacements of the tops of the caissons ranged from 1.9 to 5.7 m (7).

FIGURE 10 Railway bridge over the Rio Bananito that tipped during the 1991 Costa Rican earthquake; lateral ground displacement pushed the supporting caissons from the bridge seatings leaving the truss unsupported (photograph courtesy of Laboratorio de Ingenieria Seismica de la Universidad de Costa Rica).

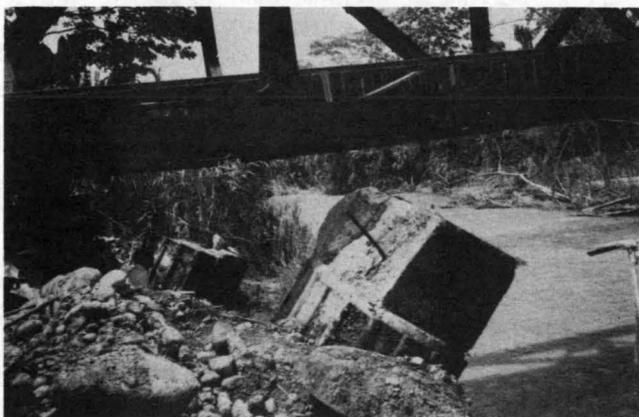
FIGURE 11 Caissons beneath the Rio Bananito railway bridge that were pushed riverward by lateral ground displacement during the 1991 Costa Rica earthquake (photograph by T. L. Youd).

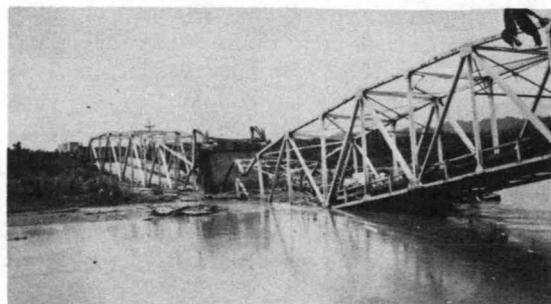
The highway bridge over the Rio Estrella is of interest because although the superstructure collapsed, the foundation did not permanently displace. The bridge was composed of one 25 m long plate girder section and two 75 m long truss sections. During the earthquake, the two trusses fell from their common support on a central pier and dropped into the river (Figure 12). Simultaneously, the roadway approach to the south end of the bridge settled about 2 m, broke up, and

FIGURE 12 Highway bridge that collapsed into the Rio Estrella during the 1991 Costa Rica earthquake (photograph by T. L. Youd).

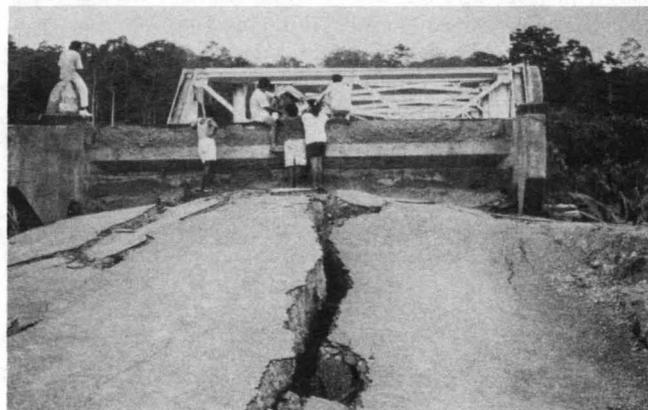
spread laterally (Figure 13). Large fissures parallel to the river developed in banana plantations on either side of the approach road. These effects indicate that liquefaction and lateral spread were widespread near the southern abutment.

FIGURE 13 Liquefaction-induced settlement and deformation of approach fill adjacent to southern abutment of Rio Estrella highway bridge (photograph courtesy of Laboratorio de Ingenieria Seismica de la Universidad de Costa Rica).

that the abutments and piers withstood earthquake shaking and the development of liquefaction without significant permanent displacement. In particular, the foundation beneath the southern abutment remained in place, even though liquefaction and substantial ground disruption occurred in the immediate vicinity (Figure 13). This abutment consisted of a concrete wall supported on two substantial groups of piles, which extend to depths of about 14 m below river level (8).
