Methodology for Inspection of Collector Systems

ZUBAIR AHMED AND THOMAS D. WHITE

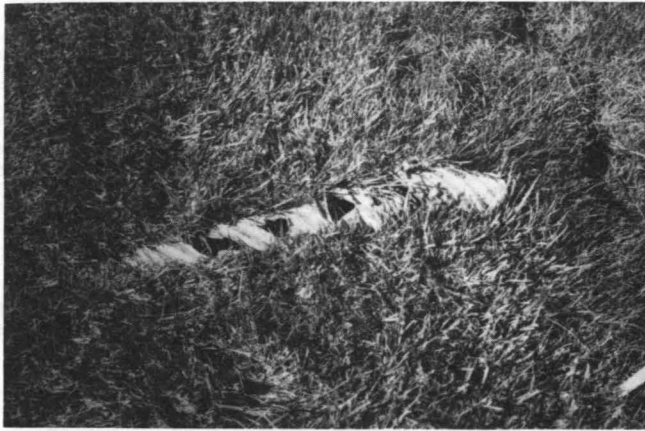
A frequent condition found was that the pipes were exposed for some length (Figure 6) or the outlet was crushed (Figure 7). Crushed outlet pipes become clogged over time, rendering the drainage system ineffective. Crushing is associated with erosion of soil on flat slopes from around the outlet and subsequent operation of mowing equipment on the embankments.

FIGURE 6 View of exposed and damaged outlet pipe.

3. Treatment of the area around the outlet pipe contributes significantly to proper functioning of the collector system. Vegetation growth, sedimentation, and erosion around outlet openings are impediments to effectiveness of the system. Rip-rap protection or concrete pads around the outlet area will minimize this effect and protect the outlet pipe from damage caused by mowing equipment.

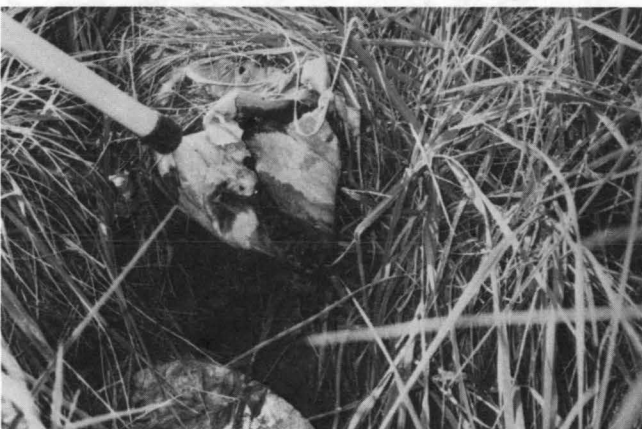
FIGURE 7 View of crushed outlet pipe.

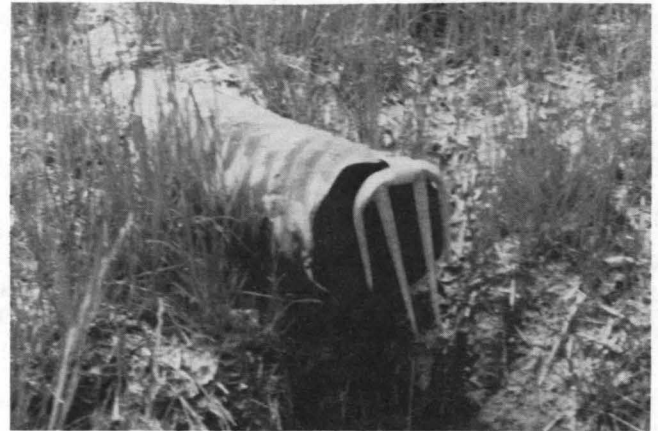
pipes were present in most of the inspected highway sections. Three outlet screen designs were found. The most common was a mesh-type screen, followed by spiral and spear types. The spear-type screen (Figure 8) did not cover the outlet and could be easily lifted, allowing rodents and small animals access to the pipe.

FIGURE 8 Spear-type rodent screen.

2. Mesh-type screens are more effective than other designs in preventing rodents and small animals from getting into the outlet pipes and edge drains.

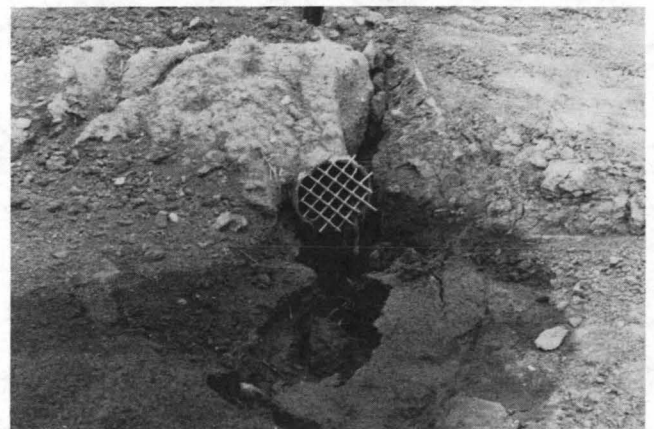
protection, the soil around the outlet pipe erodes (Figure 9), exposing the pipe. The connection between the outlet pipe and the headwall may also be broken. A headwall or lined ditch at the outlet was found to be effective in restricting vegetation growth.

FIGURE 9 Erosion around newly constructed outlet pipe.

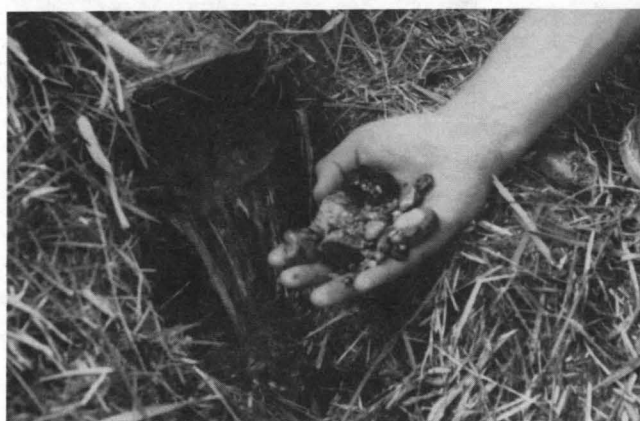
Most of the corrugated steel pipe edge drains viewed through the camera showed significant corrosion. This can be attributed to dissolved salts or other chemicals. This type of distress becomes more severe when there is standing water inside the pipe, because it allows time for the chemicals in water to react with the pipe metal. In some of the inspected pipes, the severity of the corrosion resulted in development of cavities and openings in the pipes. These openings allowed material to enter the pipe and, without flow for a period of time, the pipe system becomes plugged. In one of the inspected drains, gravel used in the embankment was being transported out of the pipe (Figure 10). Plastic pipes inspected were free from this form of distress.

FIGURE 10 Gravel from punctured outlet pipe.

5. Smooth-walled plastic outlet pipes perform better than corrugated steel pipes because corrosion and sedimentation are more pronounced in the latter.

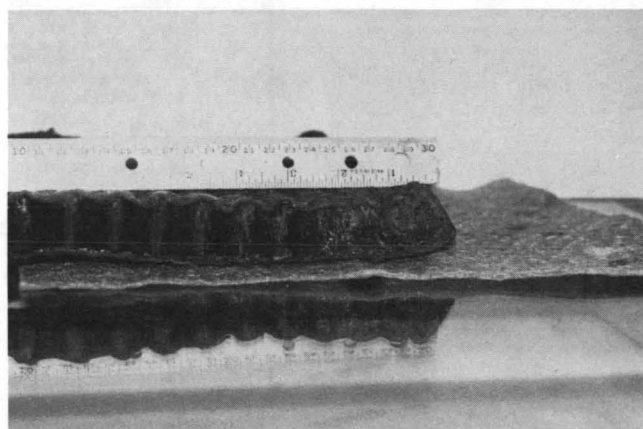
sedimentation deposits to a depth of 75 mm (Figure 11). This section of I-65 has a dense-graded aggregate base. Fin drains installed along I-65, having bituminous stabilized subbases, showed less of this problem and water flowed freely immediately after rainfall events.

FIGURE 11 Sedimentation deposits in exposed fin drain.

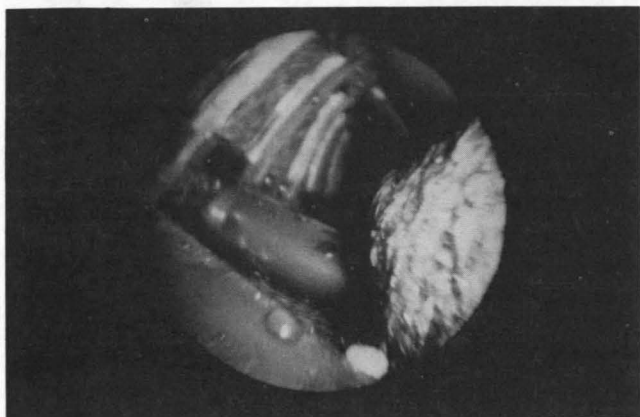
Fin drain buckling was observed at most inspection sites. The cuspatations of the drain core would appear to arch along the horizontal plane. This was more pronounced at transverse joints along concrete pavements. Sections exposed at the joint showed the width of the adjacent concrete slabs varying by 25 to 50 mm. Because the drain is placed immediately adjacent to the pavement-shoulder joint, projection of adjacent slabs causes the drain to bend in a horizontal plane (Figure 12). This in turn reduces the core flow capability of the drain.

FIGURE 12 Fabric intrusion and roll over of fin drain.

7. The type of fin drain inspected in this study has a tendency to buckle, and the use of an improved product is recommended.

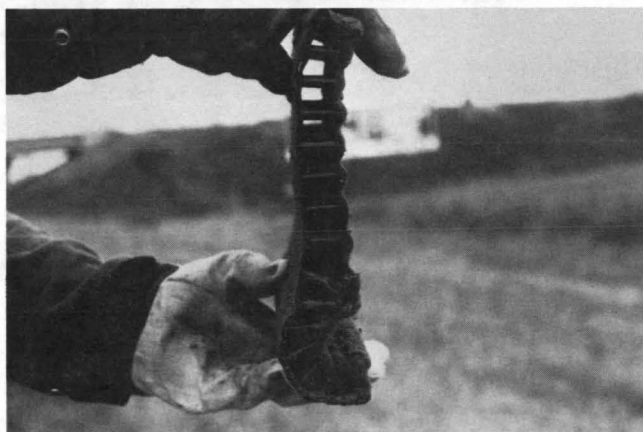
A form of fin drain distress observed in the vertical plane is termed J-buckling (Figure 13). This is attributed to the design of the Monsanto fin drain. The drain core has a perforated base on one side with cuspatations projecting from the base. The fabric is wrapped around the core. The cuspatated side of the core is susceptible to buckling when loaded vertically. Such a vertical load is applied during trench backfilling

and compacting. Also, outlet pipe connections are not made at the same time the drain is installed. Thus the trench has to be reexcavated at the point of joint connections to connect the outlet pipes. Backfilling and compaction result in the drain buckling along its bottom edge, especially at the joints. This was seen with the PLS camera system while checking the fin drain outlet pipes.

FIGURE 13 View of J-buckling in exposed fin drain.
