Pipe Failure Caused by Improper Groundwater Control

ERNEST T. SELIG AND TIMOTHY J. MCGRATH

A sewer collection system installed in a Middle Eastern city incorporated 11 km of fiberglass reinforced plastic mortar (RPM) sewer pipe 500 to 1100 mm in diameter. A short time after installation it was discovered that the pipelines were highly deflected and that some pipe was cracked at the crown. Subsequently a number of the cracked pipes failed, causing large craters and collapse of the roadway. Inspections showed that more than one-half of the RPM pipe system was deflected well over 5 percent, the limit imposed by the contract documents, with some portions deflected up to about 20 percent of their original diameter, and that numerous sections of pipe were cracked at the crown. Investigation of the conditions at the sites showed that the deflections and failures resulted mainly from inadequate control of the groundwater during construction and improper attention to the grading of the crushed stone pipe embedment relative to the natural sand materials against which it was placed. During construction the dewatering system did not maintain the groundwater level below the trench bottom, res

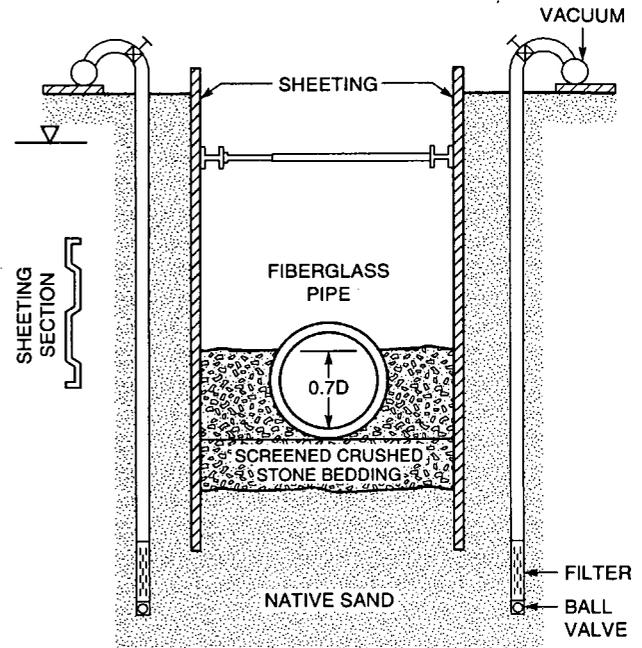
FIGURE 1 Typical braced sheeting installation.

The typical trench installation configuration using the preceding construction methods is shown in Figure 1. Although it was not directly observed during the investigation, a second sheeting system was reportedly used at some parts of the project. This method consisted of H-piles and timber lagging. As noted later, remnants of timber lagging were found at several locations during the investigation. No specific information is available on how this system was installed; however, typically the H-piles are driven before excavation and the timber lagging is installed as excavation proceeds.

• Because the sheeting did not have interlocking joints, the sheets separated as they were driven. The gaps between sheets were observed to be up to 12 in. during the investigation. Groundwater flowing into the trench through these gaps carried native sand with it and created voids behind the sheeting. These voids were also observed before the investigation conducted by the authors. At that time some were observed to be as large as 1 m³. Where the sand was above the phreatic surface, where pore pressures are negative, it was stable, even if the sheeting joints were open.

During the investigation by the authors, the contractor was aware of the voids and made attempts to fill them with stone before backfilling. If this was not done, the removal of the sheeting allowed the movement of the stone backfill out into the voids and the subsequent loss of support to the pipe. This process of stone movement is accelerated when the sheeting is removed with the aid of vibration, as was the case on this project.

On this project the use of sheeting with noninterlocking joints also contributed to the problem. Since the noninterlocking joints open up as the sheeting is driven, paths are created for sand to flow through the joints. Sheeting with interlocking joints may well have reduced the problem on this project. However, as observed at many locations, when the phreatic surface is maintained below the bottom of the trench, the sand is stable even when the joints are open.

The decision to remove the sheeting below the crown of the pipe was also a significant contributor to the overall problem. Not only did pulling the sheeting remove a barrier between the stone backfill and the voids, but also the vibration used caused the stone to settle into the void at a faster rate. These factors are in addition

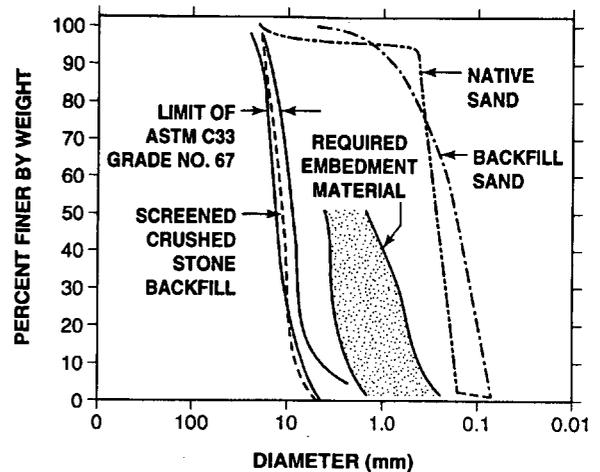
FIGURE 2 Gradations of sands and crushed stone materials.

Figure 2 shows the gradation of the trench backfill sand, the adjacent natural sand, and the pipe embedment crushed stone. Also shown in the shaded area is the required gradation of pipe embedment material that is compatible with the sand gradation based on the preceding criteria. The figure clearly shows that the crushed stone backfill is too coarse to prevent migration of fines.

Two solutions are available to prevent the problem of migration of fines. One is to place only compatible materials, based on the foregoing gradation criteria, next to each other. The other is to use a geotextile (filter fabric) between the incompatible materials. The mixing of dissimilar materials has long been known to be a problem for many construction situations (2); however, its impact on pipeline behavior is often ignored by specifiers. Even though ASTM D2321 has carried a warning against migration of fines since 1974, it was not until 1990 that specific guidance in the form of Equations 1 and 2 was incorporated into the standard. One reason why the issue of migration is often ignored is that many installations do not meet the gradation criteria but perform well. The authors believe that this is often because there is insufficient flow of groundwater to mix the adjacent materials. Unfor-

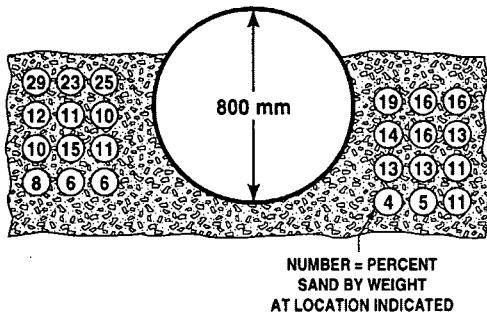
FIGURE 3 Percentage of sand in crushed stone backfill at failure site of 800-mm-diameter pipe.

During investigation of the failures, cross sections of the backfill were carefully excavated, and the migration of fines could be clearly seen. This was quantified by taking successive samples across the width and depth of the stone backfill. Since the largest particles of the sand were typically smaller than the smallest particles of the crushed stone, it was a simple matter to distinguish the amount of penetration of fines by evaluating the particle gradation on the basis that any material finer than 2 mm (No. 10 sieve) was from the sand. Figures 3 and 4 show the results of such measurements taken in the stone near the sites of two sep-

arate failures. Both show the results of gradation tests taken at approximately 150-mm spacing across the stone backfill. The figures suggest that migration was occurring, although much more dramatically in the 800-mm-diameter pipe than in the 600-mm pipe. Some mixing of the sand and stone will occur during installation but would not contribute to deflection of the pipe; however, the broad distribution of the finer than 2 mm fraction and the significant percentages present suggest that migration could have been a significant contributor to the overall deflections being recorded.
