# Performance Evaluation of a Cement-Stabilized Fly Ash Base

D. H. GRAY, E. TONS, AND T. R. THIRUVENGADAM

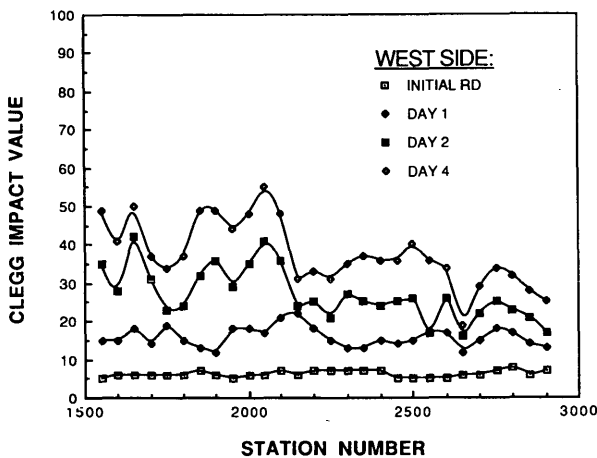
**FIGURE 4** Clegg impact readings at different elapsed times and locations along the west-side shoulder.

Typical results of the Clegg impact test along the length of the fly ash test section on the west side of the highway are shown in Figure 4. Strength gains tended to be higher on the south end of the project. In addition, east side readings were generally higher than the corresponding west side readings on the opposite side of the highway. A pronounced dip in Clegg impact values was recorded in the vicinity of Stations 26+00 to 27+00 on both sides of the highway. These low values indicated a weaker base at this location and helped to identify an area that required close scrutiny as the study progressed.

There are several possible reasons for the low values at Stations 26+00 to 27+00. Low cement contents are a possible explanation; however, the coincidence of low values at exactly the same location but on opposite sides of the highway suggest other explanations as well. The highway traverses a topographic low at this location. A small amount of standing water was observed in the road shoulder trench before placement of the fly ash base. This moisture may have adversely affected compaction of the fly ash and the cement set, thus explaining a much lower rate of strength increase relative to other locations.

Vertical displacement or heave is generally lower from Stations 15+00 to 24+00 compared with the area from Stations 24+00 to 30+00. The stabilized base in the former area tended to have higher cement contents and compacted densities. Analysis of field cores revealed relatively high cement contents in this area (e.g., 19.1 percent at Station 16+36 and 15.4 percent at Station 21+00, respectively). From Stations 25+00 to 28+00, the measured frost heave was virtually the same, but much higher for both shoulders compared with the area between Stations 15+00 to 24+00. This larger frost heave correlated with low cement contents in the base (e.g., 2.8 percent at east side Station 26+07). This is also the same area in which relatively low Clegg impact readings were recorded immediately after construction, as shown previously in Figure 4.

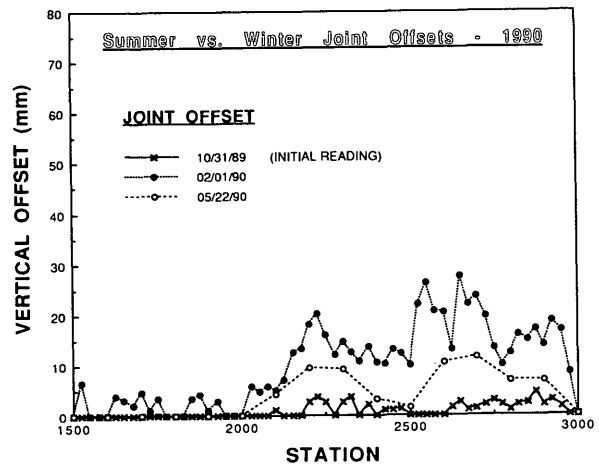
**FIGURE 5** Vertical offsets measured in 1990 at joint in pavement between shoulder and traveled way.

tions of the shoulder. Vertical deflections ranged as high as 6.8 cm (2.7 in.) along the joint in some locations after 5 years. The temporal and spatial distribution of vertical heave or offset along the joint are shown in Figures 5 and 6. Compared in Figure 5 are the vertical offsets measured in 1990, some 3 years after construction, and compared in Figure 6 are offsets measured in 1992, approximately 5 years later. Vertical offsets were measured during the winter and in the late spring or early summer. The residual vertical heave along the joint measured in late spring or early summer was approximately half that recorded in February during the height of the winter when the ice lenses in the base course were fully developed. Vertical heaving or deformation increased progressively with time, as can be seen by comparing vertical deflections in 1990 (Figure 5) versus 1992 (Figure 6).

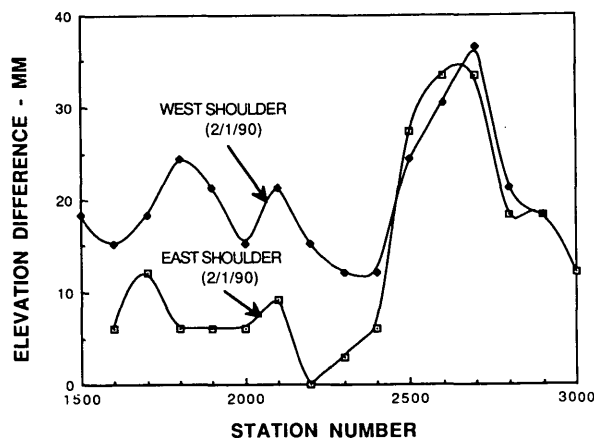
FIGURE 7 Comparison between elevation changes along centerline of east and west shoulders, respectively.

of the shoulder measured on February 1, 1990, are compared in Figure 7. The two curves are virtual mirror images, with the exception that vertical heave tends to be greater (approximately 2 times) between stations 15+00 to 24+00 on the west side compared with the east side. This finding is particularly significant because in spite of the generally higher heave on the west side, there is little or no sign of cracking or distress where the shoulder abuts the roadway. In other words, it appears that cutting a joint—the procedure adopted on the east side—has contributed largely to the subsequent vertical offset measured along the joint and associated cracking and deformation problems (discussed in the next section). The presence of the joint has allowed runoff from the roadway to flow down into the subbase. The problem is exacerbated when the shoulder heaves (relative to the roadway) and presents a vertical face that diverts runoff vertically downward directly into the base. This infiltrating water becomes a source of water for ice lense formation in the underlying base during the winter.

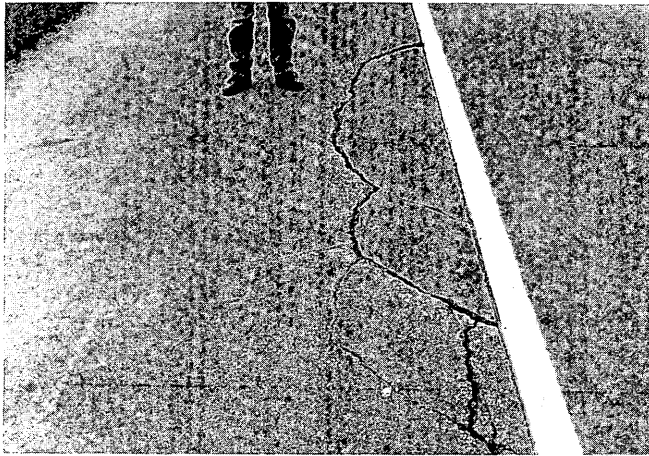
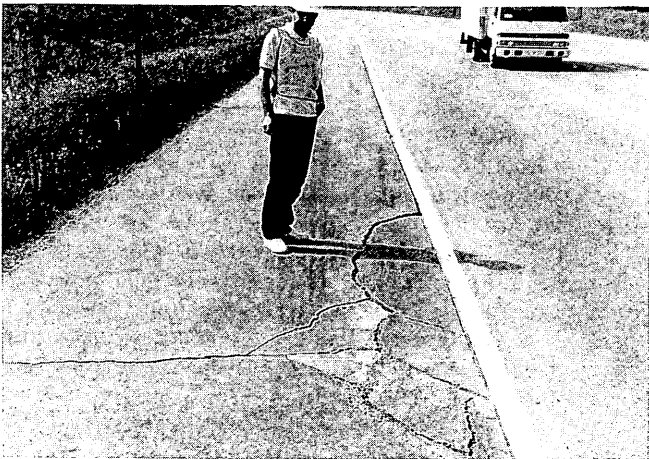
**FIGURE 8** Arcuate cracking along joint at Station 25+30 (east side) showing progression of cracking with time: (a) July 19, 1991, and (b) May 5, 1992.

Crack growth tended to progress with time. The character and development of arcuate (Type I) cracking along the joint at Station 25+30 on the east side is shown in Figure 8. The development of random (Type II) cracking at Station 25+10 on the west side is shown schematically in Figure 9. The crack growth versus time at Station 25+10 (west side) is illustrated in Figure 10.

Pronounced arcuate (Type I) cracks developed adjacent to the joint on the east side at Stations 25+30, 26+90, 27+20, and 27+50. The cracks at these locations are crescent-shaped features oriented parallel to the joint. These cracks coincide with areas of maximum joint offset (see Figures 7 and 8) and generally lower strengths (see Figure 4). The cracks most likely developed in response to traffic loads during the spring thaw when the shoulder was raised in a sharp vertical discontinuity at the joint. This problem was not observed in the west-side shoulder in spite of generally higher elevation changes along the west side (see Figure 9). This finding indicates that it would have been advisable not to cut

a joint in the pavement. The presence of the joint not only tended to divert run-off water downward into the fly ash base, it also contributed to the cracking problems observed along the east-side shoulder.

A groove or joint should not be cut in an asphalt pavement between the shoulder and traveled way. The joint ultimately intercepts and diverts runoff and meltwater into the underlying fly ash base with serious consequences. The presence of a joint was the main cause of severe heave and cracking in sections of pavement on the east side.

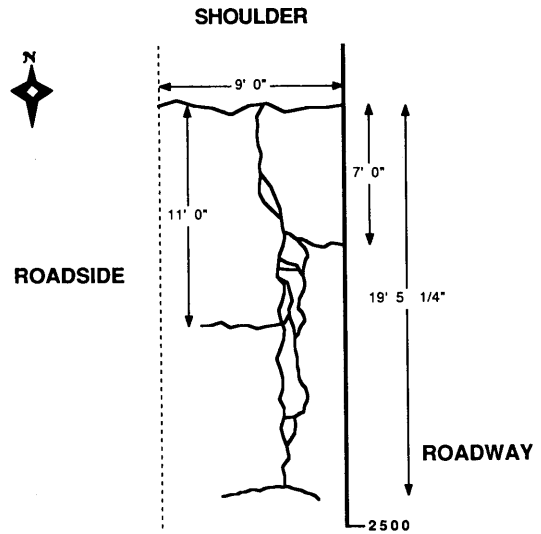
**FIGURE 9** Schematic diagram of cracking pattern measured May 22, 1990, in vicinity of Station 25+10 on west-side shoulder.

The temporal pattern of crack development at Station 25+10 (west side) shown in Figure 10 indicates that crack growth is most rapid during the winter months and is associated with frost heaving in the base. The density and strength of cores from this area are generally much lower than those at other locations. The cement content of a core from this location was also quite low (2.8 percent by weight). Visual evidence during the winter indicated that localized heaving was occurring here as well. Snow plow striations in the pavement surface were clearly visible here as a result of a slightly raised "mound" in the pavement surface.

**WEST SIDE CRACK #3**  
STATION 25+10 05/22/90
