Portland Cement Concrete Pavement Rehabilitation in Washington State: Case Study

LINDA M. PIERCE

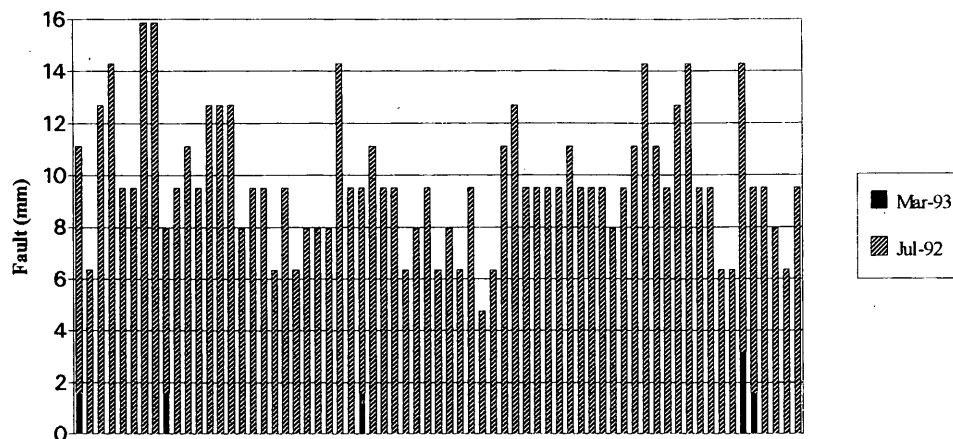
Section A - Dowel Bars Only

measurement after 7 months and approximately 700,000 ESALs the retrofitted dowel bar sections (Sections A and B) have performed extremely well with an average fault of 0.1 mm, the tied shoulder-only section (Section C) has an average fault of 0.6 mm, and the control section has an average fault of 1.8 mm (Figure 6). A straight-line regression analysis was performed on the average fault measurements for each of the sections (Figure 7). Life to previous (before rehabilitation) fault measurements for the control section (Section D) was used as an ending point. From the regression analysis it was determined that within 28 months Section D would be faulted to the level that it was before rehabilitation (which in this case was only pavement grinding). This tends to support the previous deduction that grinding alone on faulted pavements in Washington is not a cost-effective rehabilitation option.

FIGURE 6 Fault measurements.

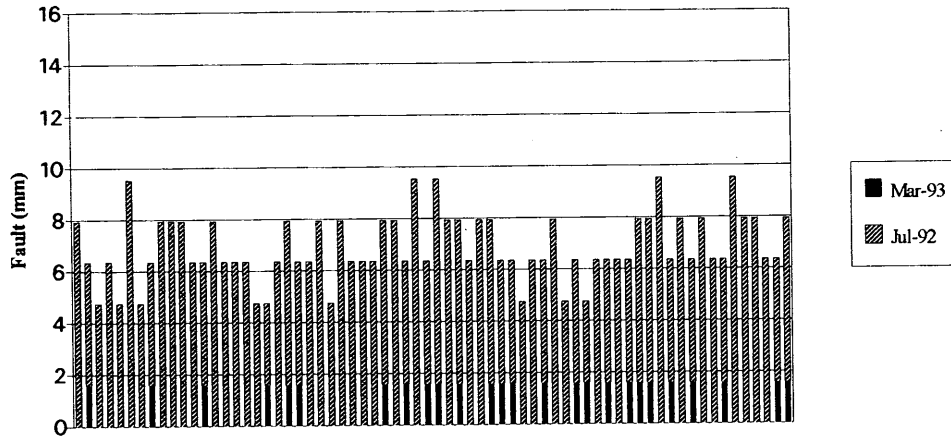
Section C - PCC Shoulders Only

FIGURE 6 Continued.

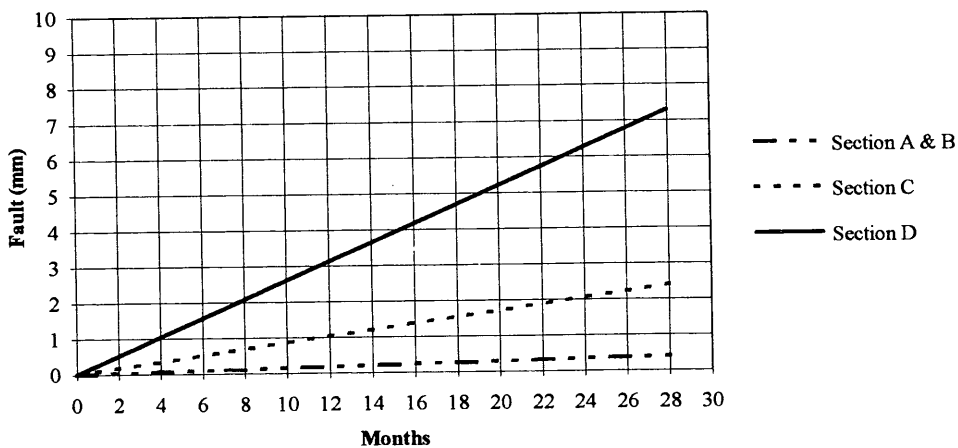
Because pavement grinding does not correct the pavement deficiencies that initially caused the faulting and a reduction in pavement thickness increases the pavement edge stresses, faulting often recurs shortly after grinding has been completed. This rapid faulting recurrence has been noted on several PCC pavement sections on I-5 (Pierce-King County Line) and on I-90 (Snoqualmie Pass) where grinding was completed and joint faulting returned within 2 to 3 years.

FIGURE 7 Timing for return of original faulting.
