Twenty-Five-Year Performance History of Interlayer Membranes on Bridge Decks in Kansas

JOHN WOJAKOWSKI AND MUSTAQUE HOSSAIN

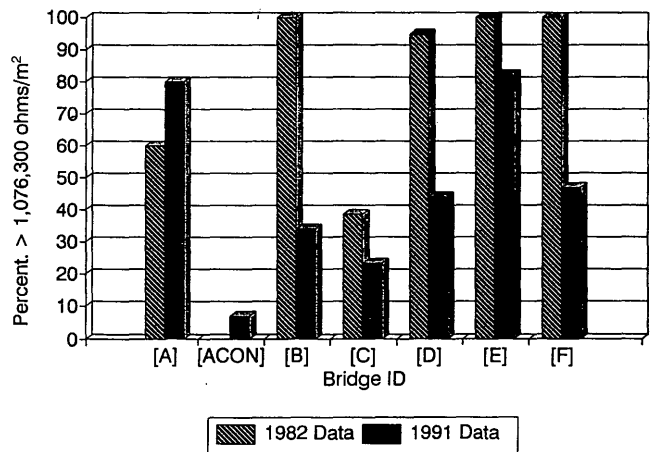
FIGURE 1 Comparison of 1982 and 1991 electrical resistivity readings (percentage of deck > 1 076 300 ohms/m²).

Figure 1 shows the percentages of each deck area that had a resistivity measurement greater than 1 076 300 ohms/m² (100,000 ohms/ft²) in 1982 and 1991. The bare part of the deck on Bridge A is also shown as [ACON]. It is apparent that four of the six bridges

showed a decrease in the performance of the membranes from 1983 to 1991. However, there is some variability in the data presented, and that may be a result of the condition of the asphalt overlay at the time the electrical resistivity measurements were taken, the way a specific mastic responds to the traffic or other factors.

Electrical resistivity data obtained on Bridges B through F, which received interlayer membranes during 1970 and 1971 changed markedly from 1982 to 1991. In 1982 86.7 percent of the total bridge deck area tested had resistivity higher than 1 076 300 ohms/m² (100,000 ohms/ft²), whereas in 1991 only 47.3 percent of the area showed resistivity higher than 1 076 300 ohms/m² (100,000 ohms/ft²). The bridges were showing signs of deterioration that were most likely related to salt contamination. However, traffic on some of these bridges also has increased considerably. When the electrical resistivity values measure below 1 076 300 ohms/m² (100,000 ohms/ft²) for 50 percent of a bridge deck area, the useful life of the interlayer membrane should be considered complete. The state of Oregon uses the same guidelines for determining the useful life of an interlayer membrane (6). Using the data from the bridge decks in this study, the useful life of an interlayer membrane in Kansas would range from 15 to 20 years. The membrane should be replaced before deterioration of the concrete structure begins.
