Case Study of Insulated Pavement in Jackman, Maine

MAUREEN A. KESTLER AND RICHARD L. BERG

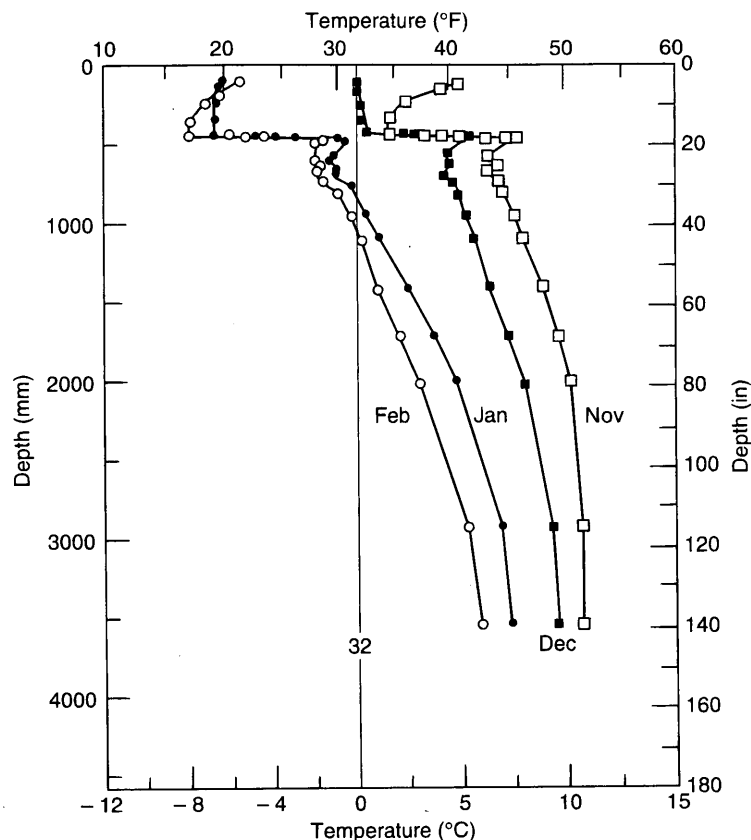
Figure 3 shows a general trend of increasing temperatures with increasing depth beneath the surface of the pavement for noninsulated Nichols Road. Figure 4 shows the same trend but also demonstrates the efficiency of the insulating layer in the test sections. Figure 5, however, shows a distinct temperature discontinuity immediately beneath the insulating layer in the runway. A probable explanation of the temperature discontinuity and resulting frost penetration follows.

Two vertical thermocouple assemblies, one located in and above the insulation and the second located entirely below the insulation, are separated horizontally by approximately 1.5 m (5 ft). It is believed that the temperature discontinuity between thermocouple assemblies is caused either by damage to the insulation or by horizontal separation of the insulation panels. The problem probably occurred during construction. Evidence of this problem was encountered during construction in areas 9 to 5 m (30 to 50 ft) square near Stations 4+50 and 8+00. At both locations trucks, bulldozers, and other construction traffic caused a large subgrade flow that in turn raised the insulation. Under direction of the resident engineer, insulation was removed in the problem areas; subgrade was removed to the desired depth; and the geotextile, insulation, and base course were all replaced.

FIGURE 5 Newton Field temperature profiles, Station 4+50, winter 1987-1988.

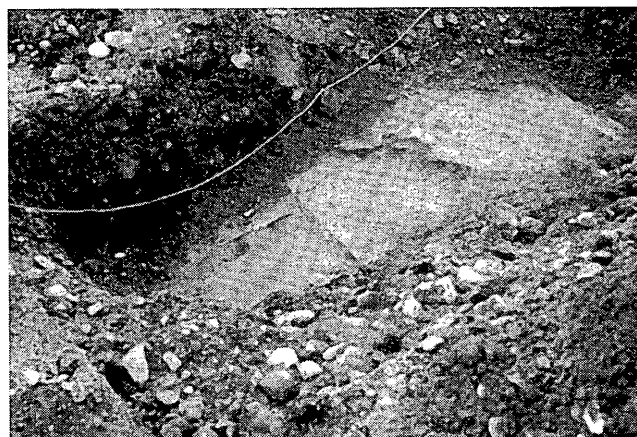
In July 1987, a 3- × 9-m (10- × 31-ft) section of pavement near station 30+00 was removed because of excessive local settlement. Figure 6 shows the overlapping and damaged insulation that was removed and replaced.

FIGURE 6 Damaged and overlapping insulation panels, Station 30+00, Newton Field runway.

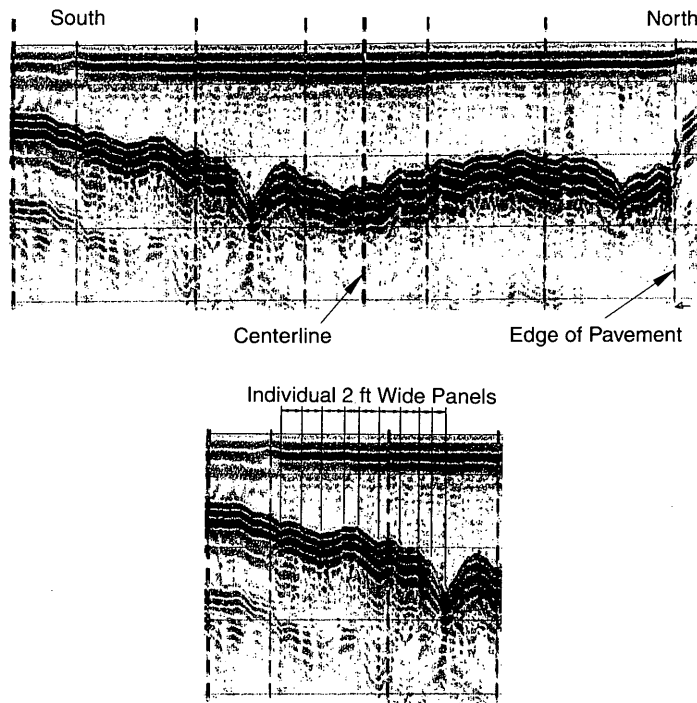
Ground-penetrating radar provided more information than did infrared photography. Investigations yielded profiles such as those shown in Figure 7 (6). Assuming a uniform water content between the AC and the insulation, approximate depths from AC to insulation panels can be determined from these radar records. The uppermost set of dark bands represents the antenna direct coupling. The next series of bands represents the interface between insulation panels and the subbase (i.e., the bottom of the insulation). The third, less distinct set is caused by multiple reflection of the radar pulse between the various layers. Depths to insulation panels appear to range from 127 mm (5 in.) to 610 mm (24 in.) beneath the runway pavement surface. Although individual panels 610 mm (2 ft) wide can be identified in Figure 7 (bottom), the resolution of the ground-penetrating radar was not sufficient to permit estimation of gap sizes between individual panels. It should be noted that, in contrast to the nonuniform depth of insulation panels beneath the runway, the depth of insulation panels beneath the test sections was uniform. As stated previously, the primary differences between the test sections and the runway were that the test section site was not so wet as the runway site and that the test sections were constructed under tighter controls. The test sections also had a deeper subbase than the runway.

FIGURE 7 Ground-penetrating radar profile, *top*, and enlargement of south end of profile showing insulation panels 610 mm (2 ft) wide, *bottom*.

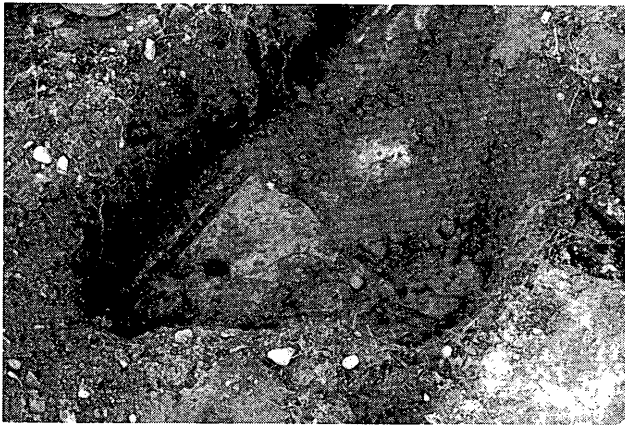
panels. A 64-mm (2.5-in.) gap was uncovered in the second 610- × 1520-mm (2- × 5-ft) trench alongside the runway at Station 7+75 in 1988. Further excavation yielded several gaps of approximately 51 mm (2 in.). During summer 1991 small holes alongside the runway at or near the ends of transverse cracks were excavated down to the insulation. Figure 8 shows cracked insulation at Station 22+80, which was representative of most test holes. It appears that cracking that occurred during periods of freezing conditions propagated down through the insulating layer and broke the insulation panels. The figure also shows a gap between insulation panels, which was typical.

FIGURE 8 Insulation panels alongside runway, showing crack and gap between panels.

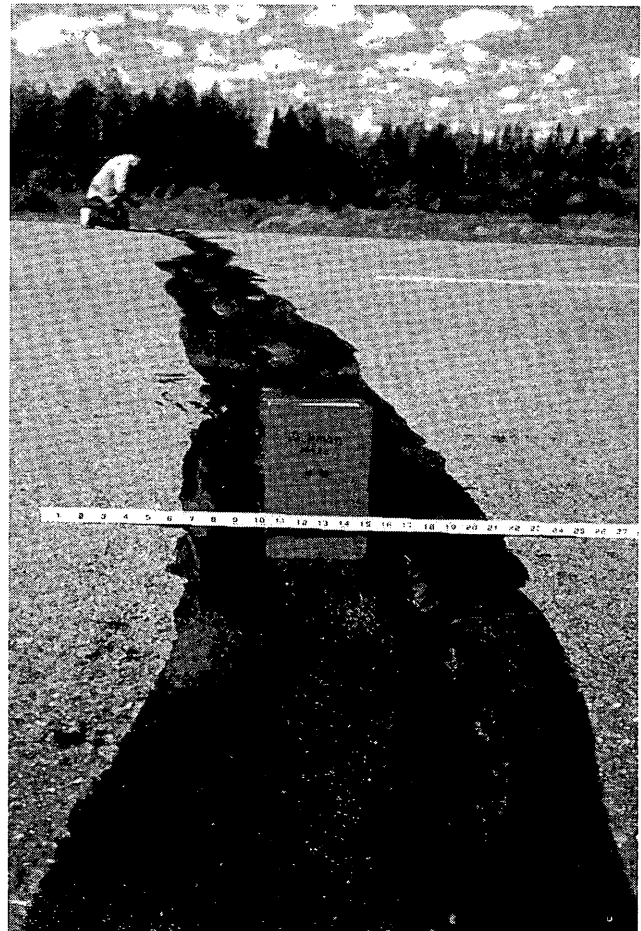
In December 1992 several cracks were measured, of which the maximum width was approximately 127 mm (5 in.). By June 1994 the maximum width had increased to 229 mm (9 in.). Figure 9 shows one of the more severe cracks. Cracks have been sealed with a rubberized crack sealer several times. Nevertheless, the AC is exhibiting signs of secondary cracking and some crack settlement. One possible reason for this is that the base course may have eroded from beneath some of the larger cracks. During several heavy rains, granular material was observed in motion atop the AC at unsealed cracks, where the sealer has been removed by snowplows.

It is suspected that abnormally wide cracks are initiated by something other than the insulation but may be made worse by the insulation. During construction the asphalt mixture was hauled several hours from the asphalt plant to the project site. It is quite possible that the asphalt was overheated at the plant or placed at the site at a temperature below that desired. This could accelerate oxidation, making the AC brittle and susceptible to shrinkage and fracture (7).

FIGURE 9 Transverse runway crack.

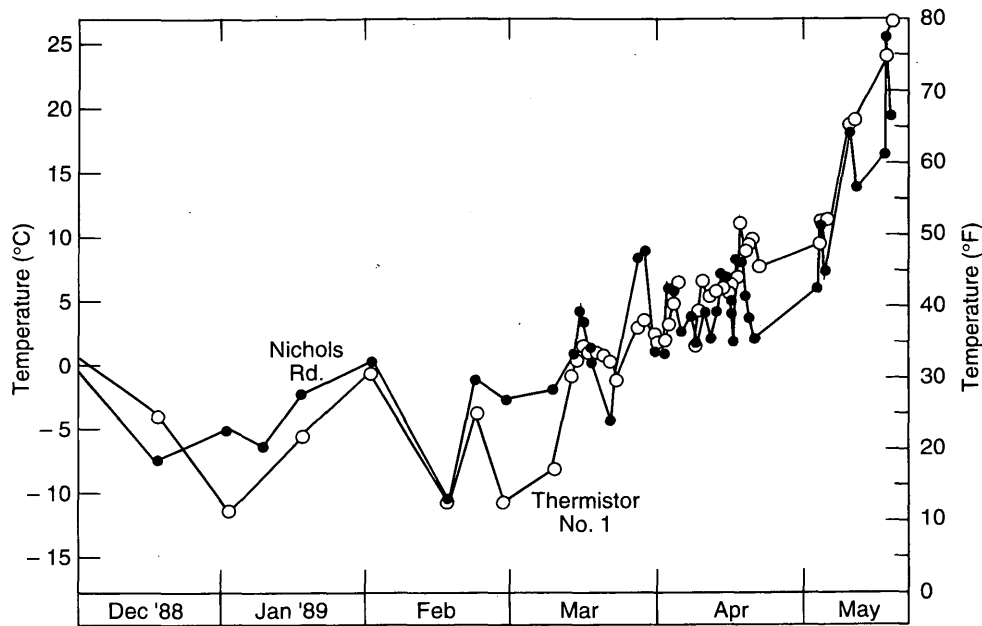
above the insulating layer in Test Section 1 and at a comparable depth in Nichols Road during the 1988-1989 observation season. Even if the lower temperatures contributed to additional cracking, they should not be responsible for the 229-mm (9-in.) crack observed during June 1994.

FIGURE 10 Base course temperatures for insulated and noninsulated pavements.

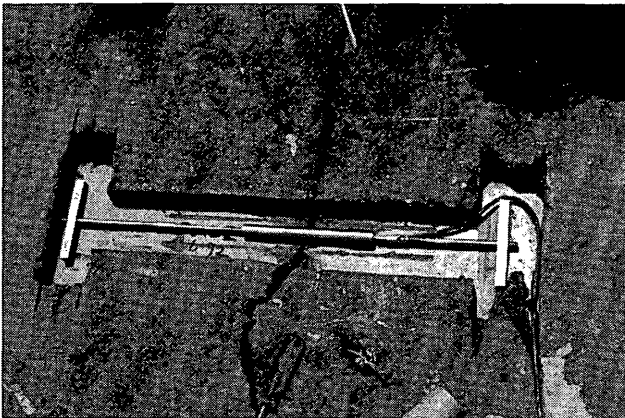
To differentiate diurnal thermal contraction and expansion, seasonal thermal contraction and expansion, and shrinkage of AC caused by aging, linear-motion potentiometers (LMPs) were installed across a transverse crack at Stations 16+15 and 18+00 (Figure 11). Figure 12 shows diurnal crack movement at Station 16+15 and corresponding temperatures recorded by temperature sensors embedded in the AC. Neither LMP functioned continuously for an entire year, so shrinkage because of asphalt aging could not

FIGURE 11 Linear-motion potentiometer installed across crack.

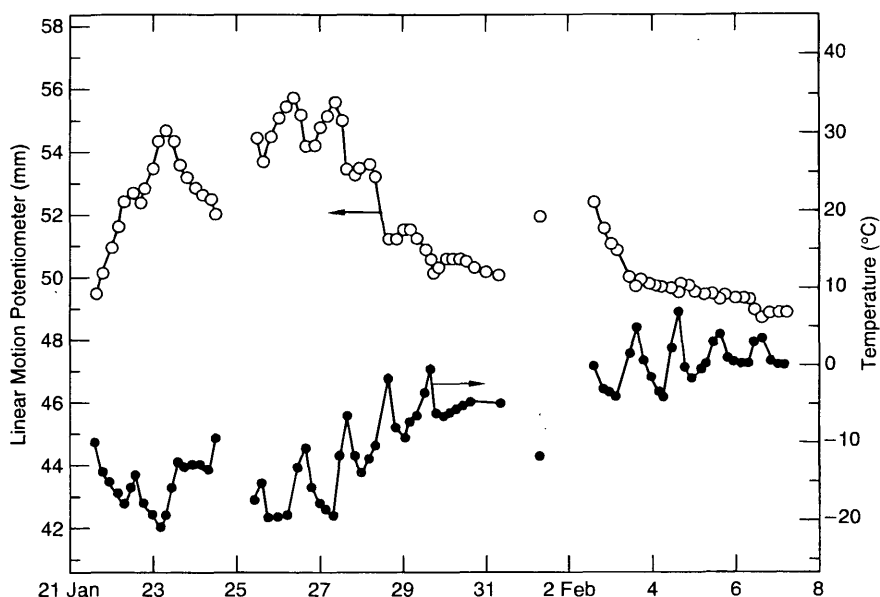
be determined by this means. It is, however, believed that an LMP picked up a cracking event. Figure 12 shows appreciable damping in diurnal crack width variation starting February 3, 1991. During the first visit following February 3 a new crack between Station 16+15 and what had been the next closest crack was observed. Clearly, the reduced slab length on one side of the monitored crack would cause some or all of the observed LMP attenuation.

FIGURE 12 Linear-motion potentiometer data.
