Development of Variable Yaw Angle Side Impact System and Testing on Double Thrie Beam Median Barrier

GARY P. GAUTHIER, JOHN R. JEWELL, AND PAYAM ROWHANI

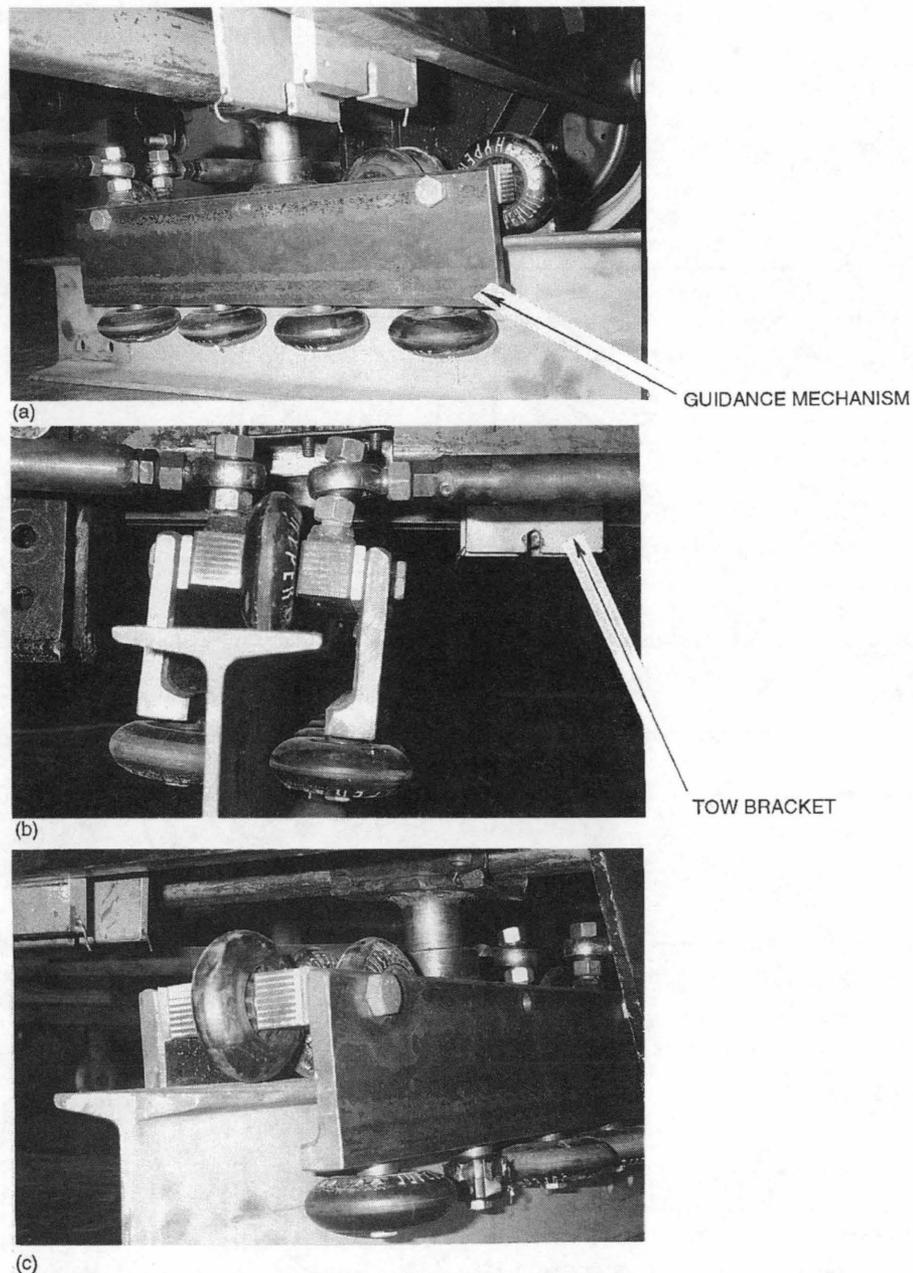
FIGURE 3 Guidance mechanism and tow bracket: (a) right side view from front, (b) rear view, and (c) left side from front (lateral guide wheel is damaged).

Approximately 70 m from the impact attenuator, the guidance rail shifted out of alignment, the guidance mechanism broke off, and the SIC was pulled into the skid deck without guidance. Consequently, the SIC did not reach the skid deck at the correct position and speed.

The guidance mechanism problem can be eliminated if it is restrained from lateral movement by connecting it to the SIC frame in an additional location. The problem of the too-high impact with the wheel supports can be corrected by adjusting the skid deck elevations. Crushing tests of the FRP tubes should be conducted to select a smaller size that will allow the SIC to decelerate over a longer distance and decrease the acceleration at a rate closer to the design value.

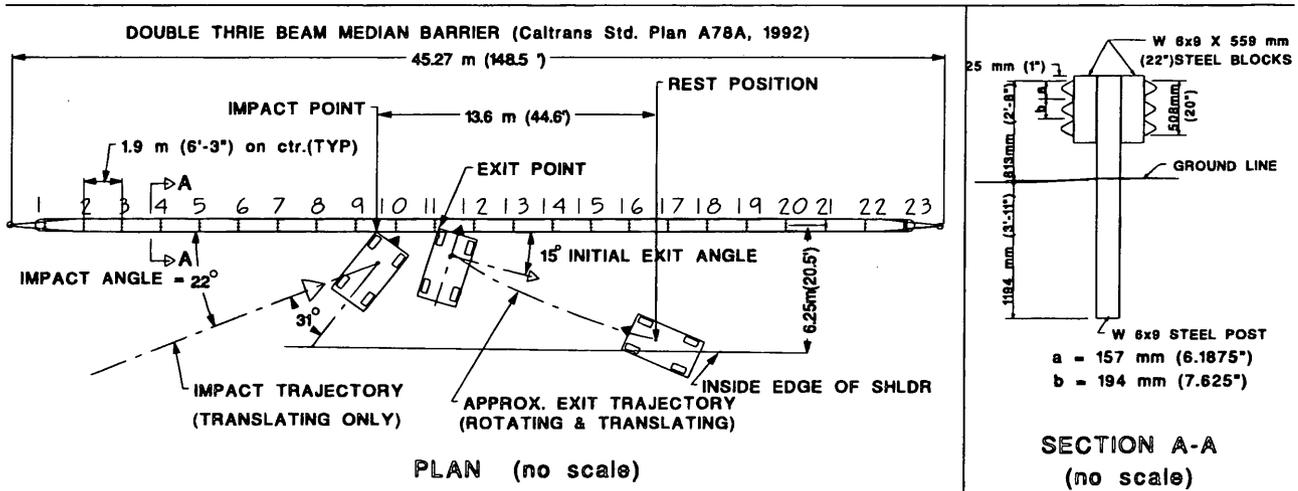
FIGURE 6 Data summary sheet Test 523.

Speed:	66.5 km/hr	Interior:	
Trajectory Angle:	22°	OCDI:	LF0010000
Yaw Angle:	31° Counterclockwise	POST IMPACT VEHICLE ROTATIONS	
EXIT CONDITIONS		Max Roll Angle:	negligible
Speed:	43.4 km/hr	Max Pitch Angle:	approximately 5°
Trajectory Angle:	15° initially (rotating)	Max Yaw Angle:	103°

The barrier dynamic lateral deflections were measured with eight displacement transducers attached to Posts 8 through 15 (see Figure 6(a) for post locations). Permanent deflections were measured longitudinally and laterally from benchmarks placed in the ground before impact. Strain gauges were installed on the four anchor rods.

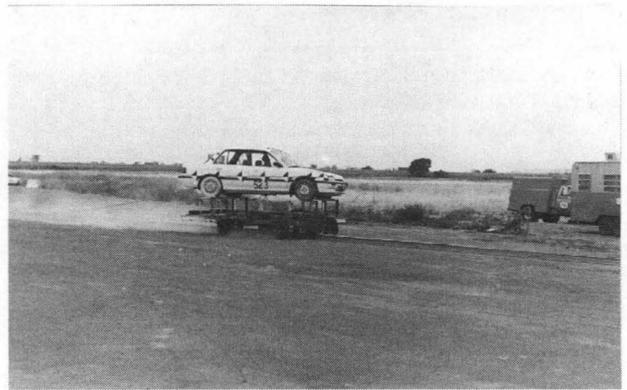
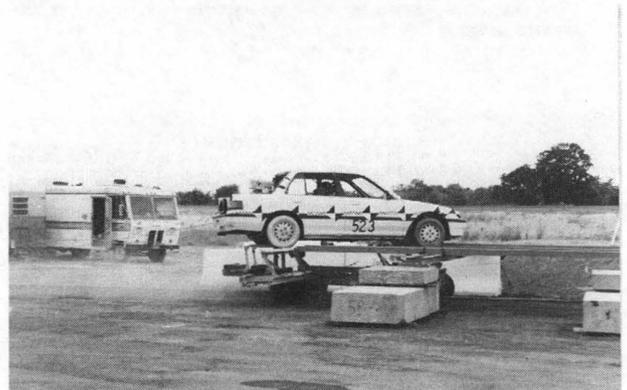
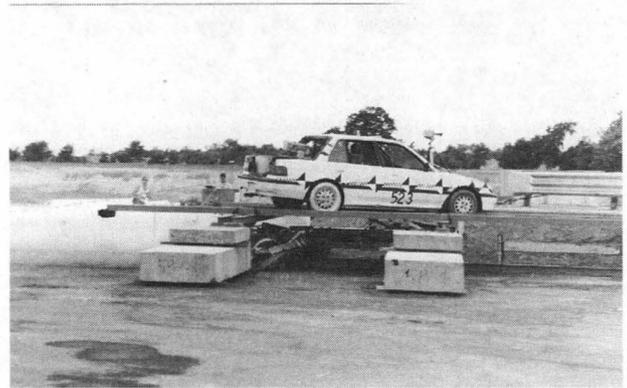
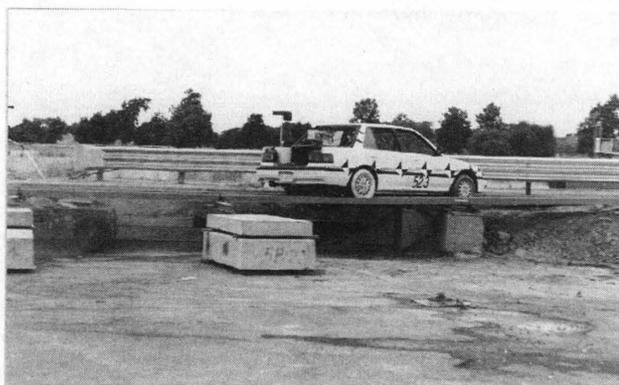
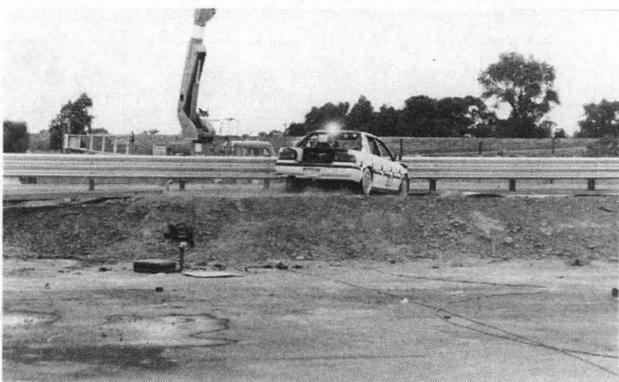
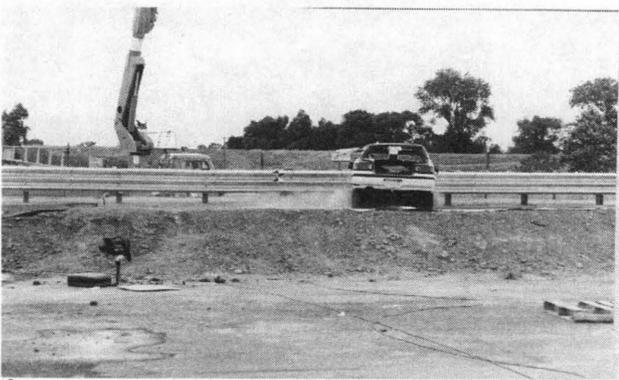
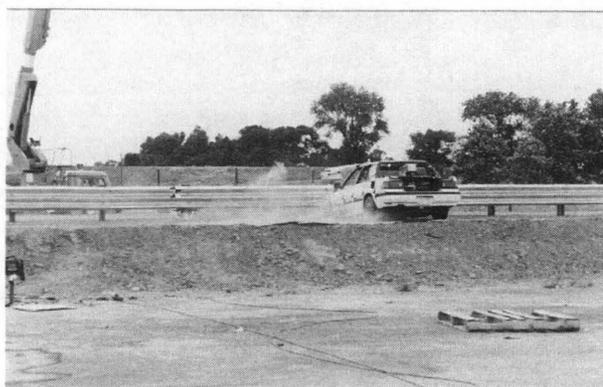
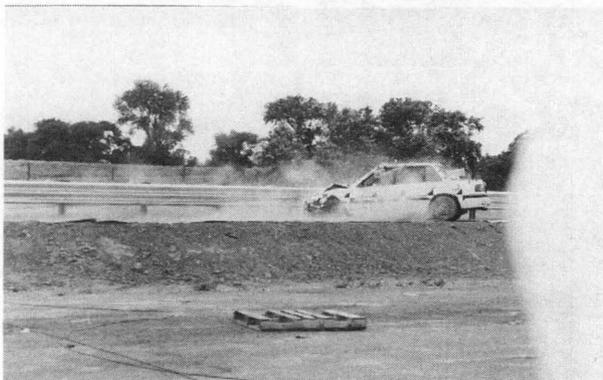
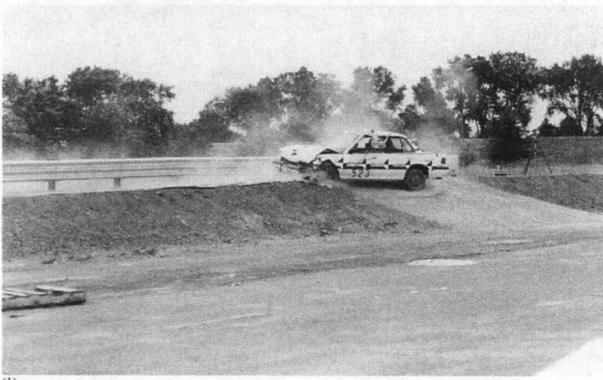
Impact Description/Vehicle Behavior The Honda side skidded into the barrier at a 22 degree trajectory angle and 31 degree counterclockwise yaw angle. Impact speed was 66.5 km/hr (see Figure 7).

The vehicle was pitched down slightly as it hit the dirt median, causing the front bumper to drop lower than the bottom of the thrie beam rail. It passed underneath it as the left headlight and hood made first contact with the rail approximately 0.8 m upstream of Post 10. About $\frac{3}{4}$ of the front-end width crushed and slid against the rail for approximately 3 m before the vehicle left the barrier at an angle of 15 degrees and a speed of 43.4 km/hr. The Honda began to rotate as it exited the barrier, and continued to rotate and translate to a point approximately 14 m downstream, straddling the edge of shoulder 6.25 m from the barrier center line. Total change in yaw from impact was 103 degrees counterclockwise.

FIGURE 7 Test 523 Sequential Photos: (a) 1.940 sec before impact, (b) 1.025 sec before impact, (c) 0.855 sec before impact, (d) 0.500 sec before impact, (e) 0.075 sec after impact, (f) 0.265 sec after impact, (g) 0.465 sec after impact, (h) 0.805 sec after impact, and (i) 2.260 sec after impact. (continued on next page)

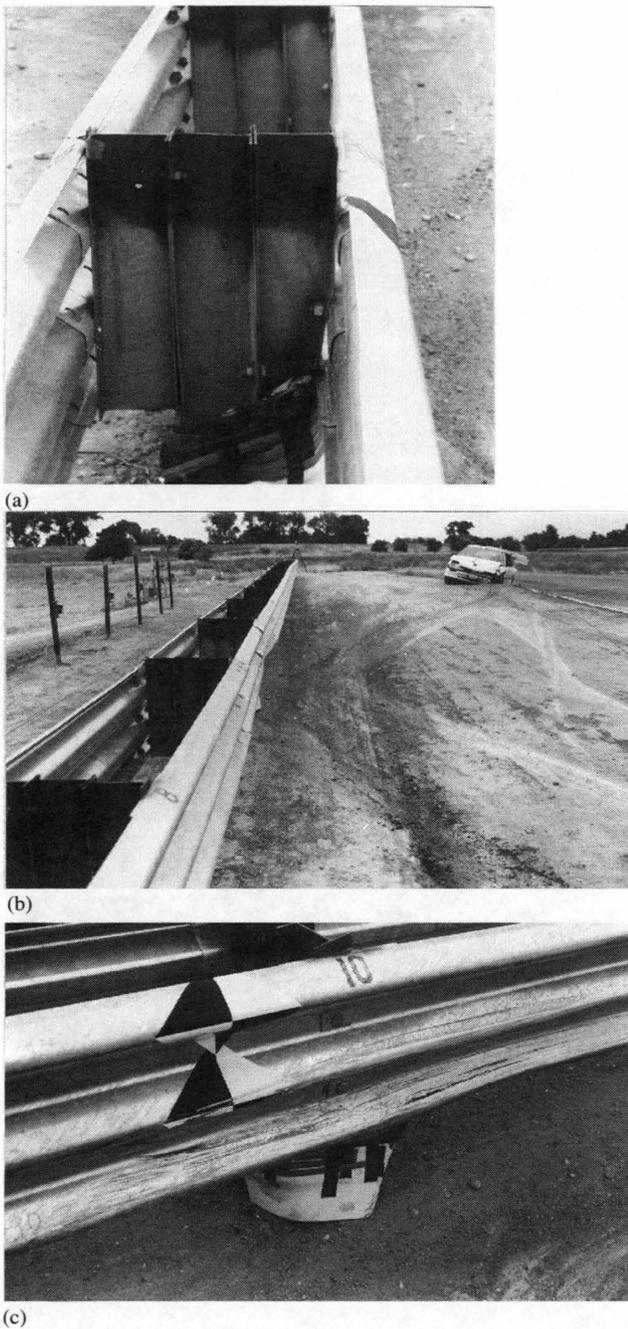
Barrier Damage The test article deflected very little (see Figure 6(b) for data). Only Post 10 and its front block were damaged significantly. The thrie beam rail on the impact side was bent, but would not require immediate replacement (see Figure 8). The anchor rod on the upstream impact side resisted 28.6 kN of tension, and the anchor rod on the downstream impact side resisted 18.1 kN of tension.

FIGURE 8 Test article damage: (a) Post 10 looking downstream, (b) looking downstream, and (c) impact side of barrier.

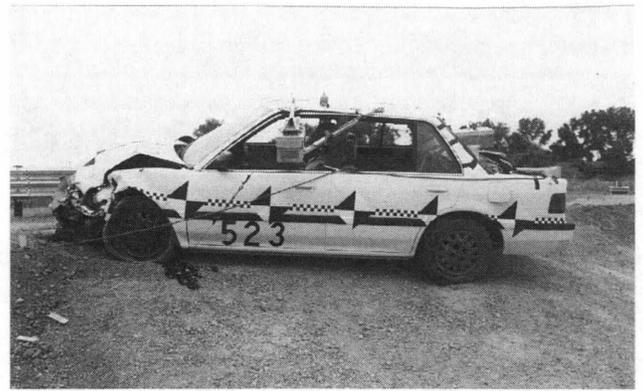
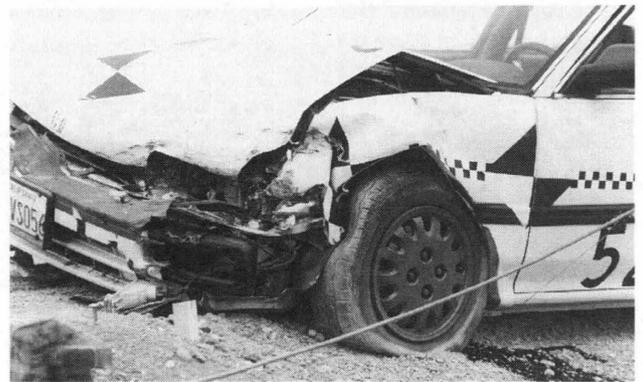
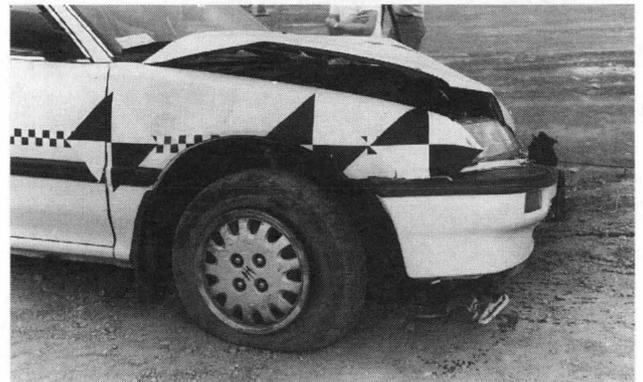
Vehicle Damage The vehicle could not be driven after the impact, but most of the damage was confined to the front left corner of the vehicle (see Figure 9). Debris scatter amounted to pieces of plastic from the Honda's lights. A portion of the plastic bumper was ripped off the Honda and got stuck at Post 10. See the Data Summary Sheet, Figure 6(b), for damage ratings.

FIGURE 9 Test vehicle damage: (a) left side view, (b) left front view, and (c) right side view.
