IDEA PROJECT FINAL REPORT
Contract NCHRP-93-ID011

June 1996

**REHABILITATION OF STEEL BRIDGE
GIRDERS THROUGH THE
APPLICATION OF ADVANCED
COMPOSITE MATERIALS**

Prepared by:
Dennis R. Mertz and John W. Gillespie, Jr.
University of Delaware

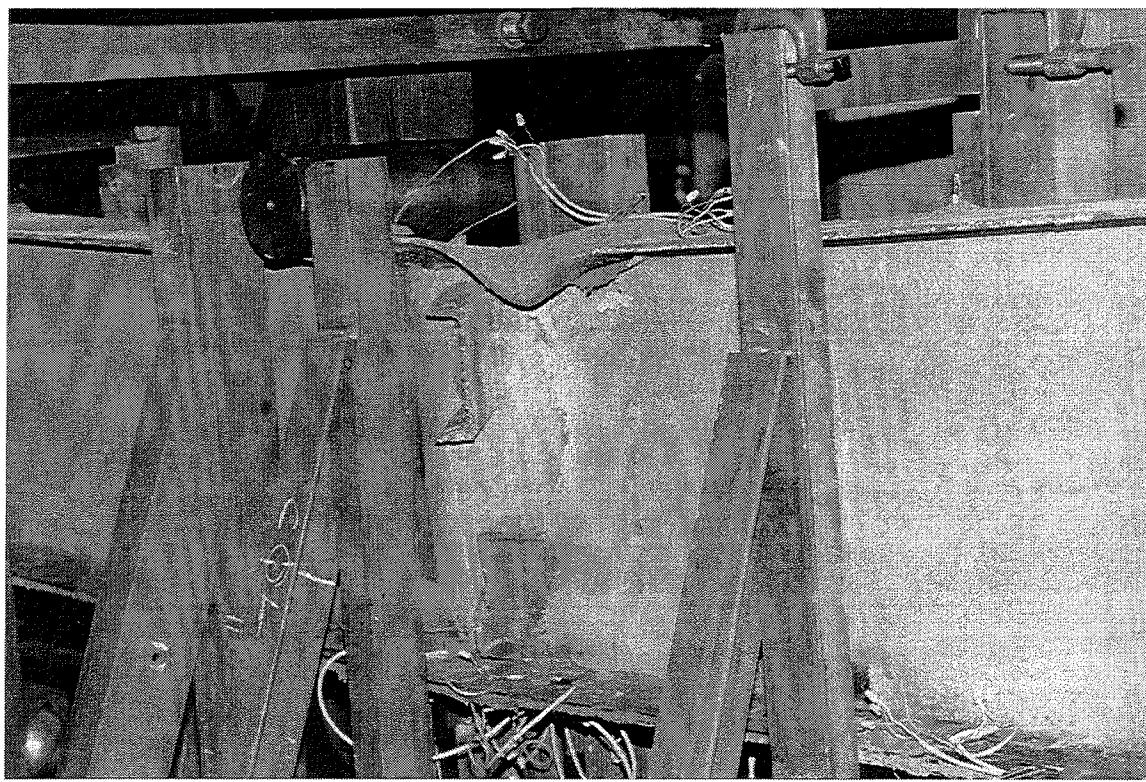
FIGURE 16 Local buckling of top flange.

Strength and stiffness increases were significant. The strength of the girders could have been larger had local buckling been prevented, which is typical of the case in which a concrete slab is present on the top flange. Analysis of the severely corroded girder 1 with the current composite size shows a 25% increase in stiffness and a 100% increase in strength. Furthermore, better performance could be achieved through the use of larger composite elements, provided an adequate bond is present.
