ITALIAN MARITIME INVESTIGATIVE BODY ON MARINE ACCIDENTS

MARINE ACCIDENT
INVESTIGATION
C/S COSTA CONCORDIA
13th January 2012

*MSC90
London - May 18th, 2012*

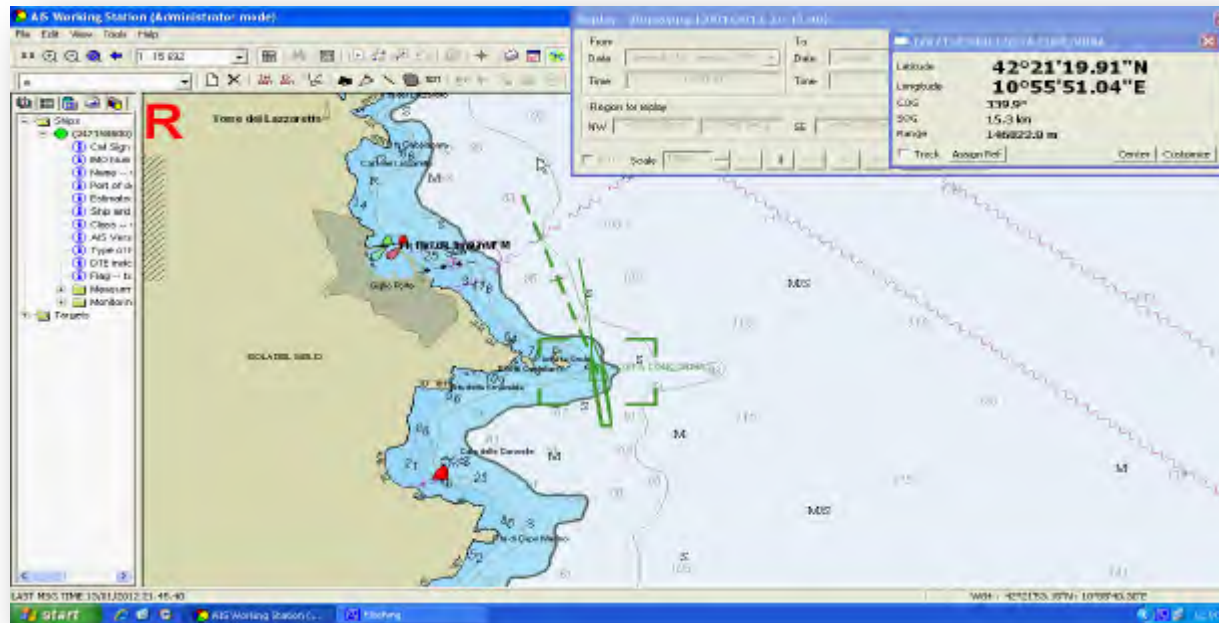
- 1) "hard to starboard" and the Ship's bow avoids the shallows;
- 2) "hard to port", but the Ship's stern cannot avoid them

09.45 pm : COLLISION between the port side of the hull and the eastern rock of "Le Scole"

- 3) "hard to starboard" and the ship speed reduces instantly up to 8,3 knots, drifting off in headway, on a heading of 350°

IMMEDIATELY the two Ship's main electrical engines lose power

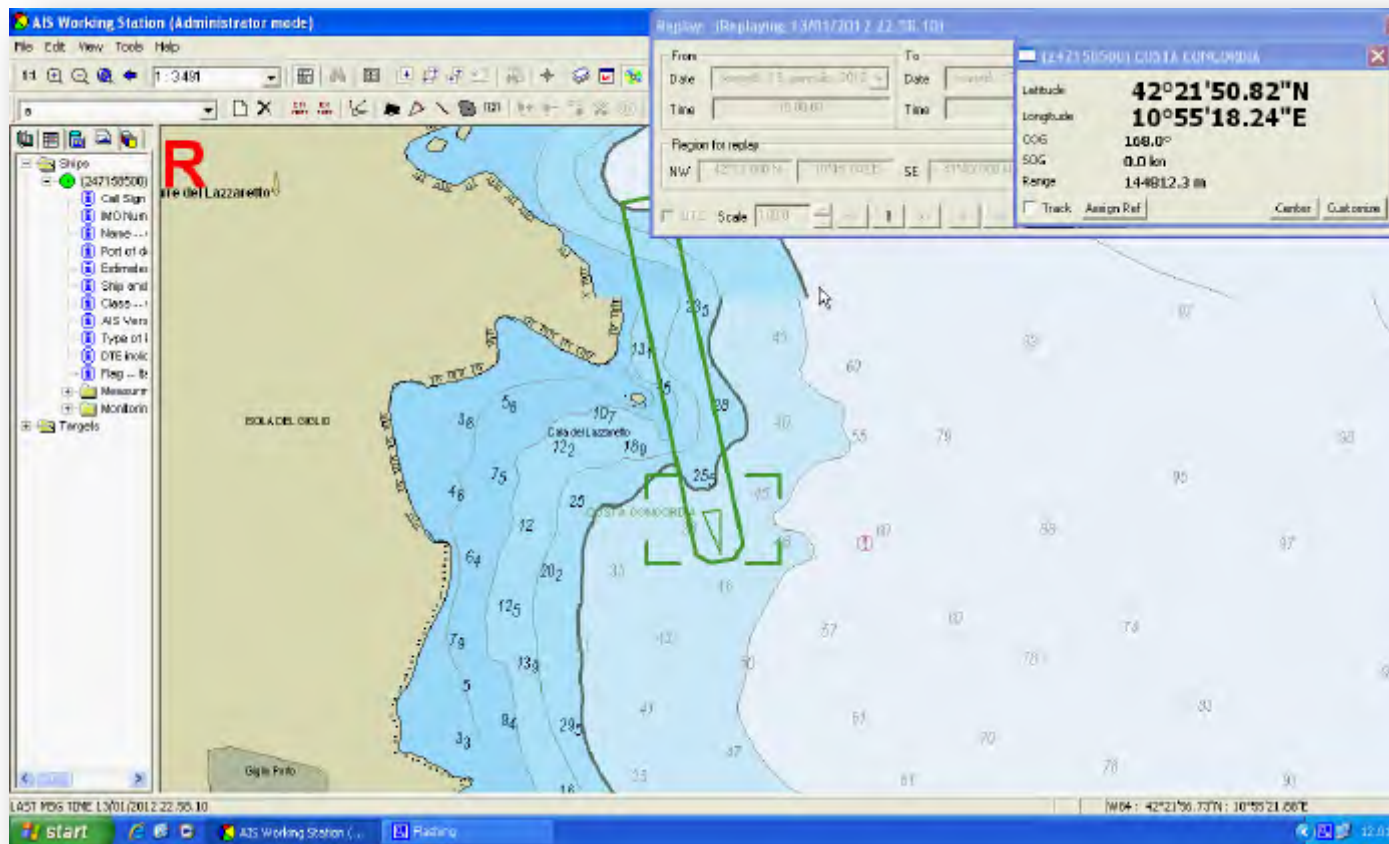
Almost in **final grounded position**, struck, Lat $42^{\circ}21'50''N$ – Lon $010^{\circ}55'18''E$
Island of Giglio – Cala del Lazzereto

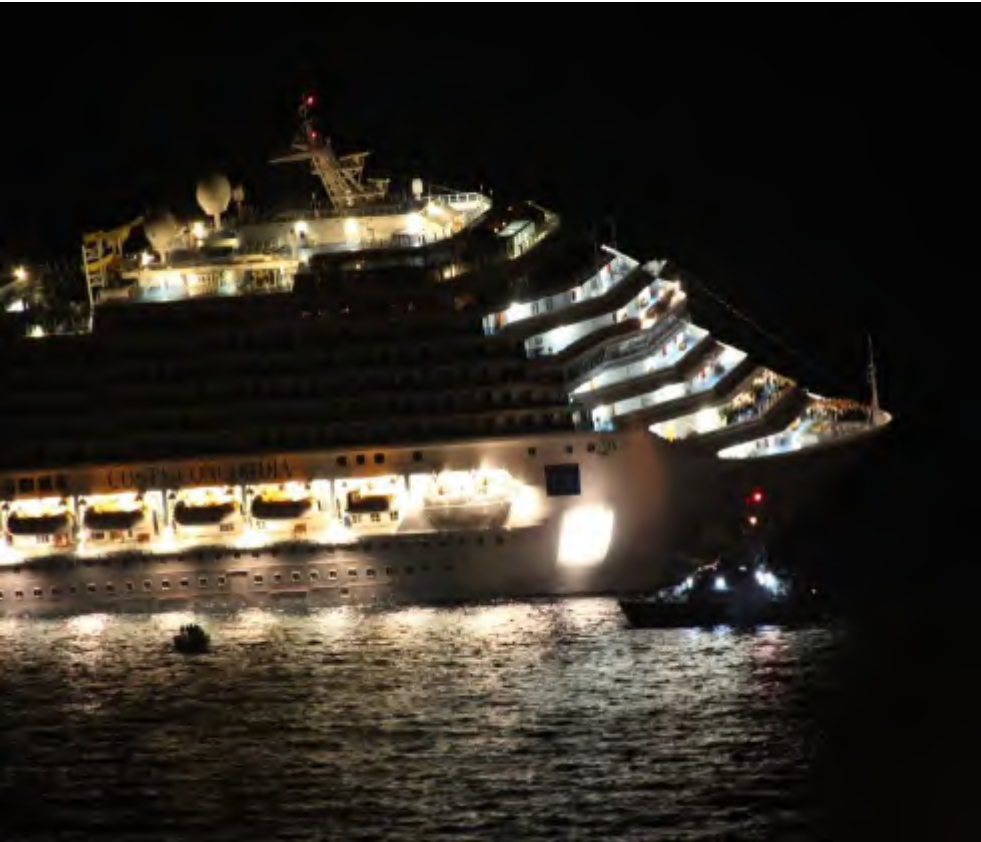
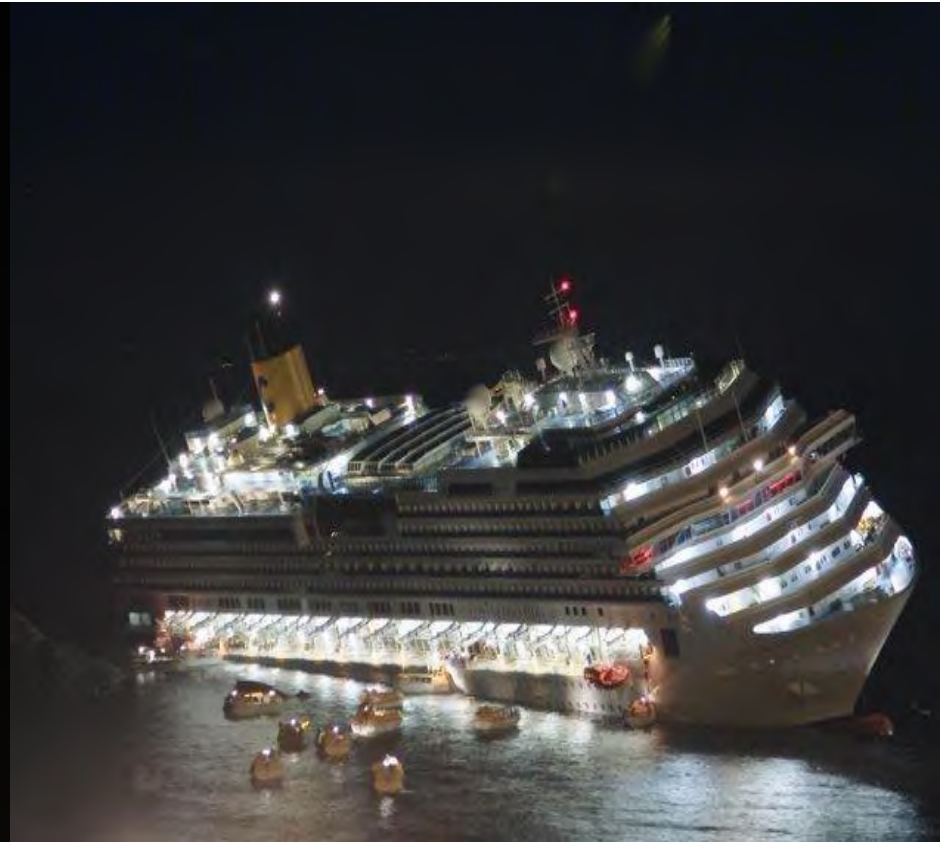
*The pictures were taken from the Island of Giglio
the image does not correspond to the present history of events, but it is noteworthy for showing the exact
moment when the lifeboats are launched on the starboard side*

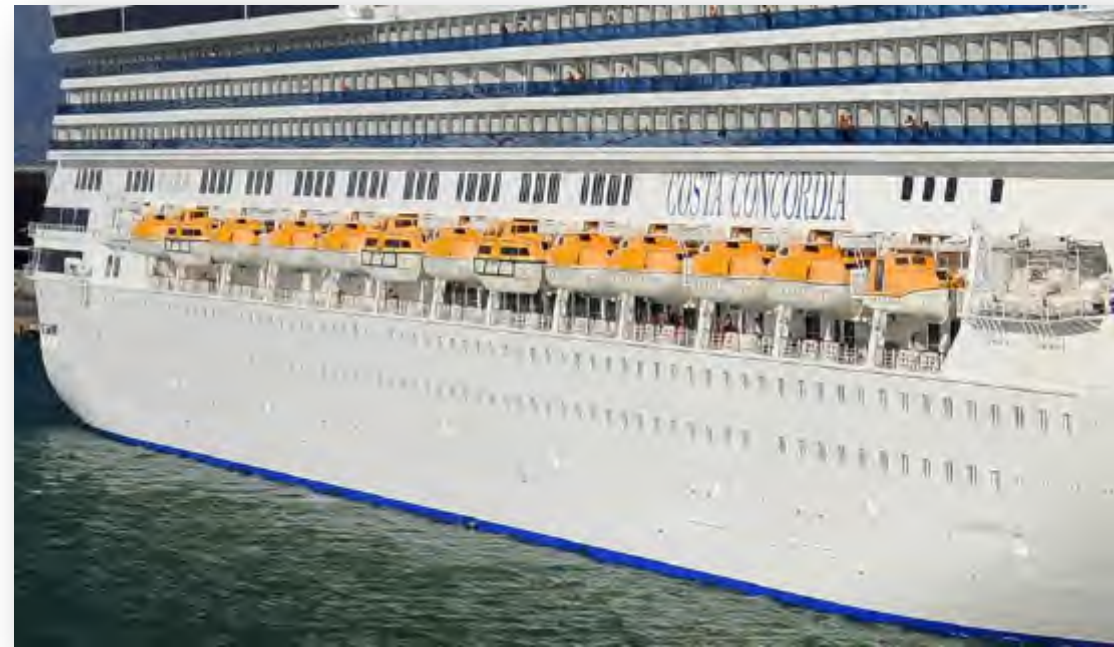
- 26 lifeboats
- 23 the launched ones
- 3 lifeboats on portside could not be launched due to the significant list of the vessel

- 6 Liferrafts were launched

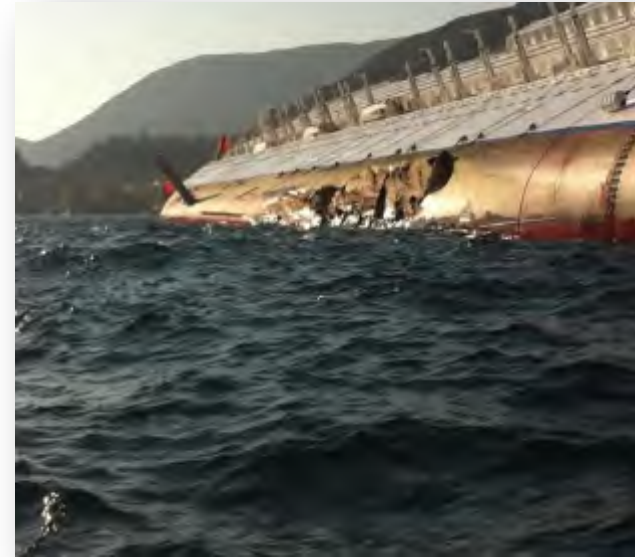
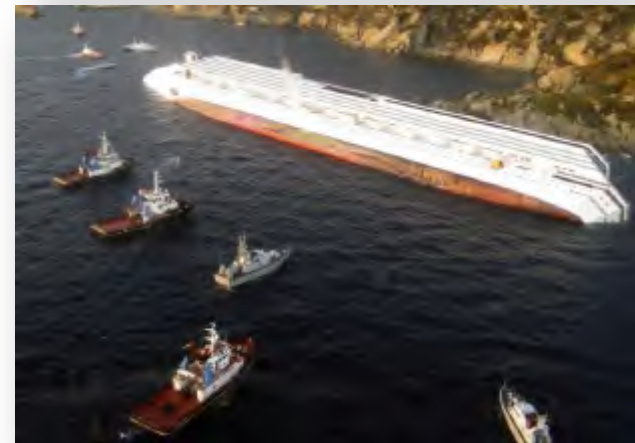
**Damage between frame no. 58 and frame no. 125/128,
creating a 60 meters hole into the hull – portside**

- **The two most affected watertight compartments (contiguous), immediately flooded:**
 - no. 5 (Propulsion Electric Motor)
 - no. 6 (aft generators)
- **Partially flooded at the time of crew inspection (10 minutes after the impact)**
 - no. 7 (forward generators)
 - no. 4 (Galley compressors)

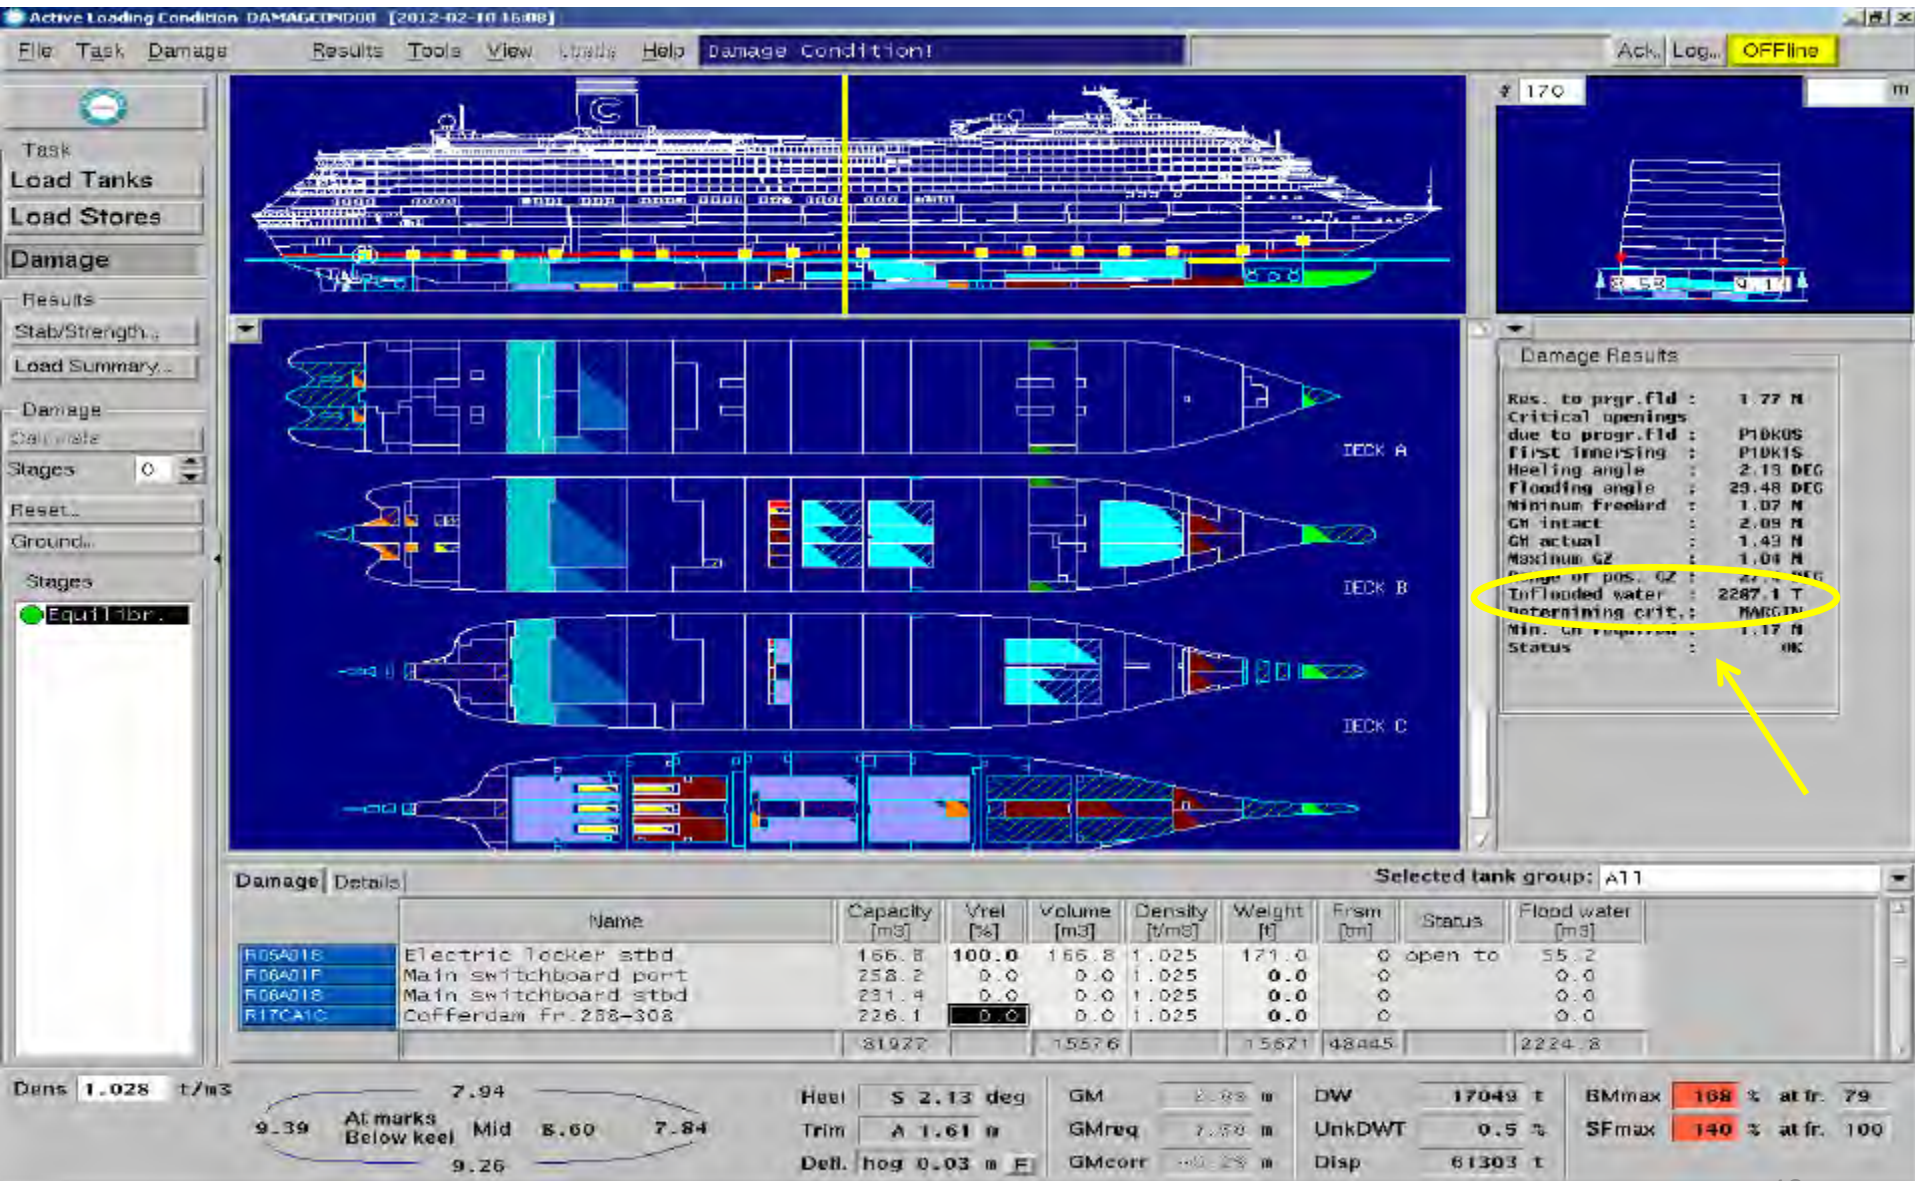
Costa Serena simulation after the impact – Damage condition 0

Compartment no. 5 flooded immediately 2287.1 t of water

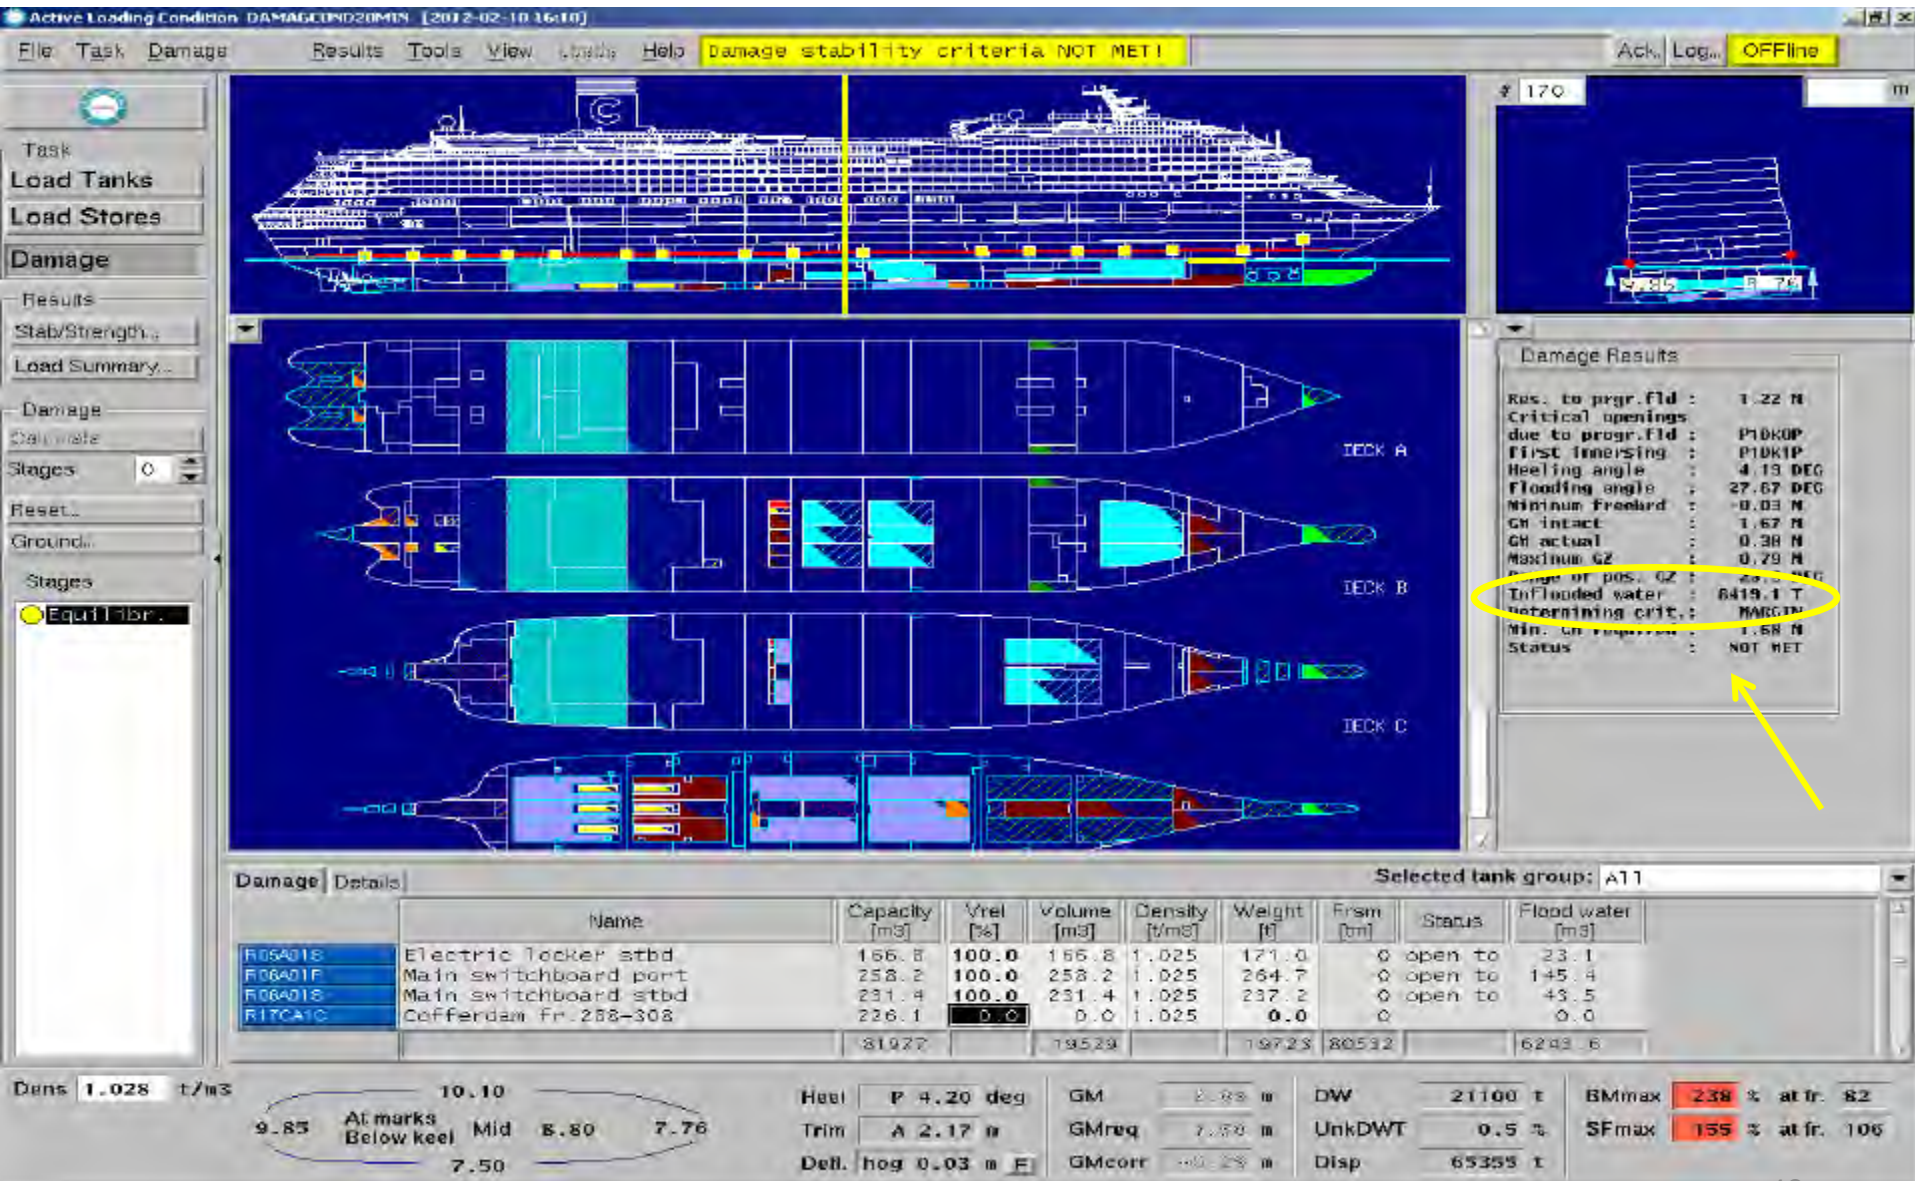
Damage condition after 20 minutes inflowed water 6419.1 t

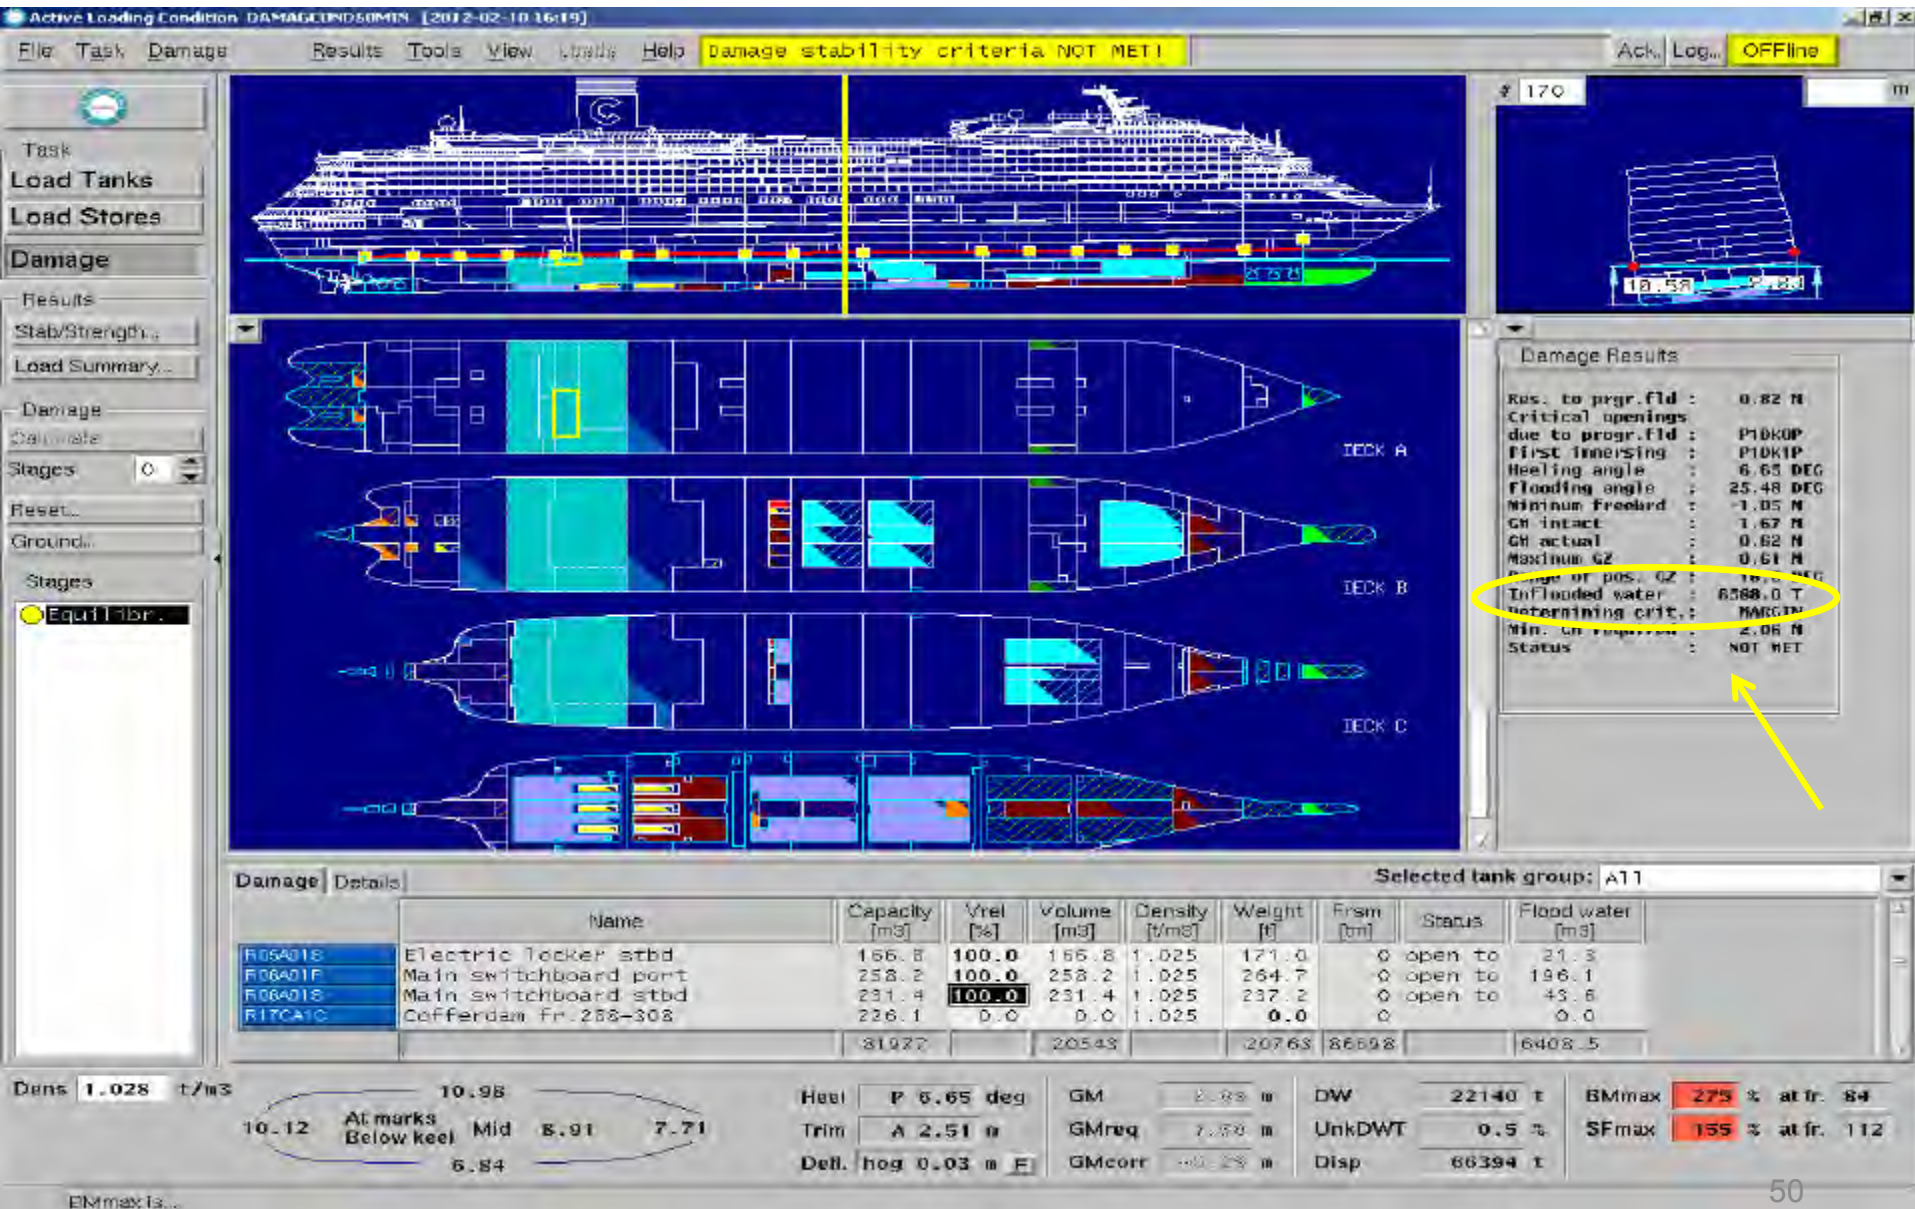
Damage condition after 50 minutes inflowed water 6588.0 t

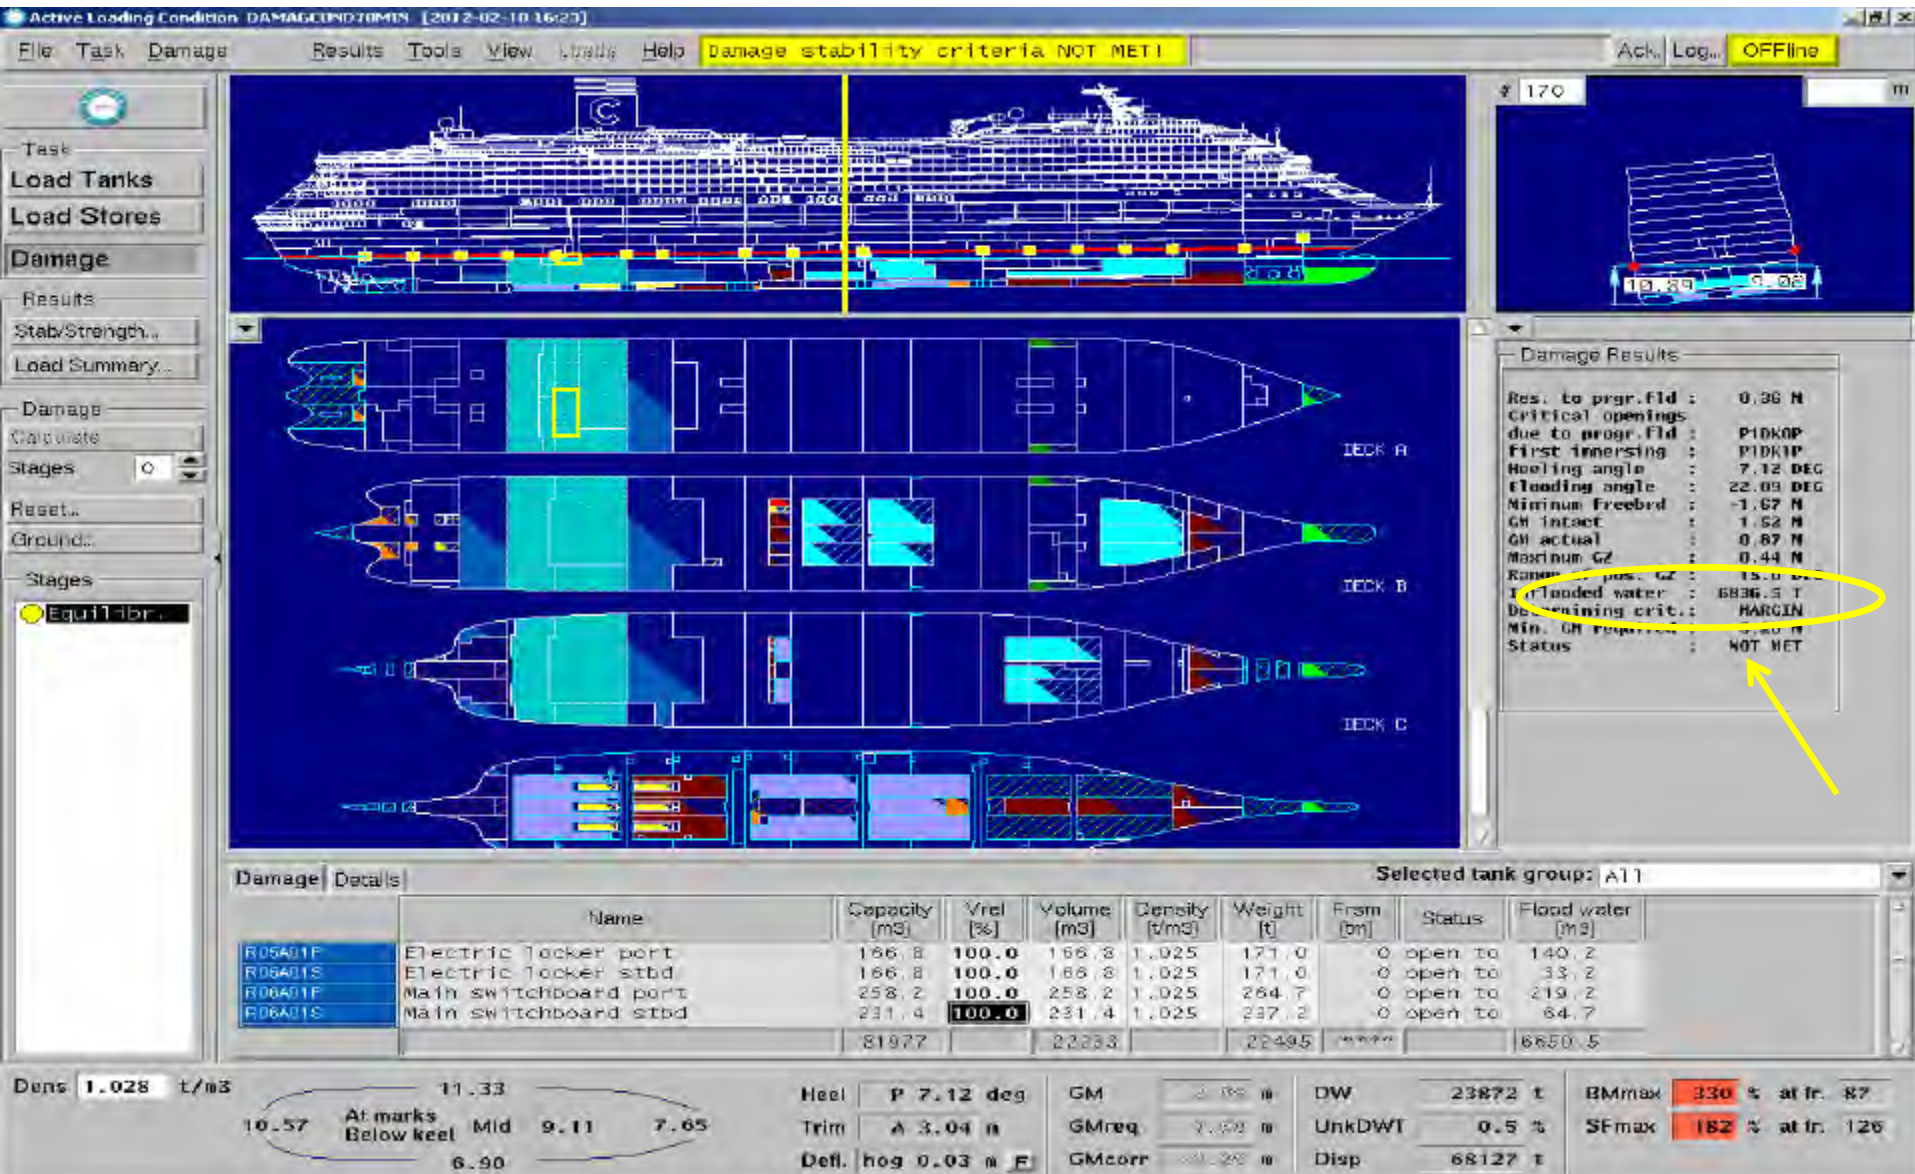
Damage condition after 70 minutes inflowed water 6836.5 t

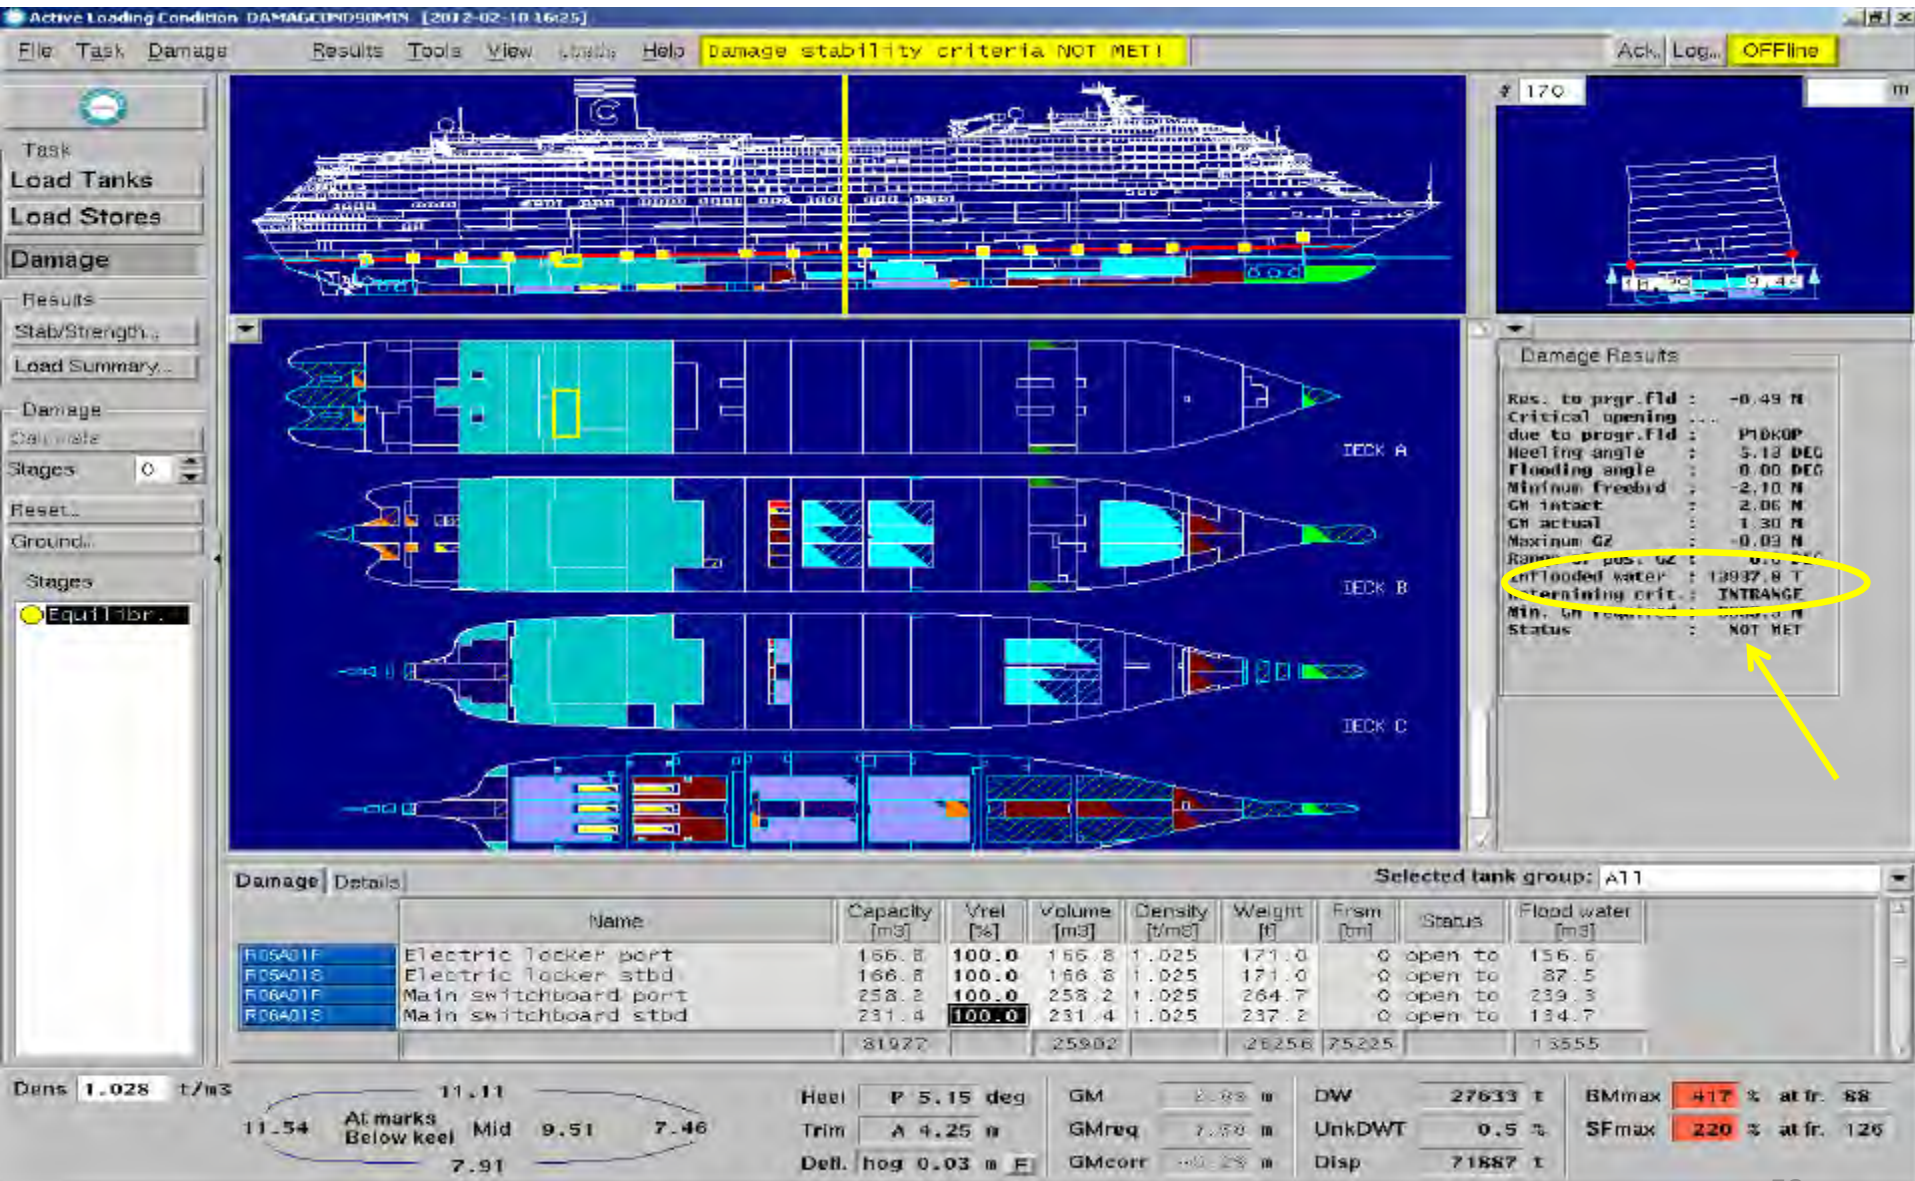
Damage condition after 90 minutes inlooded water 13937.8 t

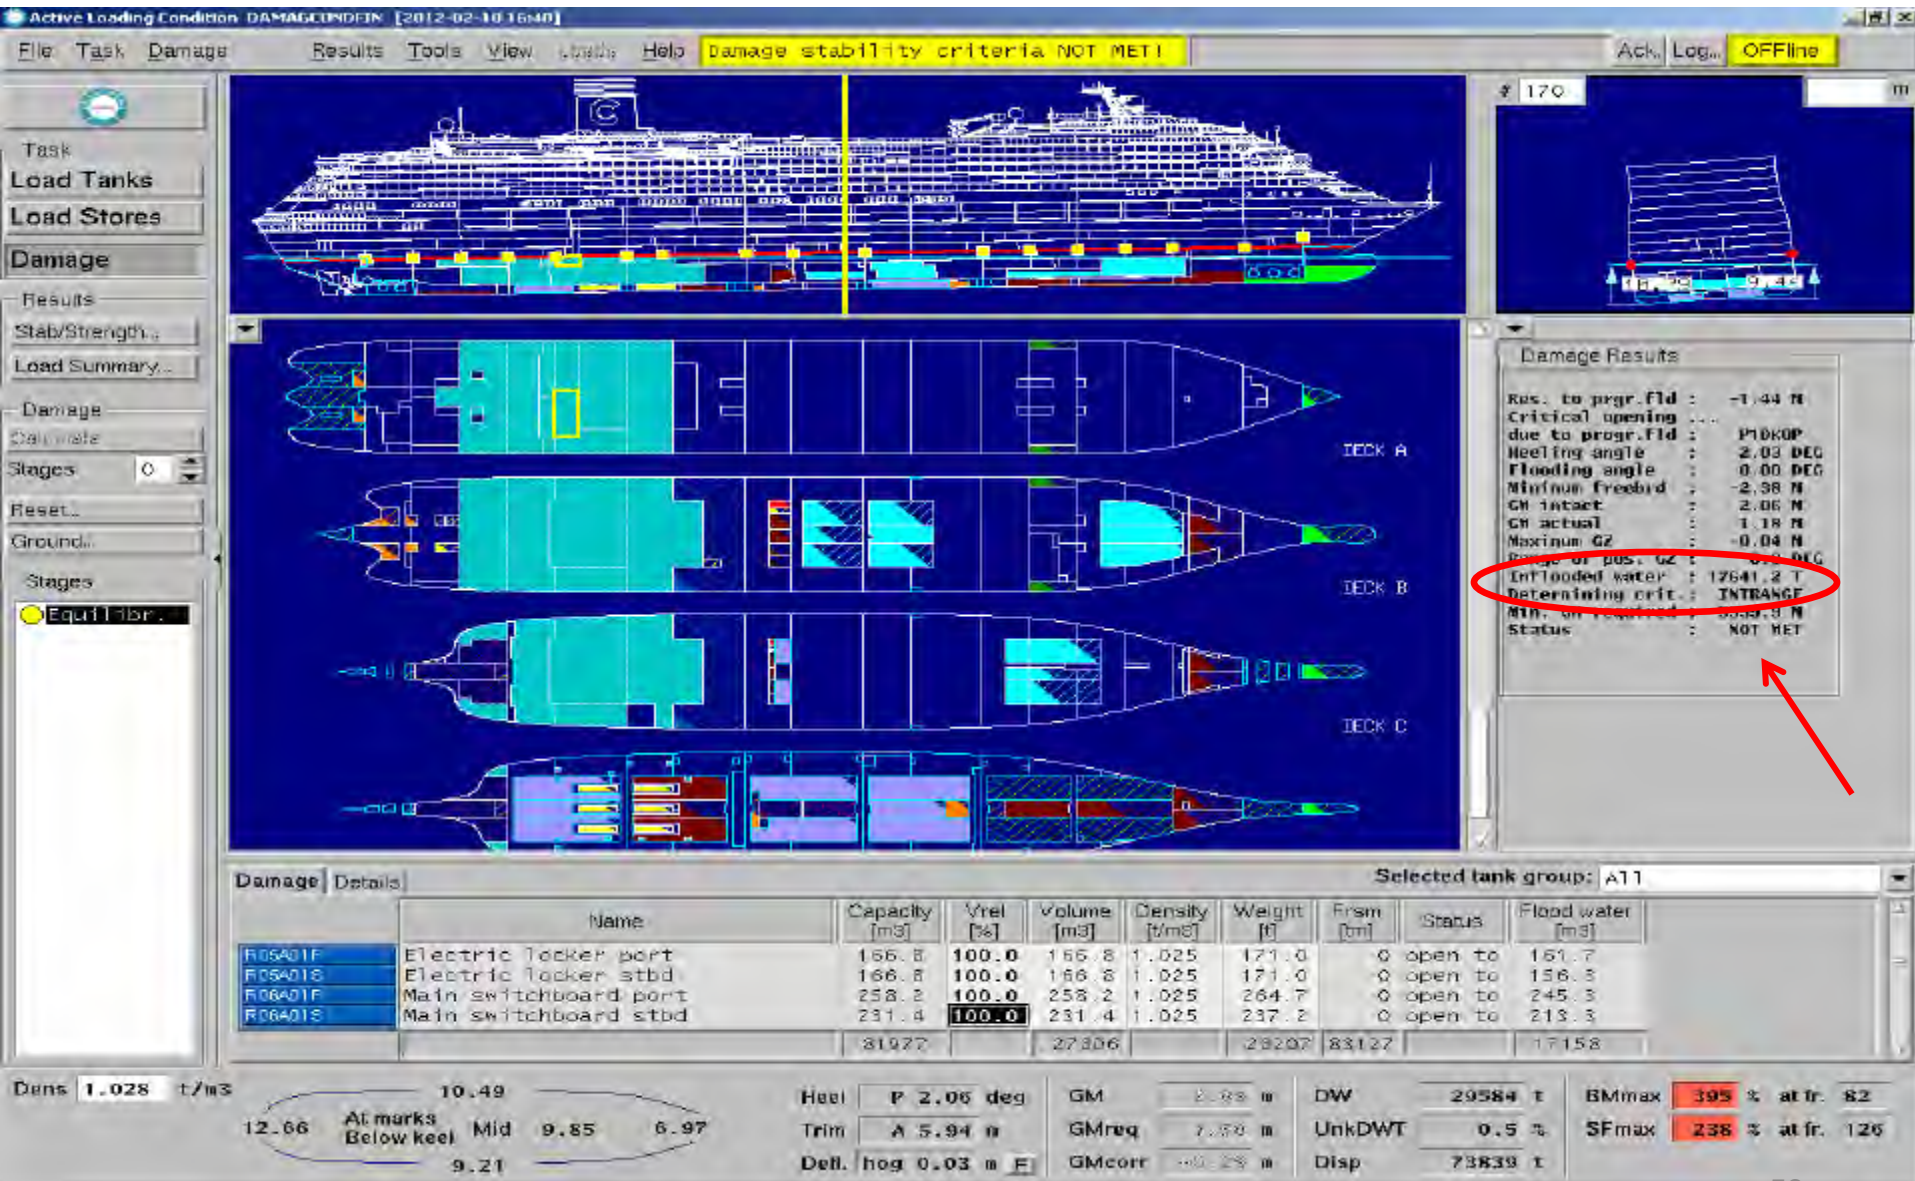
Damage final condition inflowed water **17641.2 t**
