APPENDIX F

I-BEAM SUMMARIES—0.5-IN. STRAND

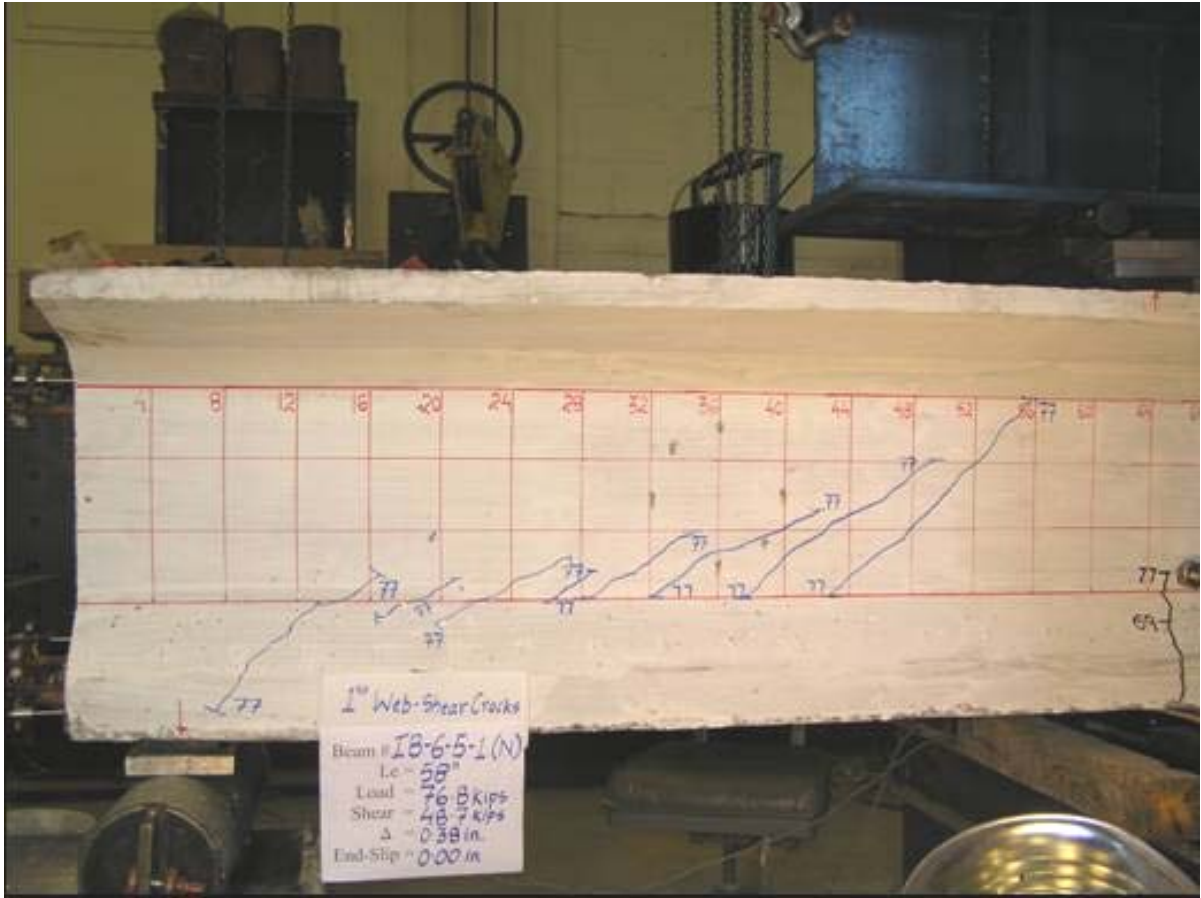
Photo of the North end of the beam IB-6-5-1 showing the first web shear cracking

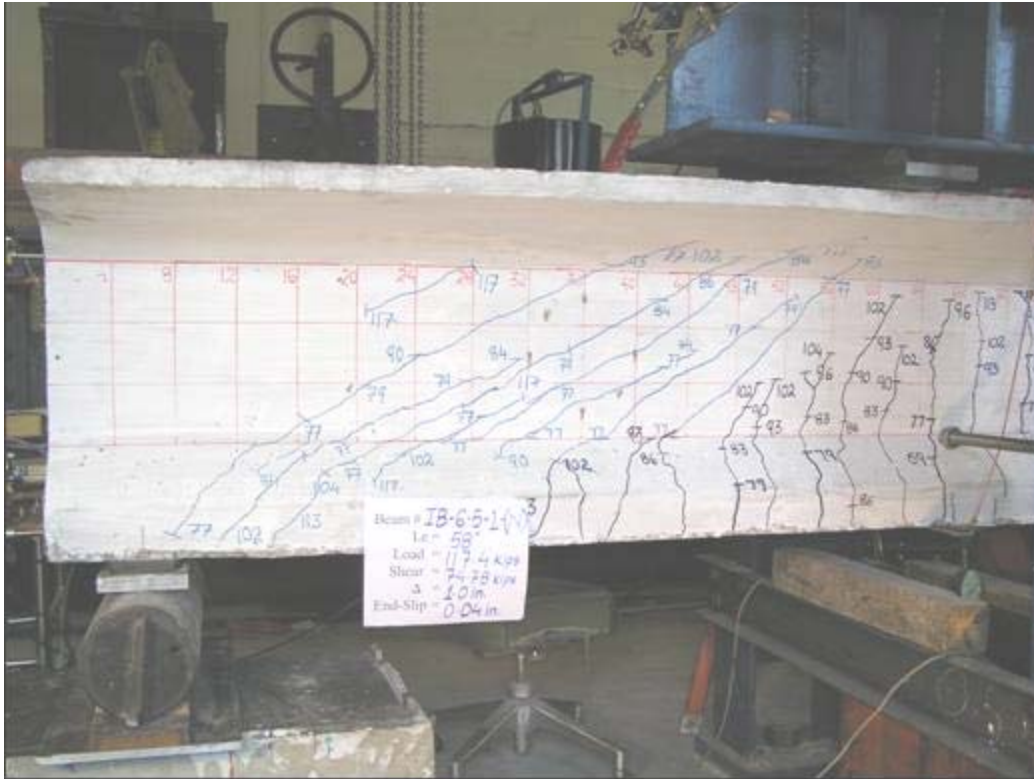
The failure of the beam was determined to be a shear failure as web shear cracks were widening. Also, the measured load vs. deflection curve generally conforms to that of a shear failure, and nominal flexural capacity was not achieved. The loud noises are believed to be stirrup or strand wire ruptures though no excavation of the failed beam was performed to confirm this conclusion.

Photo of North end of beam IB-6-5-1 showing the cracking pattern at the maximum load

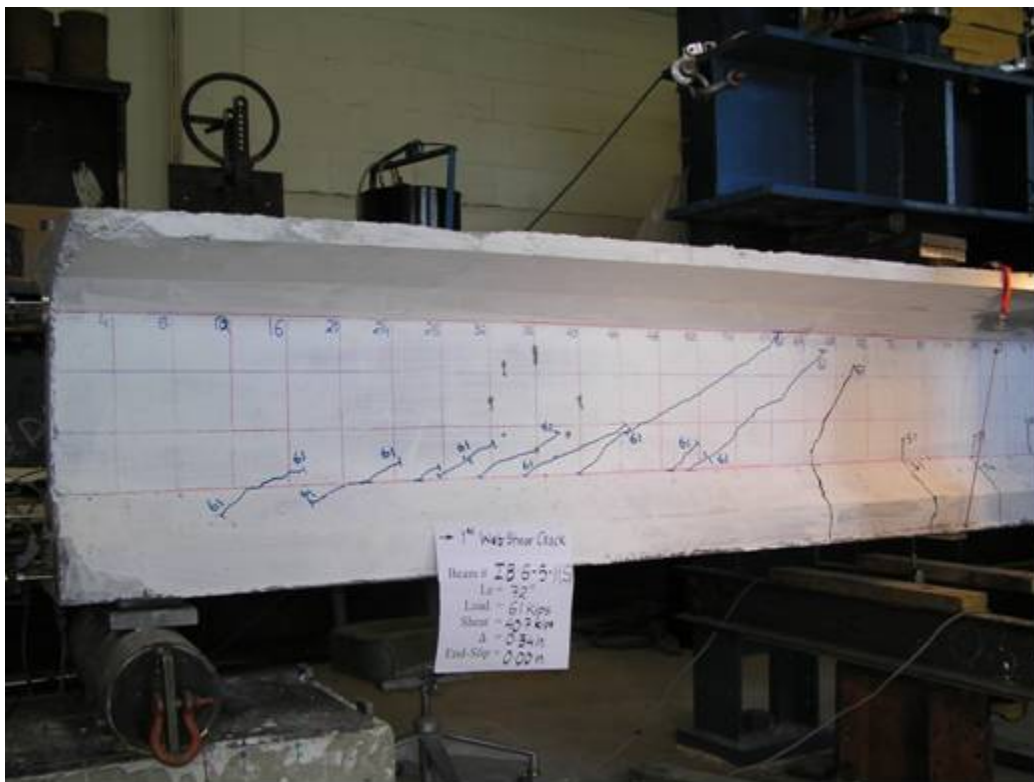
Photo of the South end of the beam IB-6-5-1 showing the first web shear cracking

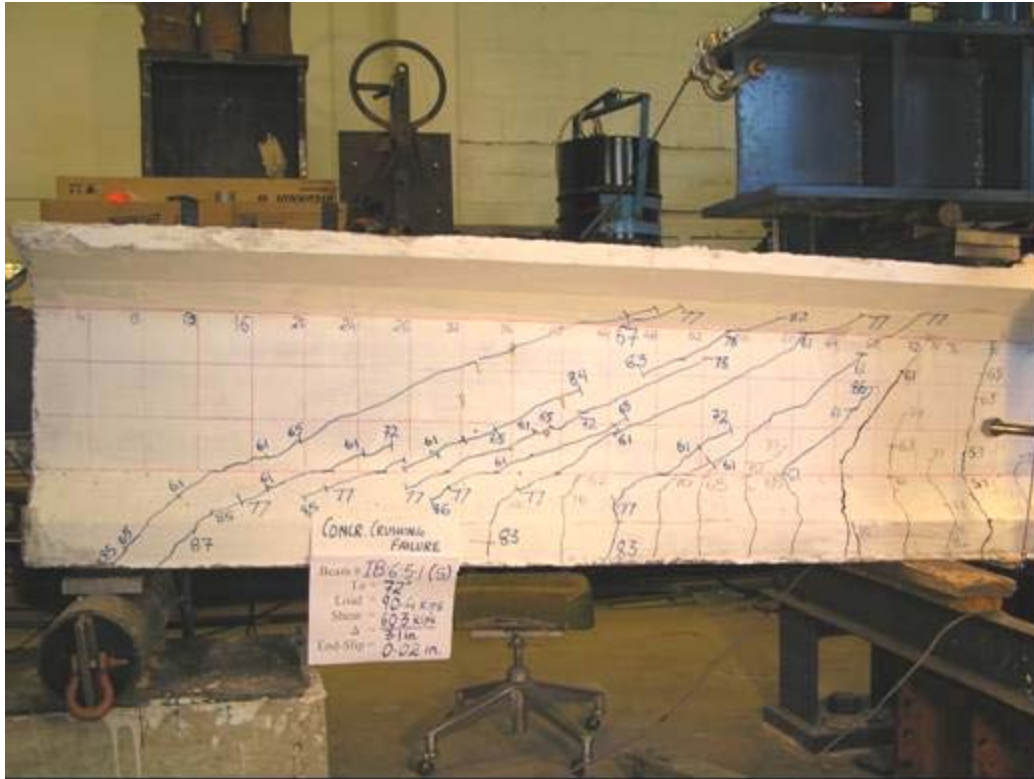
First end slip of 0.01 in. was noted at the load of 85.2 kips (Shear = 56.8 kips; $\Delta = 1.4$ in.). The end slip value remained at 0.01 in. until failure occurred. At failure end slips suddenly increased to 0.025 in. Failure was distinguished by a concrete crushing failure of the compression flange. Crushing failure was accompanied by a large sound at the load of 90.4 kips (Shear = 60.3 kips; deflection = 3.1 in.)

Photo of South end of beam IB-6-5-1 showing the cracking pattern at concrete crushing failure

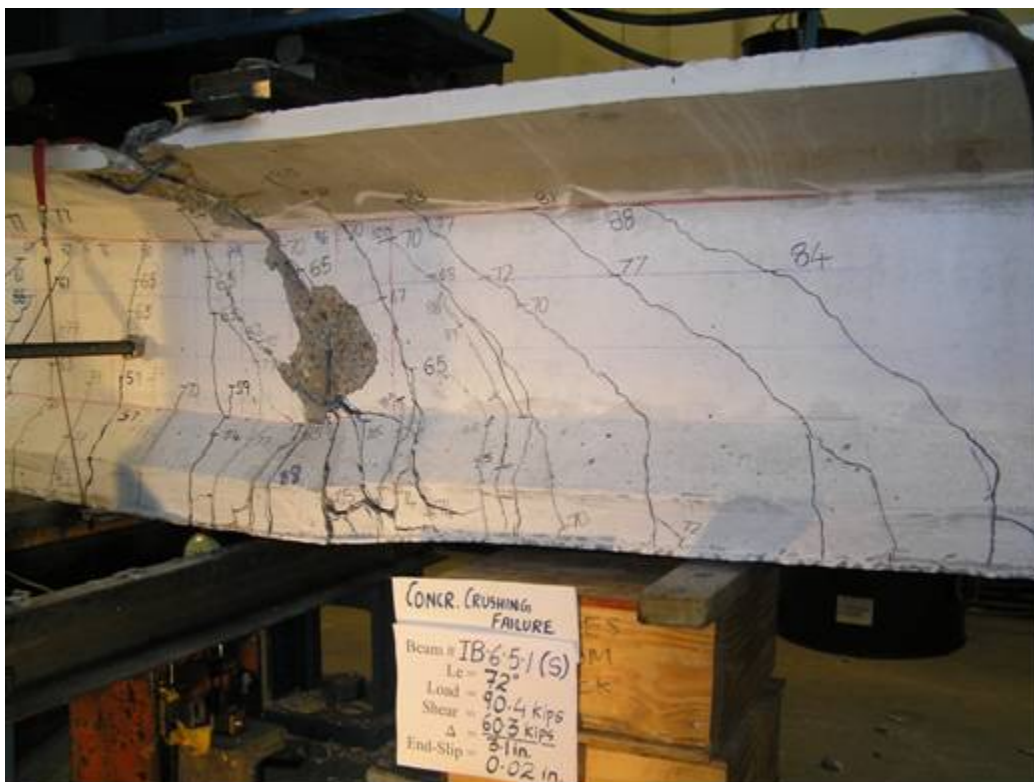
Photo of the crushed region of beam IB-6-5-1 (South end test)

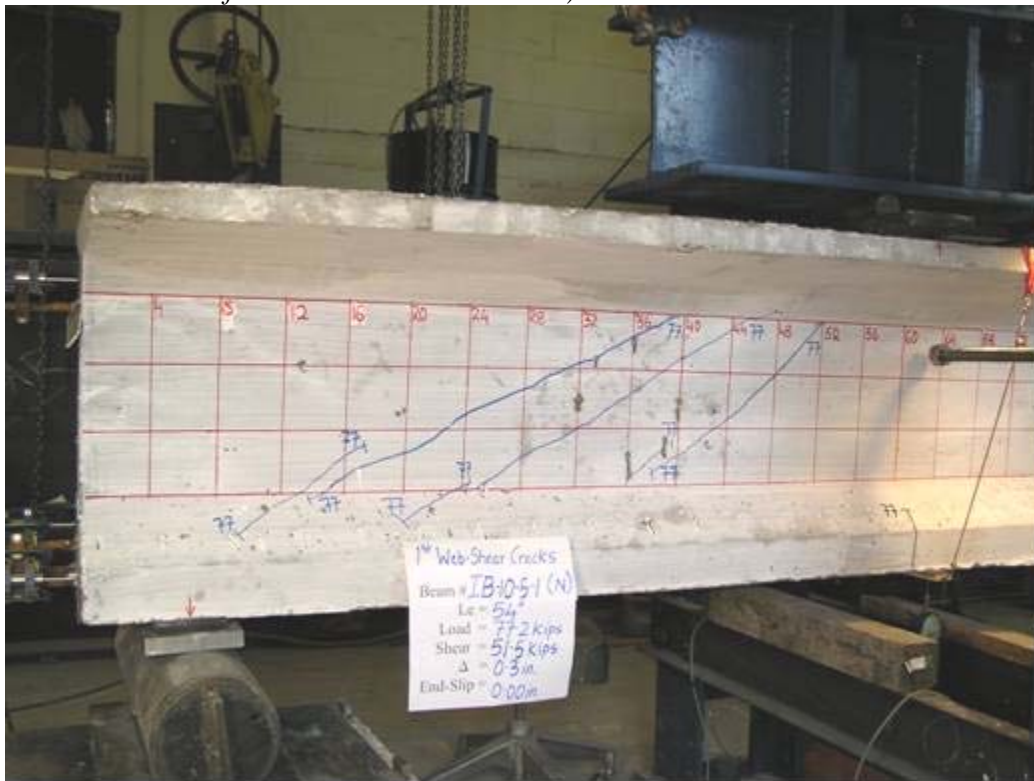
First flexural cracks occurred simultaneously with the first web shear cracks at the load of 77.2 kips (Shear = 51.5 kips) and deflection of 0.3 in. First flexural cracks occurred in a pair of cracks located approximately below the two load points. First web shear cracks occurred in the form of a number of cracks almost parallel to each other in the shear zone.

Photo of the North end of the beam IB-10-5-1 showing the first web shear cracking incidentally the point of first flexural cracking as well)

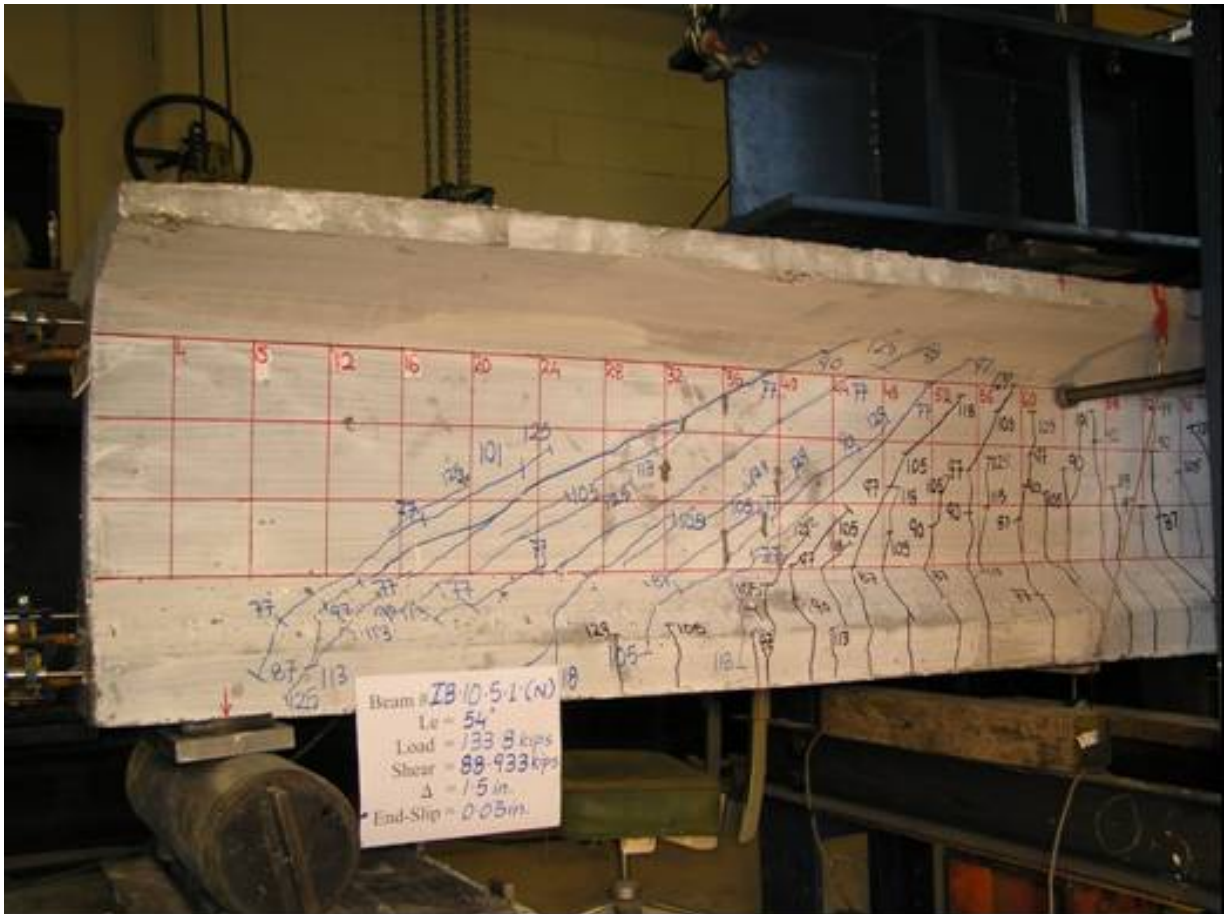
Photo of North end of beam IB-10-5-1 showing the cracking pattern at the maximum load

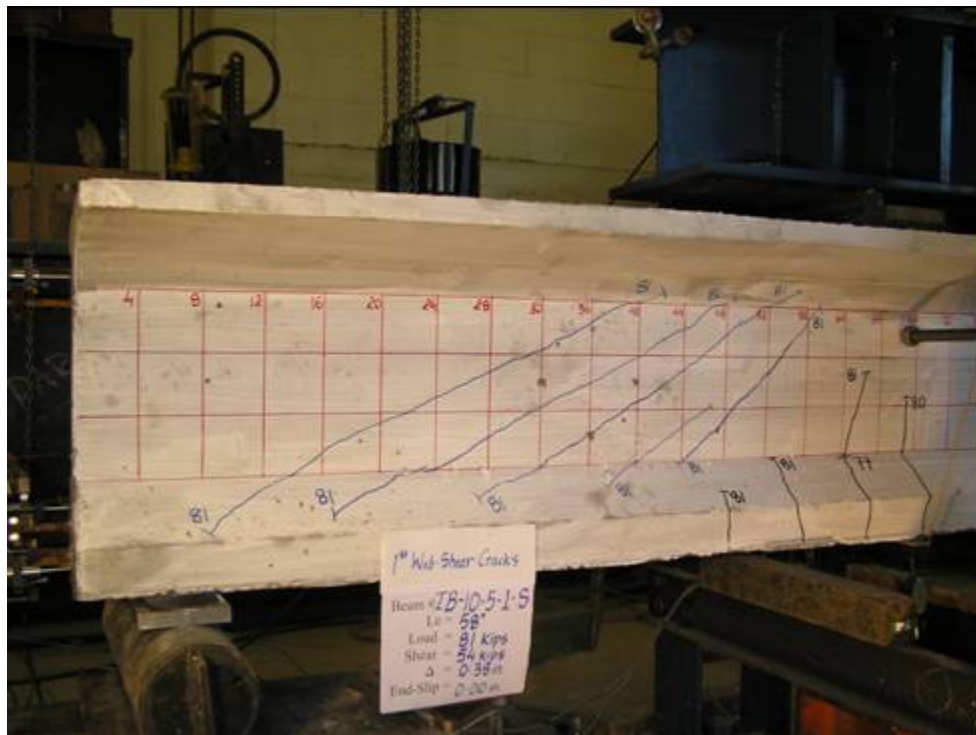
Photo of the South end of the beam IB-10-5-1 showing the first web shear cracking

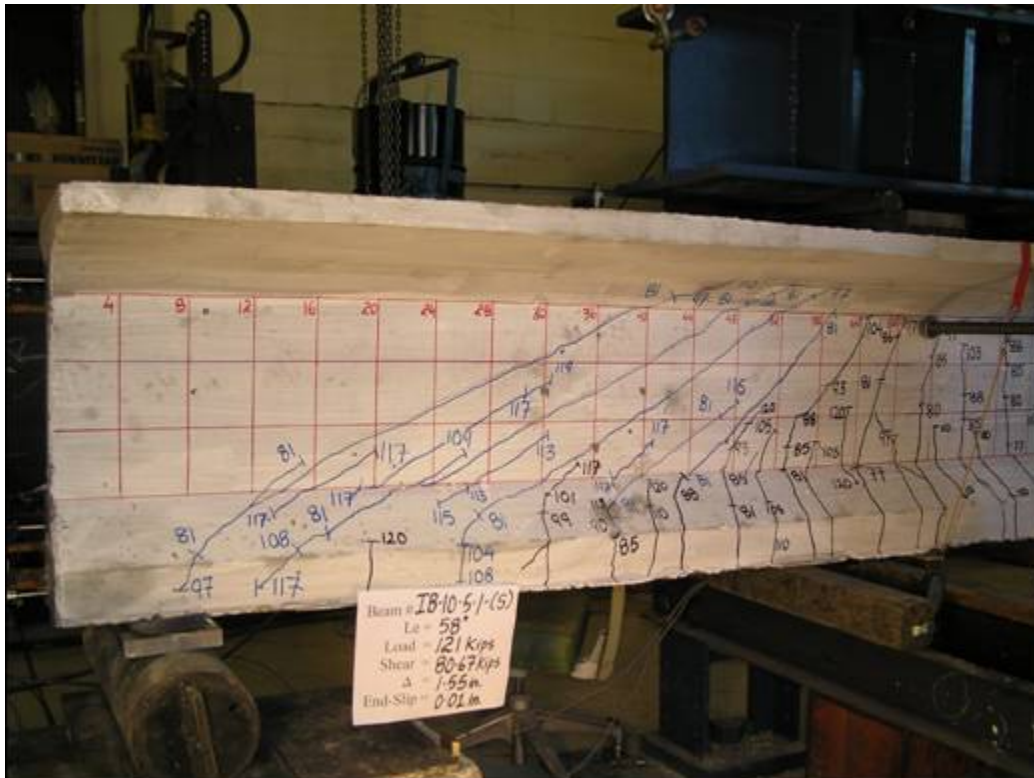
The applied load was increased with every deflection increment until the applied load reached 121 kips (Shear = 80.7 kips; $\Delta = 1.55$ in.). At this load, the flexural crack near Station 96 had grown considerably wide to suggest strand yielding and a flexural failure. Web shear cracks were not wide enough to suggest a shear failure. Loading was stopped concluding that the beam was failing in flexure.

Photo of South end of beam IB-10-5-1 showing the cracking pattern at the maximum load

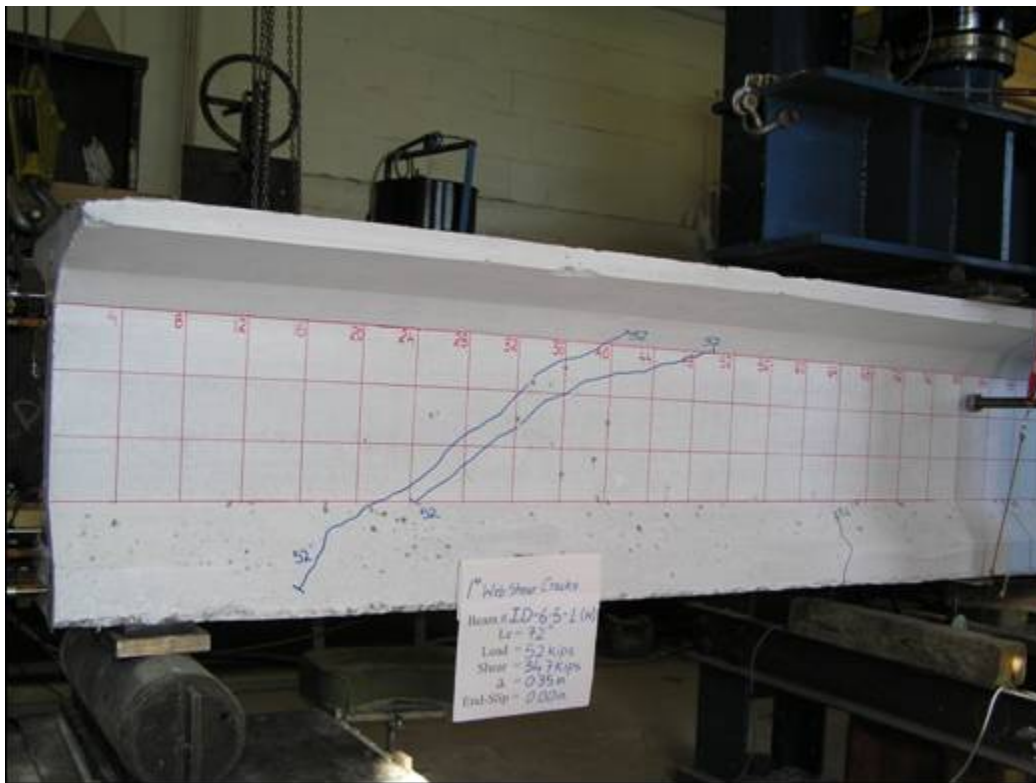
Photo of the North end of the beam ID-6-5-1 showing the first web shear cracking

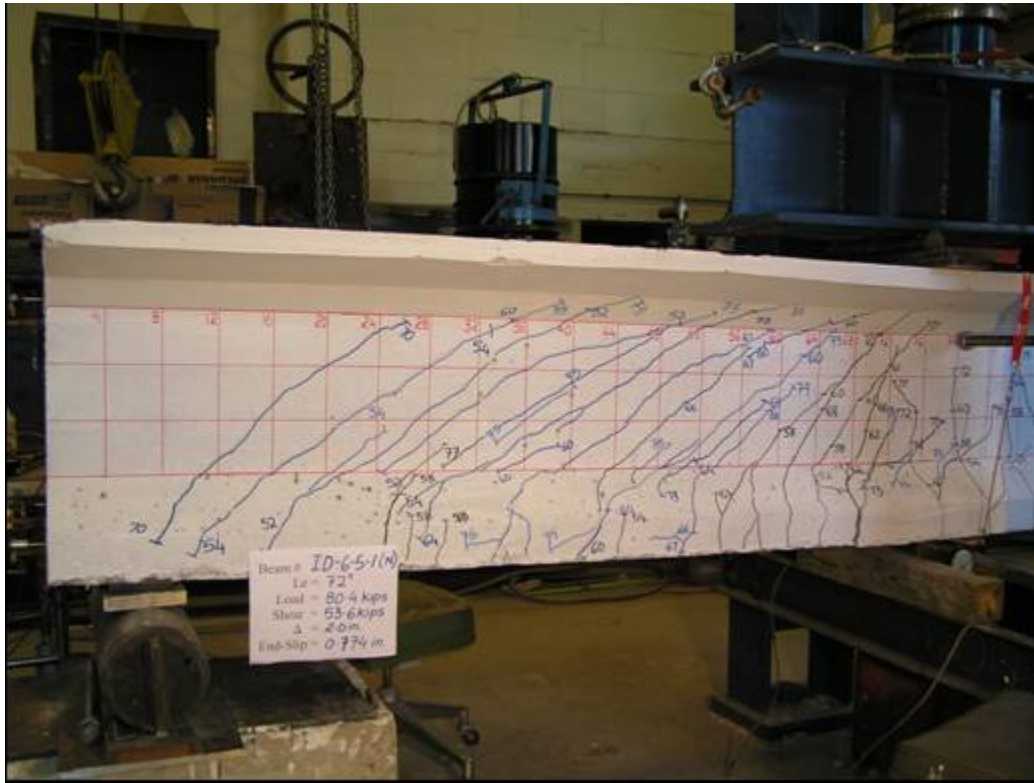
The beam exhibited a BOND FAILURE in that strand slippage prevented further increases in beam capacity. The flexural moment achieved during the test was only 3500 k-in., or about 82% of the nominal flexural capacity. Likewise, the maximum shear achieved by the beam was only 53.6 k which is well below the 74.4 k of shear that resulted in a shear failure in the companion beam IB-6-5-1-N. Clearly, slippage of the strand and bond failure prevented the beam from achieving its calculated design capacity.

Photo of North end of beam ID-6-5-1 showing the cracking pattern at the maximum load

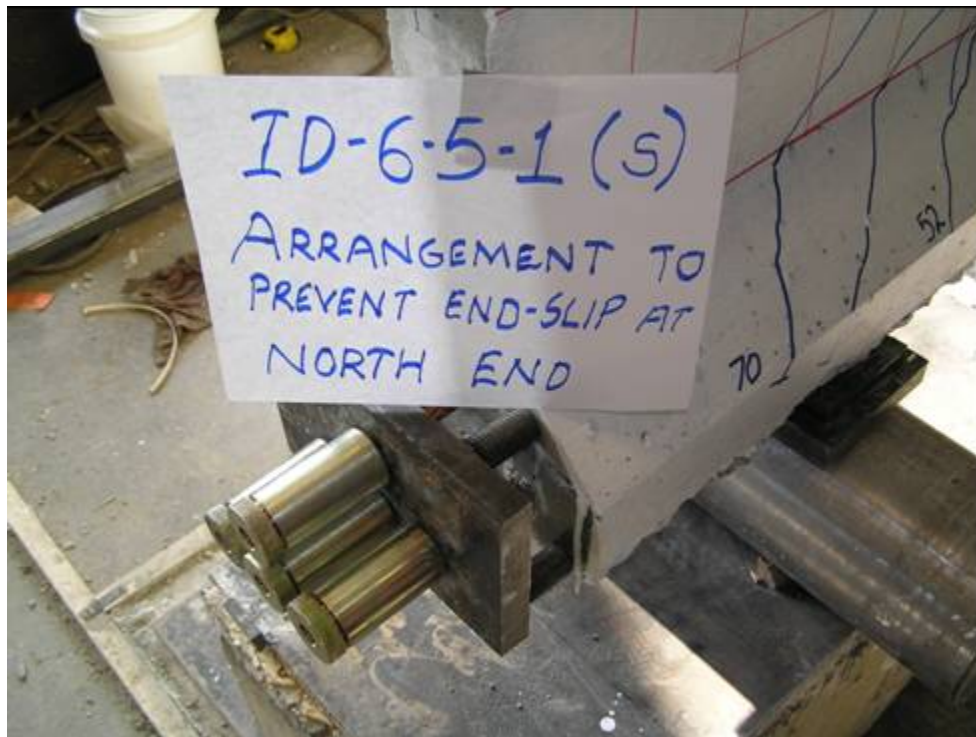
Photo showing chucks attached to strands to prevent any possible end slip.

North end test of the beam ID-6-5-1 resulted in total end-slip of 0.8 in. and a BOND FAILURE. To avoid any further end slip at the North end while the South end was tested, prestressing strand chucks were fixed to the strands at the North end of the beam. The chucks holding the strands in place are shown in the following photograph.

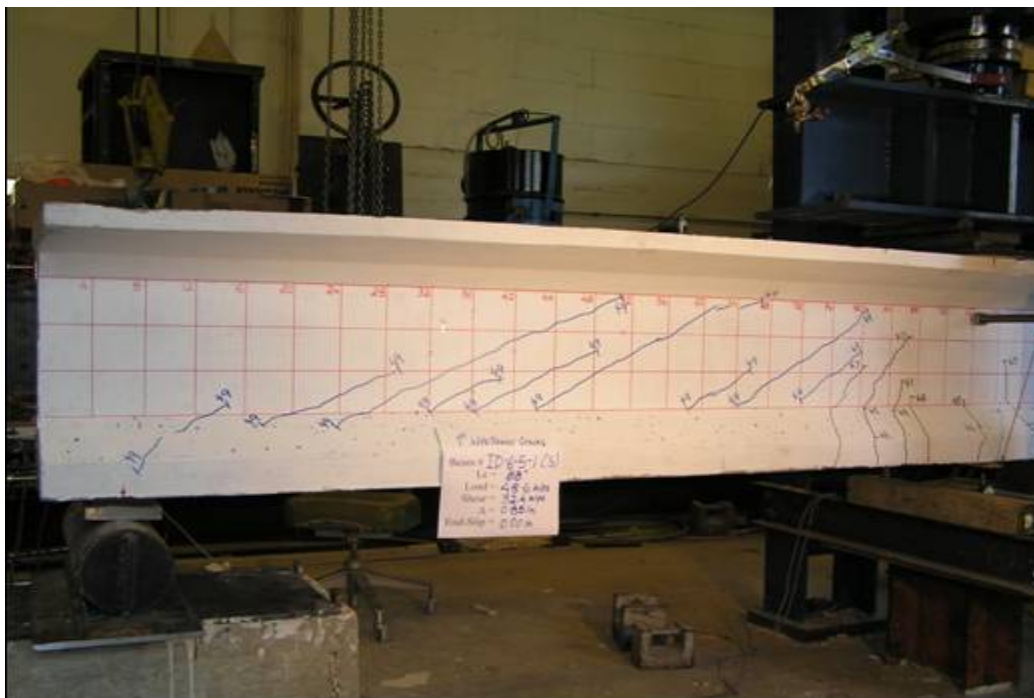
Photo of the South end of the beam ID-6-5-1 showing the first web shear cracking

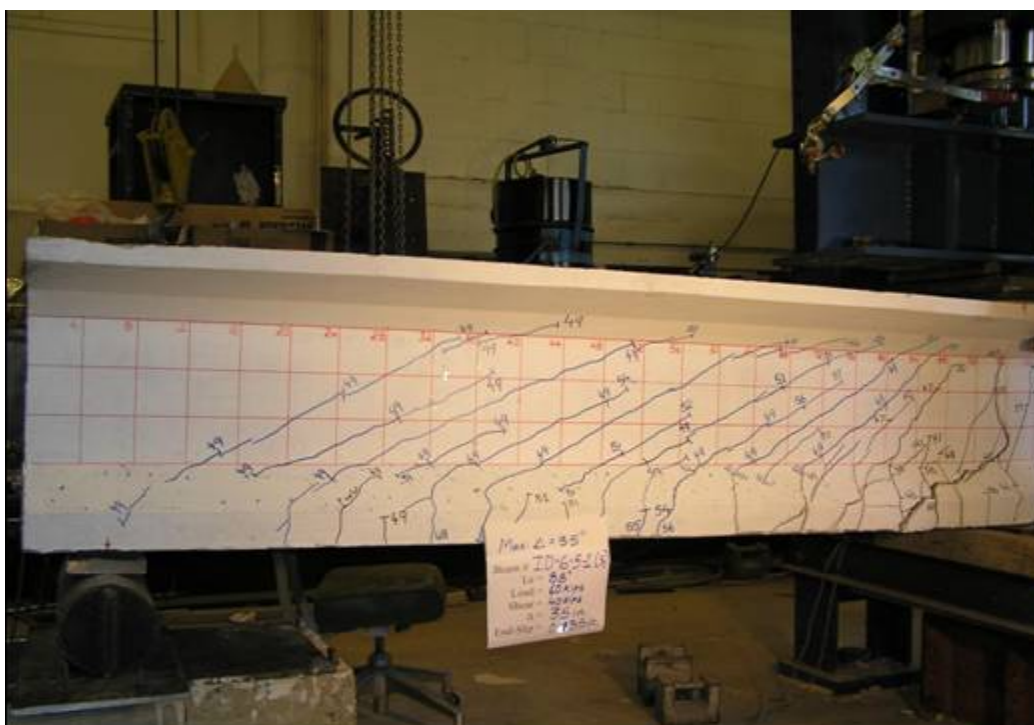
The beam exhibited a BOND FAILURE in that strand slippage prevented further increases in beam capacity. The flexural moment achieved during the test was only 3500 k-in., or about 81% of the nominal flexural capacity. Likewise, the maximum shear achieved by the beam was only 53.6 k which is well below the 74.4 k of shear that resulted in a shear failure in the companion beam IB-6-5-1-N. Clearly, slippage of the strand and bond failure prevented the beam from achieving its calculated design capacity.

Photo of South end of beam ID-6-5-1 showing the cracking pattern at the maximum deflection

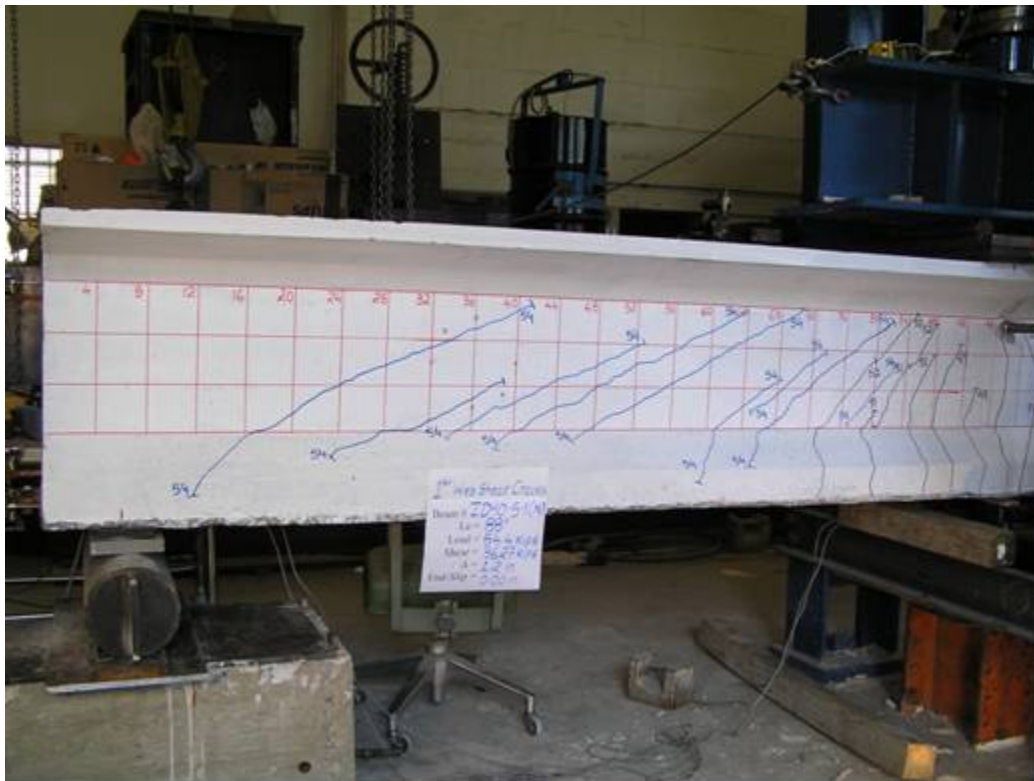
First web shear cracking was noticed at 54.6 kips (Shear = 36.4 k; Δ = 1.2 in.). The first web shear cracks occurred in the form of a number of diagonal cracks fairly parallel to each other in the shear zone. All cracks right from the first flexural cracks were clearly audible.

Photo of the North end of the beam ID-10-5-1 showing the first web shear cracking

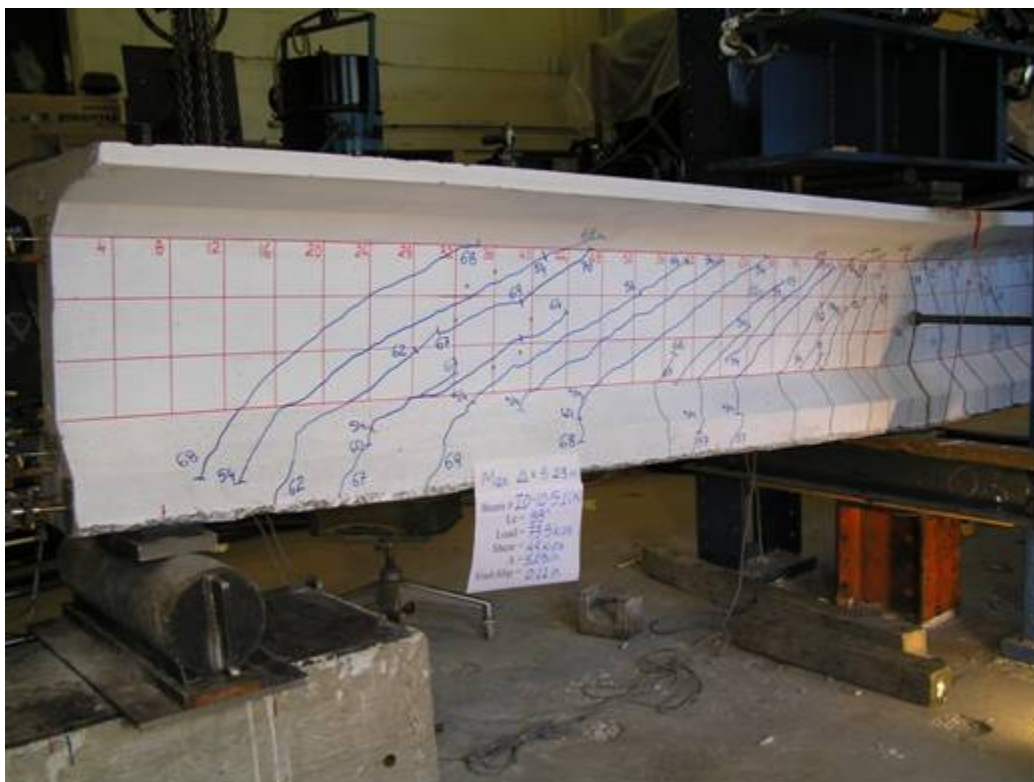
Deflection increments were stopped since the hydraulic ram reached its maximum stroke. Complete failure was not attained, but from the values of load, deflection and end slip it was evident that the beam should be classified as a flexural failure.

Photo of North end of beam ID-10-5-1 showing the cracking pattern at the maximum load

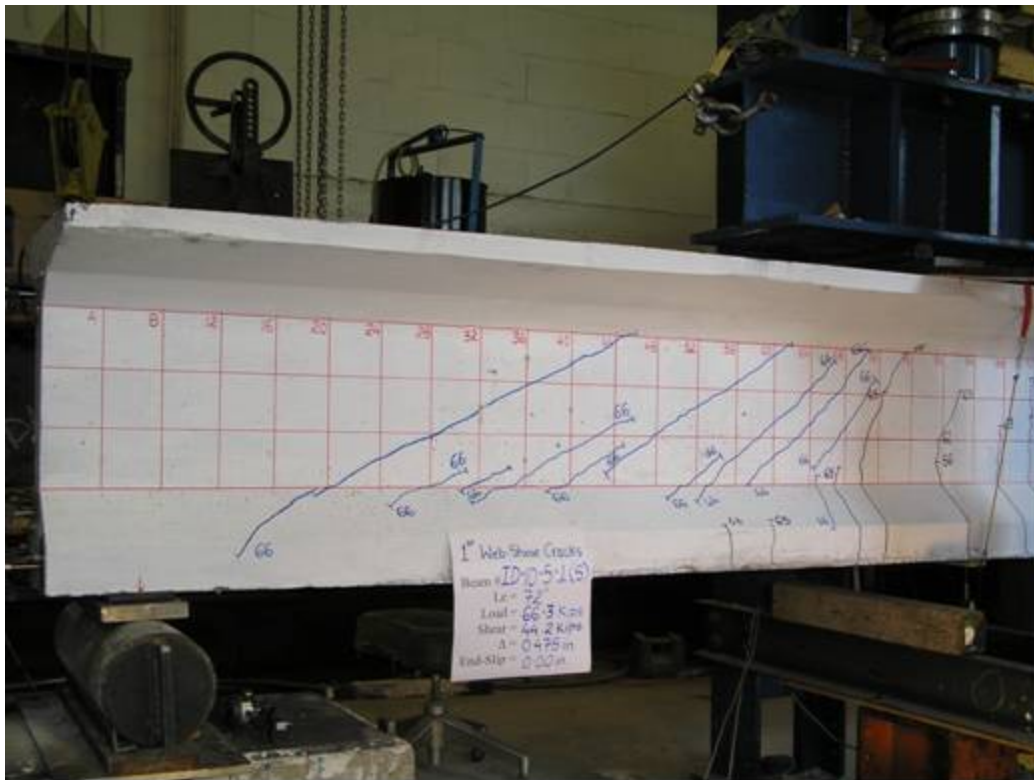
At the load of 66.3 kips (Shear = 44.2 k; Δ = 0.48 in.) first web shear cracks were observed. Corresponding with web shear cracks, the value of load dropped to 62.4 kips. DEMEC readings were taken after the cracks were completely formed and at the lower value of load. First end slip of 0.01 in. was observed when the load returned to 66.3 k at a deflection = 0.53 in. End slip values continued to increase throughout the loading cycle till it reached maximum value of 0.71 in. at the deflection of 3.7 in.

Photo of the South end of the beam ID-10-5-1 showing the first web shear cracking

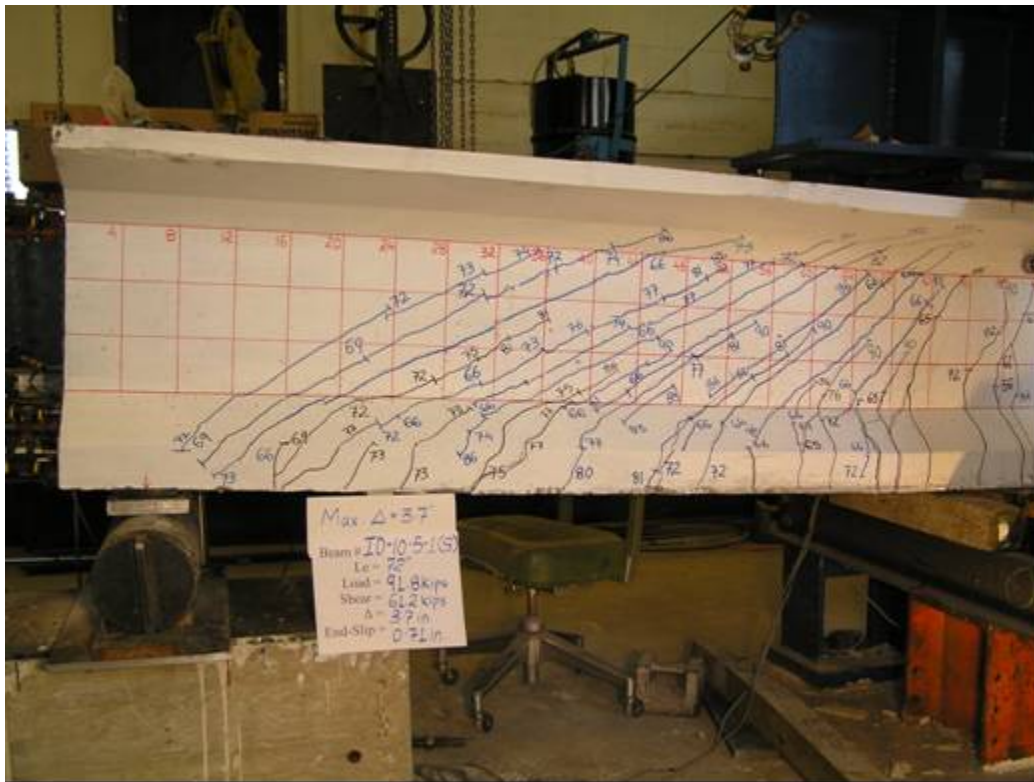
The beam exhibited a BOND FAILURE in that strand slippage prevented further increases in beam capacity. The flexural moment achieved during the test was only about 92% of the nominal flexural capacity while the strand slippage was large and increasing.

Photo of South end of beam ID-10-5-1 showing the cracking pattern at the maximum deflection
