Guidelines for Dowel Alignment in Concrete Pavements

APPENDIX B FIELD TESTING RESULTS

Prepared for
NATIONAL COOPERATIVE HIGHWAY RESEARCH
PROGRAM (NCHRP)
Transportation Research Board
of
The National Academies

**Shreenath Rao, Senior Engineer
Applied Research Associates, Inc.**

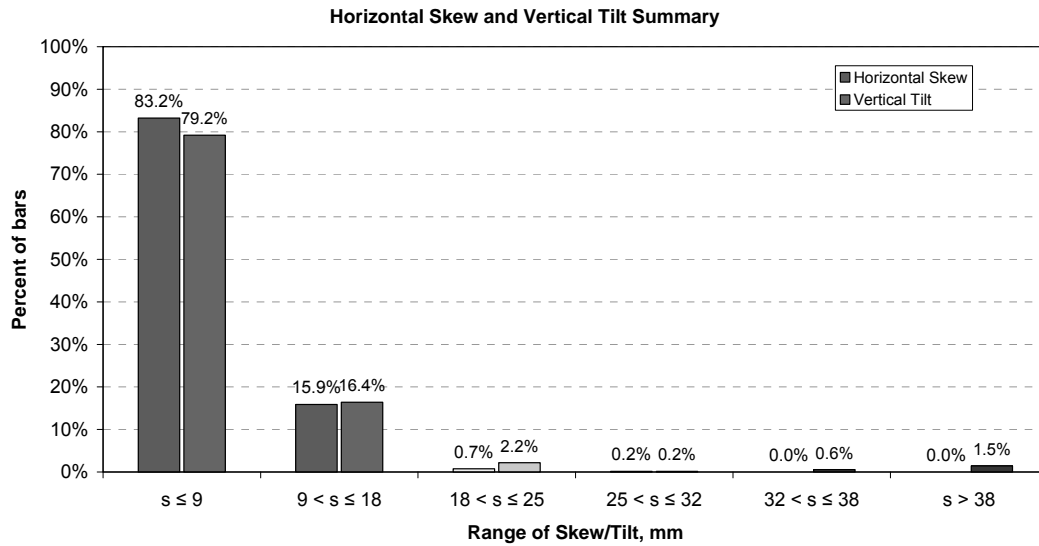
This section has good dowel alignment. Figure B.3 shows that only 0.9% of bars have horizontal skew greater than 18 mm, and only 4.4% of bars have vertical tilt greater than 18 mm. The distributions of mean and range of end to end horizontal skews and vertical tilts for each of the bar positions are shown in Figures B.4 and B.5. A summary table of the results and descriptions of terms in the table are shown in Figure B.6. A photographic overview of 1-IN1 is shown in Figures B.7 through B.9.

Figure B.3. Distribution of horizontal skews and vertical tilts results for 1-IN1.

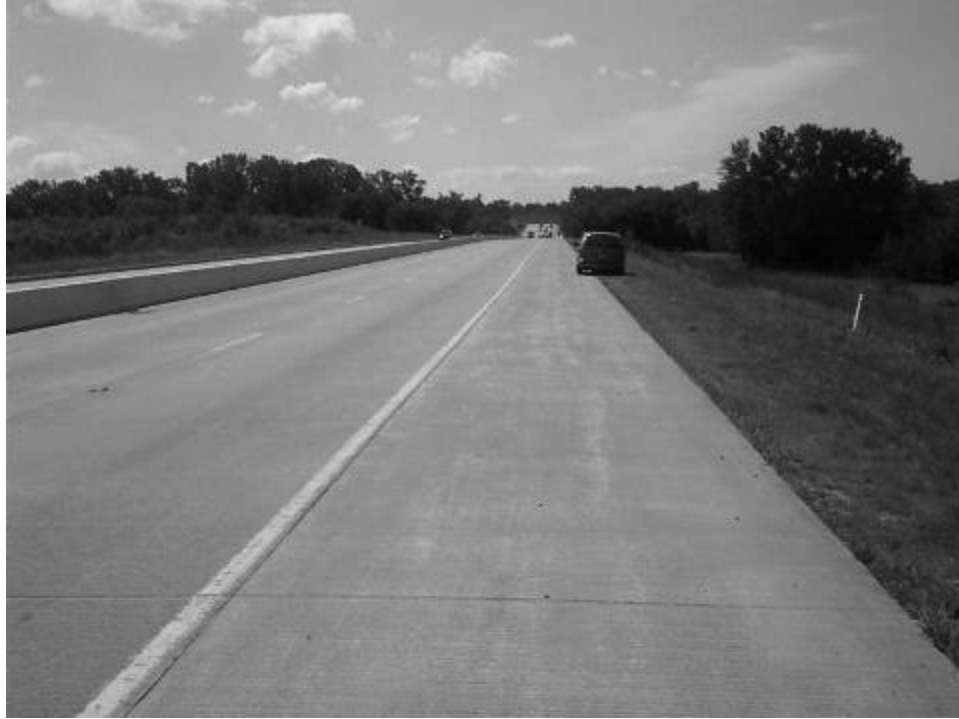
Figure B.7. Photographic overview of 1-IN1 showing no significant distresses.

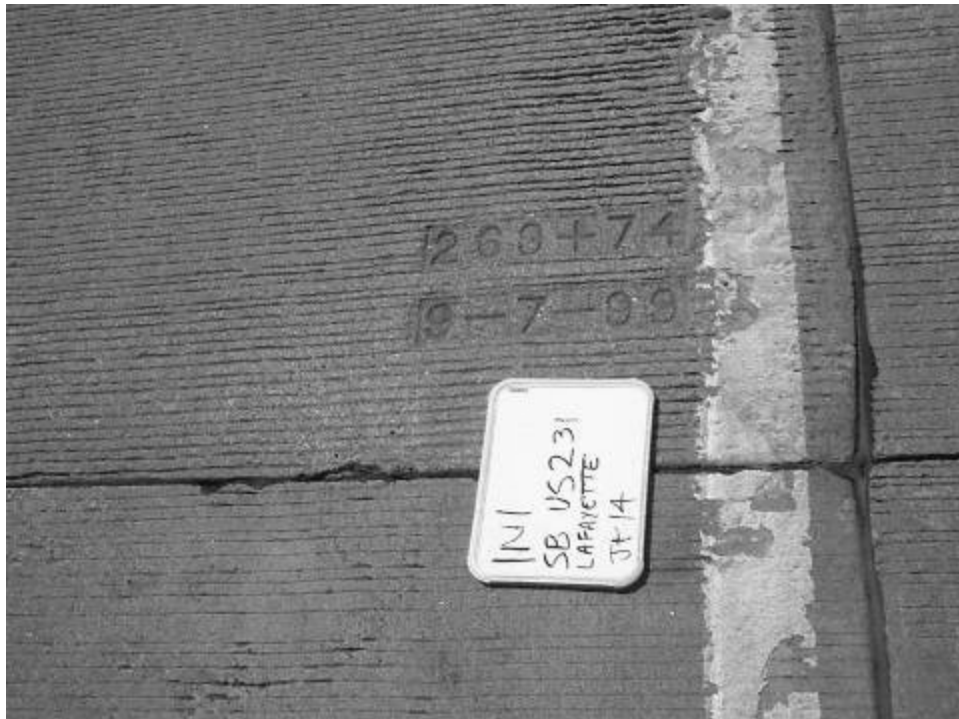
Figure B.8. Minor spalling on joint 14 on 1-IN1.

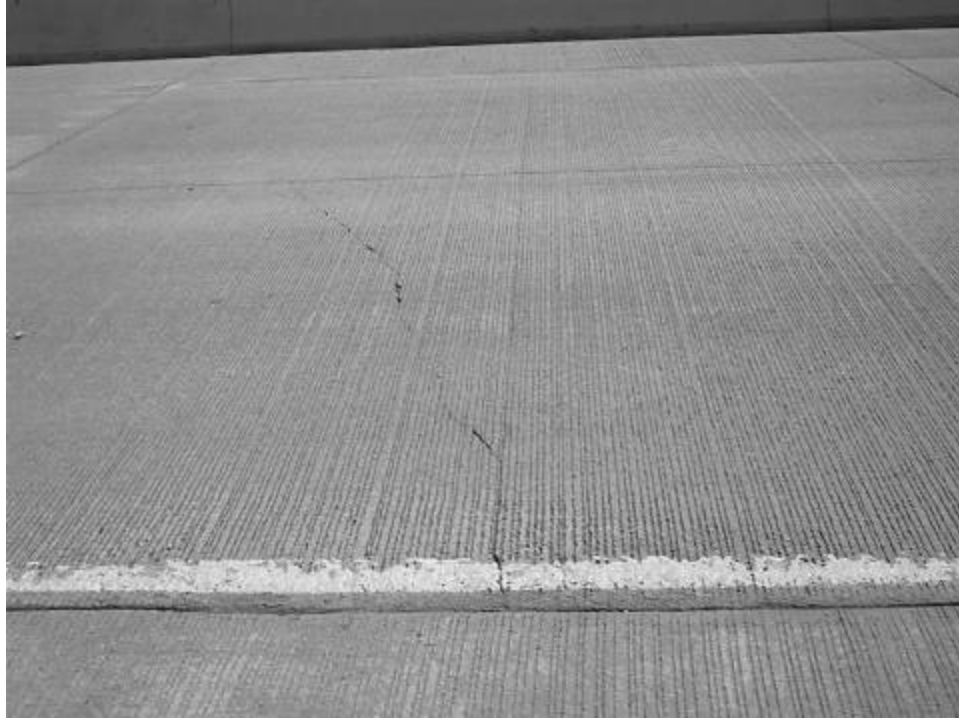
Figure B.9. Mid-panel transverse crack on slab 14 on 1-IN1.

Note that the only mid-panel crack observed on this section was on slab 14, which also coincides with the joint with the highest amount of vertical tilt. Joint 14 has average vertical tilt of 41 mm, which significantly exceeds the project average absolute vertical tilt of 6 mm. The average horizontal skew of joint 14 was 6 mm. Based on the station/date stamp near joint 14, it is surmised that this joint was a construction joint. Overall, the section was in excellent condition, with only two joints showing minor spalling, the single transverse crack on slab 14, and average faulting of 0.005 in. (0.1 mm). Most slabs had faulting less than 0.05 in. (1.3 mm), and many slabs measured minor amounts of negative faulting, likely due to differences in curling between the adjacent slabs.

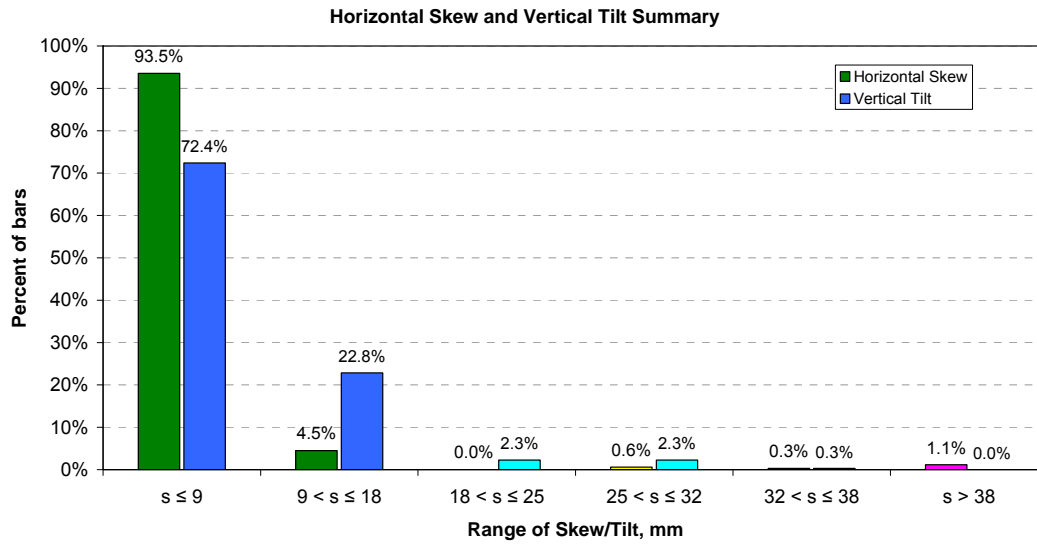
A majority of the joints scanned exhibited good to excellent dowel position/alignment. Only 1.7% of the joints have vertical depth deviation greater than 25 mm. Figure B10 shows that 2.0% of bars have horizontal skew greater than 18 mm, and 4.8% of bars have vertical tilt greater than 18 mm. The distributions of mean and range of end to end horizontal skews and vertical tilts for each of the bar positions are shown in Figures B.11 and B.12. A summary table of the results is shown in Figure B13. A photographic overview of 1-WI2 is shown in Figures B.14 through B.16.

Figure B.10. Distribution of horizontal skew and vertical tilt results for 1-WI2.

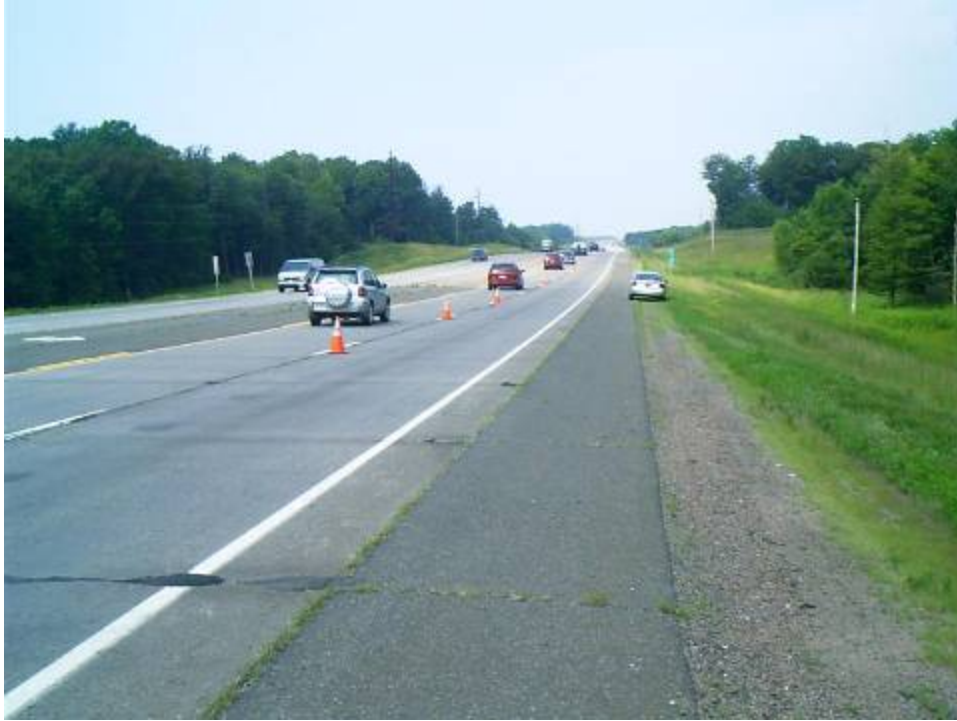
Figure B.14. Photographic overview of 1-WI2 showing significant high-severity joint spalling.

Forty percent of the joints on this project had high-severity spalling; however, none of the slabs on this project exhibited any transverse cracking. One suspected cause for the significant spalling on this project was dowel misalignment. However, MIT Scan-2 scanning and analysis showed good to excellent dowel alignment at the joints and no correlation between distressed joints and dowel position or alignment. Overall, the section was in poor condition with a large number of high-severity spalls that had been patched with HMA. The average faulting was 0.03 in. (1 mm). Most slabs had faulting less than 0.05 in. (1.3 mm).

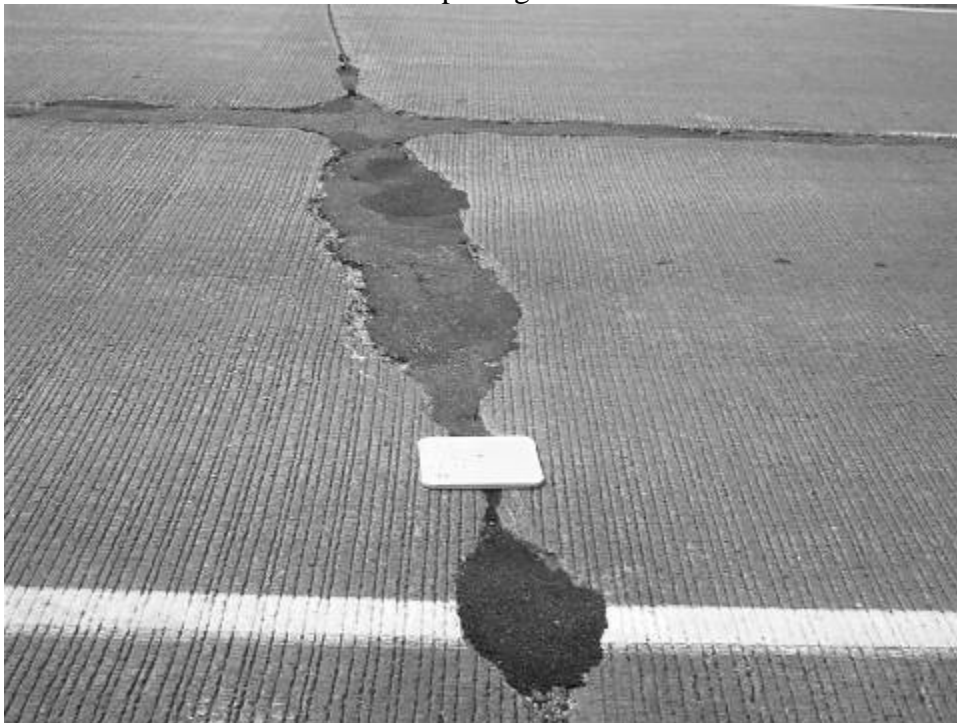
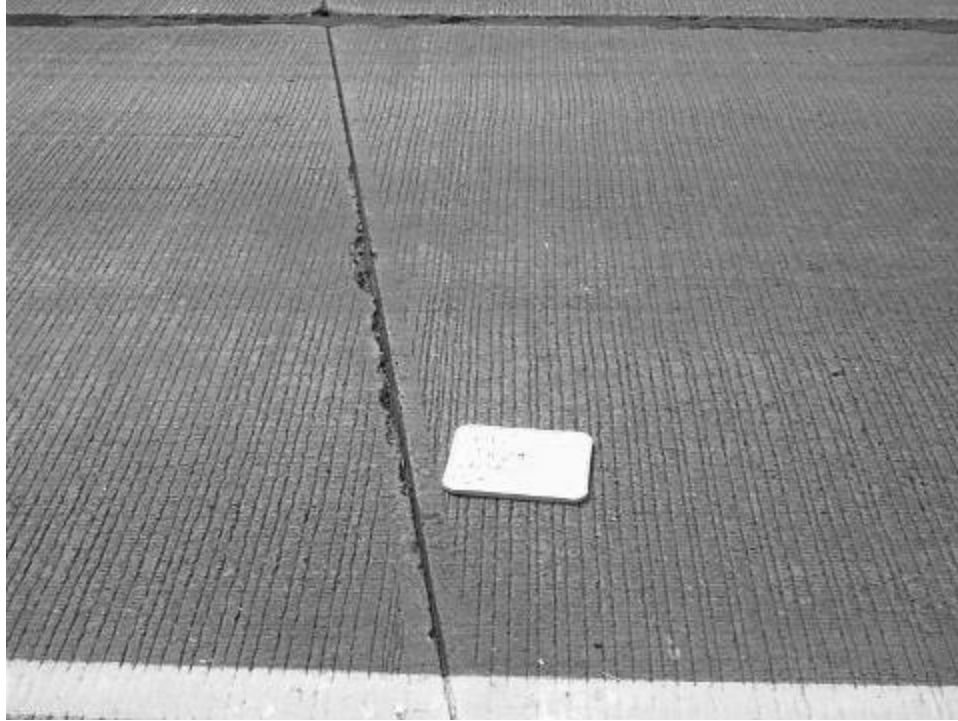
Figure B.15. Typical high-severity spalling on 1-WI2.

Figure B.16. Typical high-severity spalling on 1-WI2.

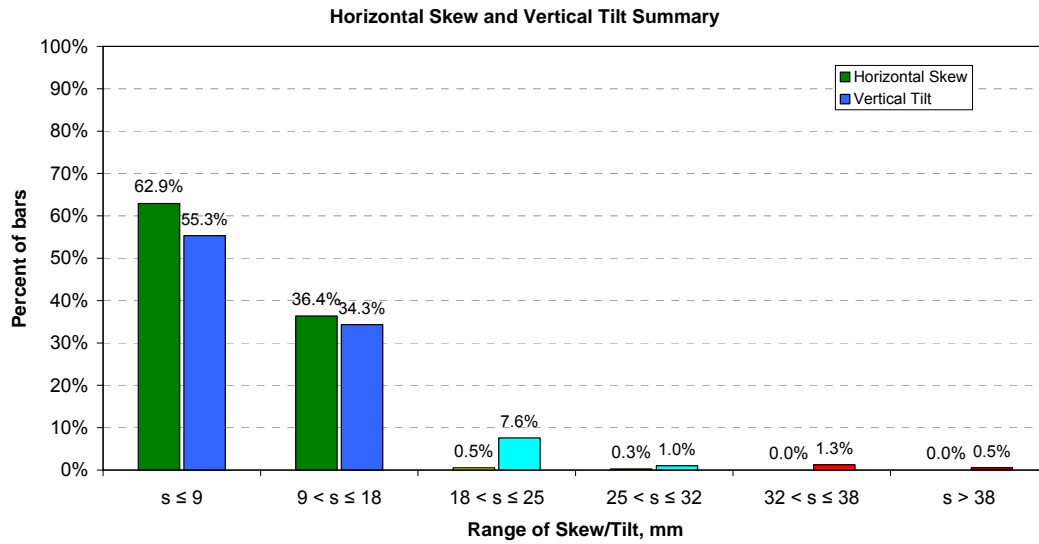
Several of the joints scanned exhibited poor to moderate vertical dowel position and tilt and excellent horizontal skew. Approximately 34.3% of the joints have vertical depth deviation greater than 25 mm. Figure B.17 shows that 0.8% of bars have horizontal skew greater than 18 mm, but 10.4% of bars have vertical tilt greater than 18 mm. The distribution of mean and range of end to end horizontal skews and vertical tilts for each of the bar positions is shown in Figures B.18 and B.19. A summary table of the results is shown in Figure B.20. A photographic overview of 1-OH1 is shown in Figures B.21 and B.22.

Figure B.17. Distribution of horizontal skew and vertical tilt results for 1-OH1.

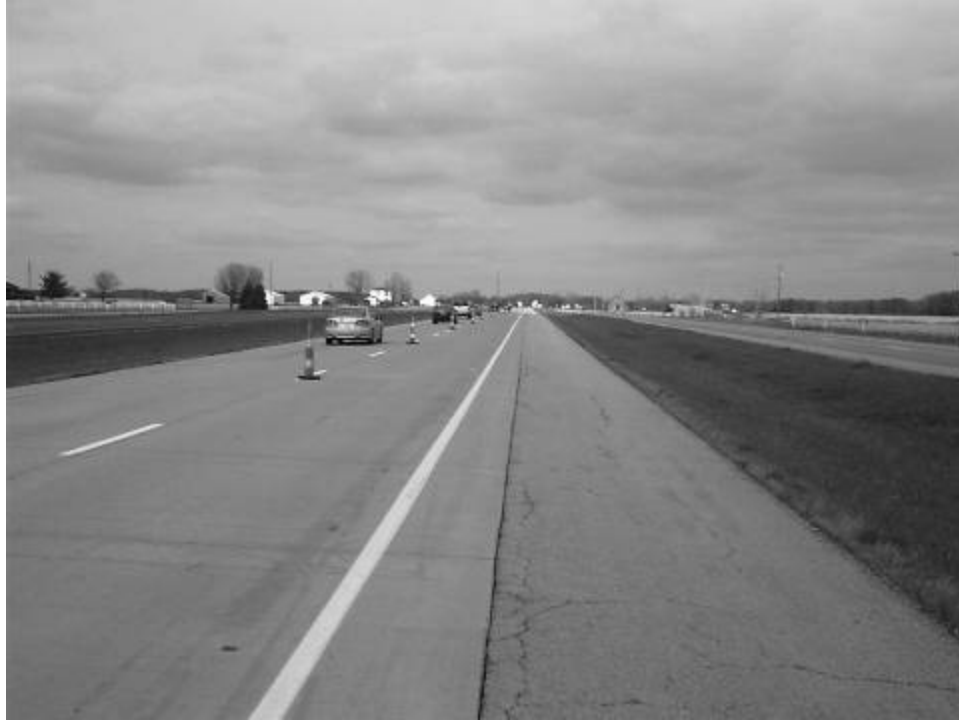
Figure B.21. Photographic overview of 1-OH1 showing no major distresses on the PCC pavement.

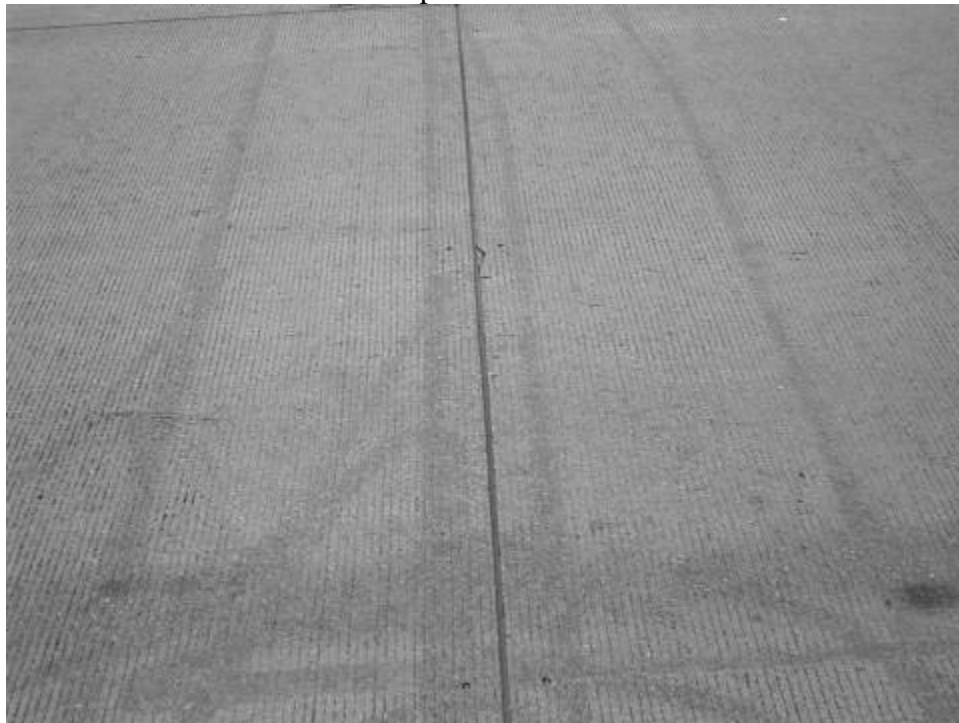
Figure B.22. One joint with very minor spalling on 1-OH1.

MIT Scan-2 scanning and analysis showed poor to moderate dowel alignment at some of the joints. Over 10% of the dowel bars had vertical tilt greater than 18 mm, and over 34% of the dowel bars had vertical position shift greater than 25 mm. A majority of this

misalignment and position deviation was in the first and second dowel bars closest to the lane-shoulder joint. Note that this section had AC shoulders and not tied PCC shoulders. Tie bars in tied PCC shoulders can affect the MIT Scan-2 readings, resulting in greater errors for the first two bars, but this was not the case here. The pavement showed excellent performance with no major distresses and only a few joints with very minor surface spalling after 13 years of moderately heavy traffic. The average faulting on this section was 0.03 in. (1 mm).

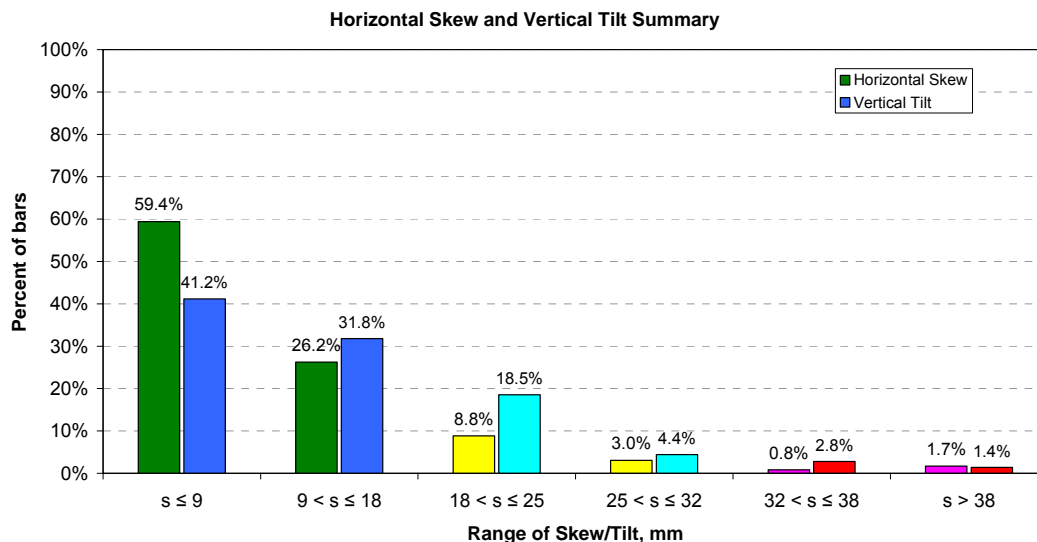
Several of the joints scanned exhibited poor to moderate dowel position and alignments. Approximately 21.6% of the joints have vertical depth deviation greater than 25 mm. Figure B.23 shows that 14.4% of bars have horizontal skew greater than 18 mm, and 27.1% of bars have vertical tilt greater than 18 mm. The distributions of mean and range of end to end horizontal skews and vertical tilts for each of the bar positions are shown in Figures B.24 and B.25. A summary table of the results is shown in Figure B.26. A photographic overview of 1-IL2 and some of the distresses are shown in Figures B.27 and B.28.

Figure B.23. Distribution of horizontal skew and vertical tilt results for 1-IL2.

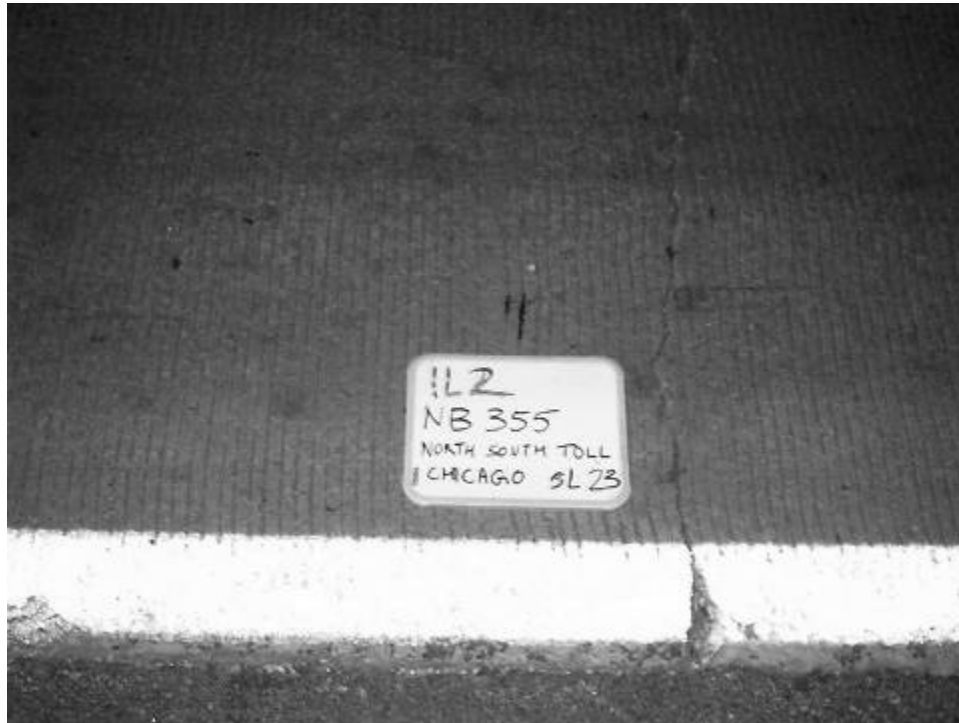
Figure B.27. Photographic overview of 1-IL2 showing mid-panel cracking.

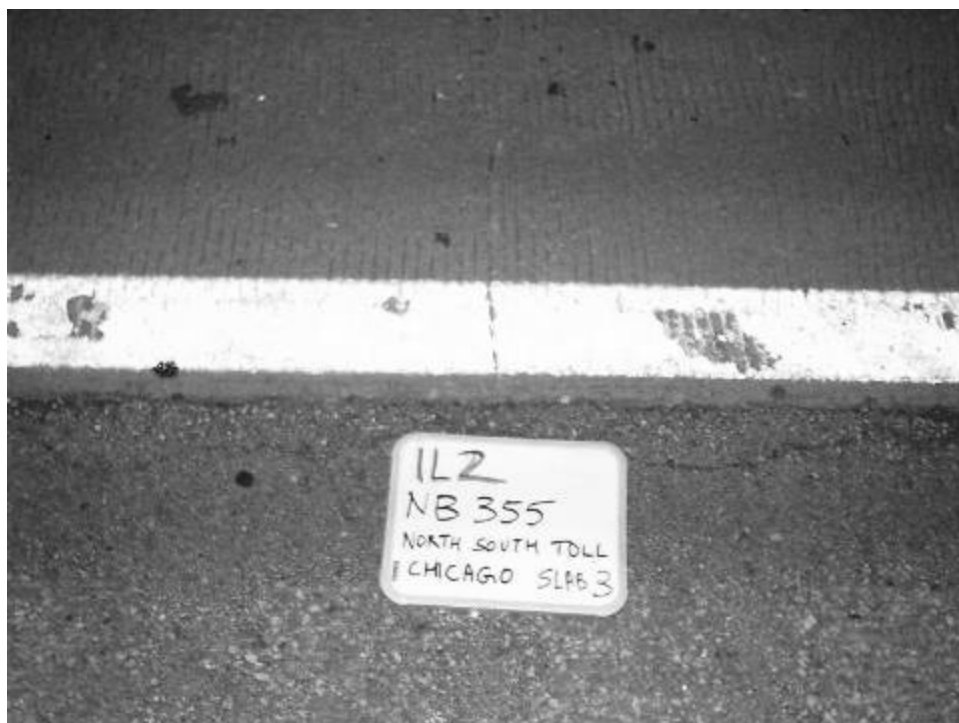
Figure B.28. Mid-panel transverse cracking on 1-IL2 on I-355.

MIT Scan-2 scanning and analysis showed poor to moderate dowel alignment at some of the joints. Over 27% of the dowel bars had vertical tilt greater than 18 mm, and over 21% of the dowel bars had vertical position shift greater than 25 mm. The pavement also had moderate levels of distresses, with 14% of the slabs exhibiting mid-panel transverse cracking. One slab had longitudinal cracking, and one joint exhibited high-severity spalling. However, the MIT Scan-2 analysis showed that the dowel misalignment and position deviations did not correlate to the observed distresses.
