**APPENDIX C**

**STRUCTURAL INVESTIGATION & FULL-SCALE GIRDER TESTING**

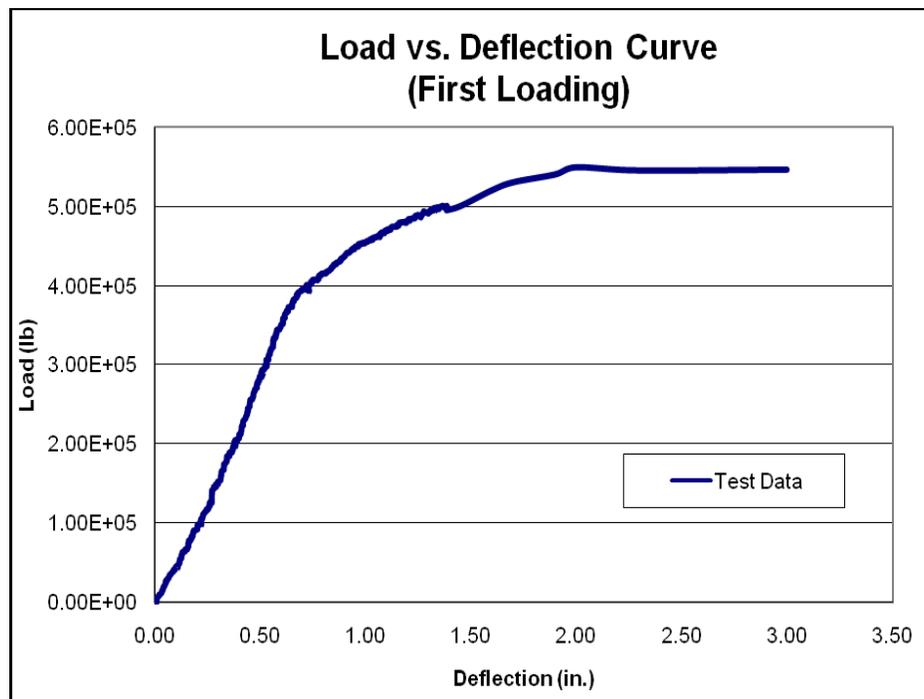
Load was slowly applied to the system in intervals of 100k. After each additional 100k, the loading was paused so that the girder could be investigated and marked for cracks. Once the design load of 500k was reached the loading was stopped. At that level, the location directly below the load was experiencing a deflection of 1.38 in., as shown in Figure C.1-11. The load was then removed, leaving a permanent plastic deformation at the location of loading of 0.29 in.

Figure C.1-11. Load Deflection Curve – First Loading Cycle

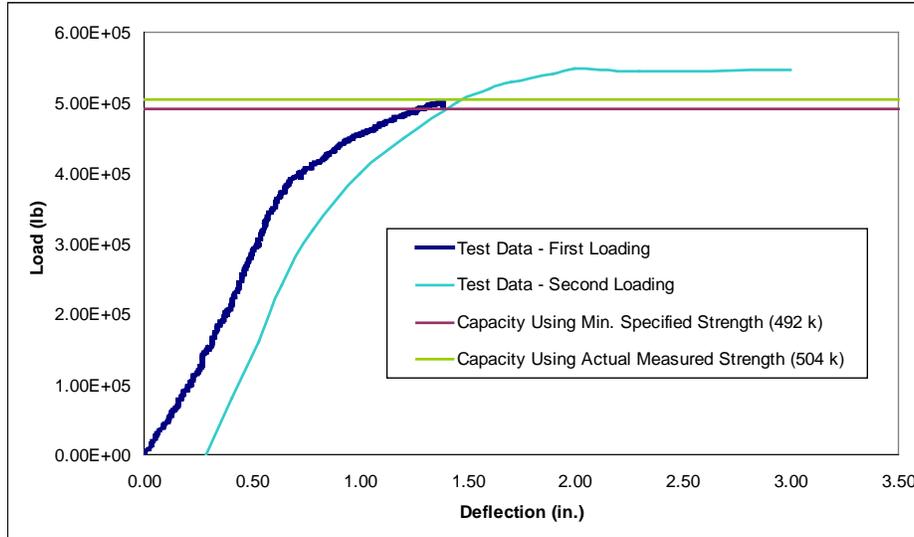
Figure C.1-14 shows the load-deflection curve of the two cycles of loading. The girder with composite topping was calculated to resist a point load of up to 504 k, located 12 ft from the end. The actual maximum load reached before failure was 546 k, 8.3% higher than the expected load. There was no reduction in strength due to the conditions at the ends. As indicated earlier, there was no visible end zone cracking due to prestress release. Whatever microcracking existed, which was not possible to measure, did not appear to have any detrimental effect on the flexural capacity of the member. The development length was not harmed by end zone cracking. Shear capacity was designed to be larger than flexural capacity of that end. Again, no indicated of any reduction in shear capacity was observed as there was no diagonal compression crushing or stirrup breakage. As indicated before, this was not a severe case specimen. It would be premature to determine at this time if web end cracking has a detrimental effect until more specimens are tested.

Figure C.1-14. Load deflection curve – first and second cycles of loading

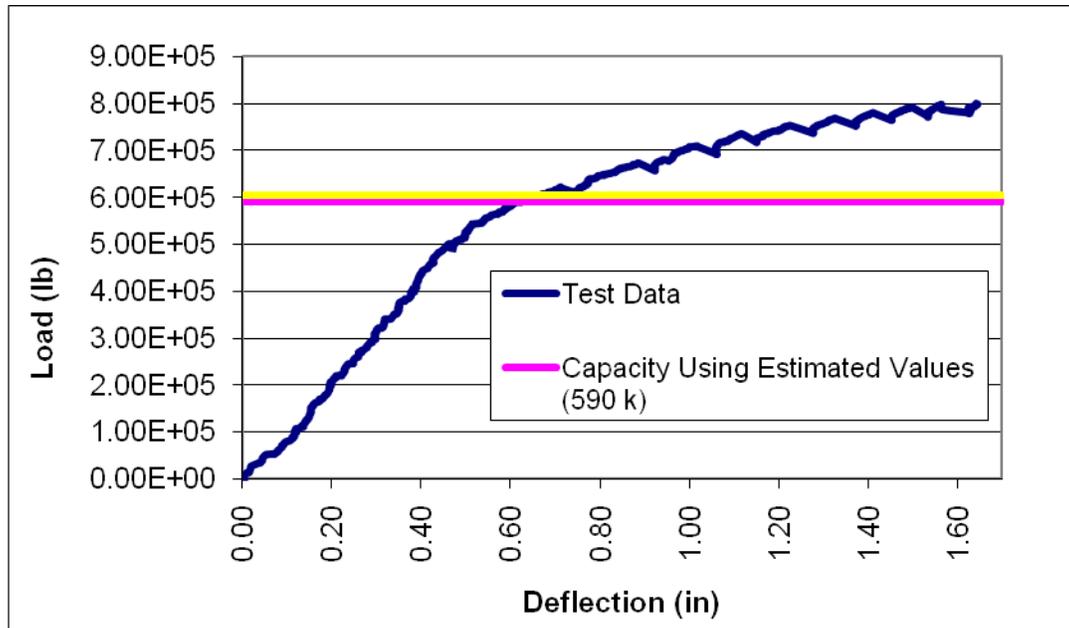
Figure C.1-19. shows the load-deflection curve of End TN2R. The girder with composite topping was calculated to resist a point load of up to 604 kips, located 12 ft from the end. The actual maximum load reached before failure when the loading had to be stopped was 800 kips.

Figure C.1-19. Load deflection curve

The point of loading where the Load Deflection curve first attempted to level out was at 630 kips. This is still 4.3% higher than the expected load. This shows that there was no reduction in strength due to the conditions at the ends. As indicated earlier, there was no visible end zone

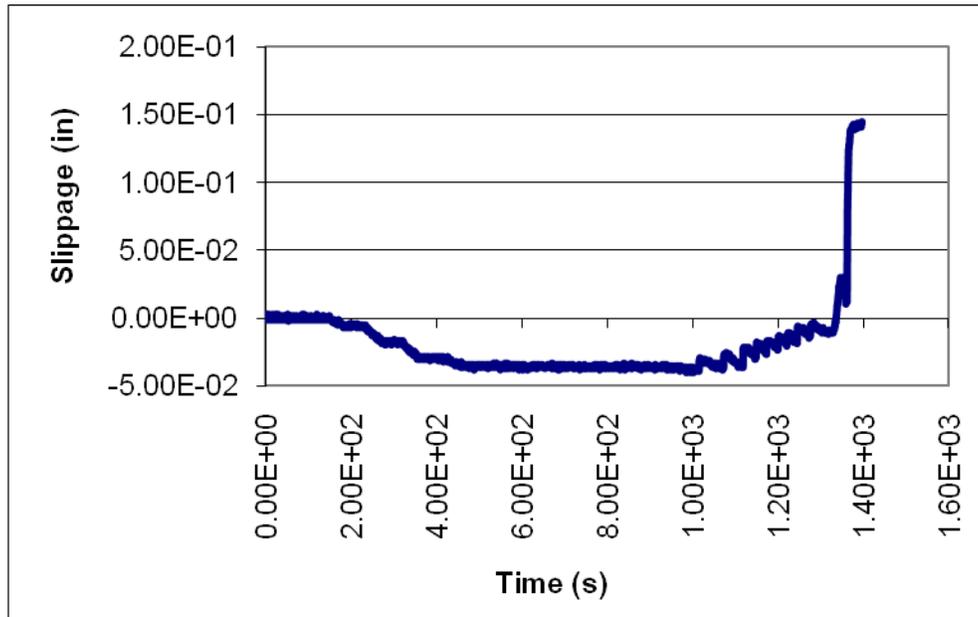
cracking due to prestress release. Whatever microcracking existed, which was not possible to measure, did not appear to have any detrimental effect on the flexural capacity of the member. No indicated of any reduction in shear capacity was observed as there was no diagonal compression crushing or stirrup breakage. [Figure C.1-20](#) shows the strand slippage with time. The curve shows that no noticeable slippage occurred until the load reaches the 800-kip level. This shows that the strands were in full bondage with the concrete up to the 800-kip load level.

[Figure C.1-20. Strand slippage vs. time curve](#)

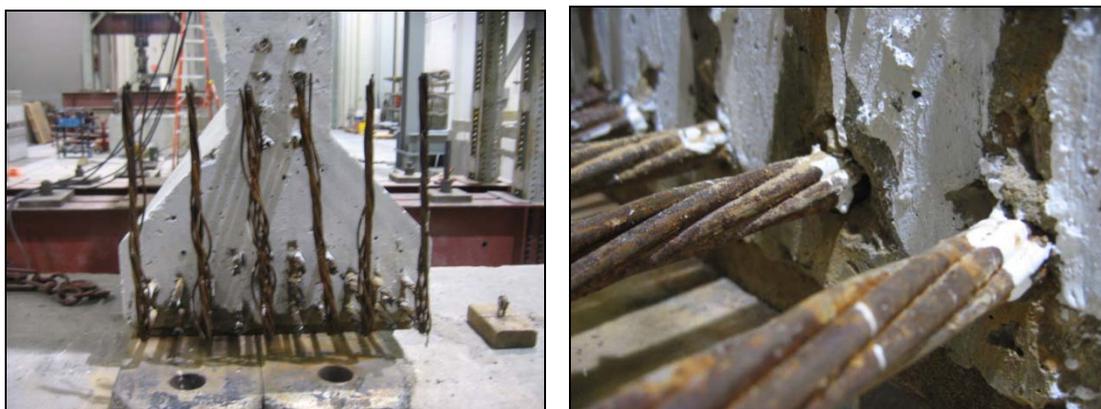
Cracking patterns that appeared were consistent with a classical flexural failure. The beam was designed to fail in flexure, and this appeared to be the primary cause of failure. Some strand slippage, or bond failure was also apparent in the testing. Some of the strands sticking out of the ends slightly rotated in the direction of the twisted wires as they slipped into the girder. Upon closer inspection, one could also see that the strands had recessed into the face of the girder. [Figure C.1-24](#) and [Figure C.1-25](#) show slippage of the strands as the girders were tested. The strand on the East side of the lab slipped 0.39 inches while the strand on the West side of the lab slipped 0.50 inches. [Figure C.1-26](#) shows the load-deflection curve of End TN1R, and [Figure C.1-27](#) shows the slippage of the East and West strands.

[Figure C.1-25](#). Evidence of strand slippage

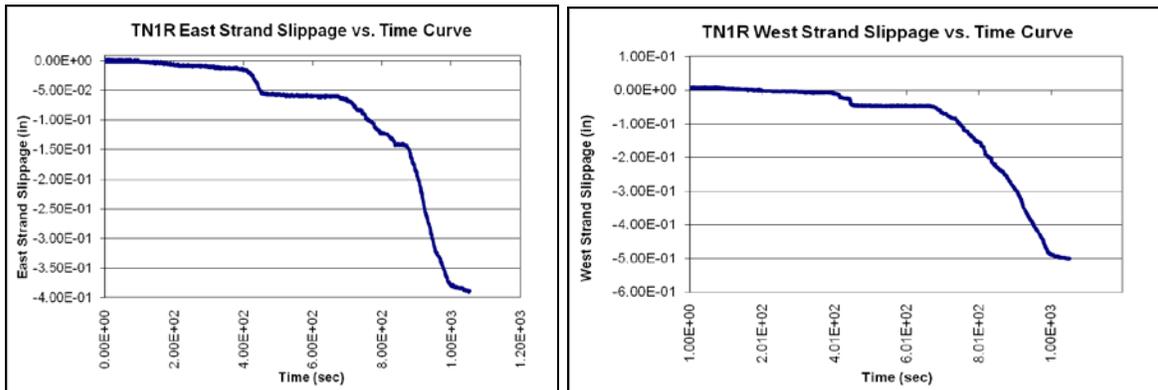
Figure C.1-27. Strand slippage vs. time curve for the East and West strands

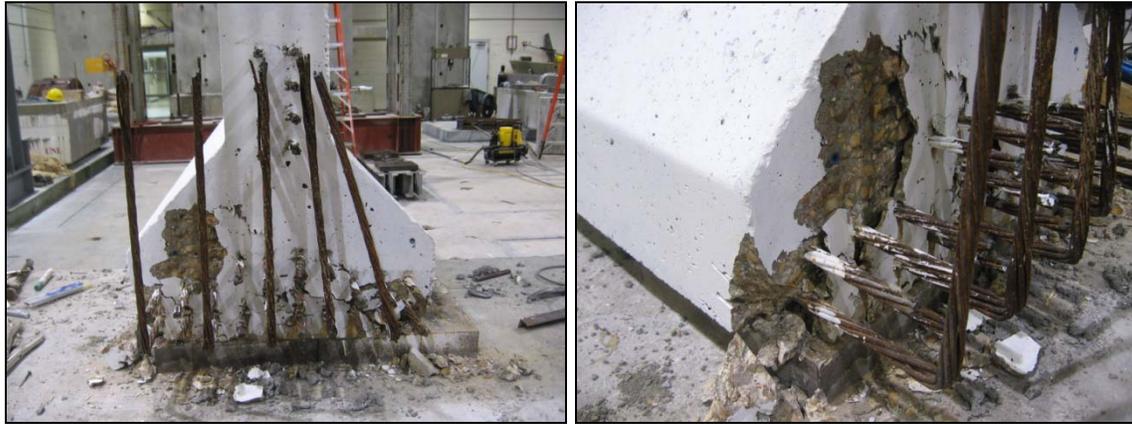
Figure C.1-30. Evidence of strand slippage

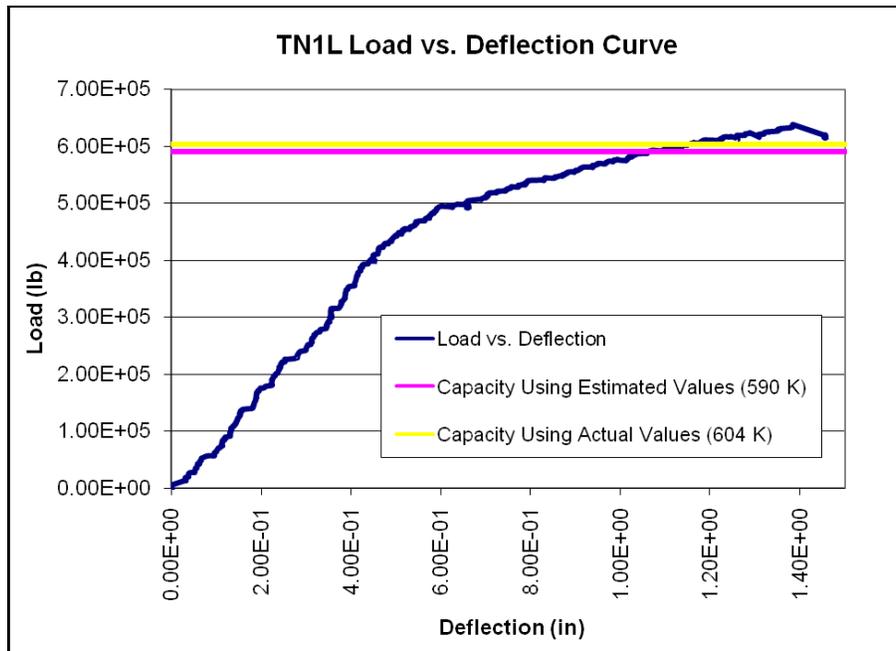
Figure C.1-33 shows the load-deflection curve of End TN1L. The girder with composite topping was calculated to resist a point load of up to 604 kips, located 12 ft from the end. The actual maximum load reached before failure was 604 kips, 2.4% higher than the expected load, as shown in Table C.1-6. There was no reduction in strength due to the conditions at the ends. As indicated earlier, there was no visible end zone cracking due to prestress release. Whatever microcracking existed, which was not possible to measure, did not appear to have any detrimental effect on the flexural capacity of the member. The development length was not harmed by end zone cracking. Shear capacity was designed to be larger than flexural capacity of that end. Again, no indicated of any reduction in shear capacity was observed as there was no diagonal compression crushing or stirrup breakage.

Figure C.1-33. Load deflection curve

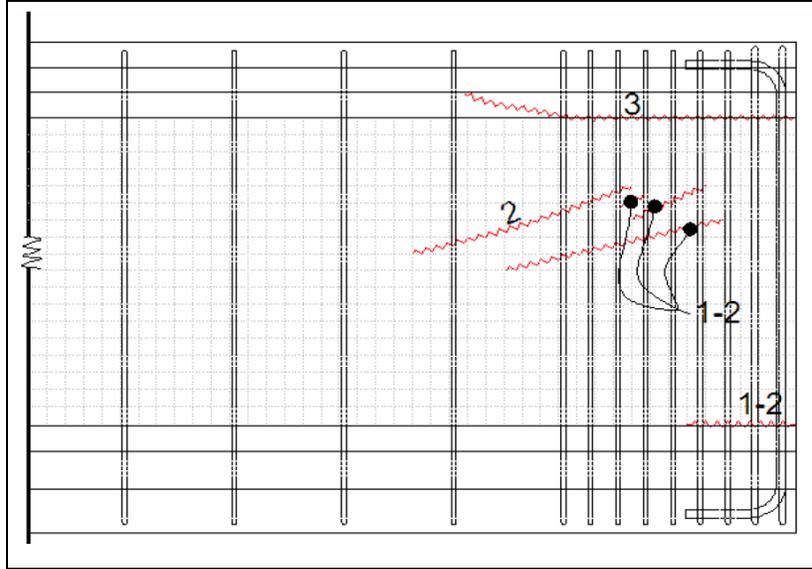
On the girders with special end zone reinforcement, cracking still occurred, but much of it was only visible beyond the end reinforcement zone. Girder WA1 on the side designed with LRFD experienced cracks in the range of 0.001 to 0.005 inches, and extended a maximum of 38 inches into the girder. Girder WA1 on the side designed with the details proposed by the project, experienced cracks in the range of 0.001 to 0.003 inches, and extended a maximum of 40 inches into the girder. On both ends of Girder WA1, the cracking did not start until a distance of a few inches into the girder. This may indicate a concentration of end reinforcement is effective in controlling the end cracks, but the reinforcement should be gradually diminished as it is distributed into the beam. The 38-40 in. cracking length is about  $\frac{3}{4}$  of the total depth of 58 in. [Figures C.2-7 to C.2-10](#) shows the end zone cracking of the WA State specimens just after release of the strands.

Figure C.2-7. End Zone Cracking of WA1L (WA1 M.E.) (Note: the cracks are shown highlighted in red. The value next to each crack is the crack width in thousands of an inch)

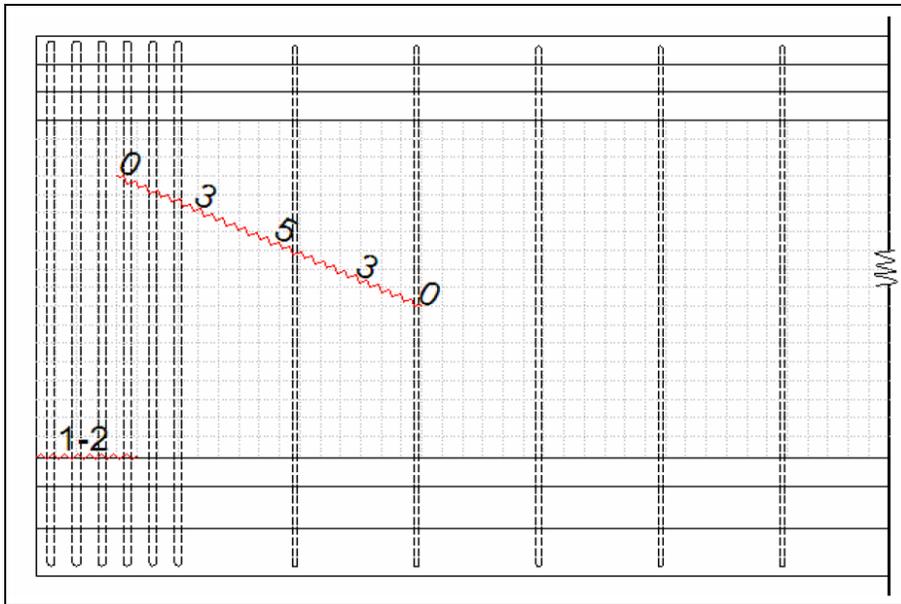
Figure C.2-8. End Zone Cracking of WA1R (WA1 U.M.E.) - LRFD Design (Note: the cracks are shown highlighted in red. The value next to each crack is the crack width in thousands of an inch)

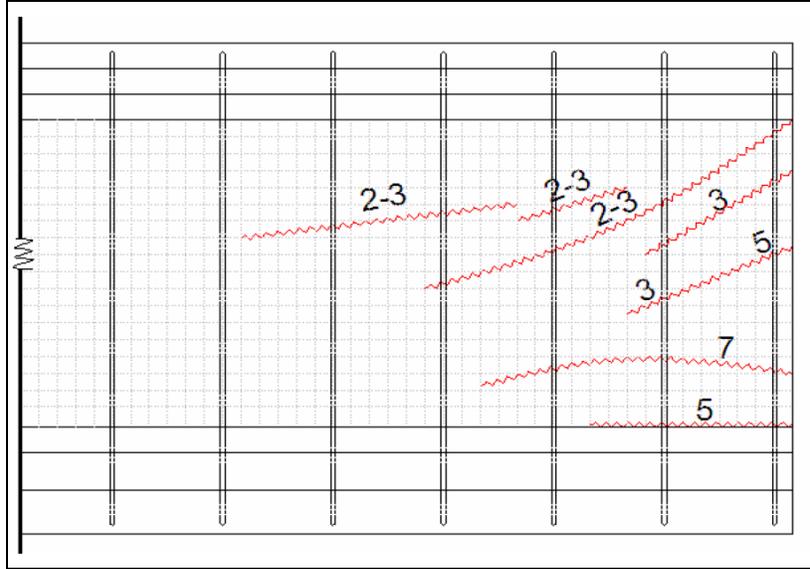
Once the concrete strength surpassed 5,800 psi, the forms were removed and the detensioning process began. While removing the forms, one form caught the upper flange on a corner of End WA2L (WA2 UME), causing a crack at the base of the flange. This crack was present before the detensioning process began, and grew in width as the strands were released. At CTC, the prestressed strands were completely jacked down, and were only cut once the tension was completely released. The detensioning process occurred in stages. First the strands in the top of the girder were partially jacked down, then the strands in the bottom half of the girder had half of the tension released. The process was repeated, fully detensioning the top strands, then fully detensioning the bottom strands. As soon as the forms were removed, cracks were apparent on all ends.

Figure C.2-9. End Zone Cracking of WA2L (WA2 M.E.) - no end reinforcement (Note: the cracks are shown highlighted in red. The value next to each crack is the crack width in thousands of an inch)

End WA2L was epoxy injected on the morning of Wednesday, April 16th. This was the marked end of the girder without any additional end zone reinforcement. The end experienced cracking to a lesser degree than the unmarked end of WA2R. The epoxy injection was done by Pete Barlow of Contech without any noted complications.

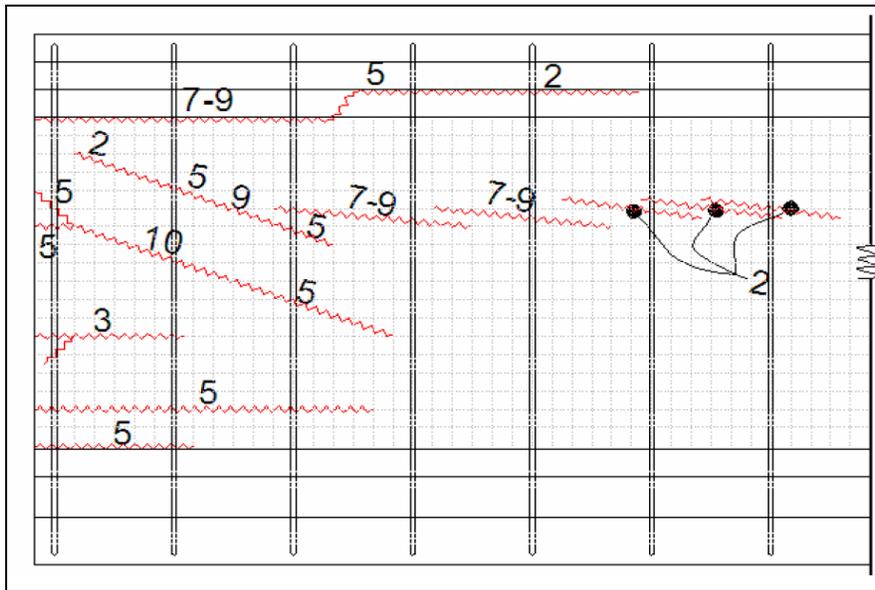
All ends experienced some end zone cracking. The cracking in Girder WA2, without extra end zone reinforcement, was much more prevalent than the cracking in Girder WA1, with extra end zone reinforcement. Girder WA2 experienced cracking in the range of 0.004 inches to 0.014 inches, with the longest crack extending 83 inches into the girder. A more comprehensive summary of the cracks is shown in the following figures.

Figure C.2-10. End Zone Cracking of WA2R (WA2 U.M.E.) - no end reinforcement (Note: the cracks are shown highlighted in red. The value next to each crack is the crack width in thousands of an inch)

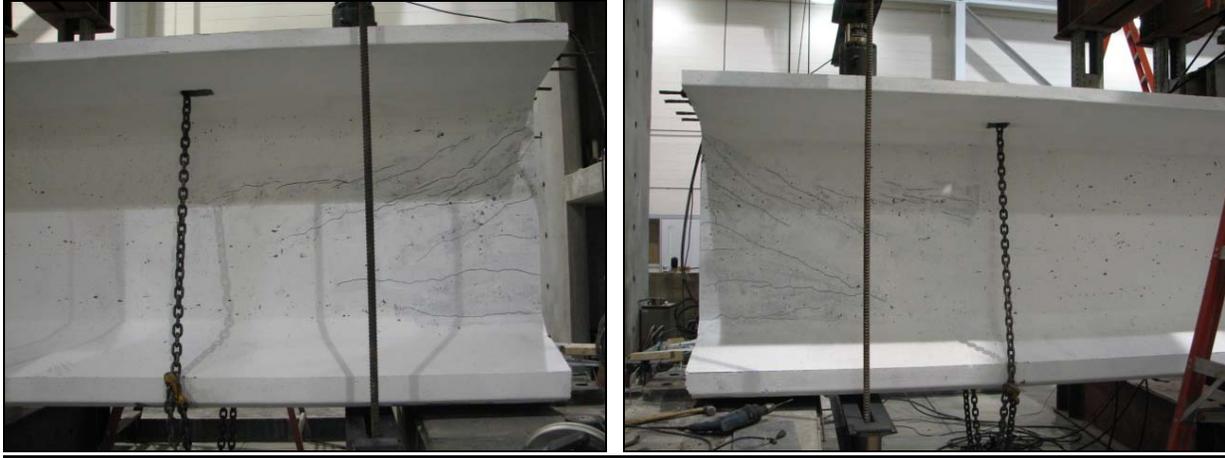
Figure C.2-16. End zone cracks before testing

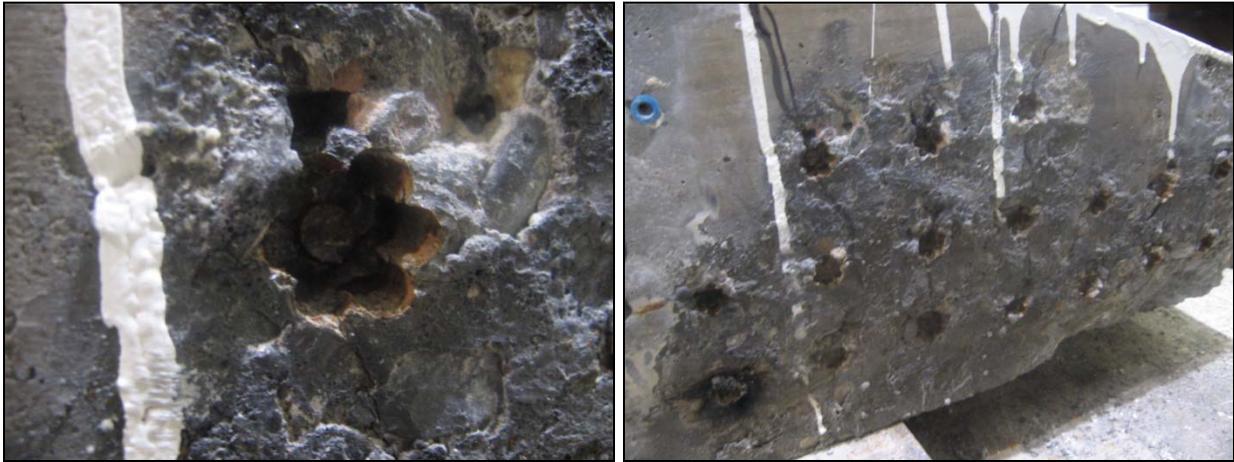
in Nebraska accentuated this flush surface by grinding down the jagged edges of the strands so that they were flat and even with the girder edge. Manual measurement of the slippage with a ruler showed that the strands slipped somewhere between 1/8 in. and 1/4 in. (0.125-0.25 in.) According to the slippage gauges, the East strand on the outer edge of the flange had a slippage of 0.340 in. at failure.(Figure C.2-20) The West strand located towards the centerline of the girder had a slippage of 0.207 in. at failure.(Figure C.2-21) This strand slippage would have affected the capacity of the girder. The failure load would have been higher if no strand slippage had occurred. Therefore, it can be deduced that in an ideal situation with improved end anchorage conditions, the girder would have performed even better than the test showed with a higher load capacity.

Figure C.2-19. Evidence of Strand Slippage

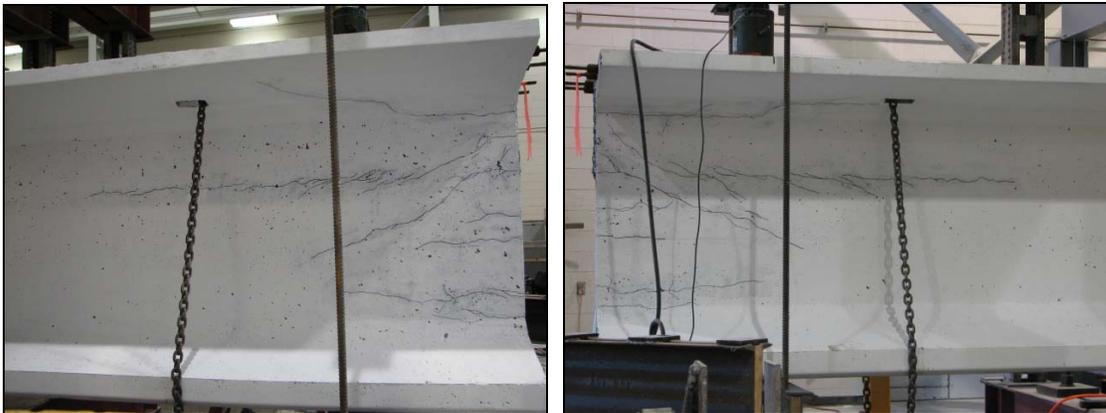
Figure C.2-23. End zone cracks before testing

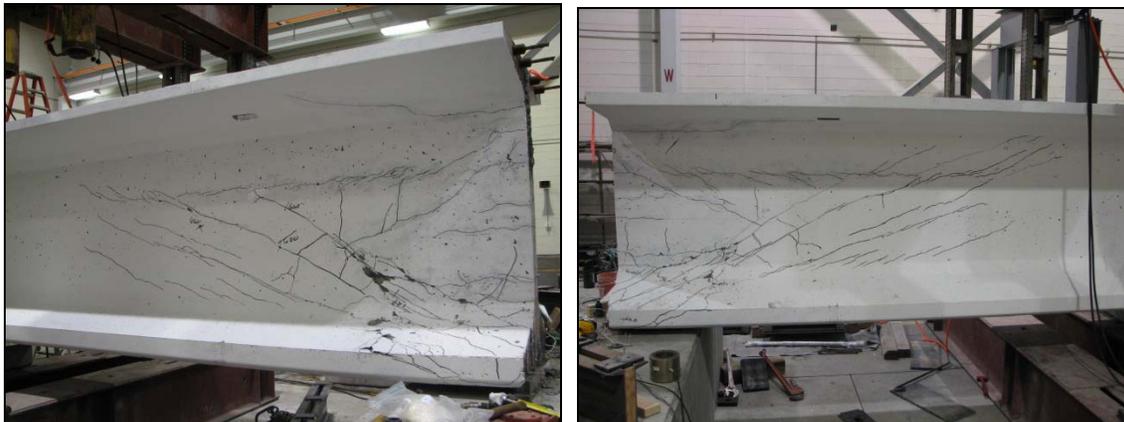
Load was slowly applied to the system in intervals of 100k. After each additional 100k, the loading was paused so that the girder could be investigated and marked for cracks. This continued until it began to approach the design load and it became not longer safe to approach the beam. After this time, loading continued until failure. The highest load reached was 749.8 k. This load produced a deflection of 0.783 in. After failure, the beam was unloaded, leaving a permanent plastic deformation of 0.426 in. at the location of loading. Figures D.2.1-25 and C.2-26 show the typical shear crack patterns after failure.

Figure C.2-25. End WA2R after shear failure

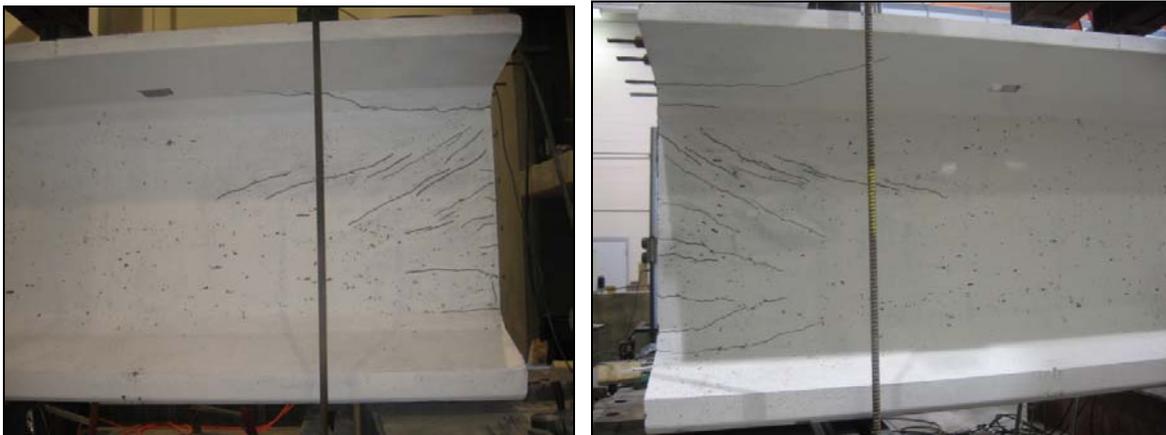
Figure C.2-32. End zone cracks before testing

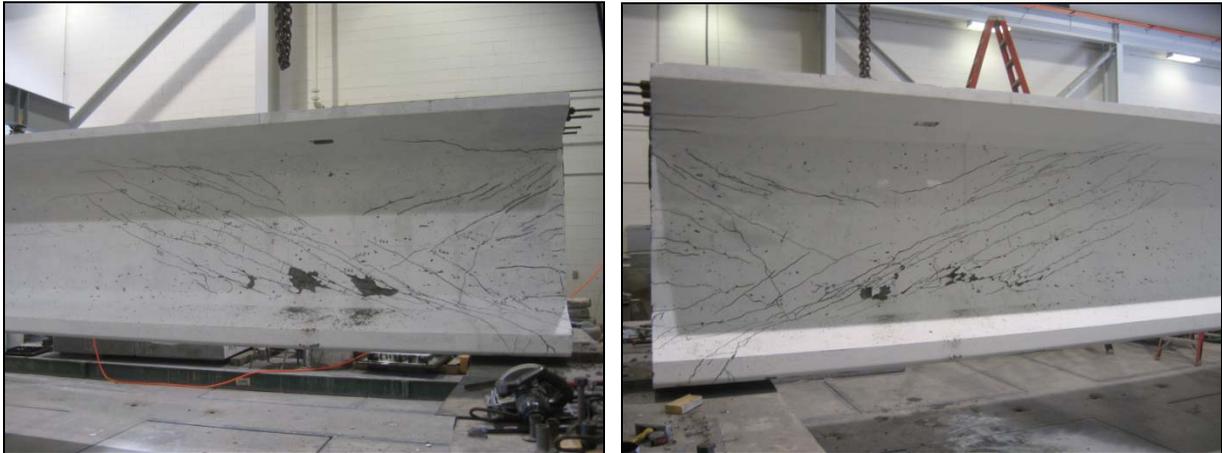
Figure C.2-33. End WA1L after shear failure

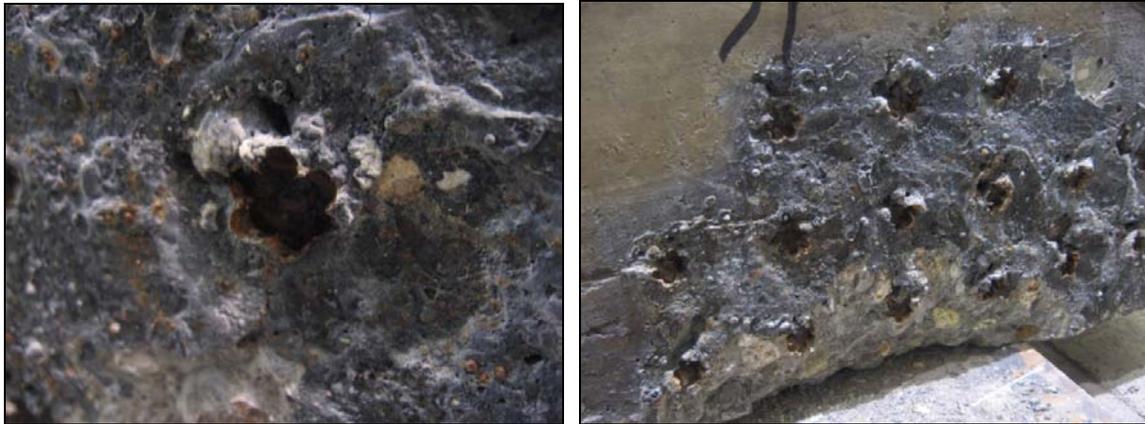
This strand slippage would have affected the capacity of the girder. The failure load would have been higher if no strand slippage had occurred. Therefore, it can be deduced that in an ideal situation with improved end anchorage conditions, the girder would have performed even better than the test showed with a higher load capacity.

Figure C.2-35. Evidence of Strand Slippage

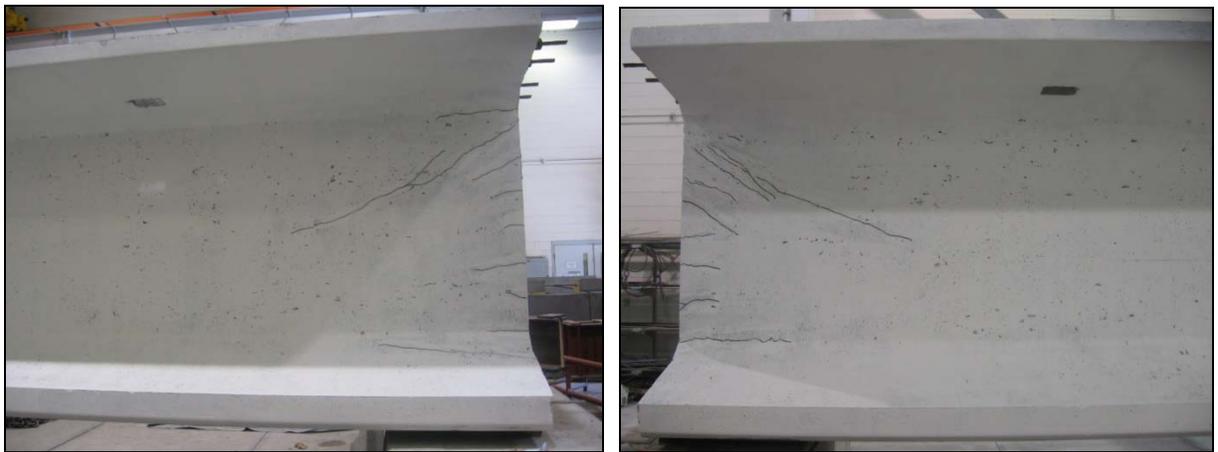
Figure C.2-37. End zone cracks before testing

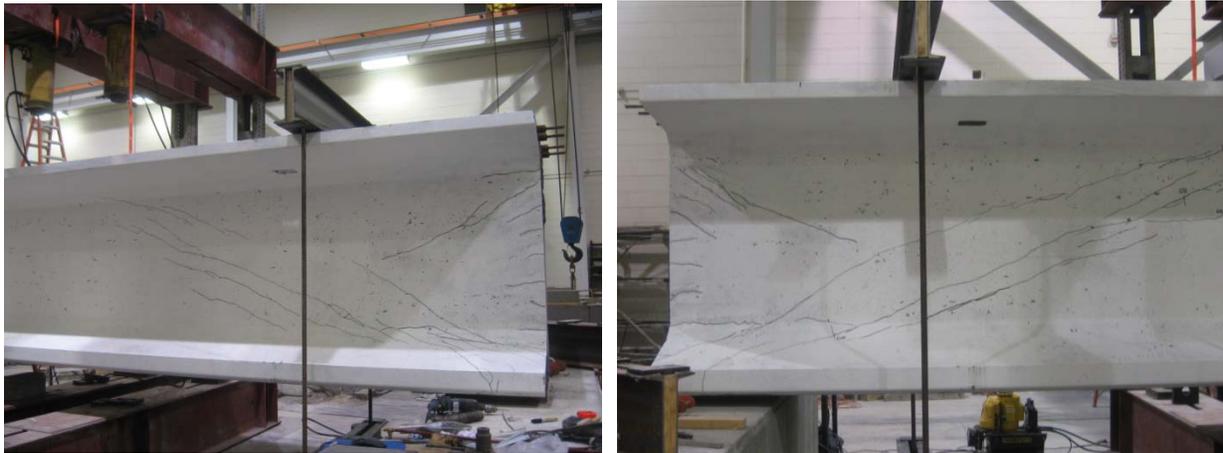
Figure C.2-38 shows the girder end after loading was stopped. From the data recorded up to that point, a load vs. deflection graph was still able to be produced, as shown in Figure C.2-39. Regardless of the actual capacity of the girder, since it reached 800 k it was still far over the calculated capacity. At 800 k when the test was stopped, the deflection read 0.629 in. After the girder was unloaded, a permanent plastic deformation of 0.19 in. remained at the location of loading.

Figure C.2-38. End WA2R after loading was stopped

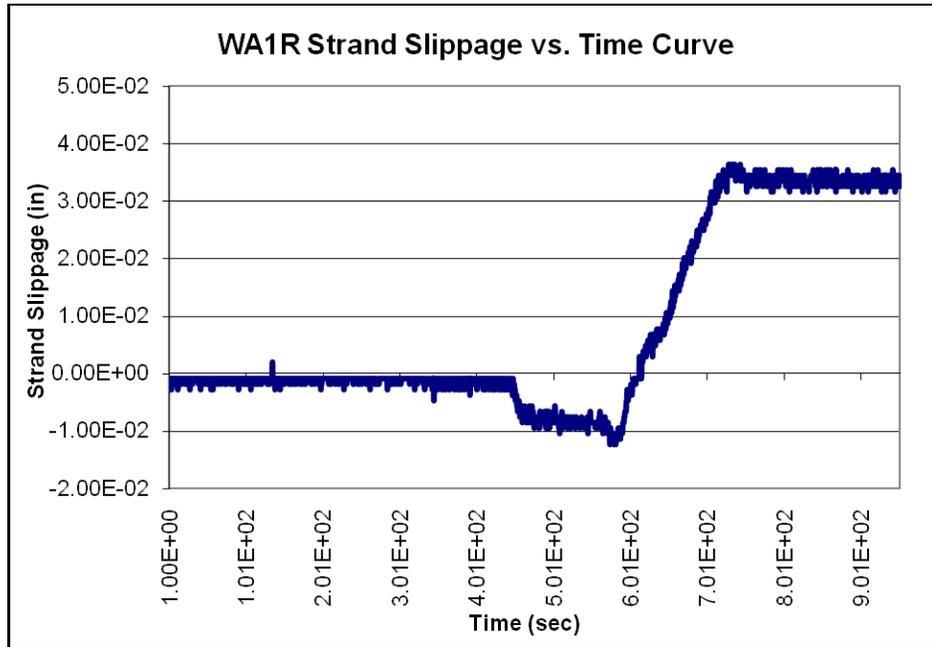
At the end of testing, the slippage gauges showed a reading that the strand had slipped 0.033 in. (Figure C.2-41) This strand slippage would have affected the capacity of the girder. The failure load would have been higher if no strand slippage had occurred. Therefore, it can be deduced that in an ideal situation with improved end anchorage conditions, the girder would have performed even better than the test showed with a higher load capacity.

Figure C.2-41. Strand Slippage on the Exterior Strand

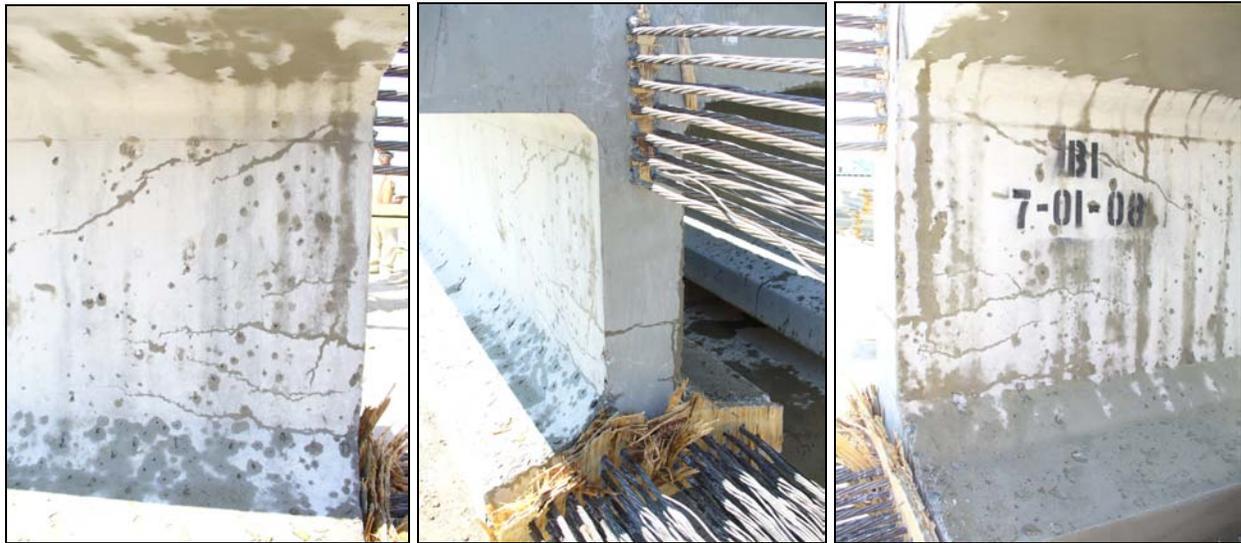
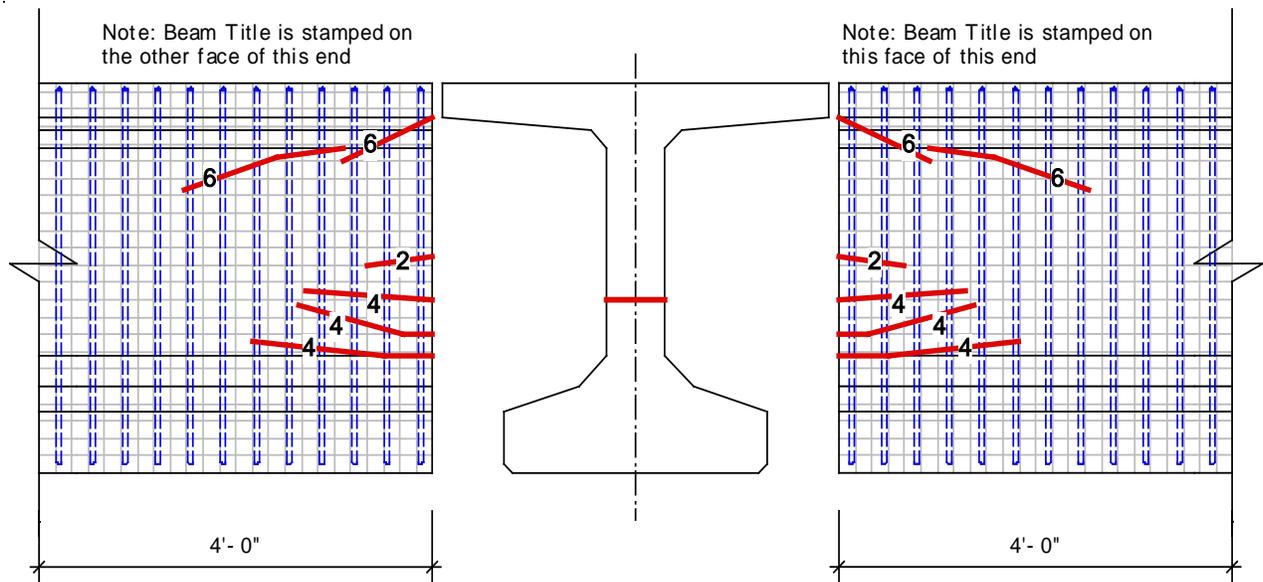
The two 42-ft long girders were fabricated by *Bayshore Concrete Products*, Cape Charles, Virginia, on July 1, 2008. A member of the research team visited the precast plant two times: (1) before the concrete was cast to check the reinforcement layout, and (2) immediately after the strands were released to document the end zone cracking. [Figures C.3-5 to C.3-8](#) show the end zone cracks detected after the prestress release.

Figure C.3-5. VA1R crack pattern (crack size in thousands of an inch)

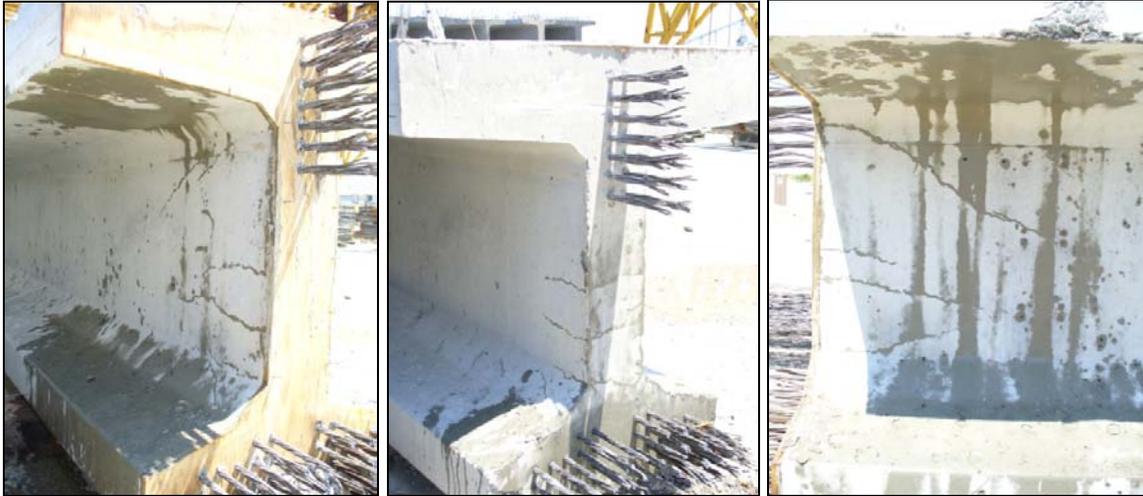
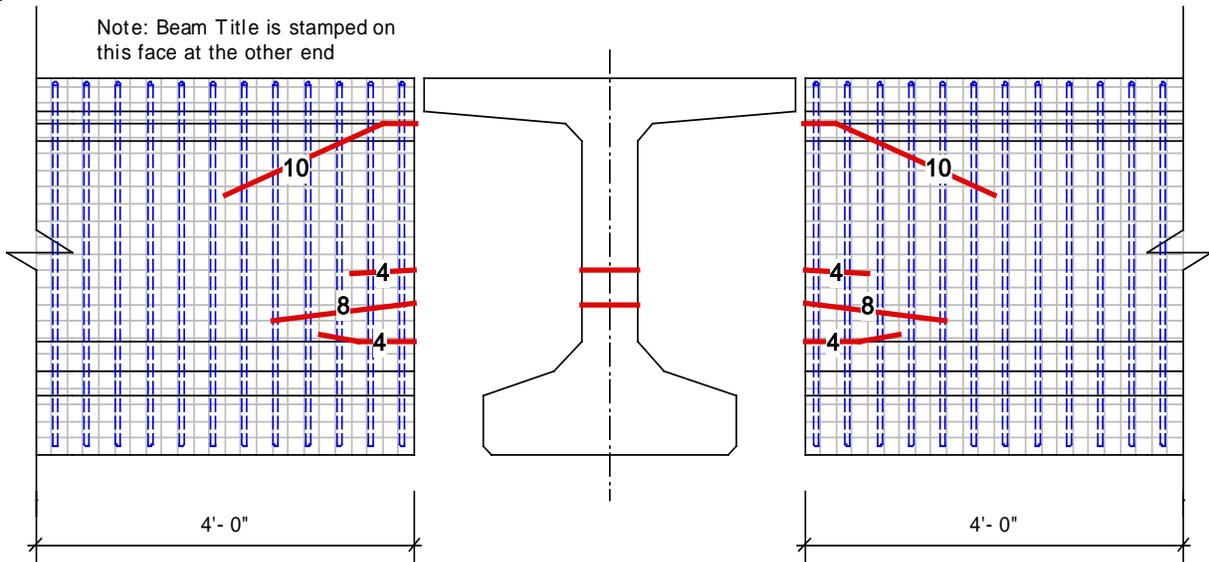
Figure C.3-6. VAIL crack pattern (crack size in thousands of an inch)

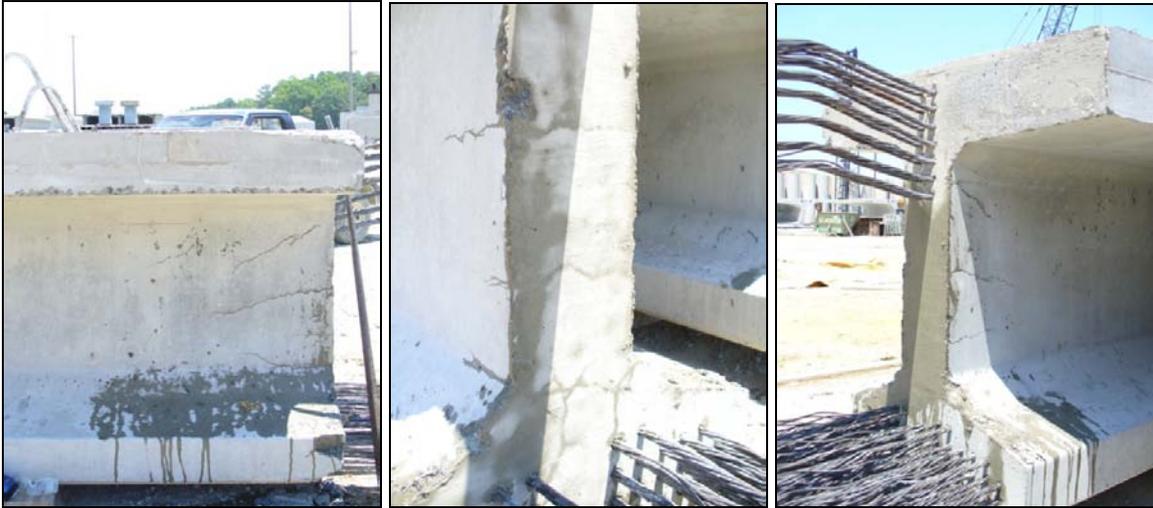
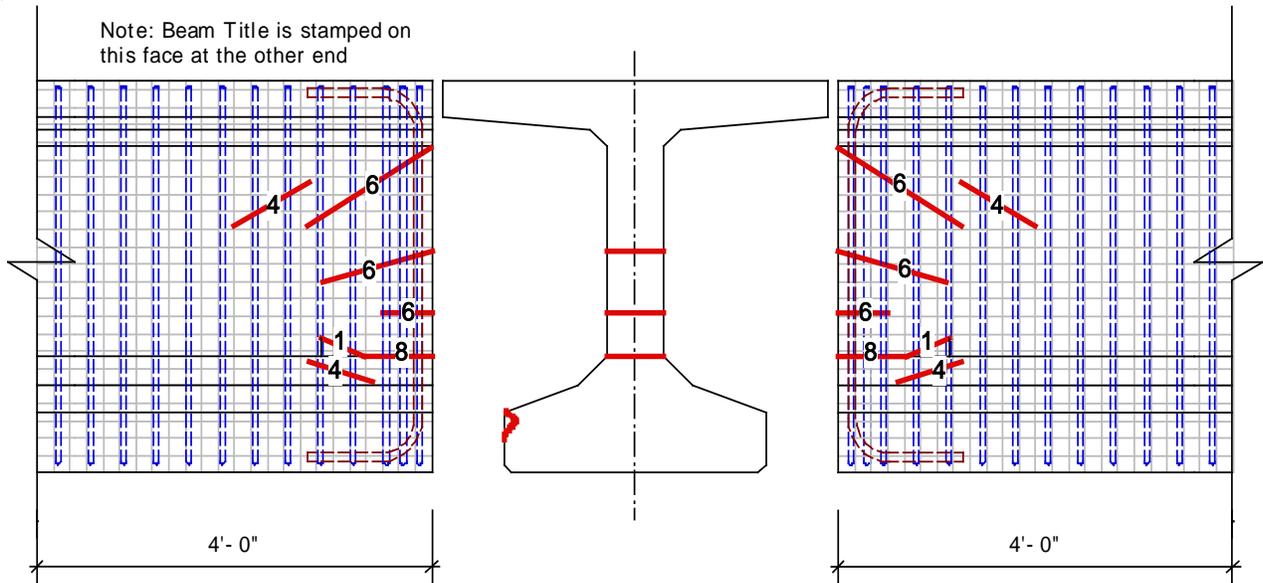
Figure C.3-7. VA2R crack pattern (crack size in thousands of an inch)

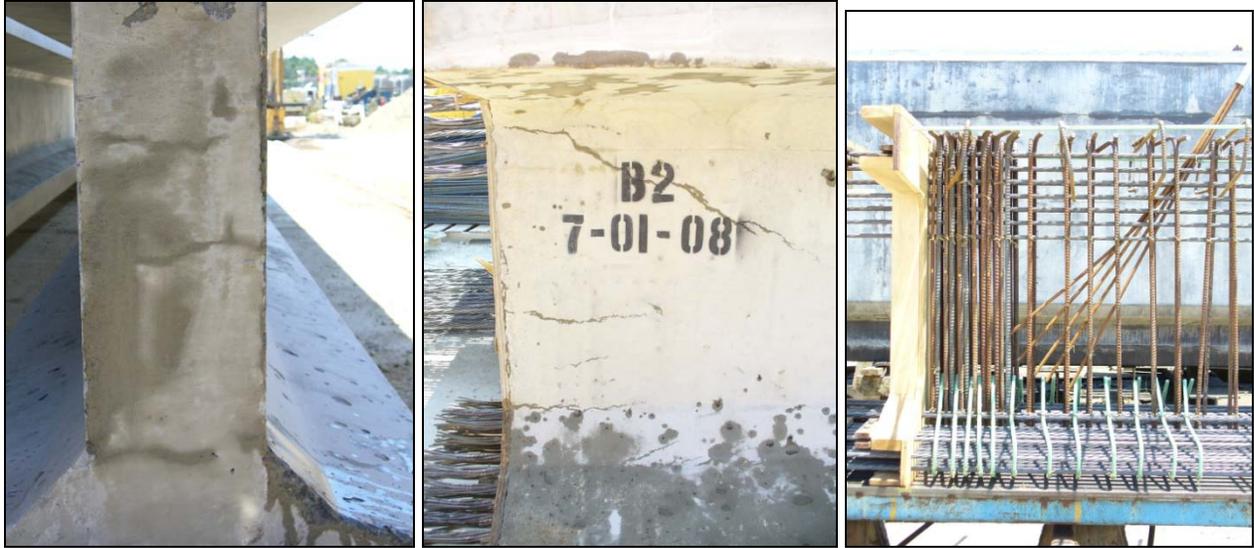
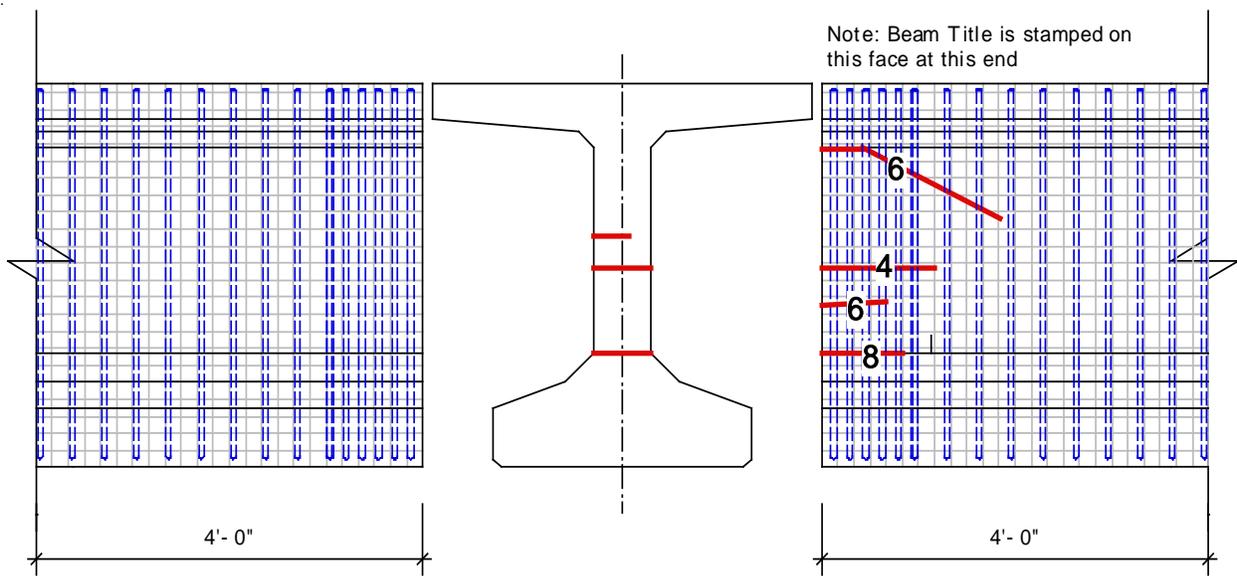
Figure C.3-8. VA2L crack pattern (crack size in thousands of an inch)

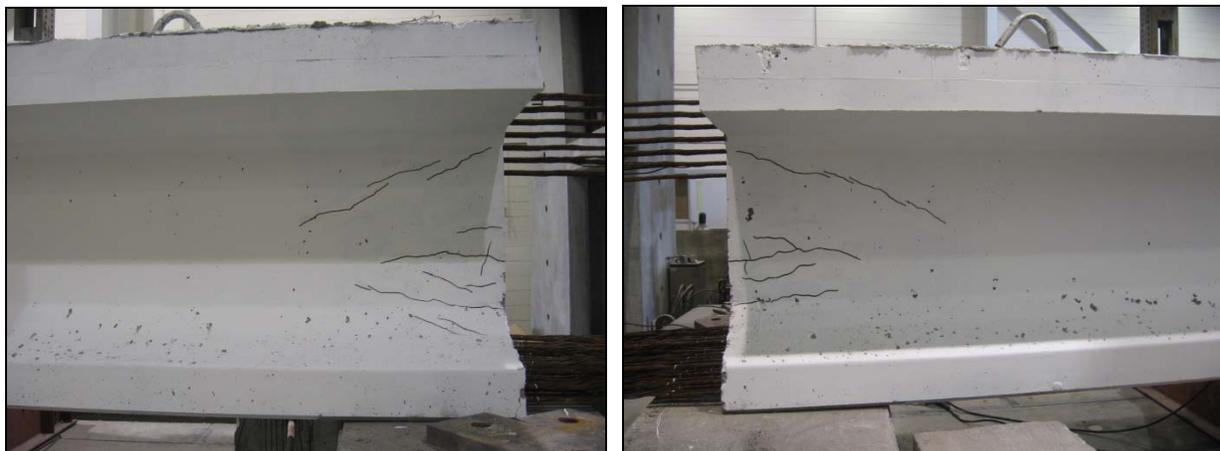
Figure C.3-11. End zone cracks before testing

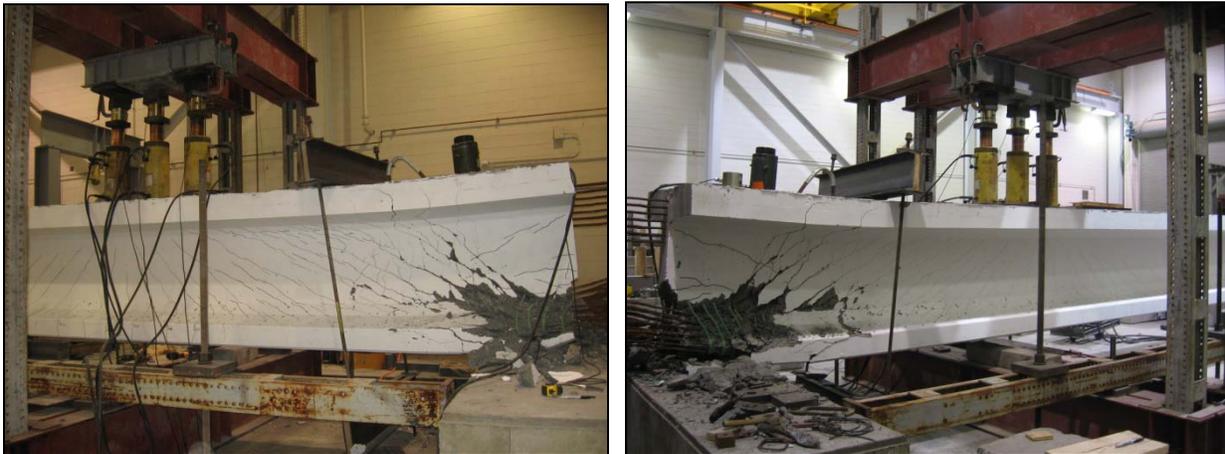
Load was slowly applied to the system in intervals of 100k. After each additional 100k, the loading was paused so that the girder could be investigated and marked for cracks. This continued until it began to approach the design load. At this point, loading continued until failure. This end of the girder was designed for flexural failure. However, in this case, the failure that occurred was bearing failure at 897 k. The girder was supported on a steel base that was 12 inches in the direction of the girder length, and 16 inches in the direction of the girder width. This was not enough bearing to support the girder under this loading. Therefore, at failure the concrete around the support crumbled and burst outwards. Images of the girder after failure are shown in [Figure C.3-12](#).

Figure C.3-12. End VA1R after bearing failure

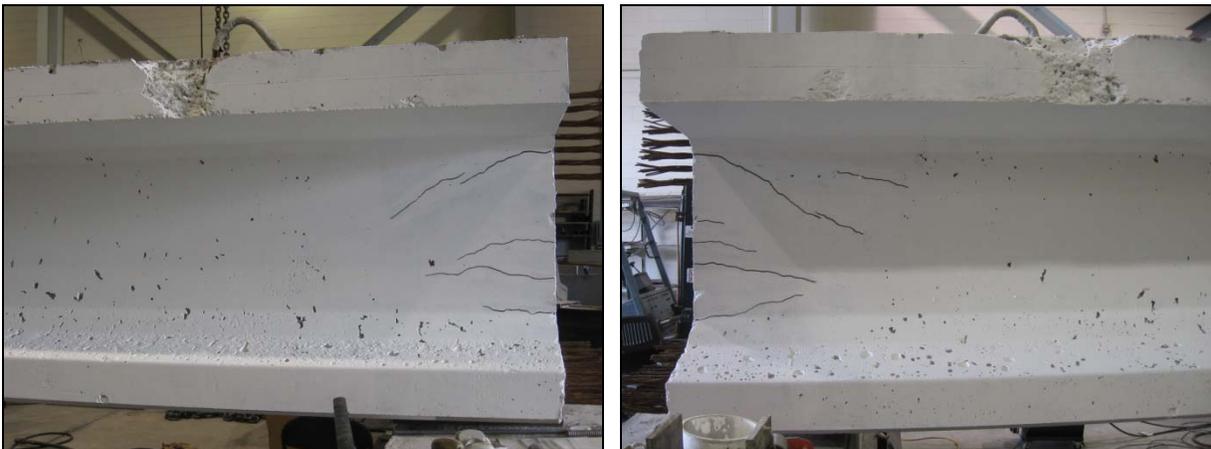
[Figure C.3-16](#). End zone cracks before testing
