**APPENDIX C**

**STRUCTURAL INVESTIGATION & FULL-SCALE GIRDER TESTING**

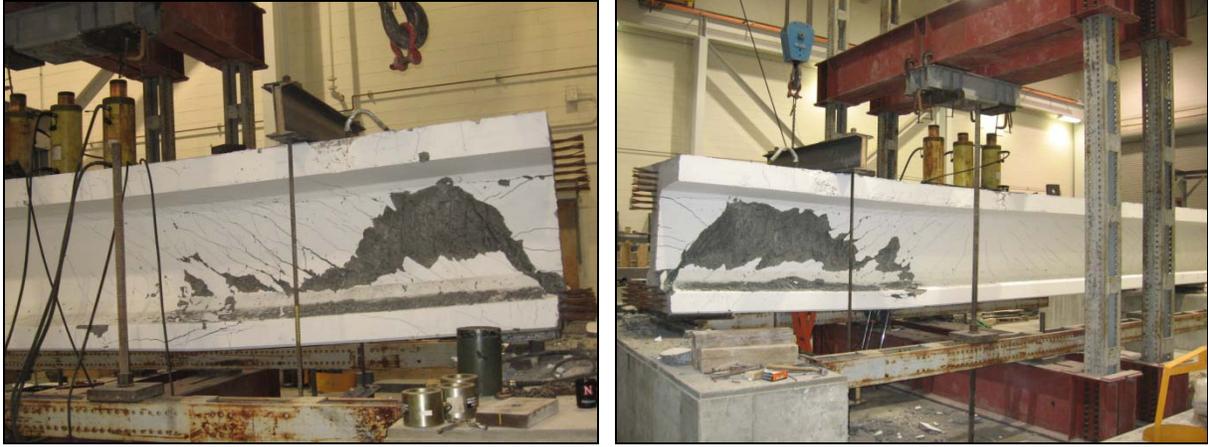
Figure C.3-19 shows the load-deflection curve of the test. The highest load reached was 1,108 k. At this point the girder failed in shear. Flexural cracks were also appearing near the girder's failure, however, the shear cracks appeared first and were much wider. At failure at the location of loading, the girder deflected 1.18 in. With the actual concrete strength of  $f'_c = 12,215$  psi, the girder was calculated to resist a point load of 1,102 k located 12 ft. away from the girder end. The failure for this case would be flexural, not shear. The capacity for this end of the girder exceeded the calculated capacity, but just by a few kips. However, the girder failed in shear when it was expected to fail in flexure. It seems that the point of flexural failure for that beam was higher than the point of shear failure. Regardless, the girder still outperformed the estimated capacity, showing that the end zone cracks were unable to lower the capacity of the girder below the expected value.

Figure C.3-17. End VA1R after shear failure

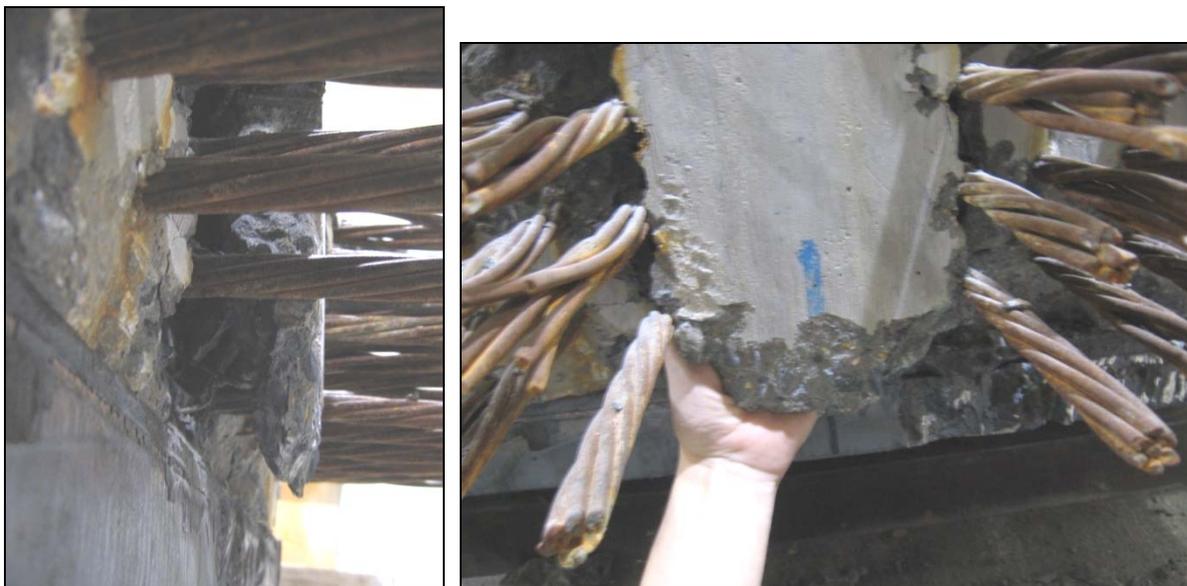
For all of the remaining three Virginia girders, it was found that during the testing the whole group of prestressing strands moved inwards toward the girder. It was not only individual strands that slipped, but the entire section of prestressing strands. This phenomenon is shown in Figure C.3-20. The midsection part of the girder remained where it originally was, while the two prestressing strand filled flanges pulled in towards the girder, bringing concrete with them. The sections moved in so far such that a space was created behind the middle section.

Figure C.3-20. Girder end showing strand bundle moved inwards

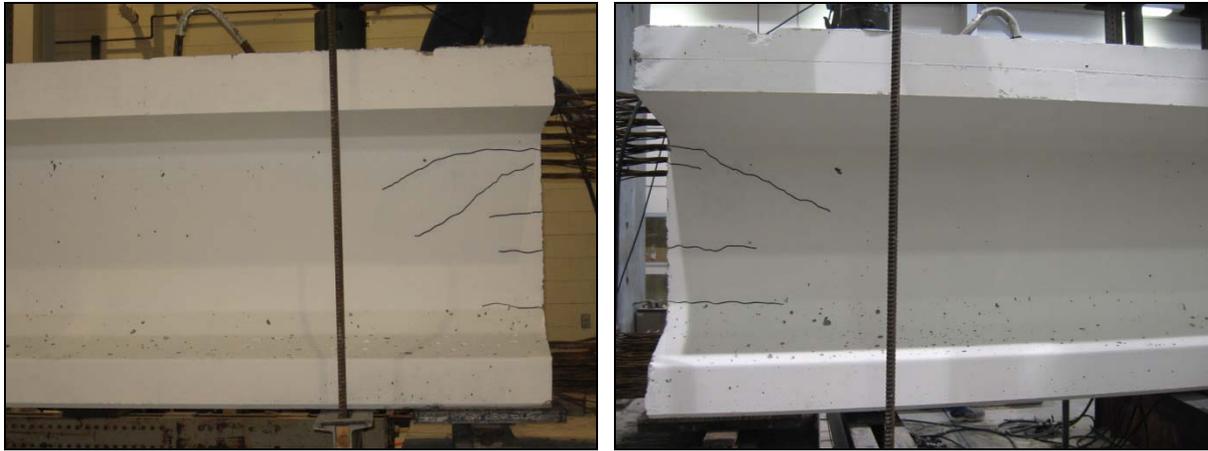
Figure C.3-22. End zone cracks before testing

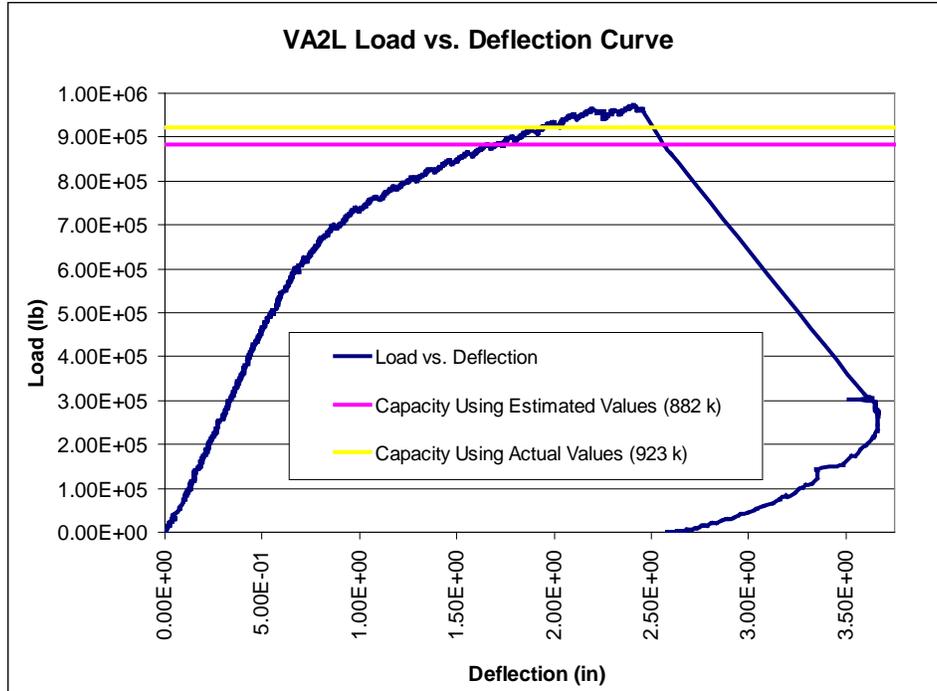
Figure C.3-23 shows the load-deflection curve of the VA2L test. The girder was calculated to resist a point load of up to 923 k, located 12 ft from the end. The actual maximum load reached before failure was 971.8 k, 5.3% higher than the expected load. Failure for the girder was both flexural and shear. Cracks consistent with shear failure appeared first and were more wide, but there was still an abundance of flexural cracks. Therefore, shear was the primary failure mode. This may skew the results in that the estimated capacity was calculated assuming flexural failure. There did not appear to be a reduction in strength due to the conditions at the ends. Even without any kind of repair at all, the girder was still able to perform above capacity when loaded in this manner.

Figure C.3-23. Load Deflection Curve for End VA2L

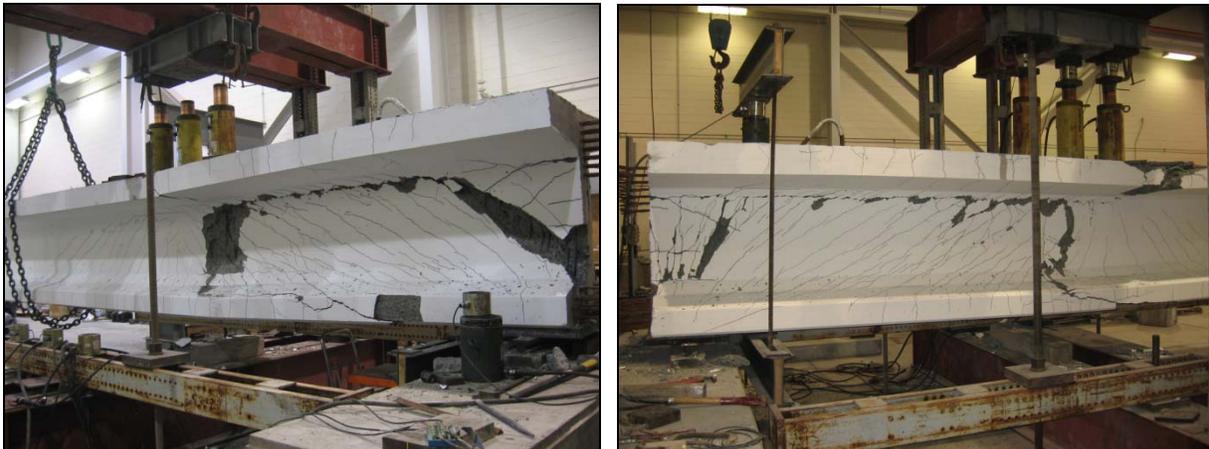
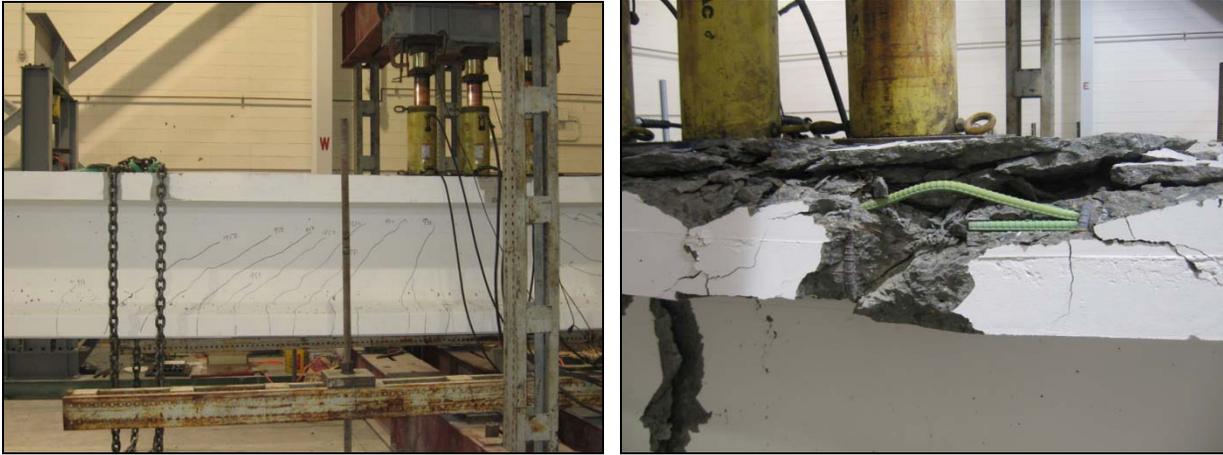
There was some evidence of strand slippage from the marked external prestressing strands. However the slip was minimal at less than ¼ in. This strand slippage would have affected the capacity of the girder. The failure load would have been higher if no strand slippage had occurred. Therefore, it can be deduced that in an ideal situation with improved end anchorage conditions, the girder would have performed even better than the test showed with a higher load capacity. Figure C.3-24 shows end VA1R after shear failure.

Figure C.3-24. End VA1R after shear failure

Figure C.3-24(cont.) End VA1R after shear failure

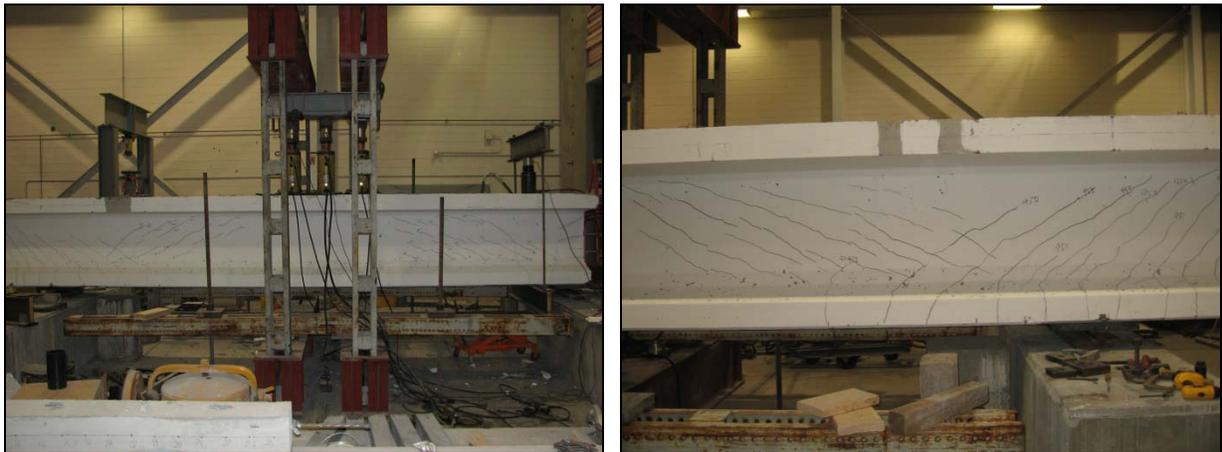
Figure C.3-26. End VA1R with signs of shear cracking

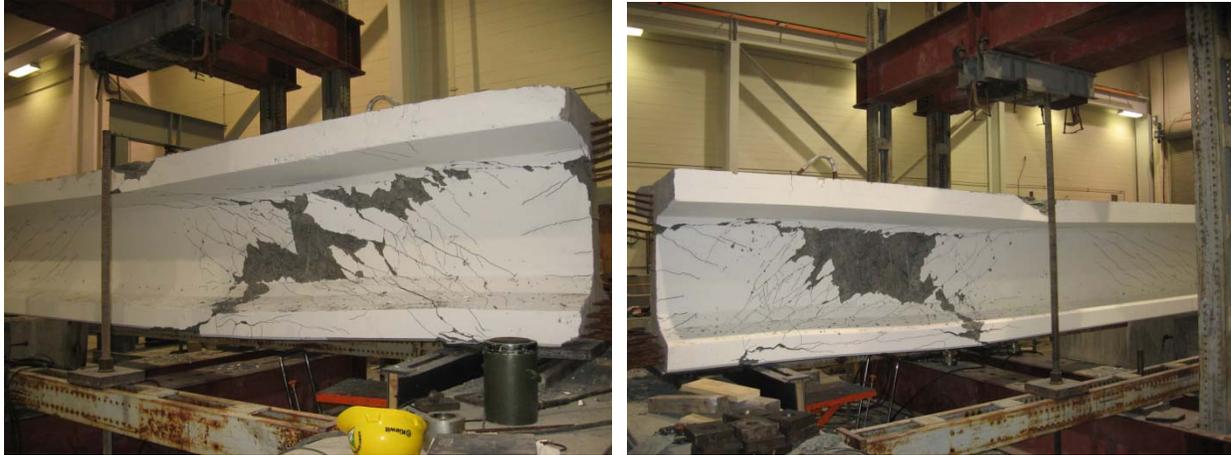
Figures C.3-26 and C.3-27 show End VA1L after failure. Figure C.3-28 shows the load-deflection curve of the test. The highest load reached was 1,199.2 k, 8.8% higher than the expected load. At this point the girder failed in shear. There were very few, very small flexural cracks. With the actual concrete strength of 12,215 psi, the girder was calculated to resist a point load of 1,102 k located 12 ft. away from the girder end. The failure for this calculation was assumed to be flexural, not shear. The capacity for this end of the girder exceeded the calculated capacity. However, the girder failed in shear when it was expected to fail in flexure, making it hard to compare the theoretical capacity with the experimental capacity. Regardless, the girder still outperformed the estimated capacity, showing that the end zone cracks were unable to lower the capacity of the girder below the calculated value.

Figure C.3-27. End VA1R after shear failure

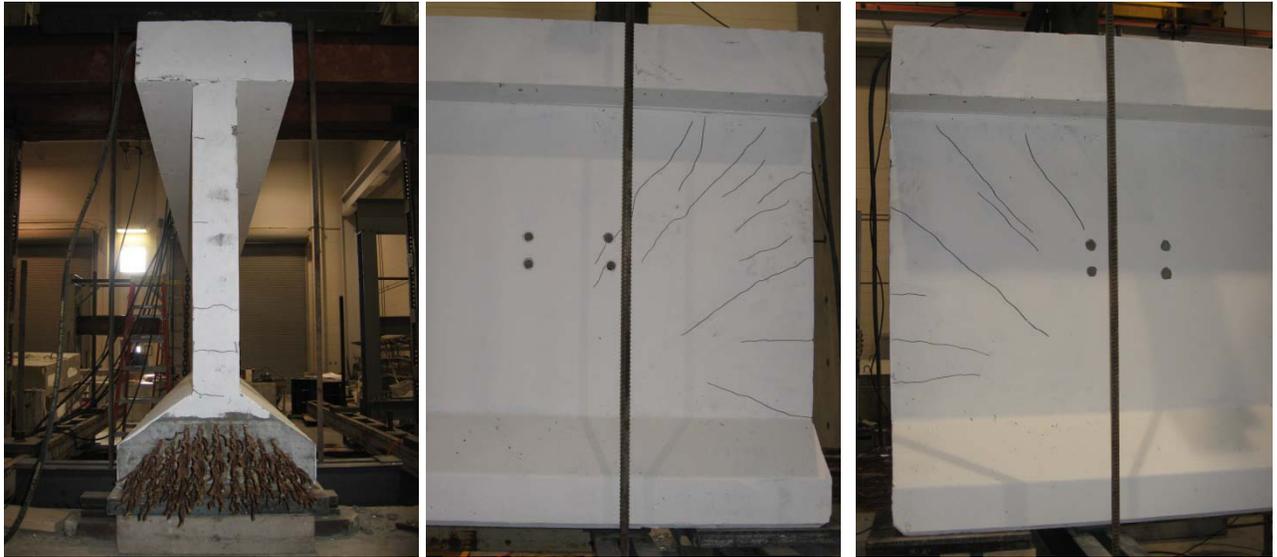
Figure C.4-12. End zone cracks before testing

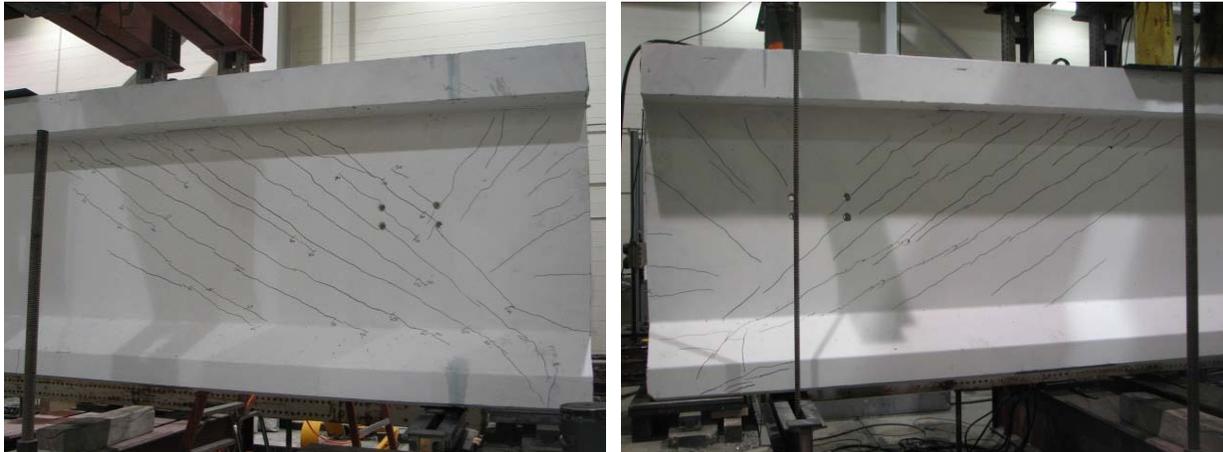
Figure C.4-13. End FL2R after loading was stopped (shear cracks)

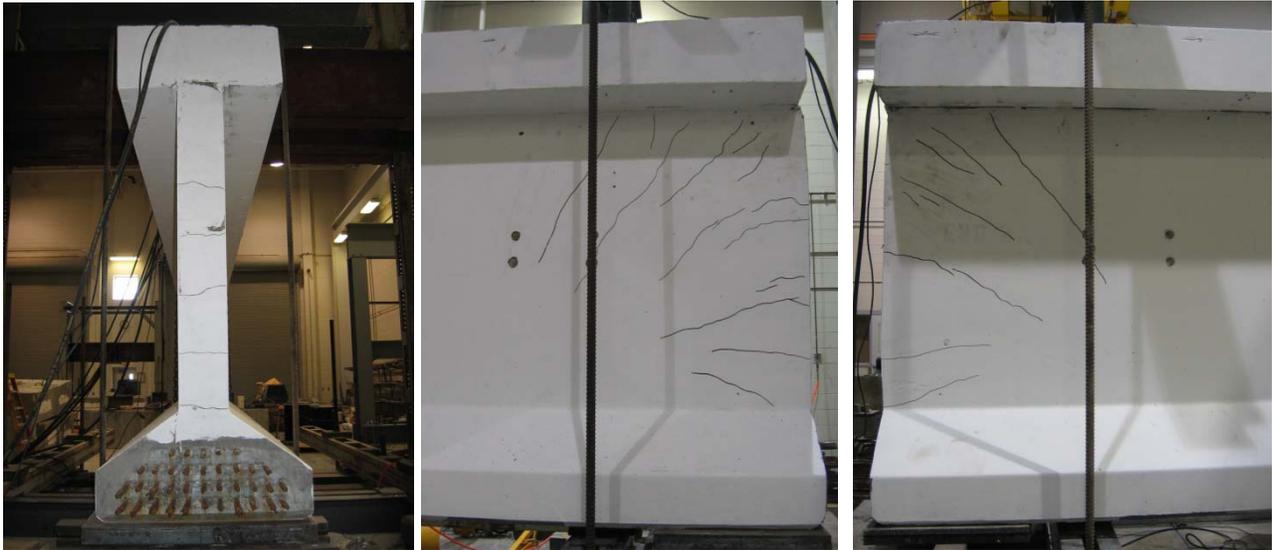
Figure C.4-16. End zone cracks before testing

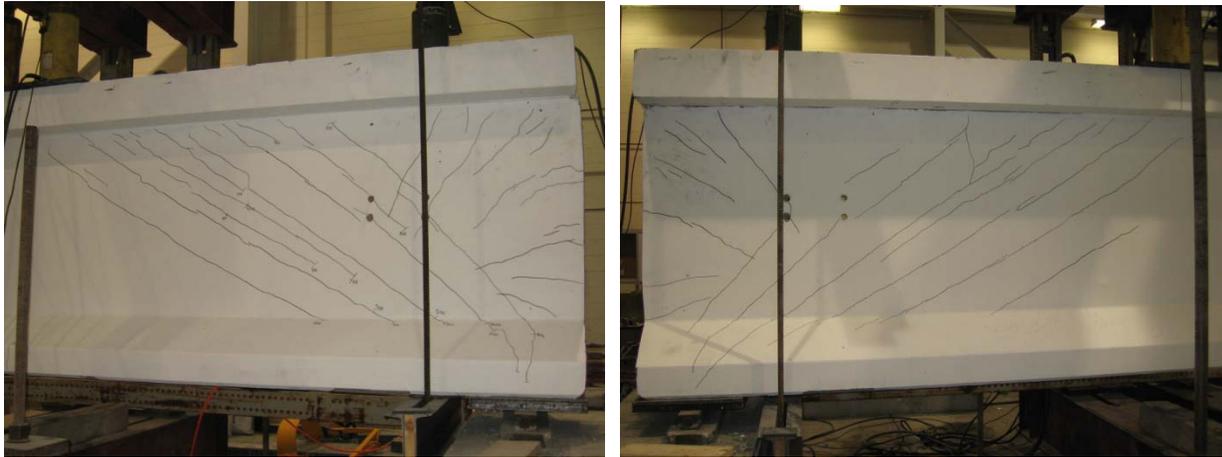
Figure C.4-17. End FL2L after loading was stopped (shear cracks)

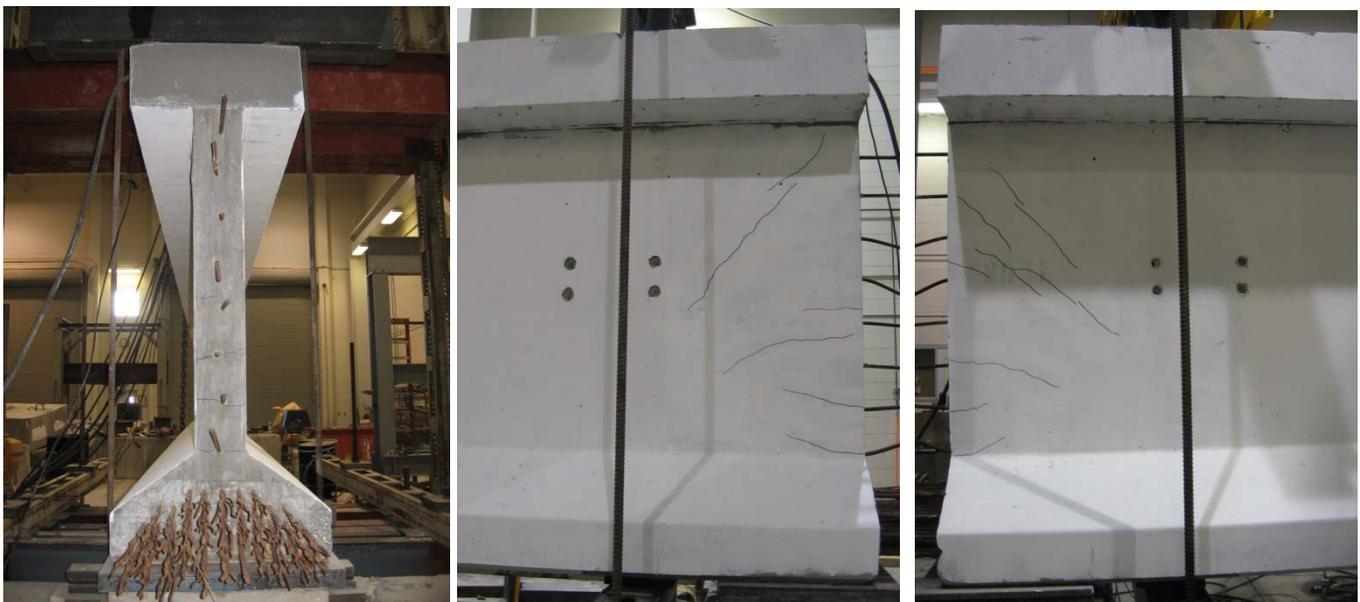
[Figure C.4-21. End zone cracks before testing](#)

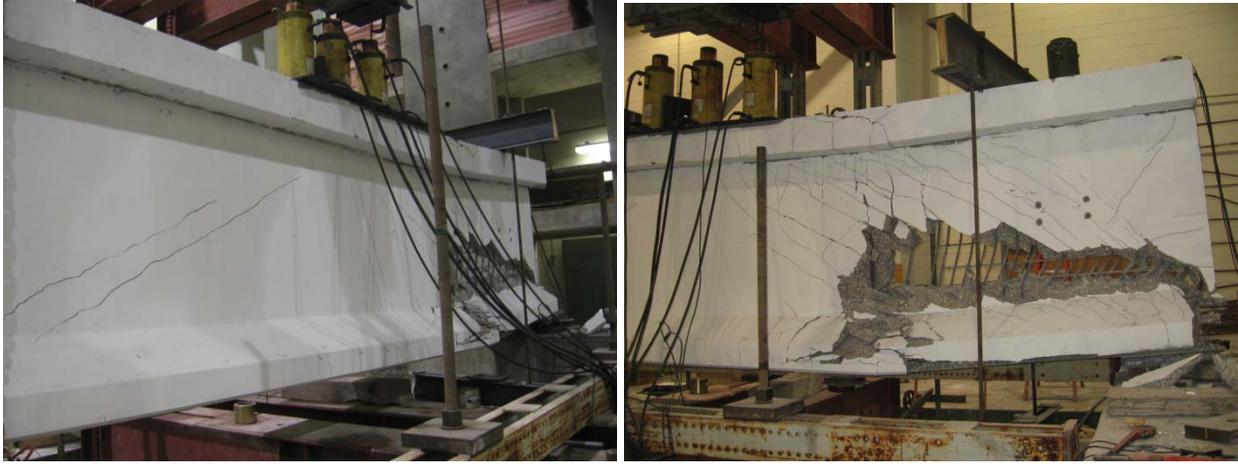
Figure C.4-23. End FL1L after failure, East Side

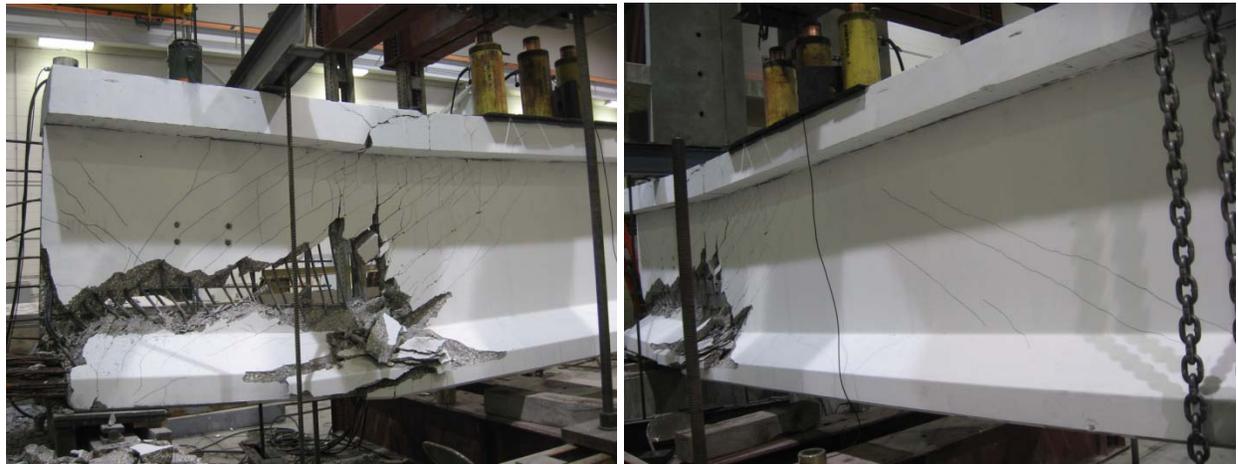
Figure C.4-24. End FL1L after failure, West Side

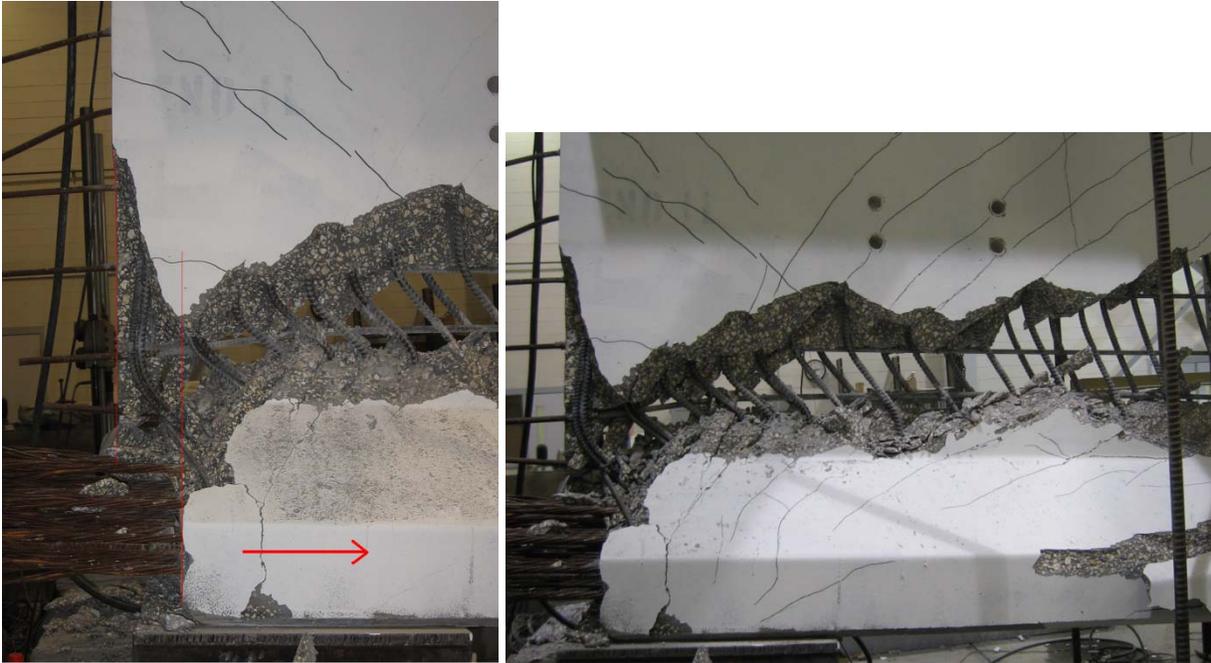
Figure C.4-25. Retraction of bottom flange and bending of shear reinforcement bars

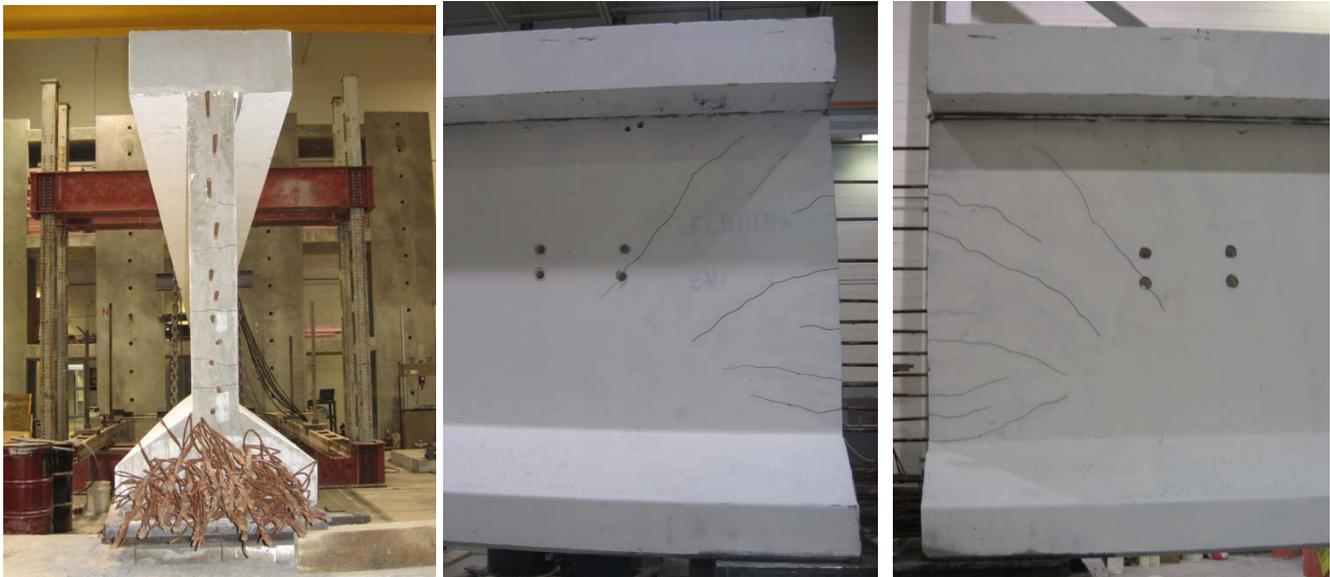
Figure C.4-27. End zone cracks before testing

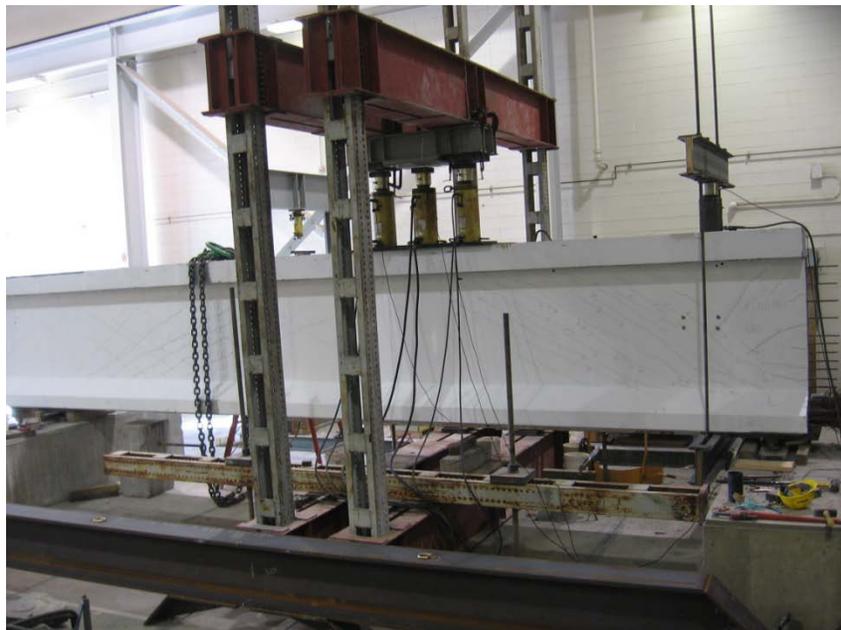
Figure C.4-28. Full girder after testing was complete; showing shear cracks

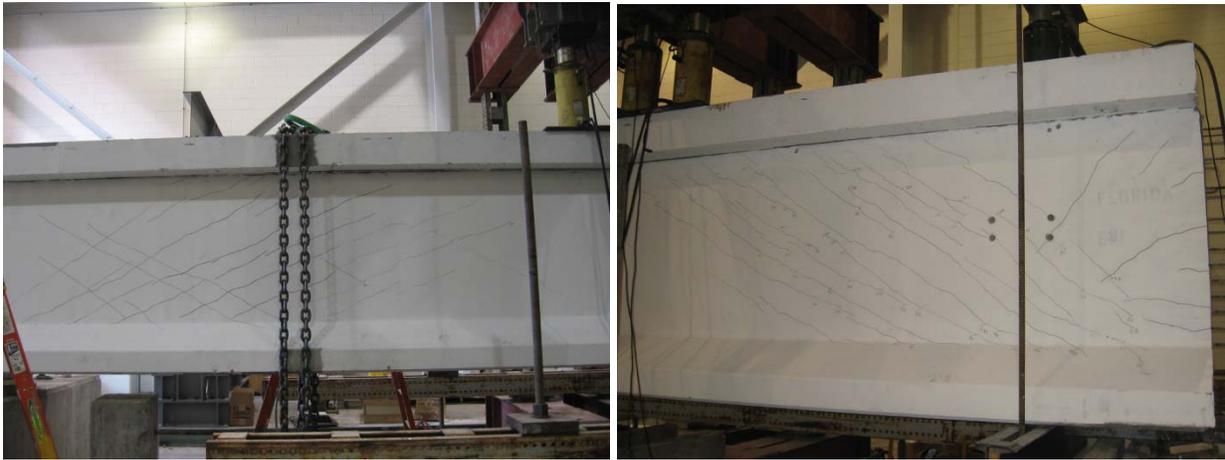
Figure C.4-29. East Side of End FL1R after loading was stopped (shear cracks)

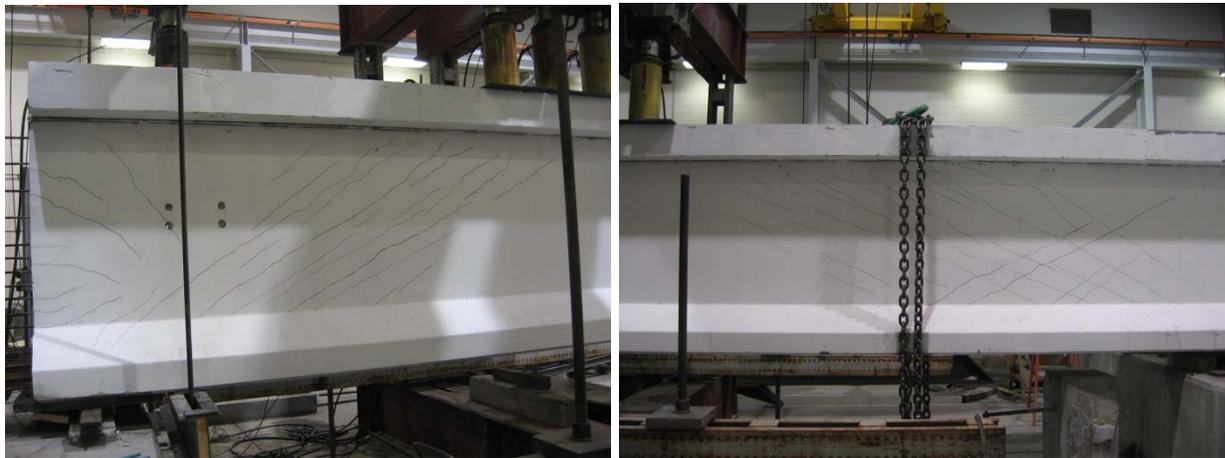
Figure C.4-30. West Side of End FL1R after loading was stopped (shear cracks)
