Retrofitting Procedures for Fatigue-Damaged Full-Scale Welded Bridge Beams

A digest of interim findings from NCHRP Project 12-15(2), "Retrofitting Procedures for Fatigue-Damaged Full-Scale Welded Bridge Beams," by John W. Fisher, Fritz Engineering Laboratory, Lehigh University

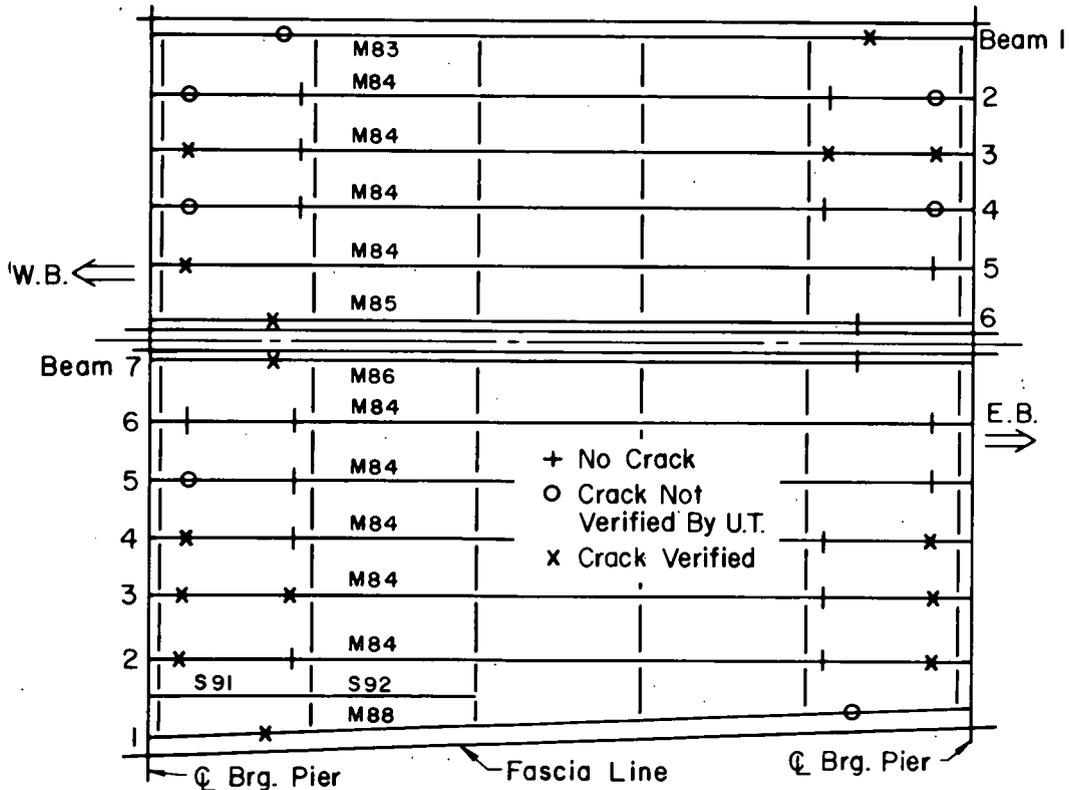
Figure 1. Plan of inspected details in span No. 10, Yellow Mill Pond Bridge.

In June 1976, 40 coverplate details in the east- and westbound bridges of span No. 10 at Yellow Mill Pond were inspected for fatigue cracking using visual, magnetic particle, dye penetrant, and ultrasonic procedures prior to retrofitting these girders. Twenty-two of these details were found to be cracked by visual inspection. The smallest visual crack indication was 6.4 mm (0.25 in.) long. Fifteen of these cracks had propagated deep enough to be detected by ultrasonic inspection.

The ultrasonic inspection provided data regarding both the length and depth of cracks. Cracks at the weld toe smaller than approximately 2.5 mm (0.1 in.) deep could not be reliably detected by the ultrasonic probe. The deepest crack depth indications of 13 mm (0.5 in.) were found at the west end of the eastbound bridge of span No. 10 in Beams 3 and 7 (see Fig. 1). Comparisons of estimated crack depths from ultrasonic inspection and actual measured crack depths after a fracture surface was exposed indicate that deviations of 1.6 mm (± 0.06 in.) are possible. Figure 1 shows the approximate location of the details that were inspected in span No. 10 and summarizes the findings.

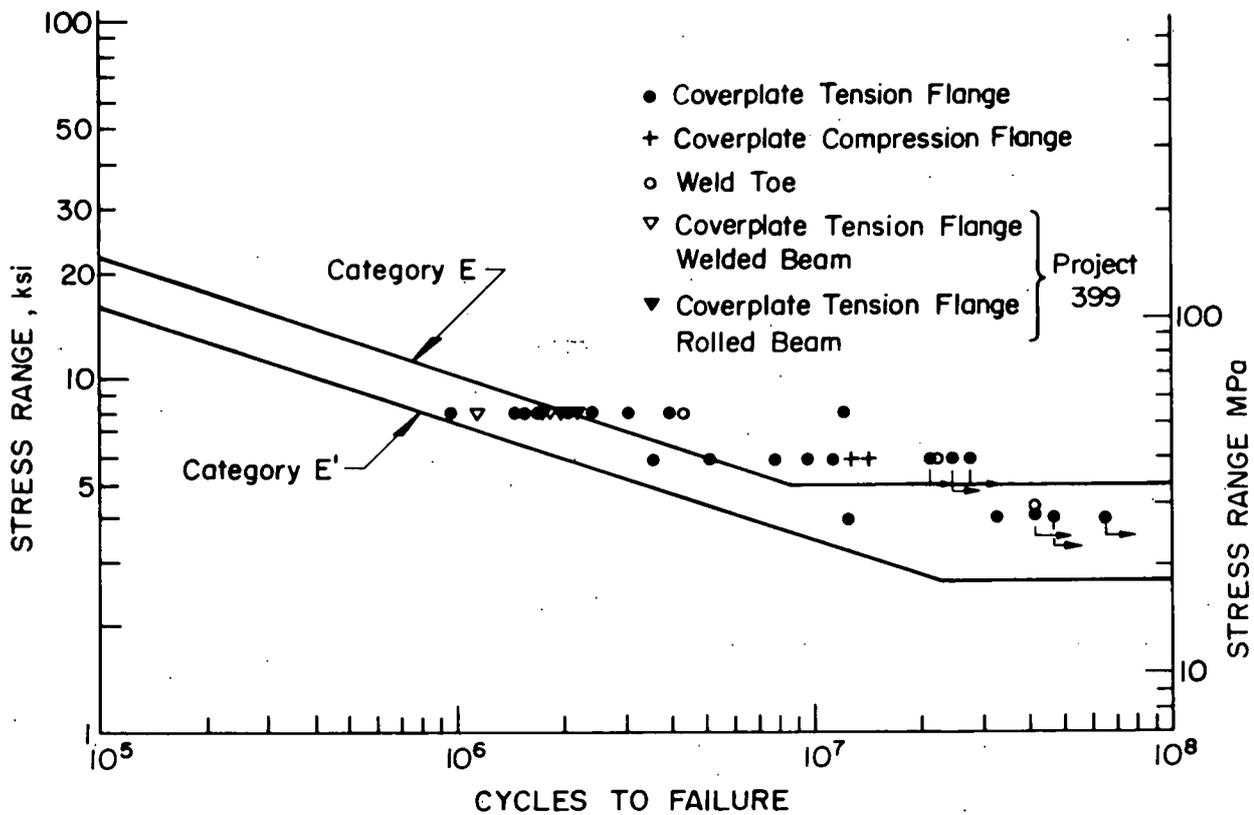
Figure 4. Fatigue strength of full-size coverplated beams.

The test data for the untreated coverplate details are plotted in Figure 4. Also shown is the Category E design line for current specifications, which is based on the 95 percent confidence limits for 95 percent survival of earlier tests on smaller beams (3). It is apparent that nearly all test data indicate less fatigue resistance.

A new lower-bound fatigue resistance was constructed based on the test data and estimates from a mathematical model developed for coverplated beams (4, 5).

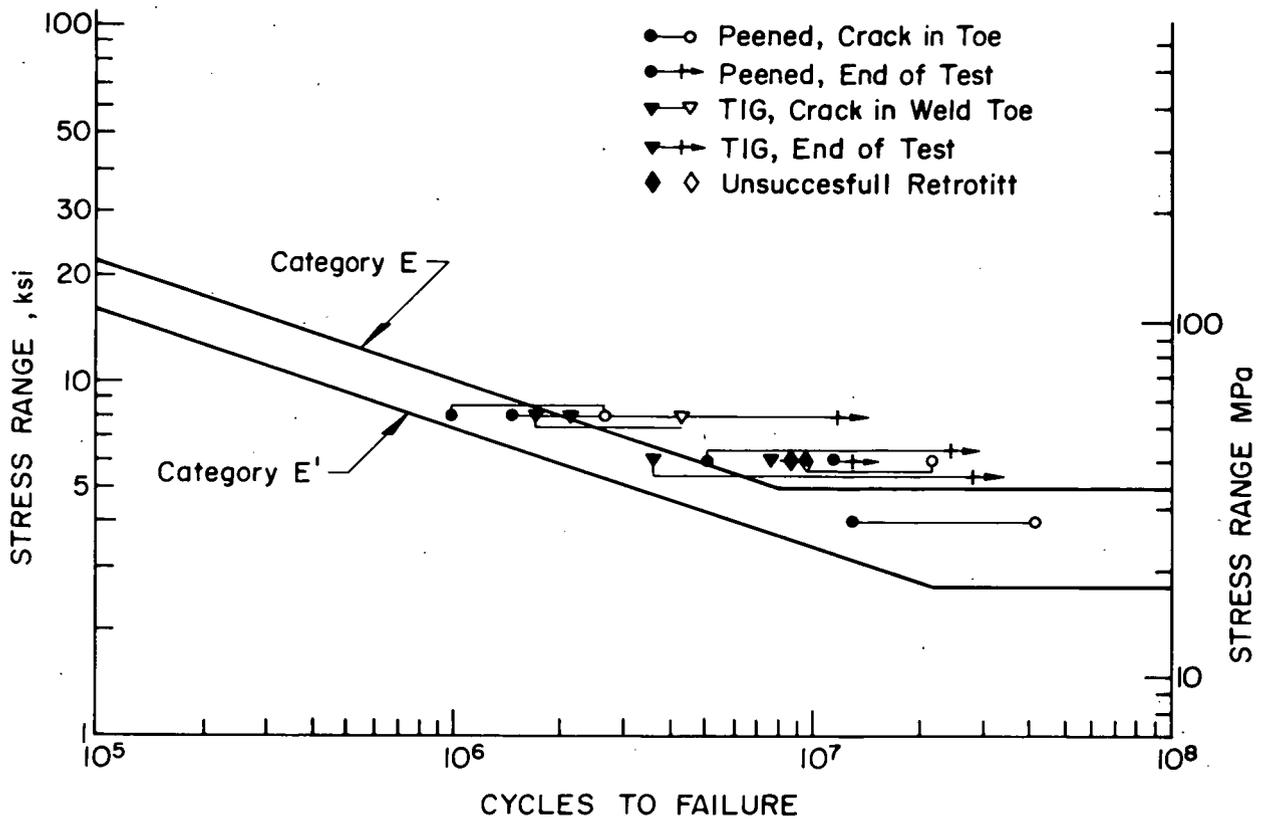
Figure 5. Fatigue resistance of retrofitted fatigue-damaged details.

The results of the tests are shown in Figure 5. Because of time limitations, all but one of the retrofitted beams were tested at either 6- or 8-ksi stress range. The results indicated that both procedures could be used to successfully extend the fatigue life and prevent further crack growth. Only details with initial crack depths greater than 1/8 in. did not achieve the desired life increments.

For details with very small or no visible crack, the peening procedure appears to provide a reliable and the most economical means of retrofitting fatigue damage; for details with slightly larger cracks (up to 3/16 in. deep) the gas tungsten arc remelt process is preferred.
