Web-Only Document 148:

Debris Photographic Archive and Supplemental Materials for *NCHRP Report 653*

Appendices to Contractor's Final Report for NCHRP Project 24-26
Submitted September 2009

Debris Accumulation at Bridges and its Effect on Scour

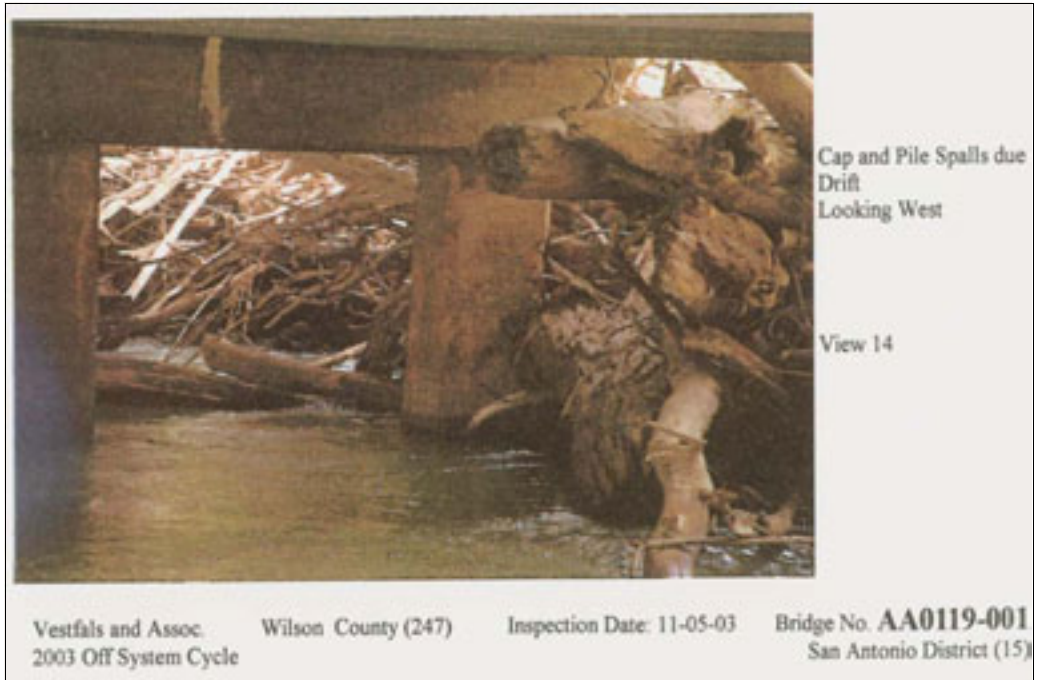
Photographs of the San Antonio River over County Road 117 were provided by Jon Kilgore of Texas Department of Transportation (TXDOT). Shown in the pictures is a small bridge with a significant amount of woody vegetation that leans into the channel on the stream banks. The bridge opening had caught a significant amount of debris that spans the entire channel (**Figure A.5**). Unique to this photo set is the visible evidence of damage caused to the structure, potentially from debris. Delaminating of the concrete and spalling can be seen underneath the upstream side of the bridge, see **Figure A.6**.

Figure A.5. Photo shows debris build up and spalls looking West on the Wilson County CR 117 Bridge.

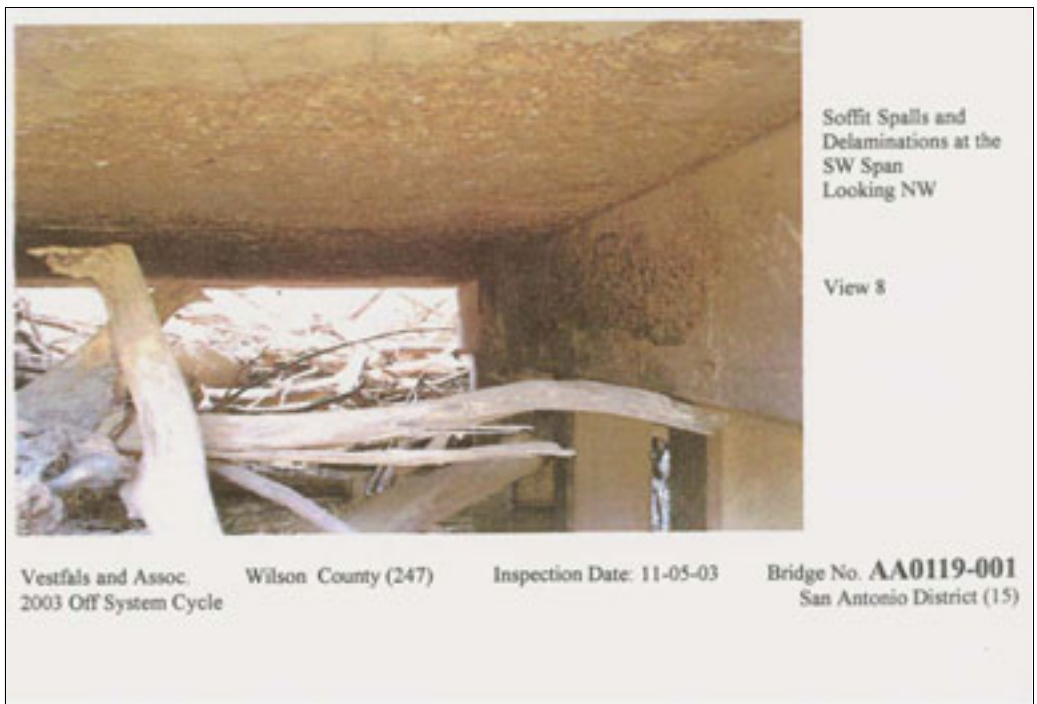
Figure A.6. Photo shows soffit spalls and delaminating at the SW span looking NW on the Wilson County CR 117 Bridge.

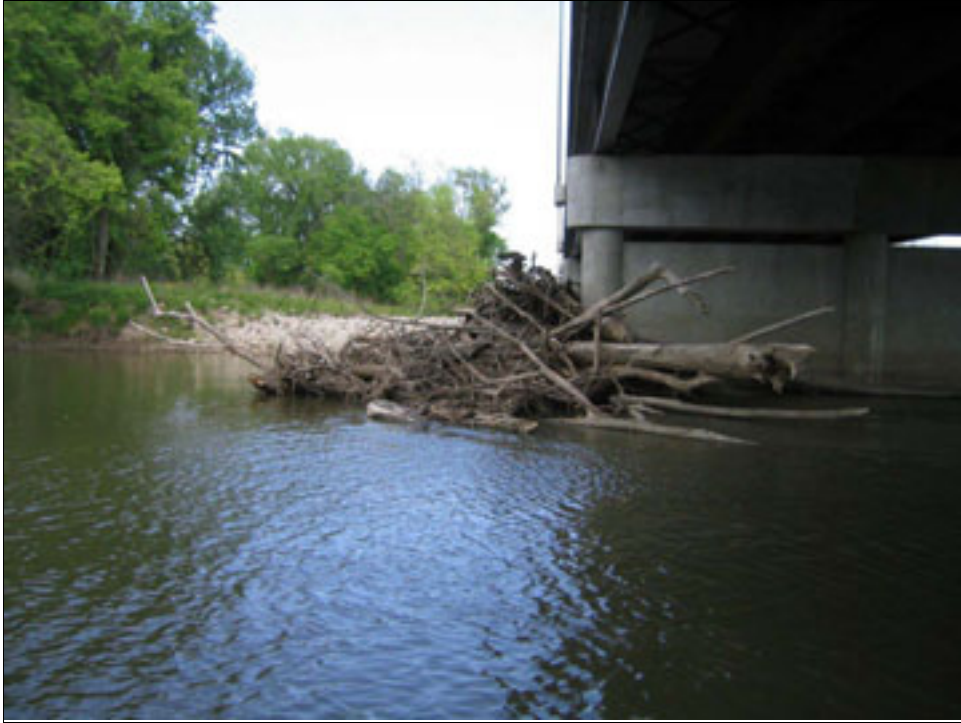
Figure 1.3. Debris buildup at Pier #3.

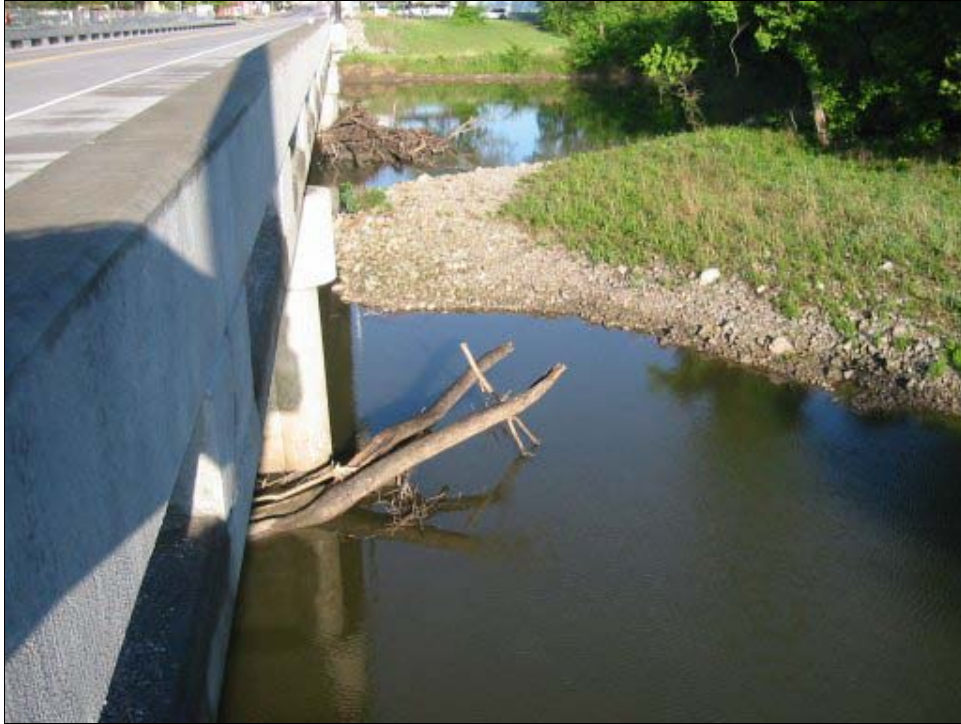
Figure 1.5. Debris at Pier #2. Note the island between Piers #2 and #3.

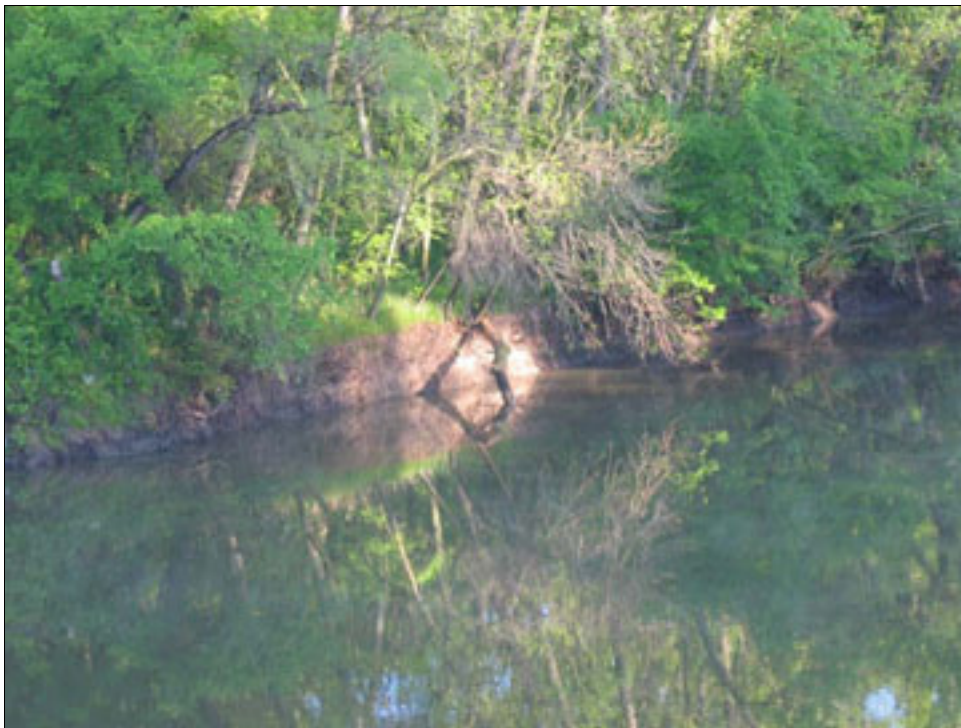
- Streambanks upstream of the bridge were vertical with approximately 3-6 feet of exposed soil visible. Numerous large trees were observed leaning into the channel (**Figure 1.6**).

Figure 1.6. Steep upstream banks and leaning trees.

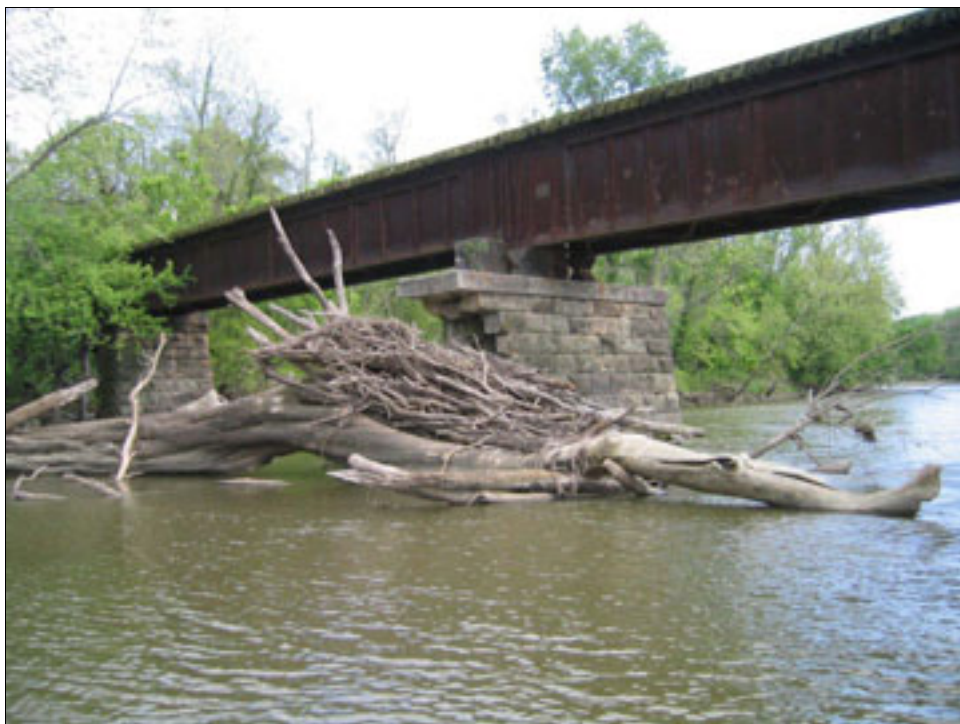
Figure 2.4. Debris at Railroad Bridge pier.

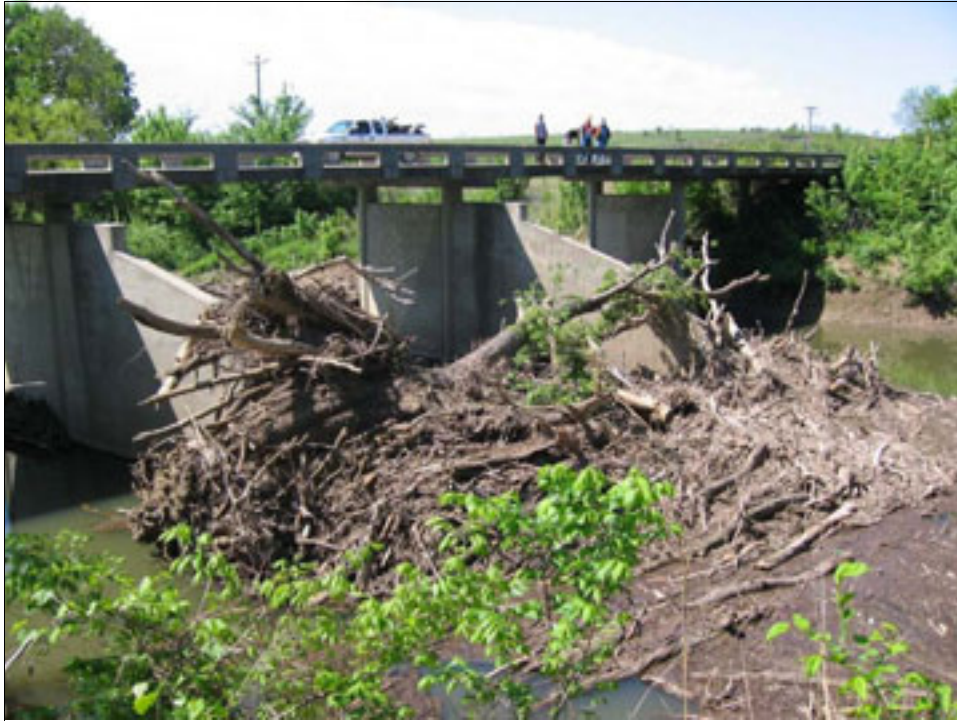
- Per conversation with a local land owner:
 - Current debris pile was typical and of average size for this bridge
 - In the past, debris has been observed within 10 feet of the bridge deck

Figure 3.3. Two piers in channel with heavy debris.

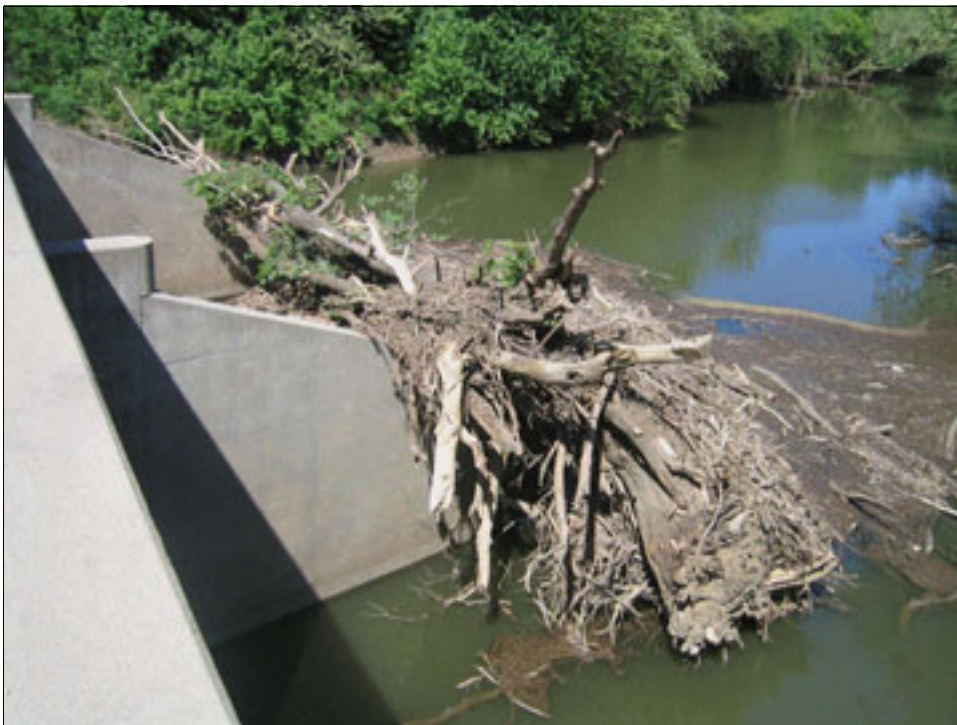
Figure 3.4. Extension walls, skewed to flow.

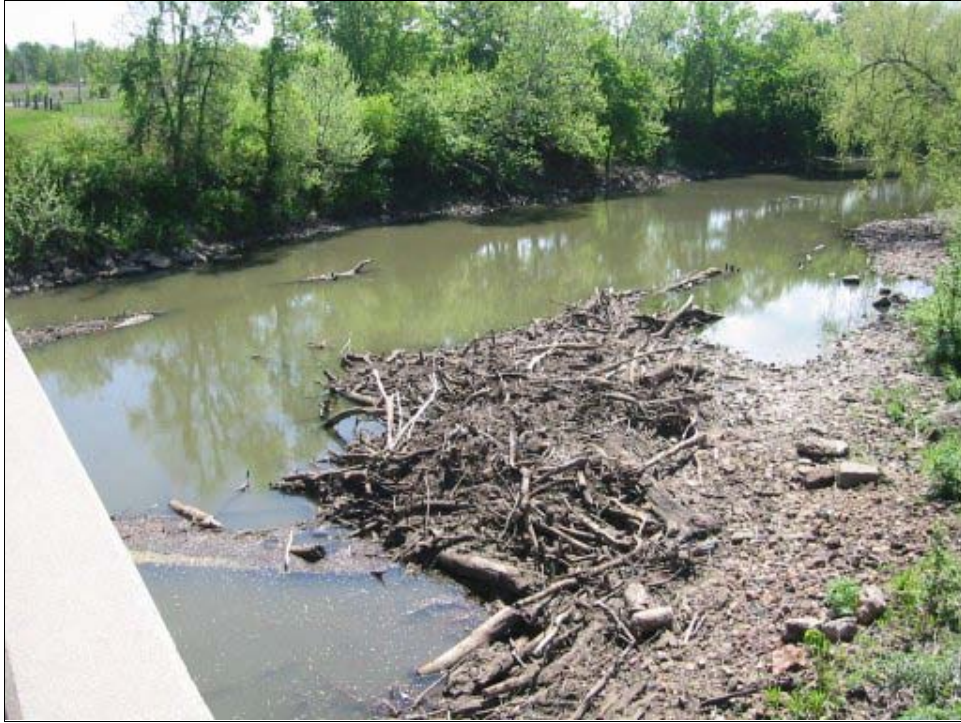
Figure 3.5. Debris removed from piers the previous year and placed downstream of bridge.

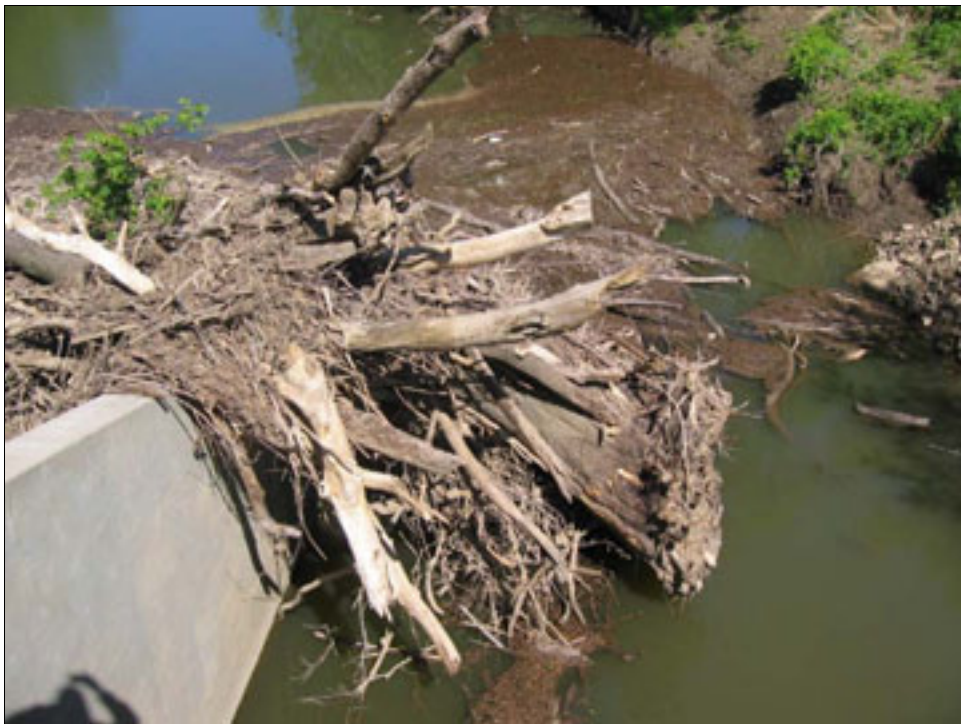
- Debris clusters of similar size can be observed along the banks of the Elk River for several miles downstream
- Large key log, approximately 5-6 feet in diameter at root wad, initially thought to have come from left bank immediately upstream of the bridge (**Figure 3.6**). Evidence of loss of large tree and slope failure could be seen on left bank (**Figure 3.7**). Pictures of left bank provided by KDOT taken July 2004 did not show a tree of similar size on banks.

Figure 3.6. Key log on left extension pier.

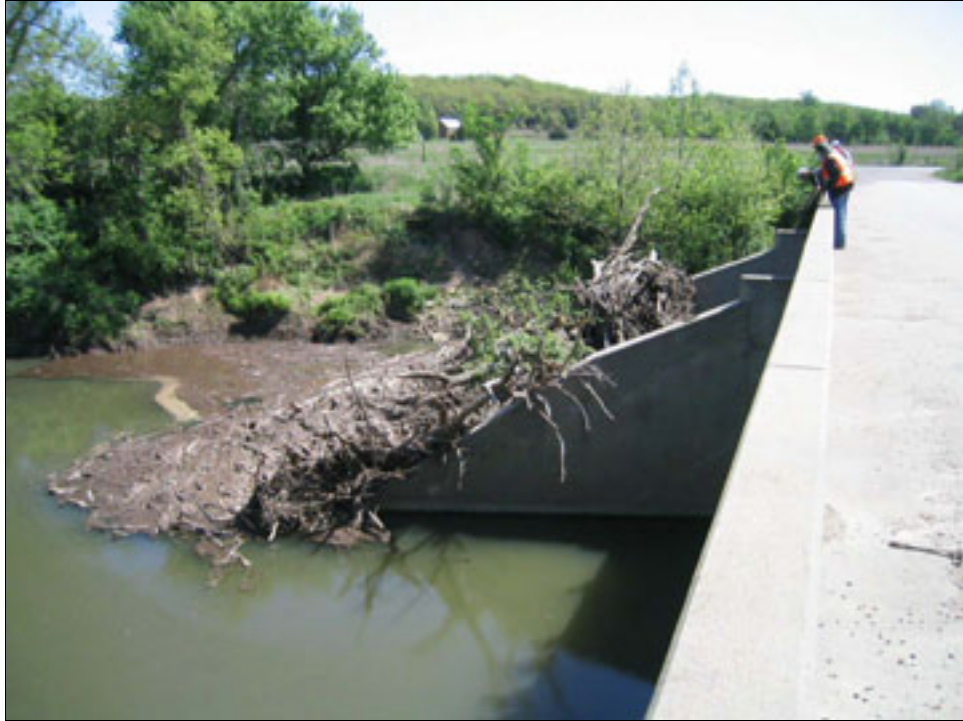
Figure 3.7. Evidence of loss of trees and slope failure on left bank.

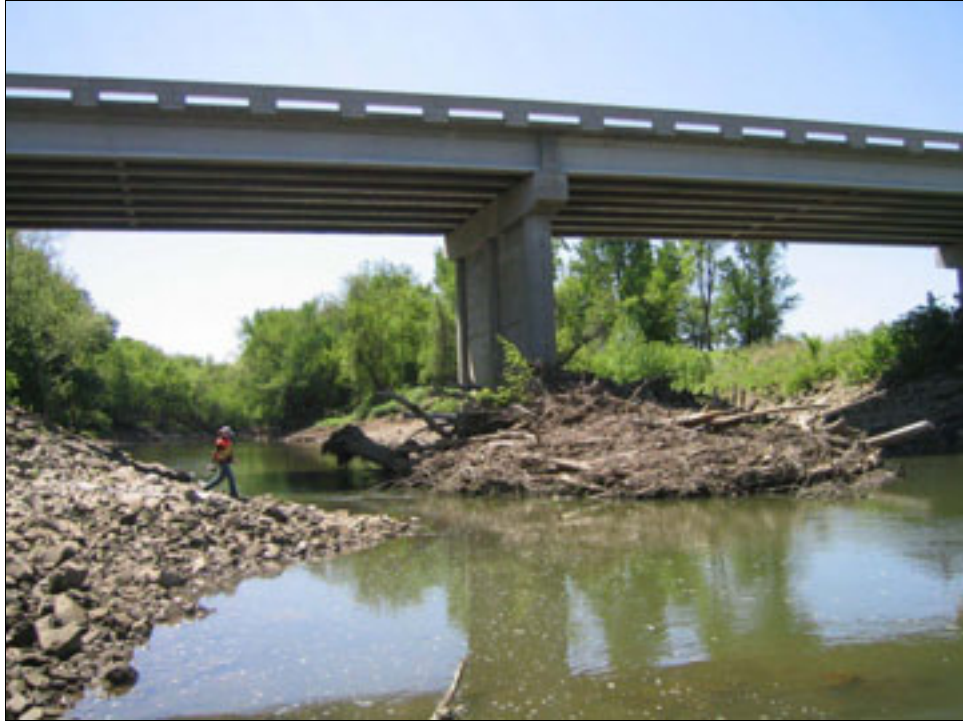
- One pier is located in the center of the channel. Large debris pile established on nose of pier (**Figure 4.2**).
- Upstream of bridge, banks show signs of erosion, large trees leaning into channel (**Figure 4.3**).
- Evidence upstream of pier of rotational bank failure and loss of tree.
- Large key log on left of pile with root wad oriented downstream.
- Riprap, approximately 1 foot in average diameter, located on both banks in the bridge cross section.
- Large riprap 3-4 feet average diameter located on upper bank, surrounding abutment.
- Vegetation wrapped on small shrubs is evidence of high water, approximately 10 feet above current water level.
- Green vegetation was established on debris pile.

Figure 4.2. Looking downstream toward the bridge.

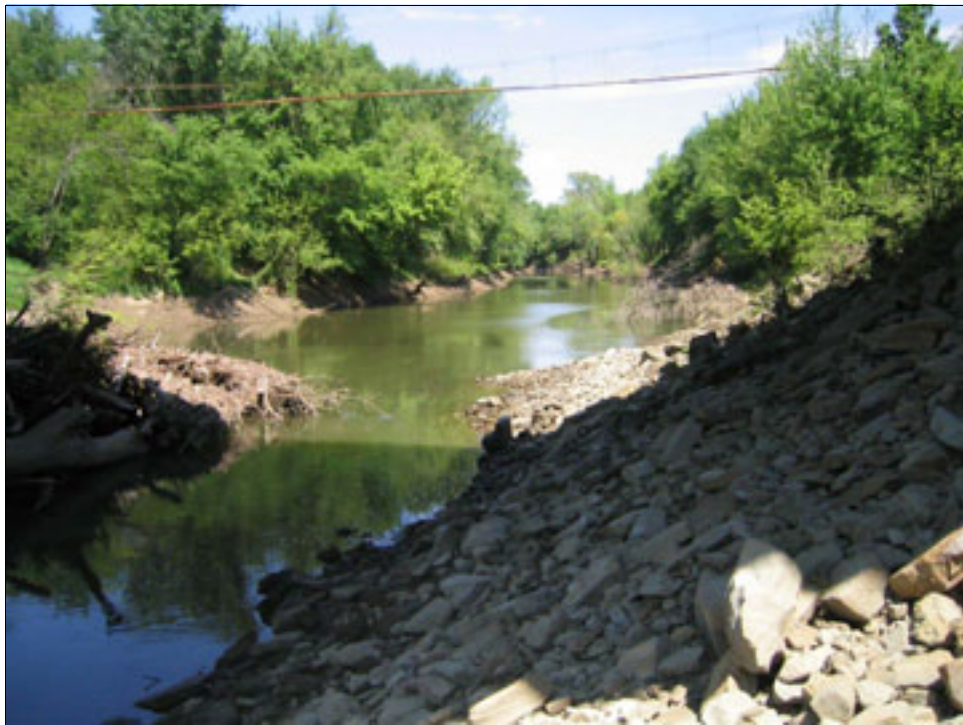
Figure 4.3. Looking upstream from below the bridge deck. Note the riprap on the banks and the trees leaning into the channel.

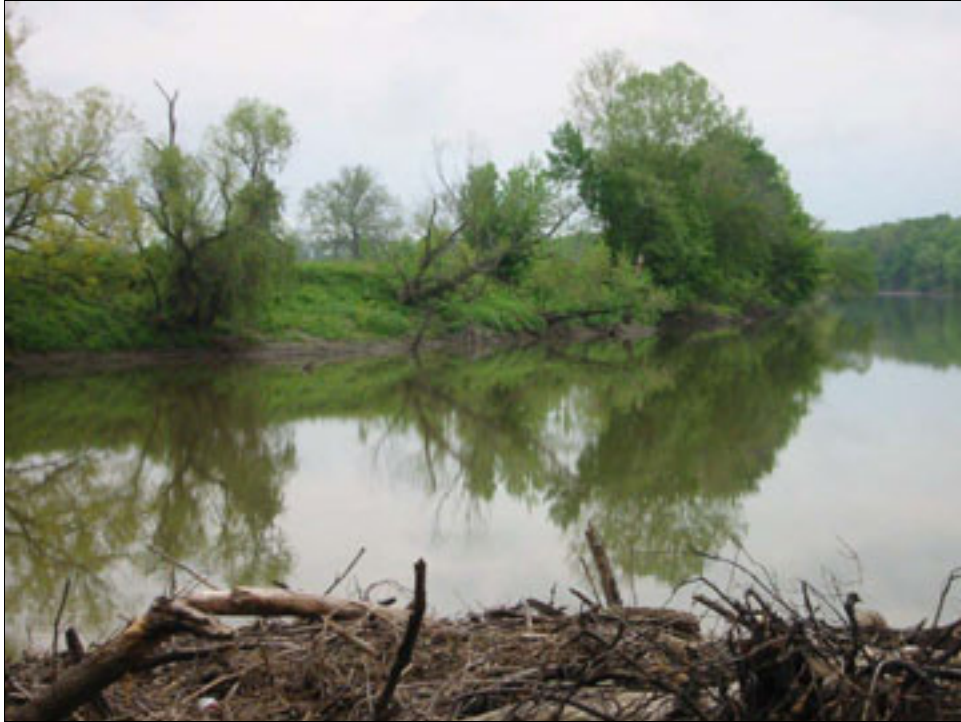
Figure 5.3. Looking upstream from debris pile. Note the eroding banks and trees leaning into the channel.

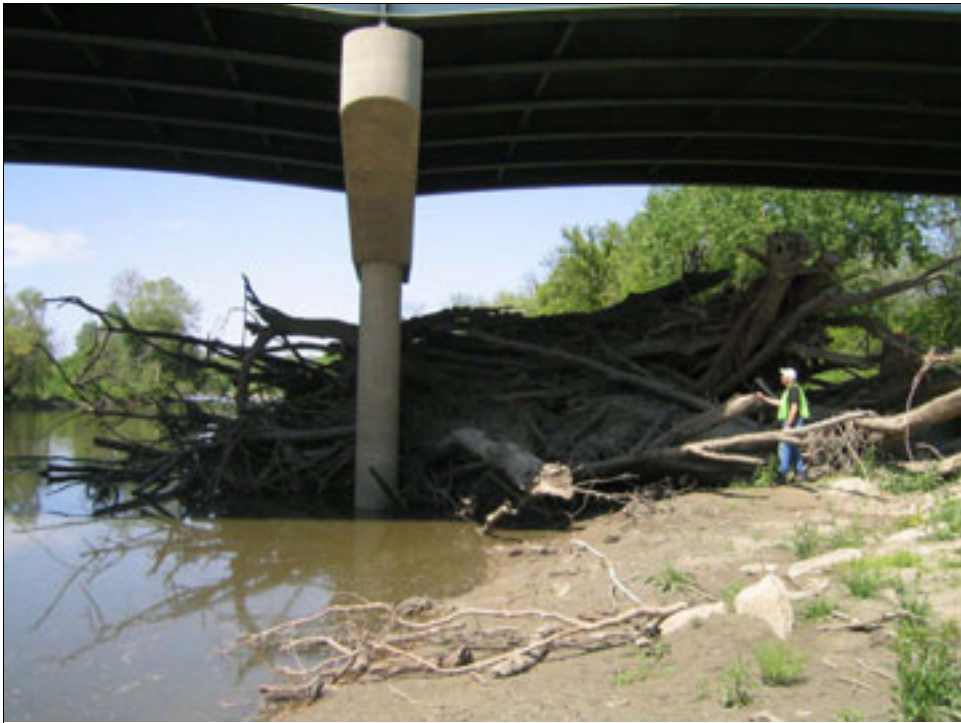
Figure 5.4. Looking upstream at debris pile.

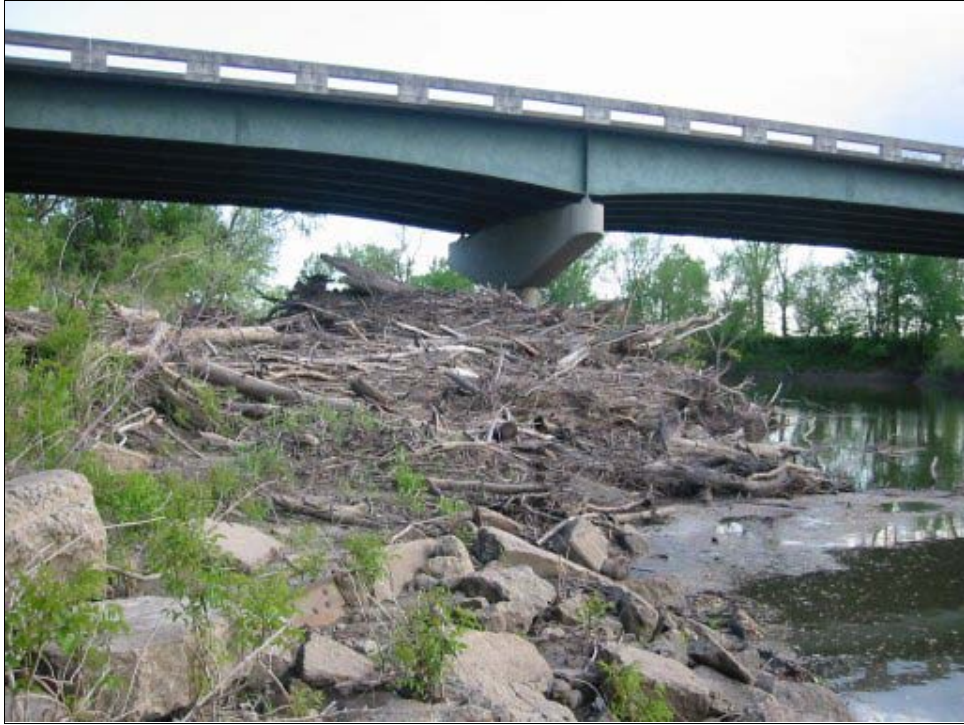
Figure 5.5. Looking downstream at debris pile.

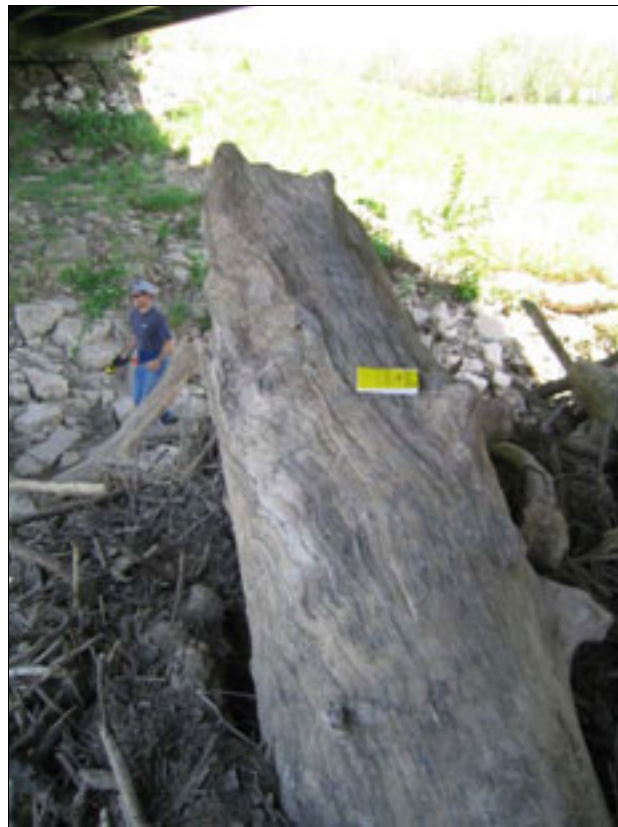
Figure 5.6. Large key log in debris pile.

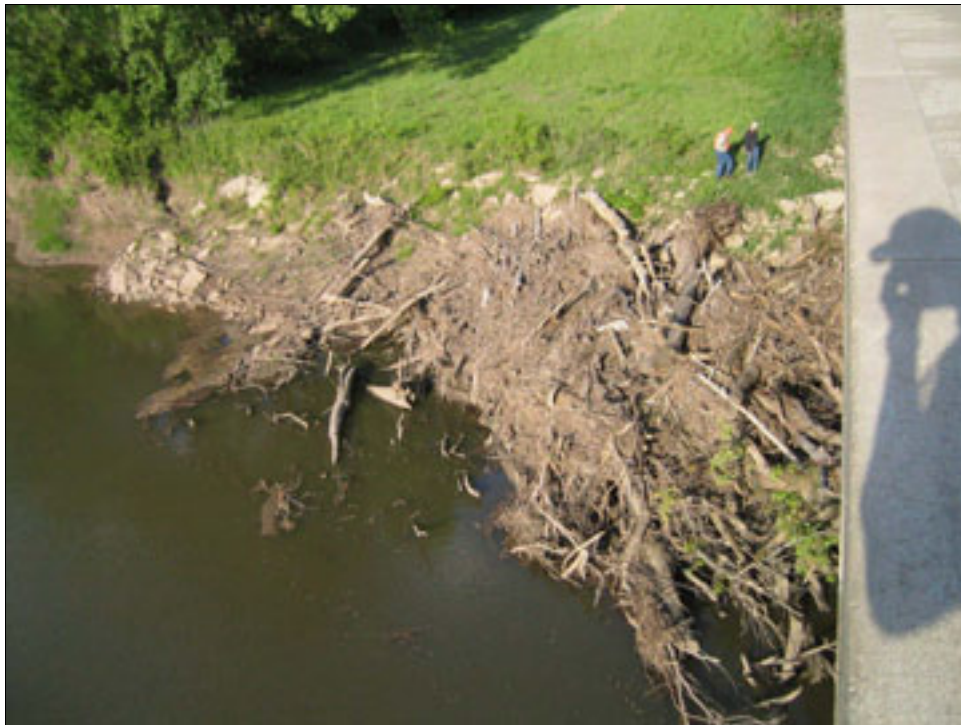
Figure 5.8. View of debris pile from bridge deck.
