**Application of Infrared Thermographic Imaging  
to Bituminous Concrete Pavements**

**Interim Report**

Research Report No. 2229-1-01-9

University of Connecticut  
Connecticut Advanced Pavement Laboratory

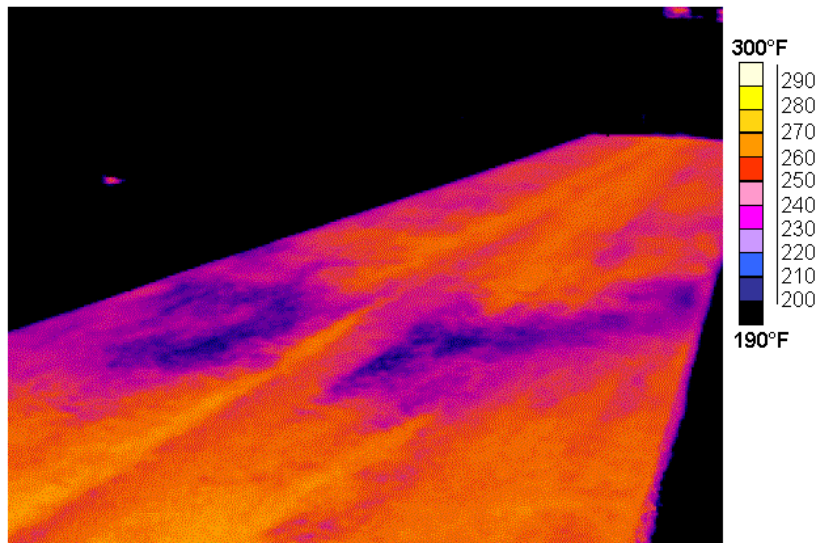
The materials used appeared to have little effect on the presence of cold spots. Since all sections, with or without the presence of RAP and with or without silo storage, showed some cold spots, it appears that the major cause of such spots may be in handling. Figure 1 shows the thermal images of cold spots in a Virgin, Silo placement and in the 10% RAP, Silo placement. Most cold spots were observed nearly across the entire width of the mat in a v-shaped pattern. This indicates cool material conveyed to the screed augers such that the augers continued to push the cool material outward from the center of the screed as the paver moved forward, thus creating the V-shaped cool spots.

**Virgin, Silo – V-shaped Cold Spots**

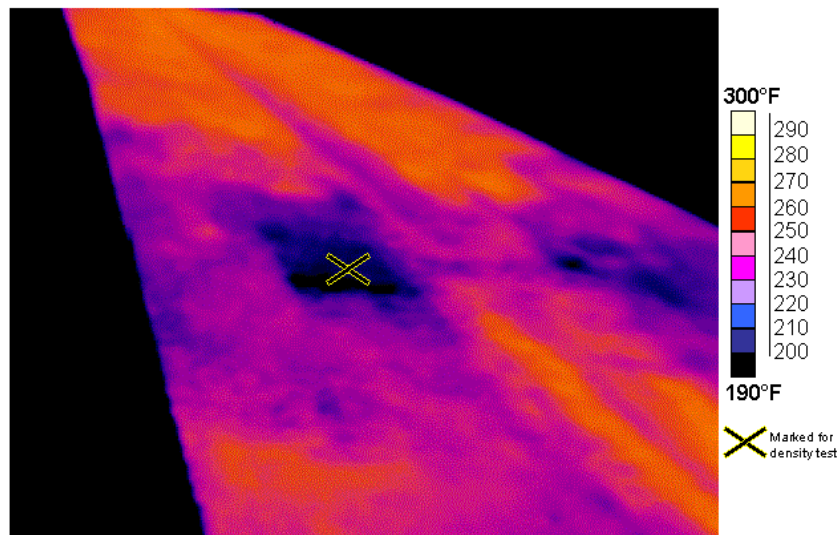
**10% RAP, Silo – V-shaped Cold Spots**

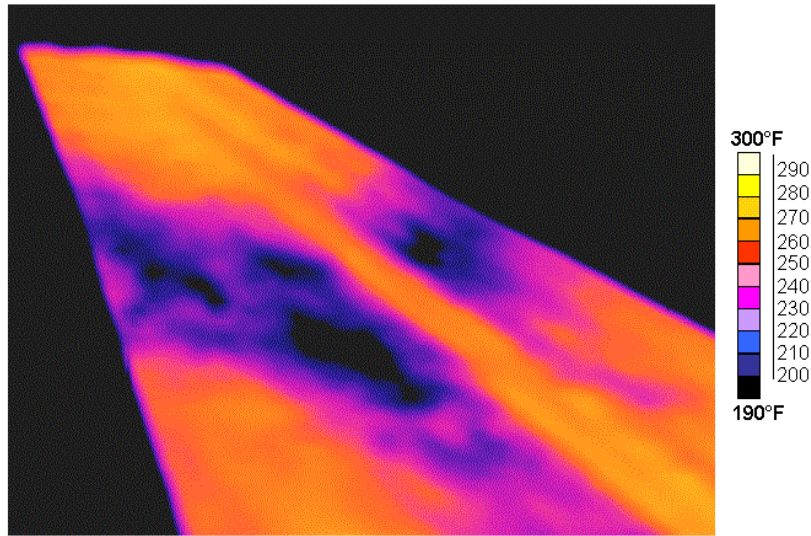
**Virgin, Non-Silo – V-shaped Cold Spots**

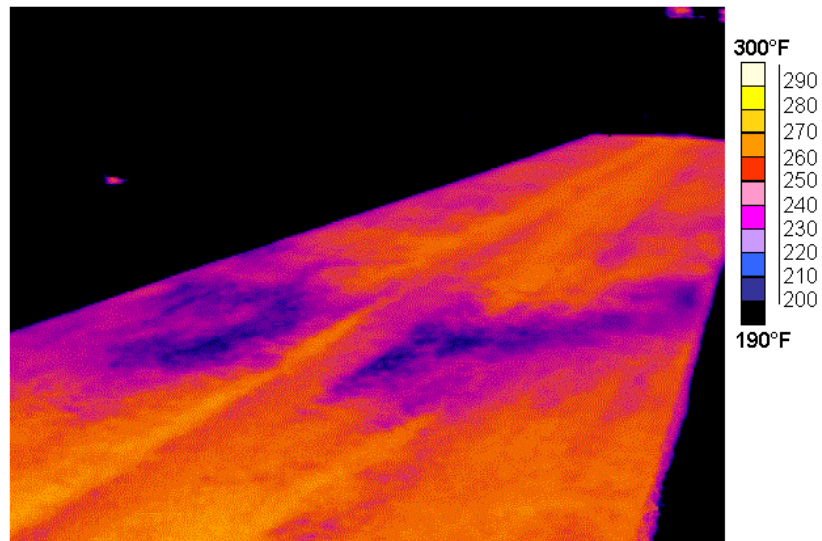
**Virgin, Silo – V-shaped Cold Spots**

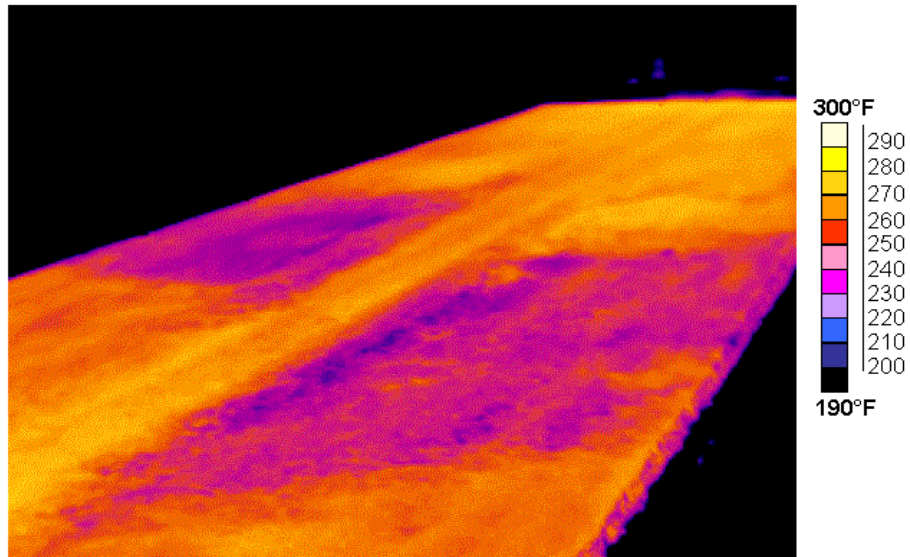
was paved. In the 1.5-inch section, cold spots were easily identified since they were visible to the human eye on the surface of the freshly placed pavement where the front of the paver had been stopped during truck changes. These cold spots were either barely or no longer visible to the human eye on the 2-inch lift; however, significant cold spots were visible in the thermal infrared images. Figure 3 illustrates the images of cold spots in both a 1.5-inch and 2.0-inch lift section. Cold spots observed in the 2.0-inch lift also were found to cover a smaller area than those observed in the 1.5-inch section.

**1.5-inch Virgin, Non-Silo – Cold Spots Both Sides of Lane**

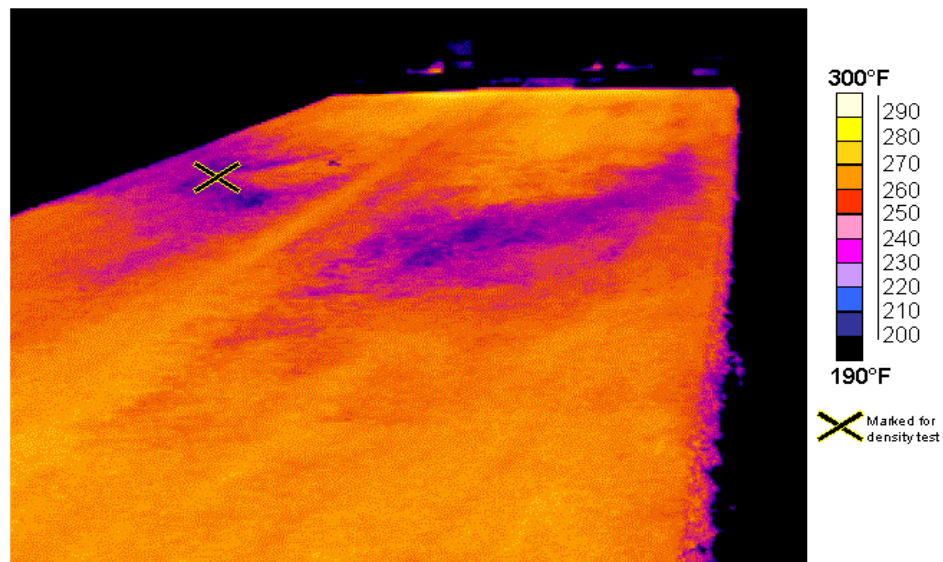
**2.0-inch Virgin, Non-Silo – Smaller V-shaped Cold Spots**

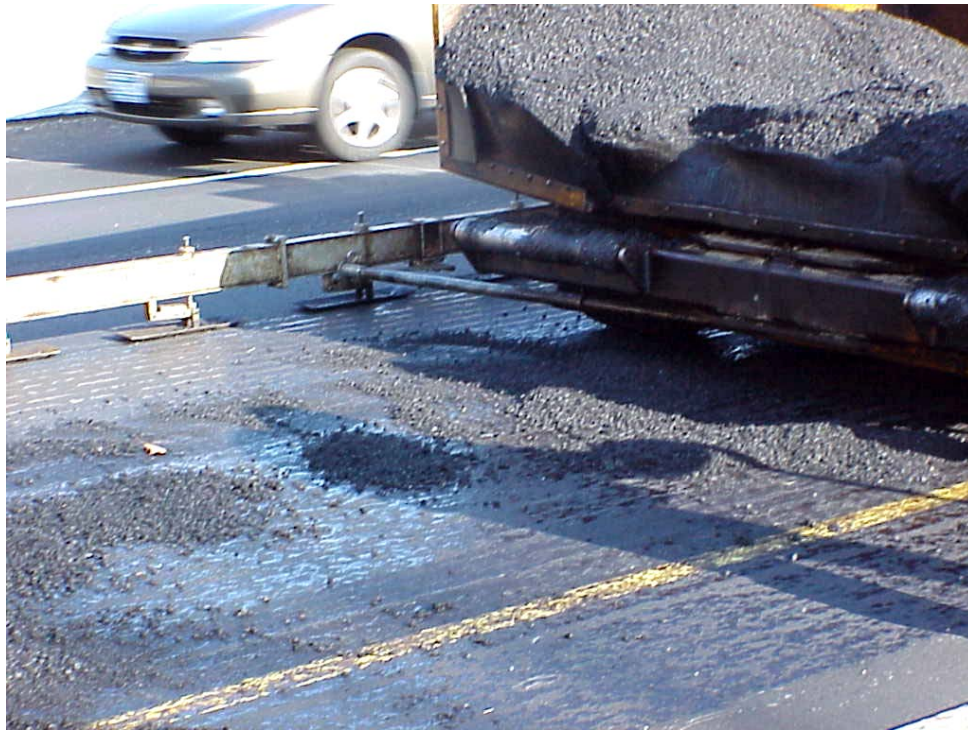
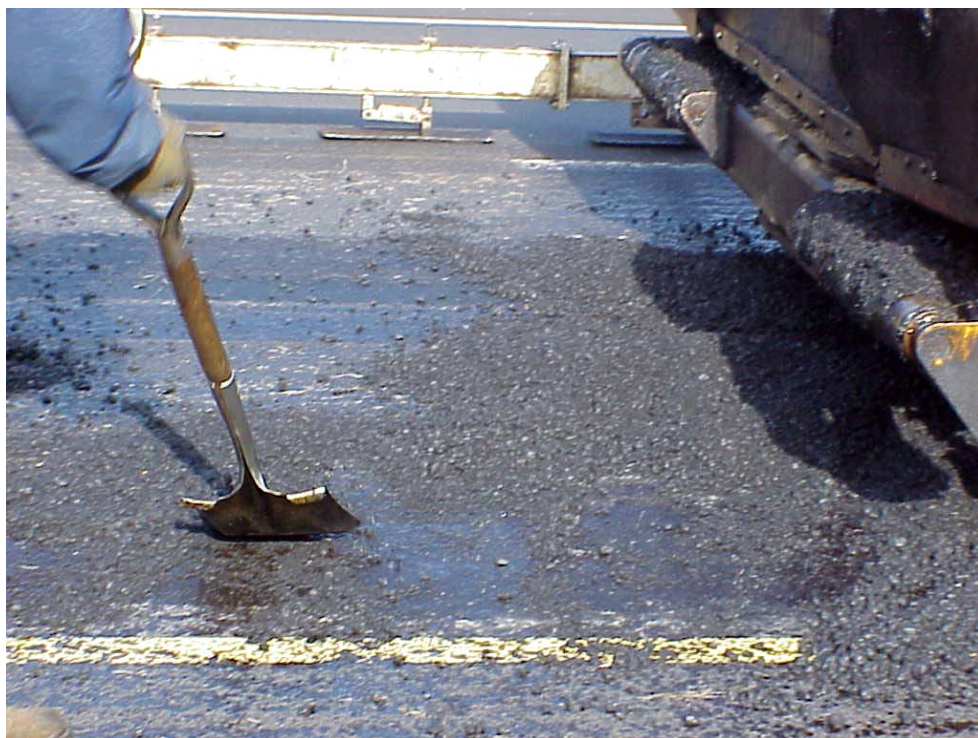
**Spillage of Material in Front of Paver and Out of Hopper Bed**

**Figure 4: Two Examples of Material Spillage in Front of Paver on I-395.**

- Reduce or eliminate loose material dropped in front of paver by departing trucks. Requiring trucks to clean out at a designated area not in the paving area would help to greatly reduce this spilled material. Any loose material that is spilled in the paving area should be shoveled up and discarded since cold spots (colder than surrounding material by 40° to 60° F) often appeared in the spillage area after the paver passed over the spillage area.

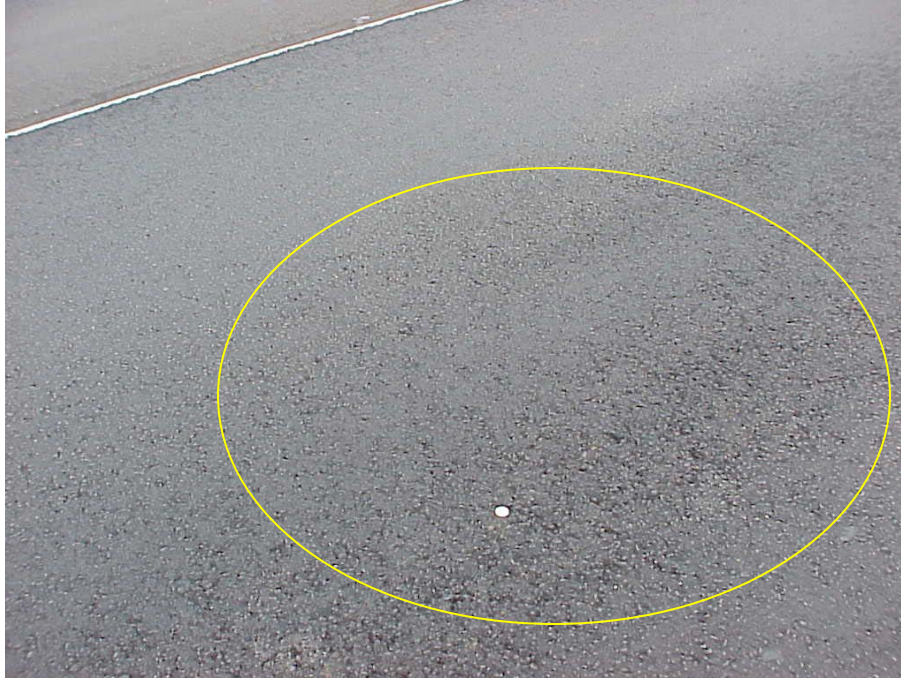
**Virgin, Silo, 1.5" Lift Thickness – Open Texture in Compacted Mat Corresponding to Cold Spot**

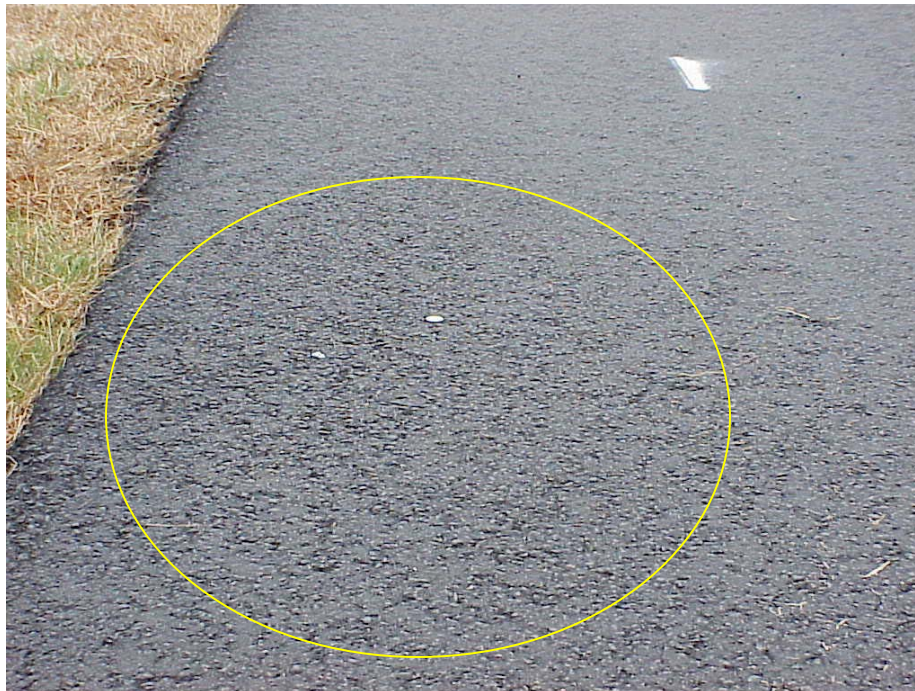
**10% RAP, Silo, 1.5" Lift Thickness – Open Texture in Compacted Mat Corresponding to Cold Spot**

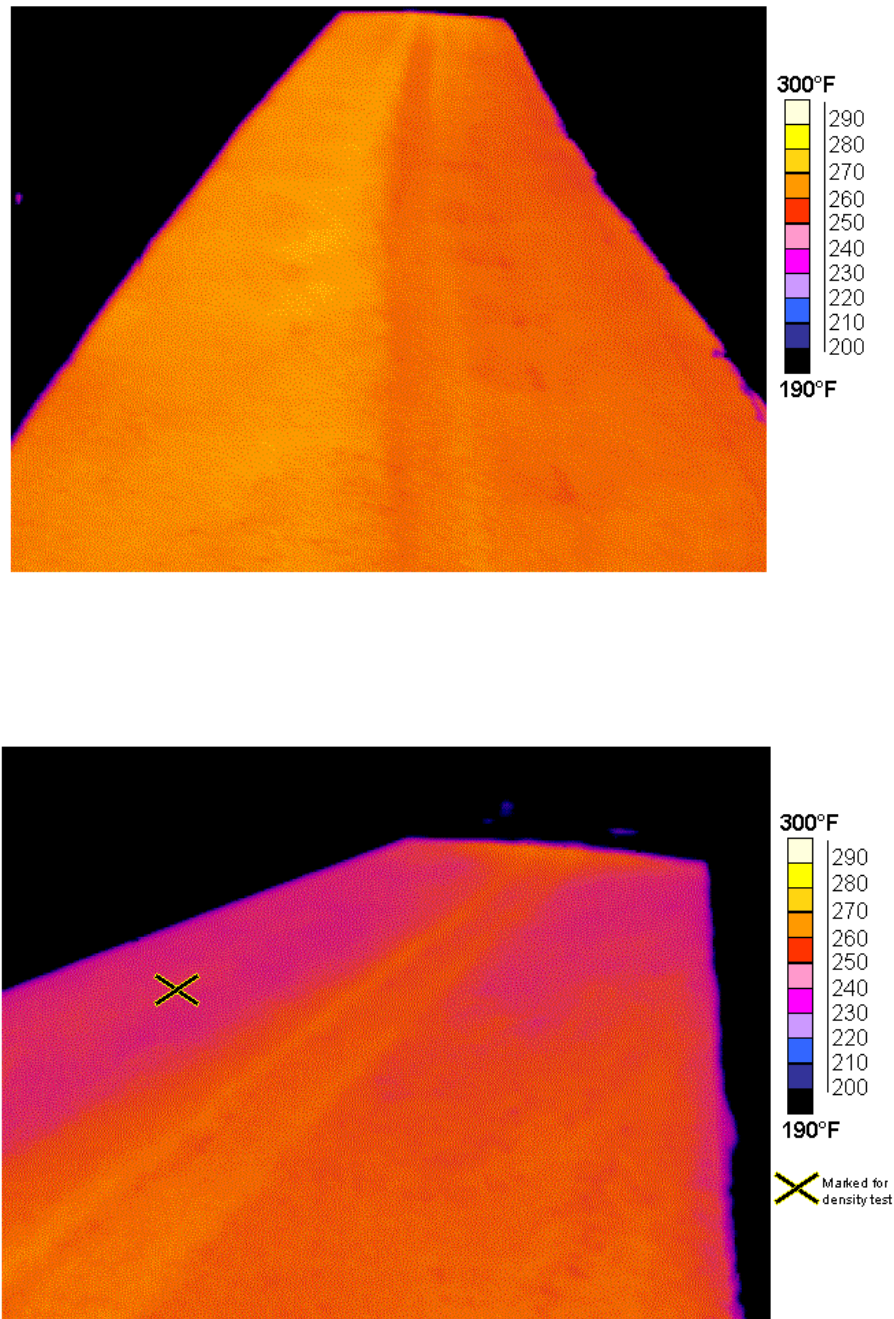
Surprisingly, thermal inspection revealed no cold spots as shown in Figure 6. The hopper that the trucks dumped into on the Roadtec MTD tended to spread any spilled material on the existing surface to a thickness of approximately the largest aggregate present in the HMA. The spreading out of the material by the Roadtec MTD combined with the speed of the paving train minimized uneven cooling of the HMA mat. These two factors, combined with the remixing of the HMA occurring within the Roadtec MTD greatly reduced or eliminated the appearance of cold spots altogether. Likewise, cold spots were not visible even when the operations were stopped for refueling of the paver or when waiting for additional material.

**Figure 6: Effect of Material Transfer Device - Mat Shows No Evidence of Cold Spots in Thermal Images for Paved Section I-395 (20% RAP, Silo, 1.5" Lift Thickness).**

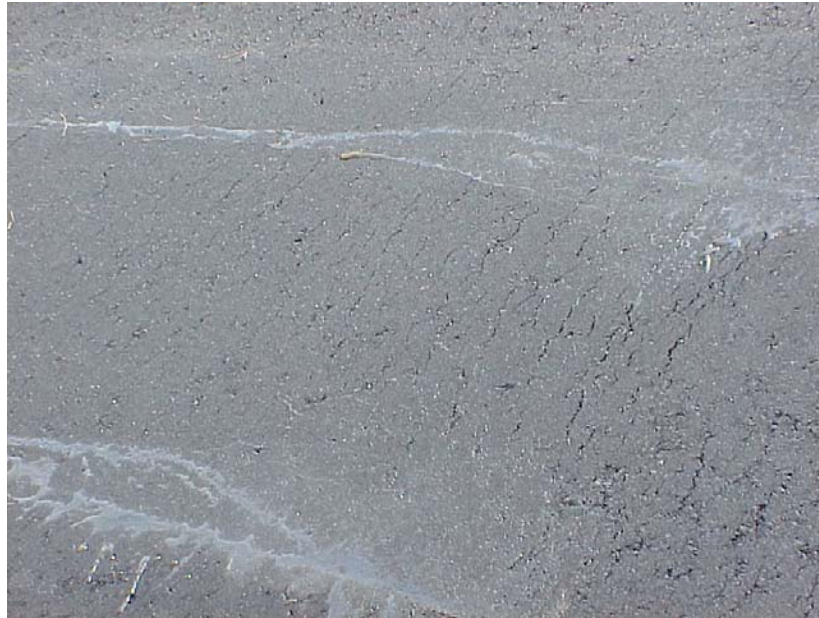
In cold weather paving, the time available for compaction is limited by rapid cooling of the mat. It may be suggested that roller operators should be alert to the formation of cold rolling cracks. Cold rolling cracks were formed when roller spacing was not tight enough and the mat cooled too much before the rolling process had been completed. These cracks were sometimes observed even on the day when the material transfer device was in operation and when the 2.0-inch mat was paved (see Figure 7). It appears that rolling these cracks out completely is very difficult, and they may later become the initiators of active surface cracks. The number of rollers needed may increase when paving in cold weather. For example, if three rollers are adequate on a 50°F day, it may require four rollers on a 40°F day because faster cooling decreases time for compaction.

**1.5-inch 20% RAP, Silo, Material Transfer Device Used – Cold Rolling Cracks**

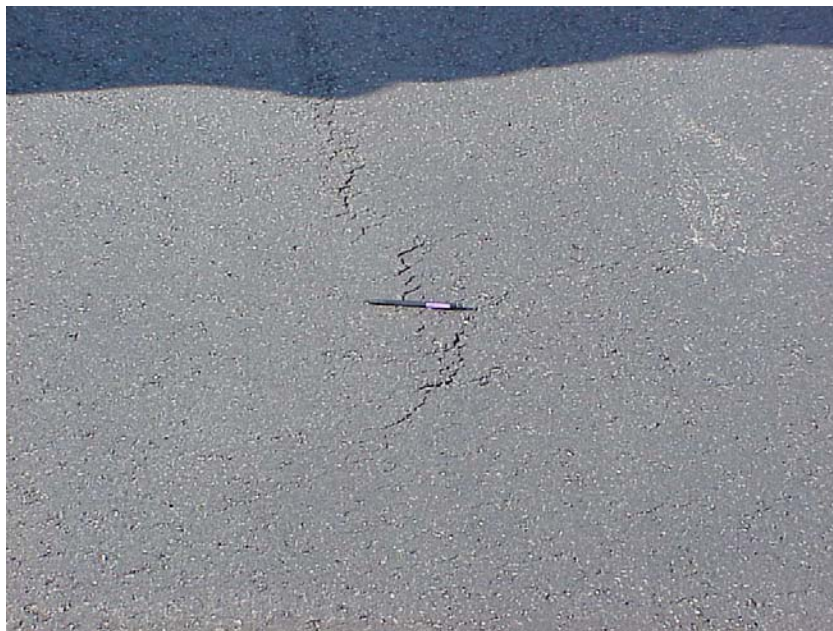
**2.0-inch Virgin, No Silo – Cold Rolling Cracks**

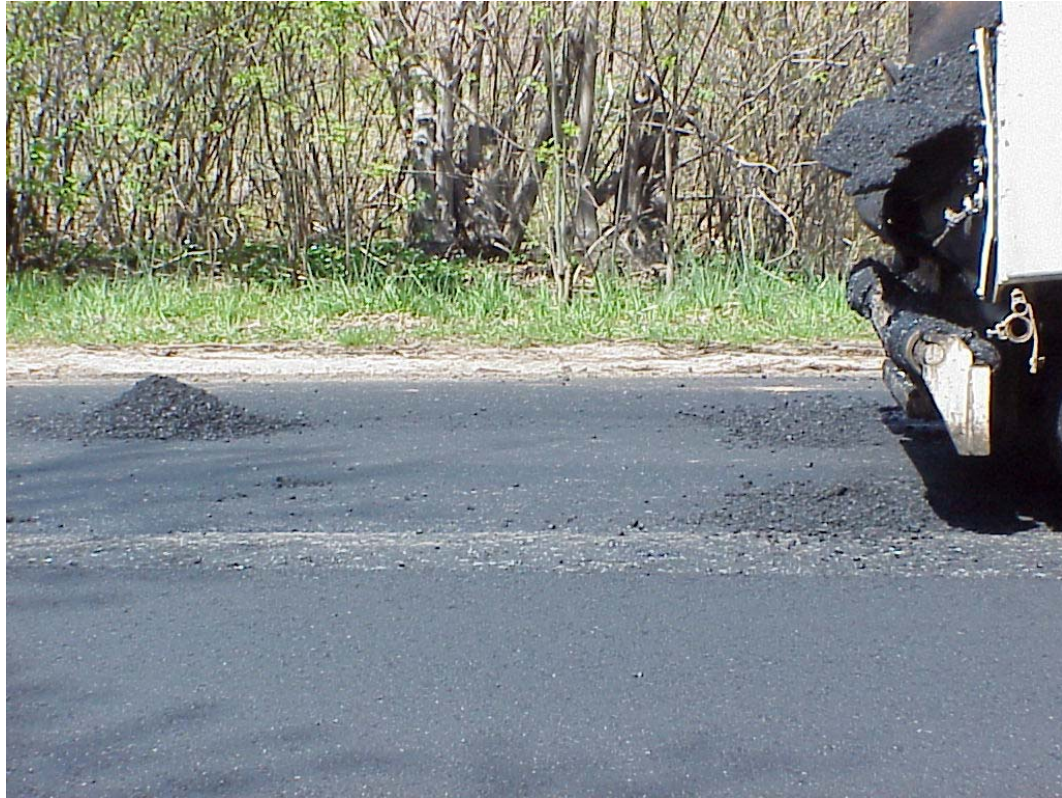
**Figure 10. Material Spilled By Truck Pull-Out After Discharge into Paver.**

Figure 10 shows a spill of loose HMA onto the existing pavement caused from the haul unit cleaning the loose material from its bed by raising the dump body after pulling away from the paver. If there is a delay between trucks and this material is allowed to stay on the existing surface, this material is already cooler than desired and will continue to cool before the paver spreads fresh hot material over it. Cooler weather conditions exacerbate this problem as well as having extended waiting periods for materials to arrive at the paving site. Figure 11 shows a cold spot that corresponds to the location of spilled

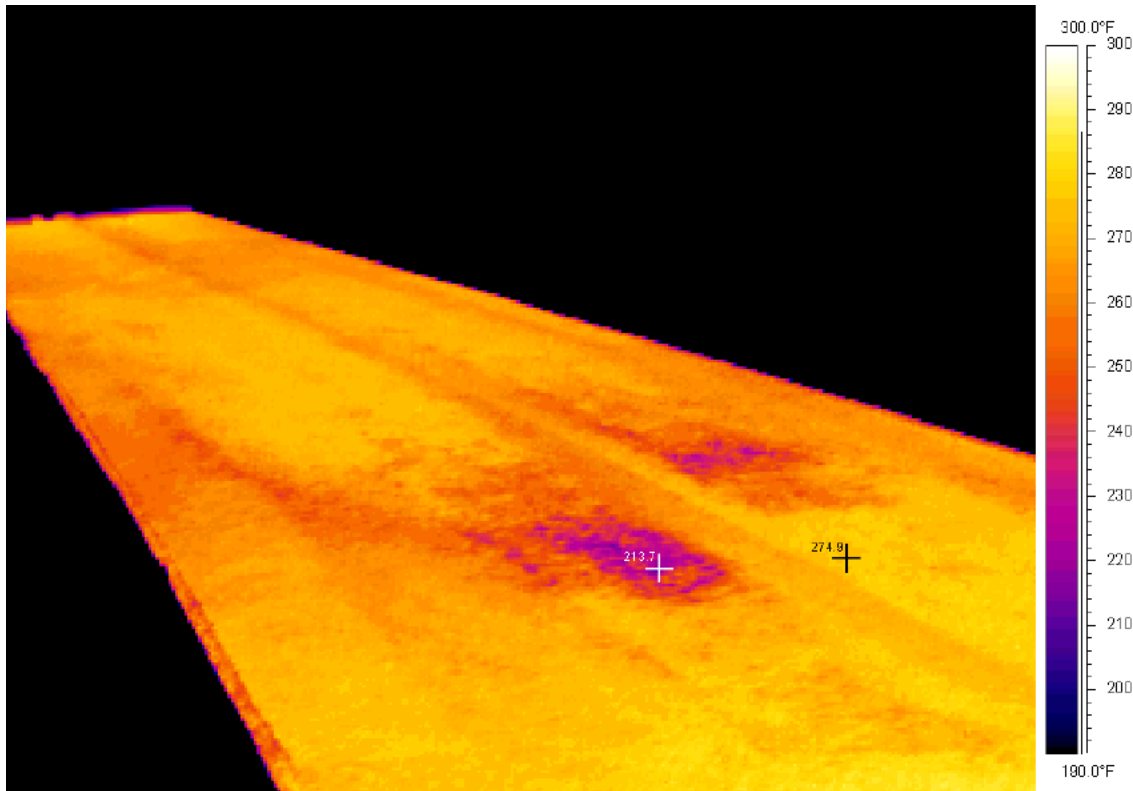
The existing mat surface temperature, prior to placement of wearing course, was recorded to be 124°F. Temperature differentials in the freshly placed pavement were observed with the thermographic camera as being typically in the outer portions of the lane. The typical mat temperature after placement, but before breakdown compaction, was recorded as 270°F. However, the maximum temperature differential was observed to be as high as 80°F. Figure 11 shows a temperature differential of approximately 60°F in the uncompacted mat.

**Figure 11. Temperature Differential in Mat Prior to Compaction on Rt. 178.**

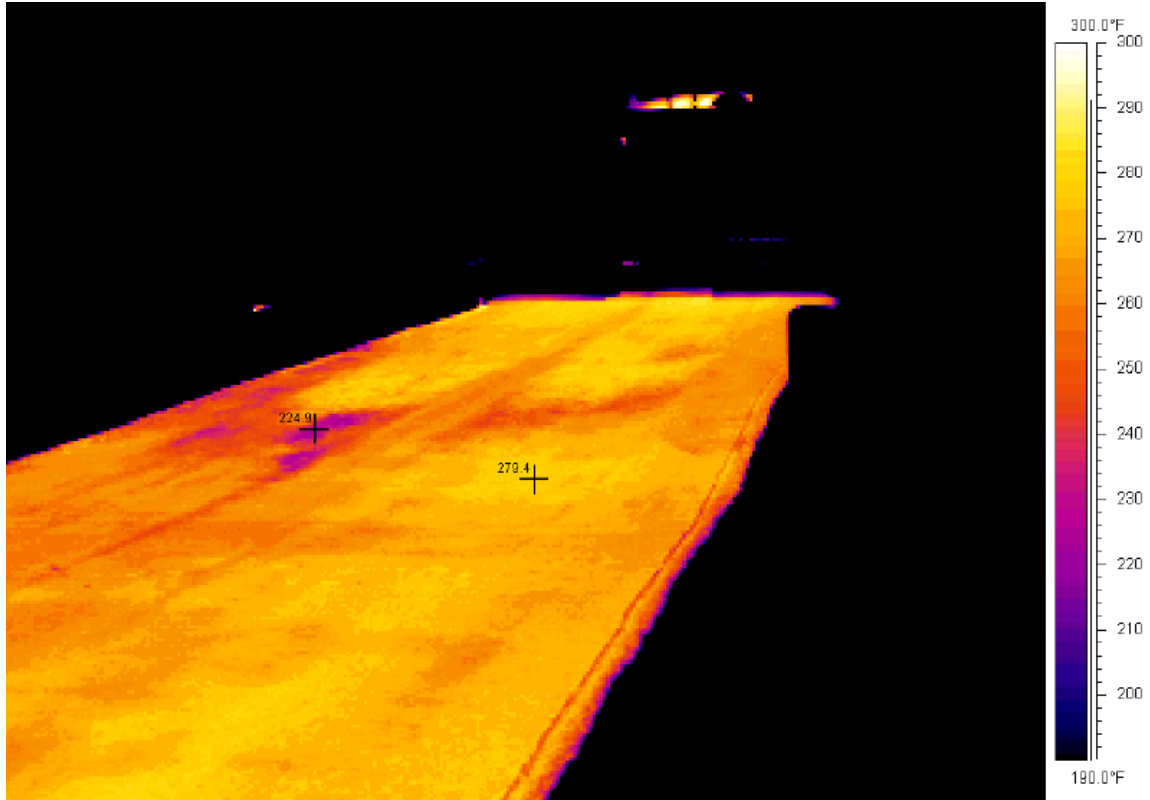
The cool spots observed in mats on Route 178 were typically not cyclic; however, they appeared to occur in conjunction with spilled material in front of the paver. The image shown in Figure 12 illustrates a temperature differential of approximately 55°F with a weak v-shaped cool spot.

**Figure 12. Temperature Differential in Mat Prior to Compaction on Rt. 178**

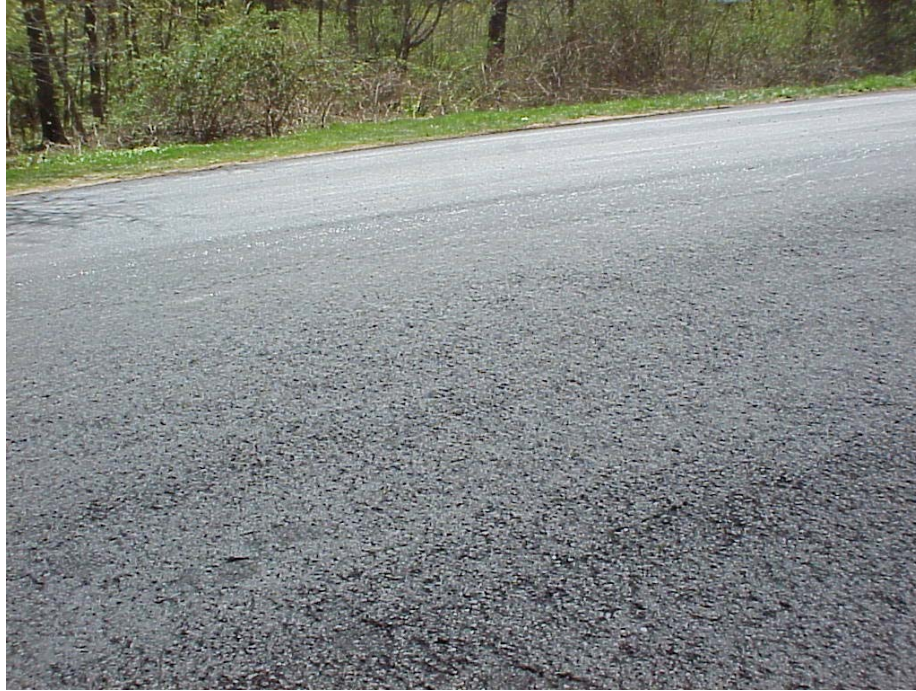
A nuclear gauge was not available; therefore, no compaction data for determining the change in air voids or range of air voids was gathered. However, visual inspection showed areas of open-textured mat, such as that seen in Figure 13, that were observed as cool spots in the same location using the infrared thermographic camera.

**Figure 13. Open-textured Mat Observed Prior to Compaction.**

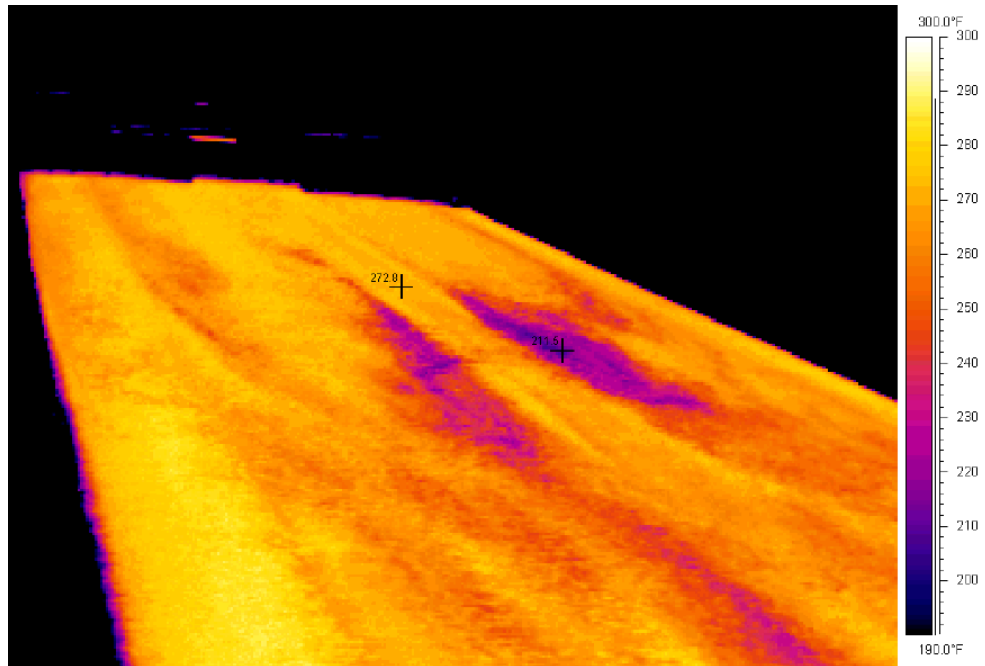
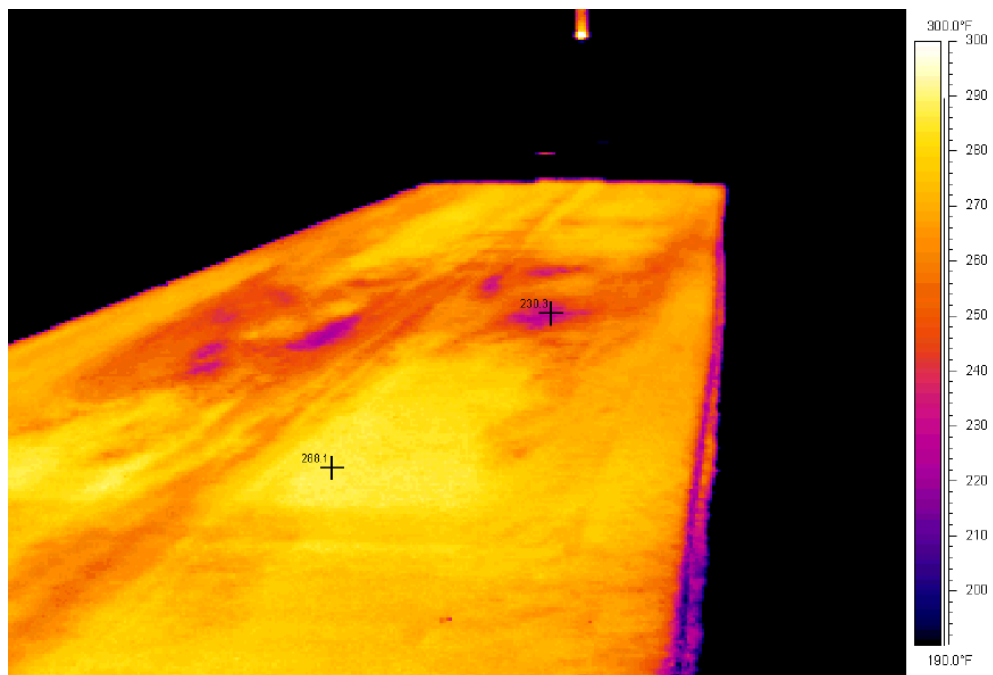
The typical mat temperature prior to compaction was 290°F. Cyclic cool spots were observed typically in the middle of the lane and a maximum temperature differential of approximately 60°F was documented. Spilled material was often left on the existing pavement in front of the paver. Delays between haul units arriving at the site permitted excessive cooling of this spilled-loose material, making it more difficult to compact once it was covered by fresh HMA since the effective heat transfer between the two materials was not attained. Figure 14 shows the typical cold spot configurations observed at this location. The cool spots were not nearly as large as were observed at other projects. This was most likely the result of the ambient air temperature being warmer than on the other projects that had much more expansive cold spots.

Figure 14 – Typical Cold Spot configuration observed on Route 66 in Windham

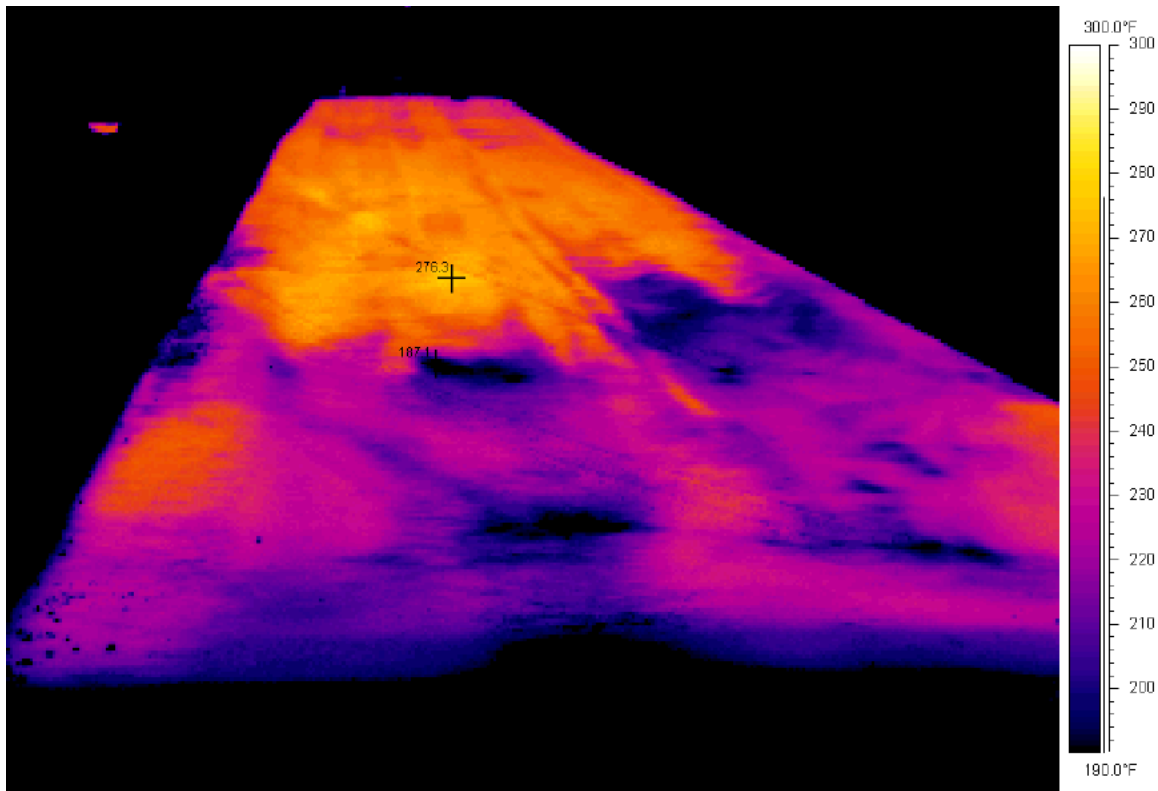
Figure 15 shows an image taken after a long delay between truckloads of material being delivered to the site. The image has the paver moving away in the image and the black region at the bottom of the image shows that the pavement placed before the delay was cooler than 190°F. The delay was approximately 50 minutes and the resulting temperature difference was almost 90°F.

Figure 15 – Image showing effect of approximately 50 minute delay between truck loads of material being delivered to the site – Route 66 in Windham.  
(The paver is moving away in this image)

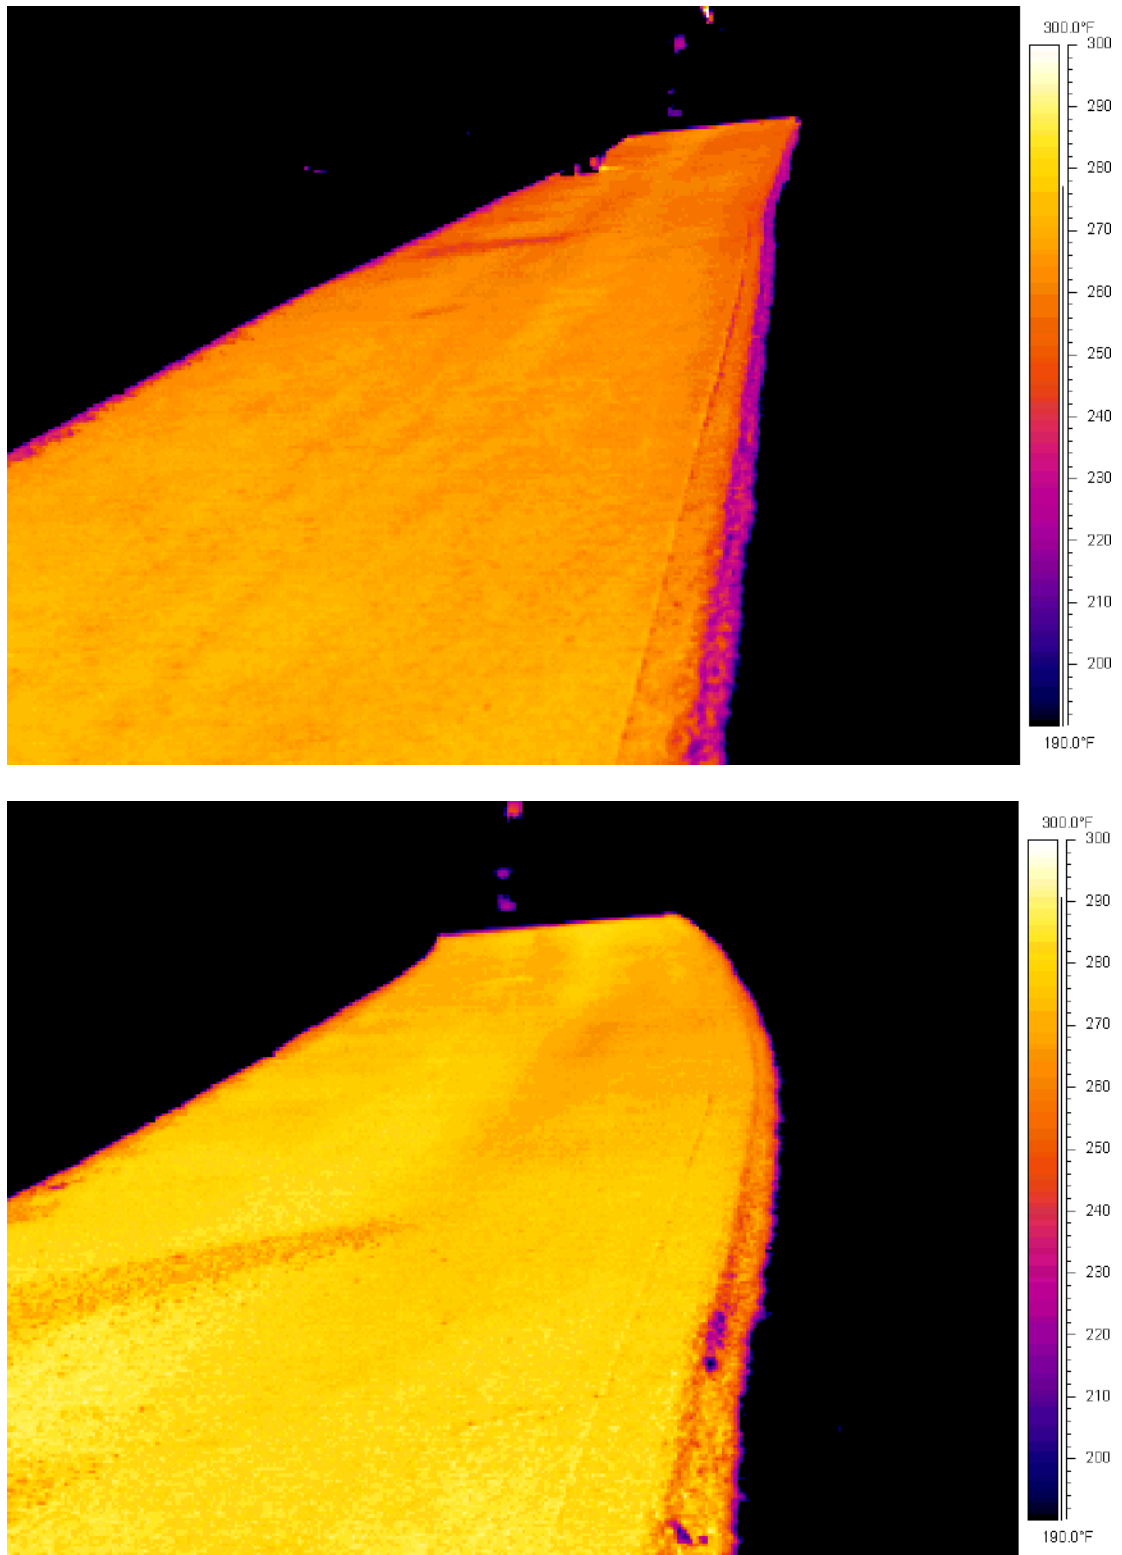
Infrared images indicated that the existing mat surface temperature, prior to placement of wearing course, was recorded to be 100°F. Temperature differentials in the freshly placed pavement were not observed with the thermographic camera. It appeared that the lack of material spillage and the advantage of remixing provided by using the material transfer vehicle virtually eliminated the presence of temperature differentials. Figure 16 shows the typical thermographic profile observed at this project.

Figure 16 – Typical Thermographic Images from Route 2 in Stonington where a re-mixing MTD was used.

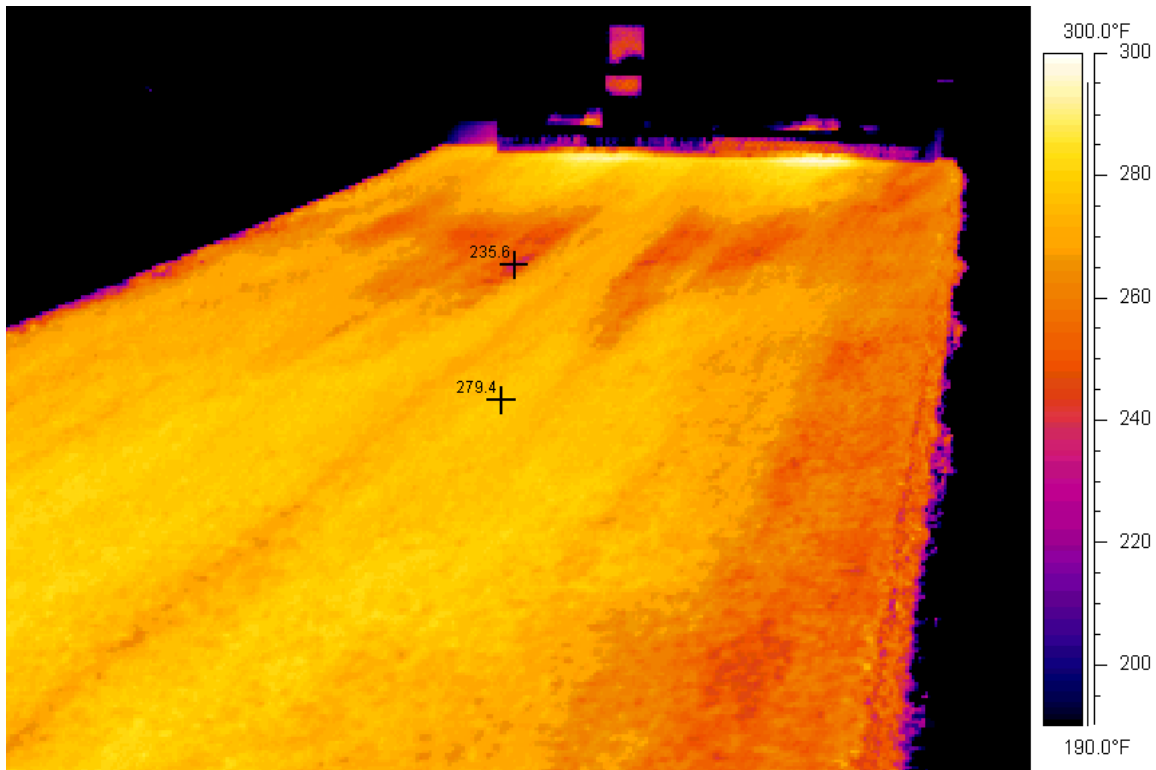
Infrared images indicated that the existing mat surface temperature, prior to placement of wearing course, was recorded to be 85°F. Temperature differentials in the freshly placed pavement were not observed to be as severe as in the paving sites where a material transfer vehicle was not used. Trucks dumping into a MTD tend to spill less material since there is no concern for maintaining some material in that hopper unlike when trucks dump directly into the paver hopper. By allowing the MTD hopper to empty completely, all of the material in the haul unit can be easily delivered to the MTD hopper. And when the haul unit leaves the MTD hopper there is little to no material remaining

**Figure 17, Area of Cooler Material Behind the Paver using a MTD that does not Re-mix the Material.**

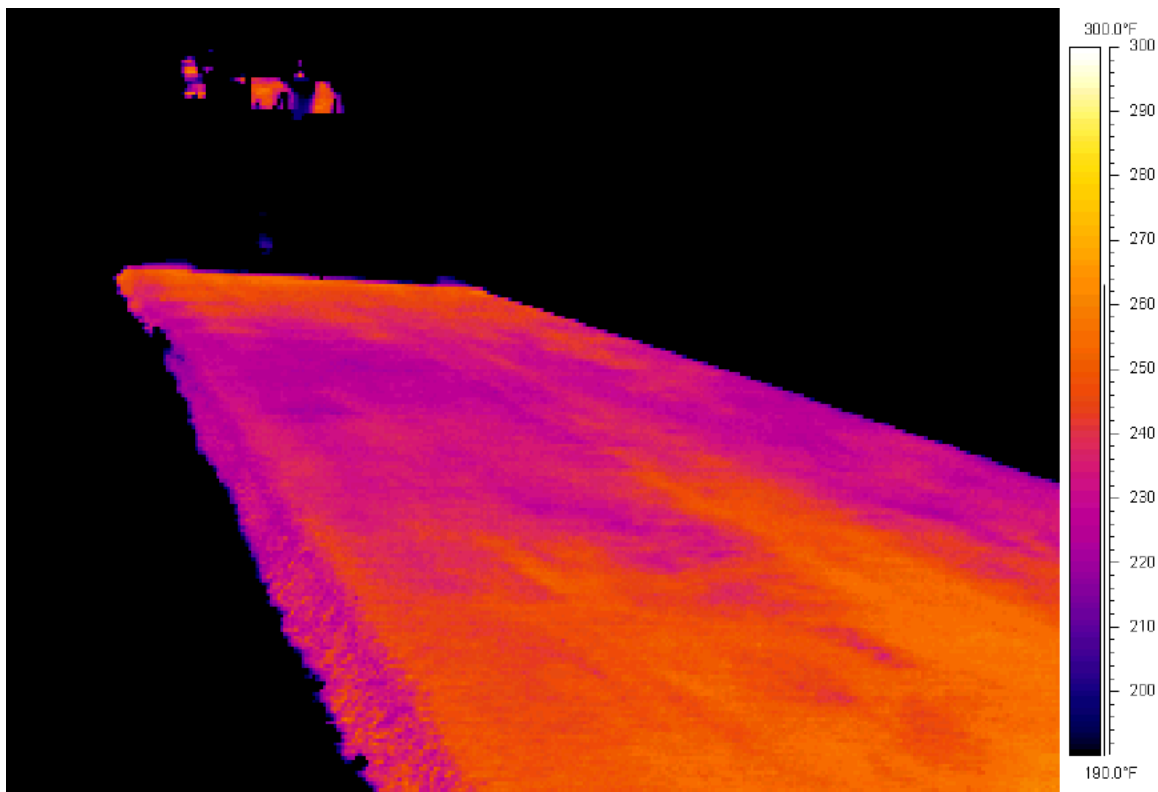
Figure 18 – Typical Thermographic Image of Paving on Route 195 with a MTD
