TRANSPORTATION RESEARCH BOARD

Performance and Benefits of Metalizing and Duplex Coating

November 18, 2021

Using Metalizing to Enhance Durability of Steel Bridges

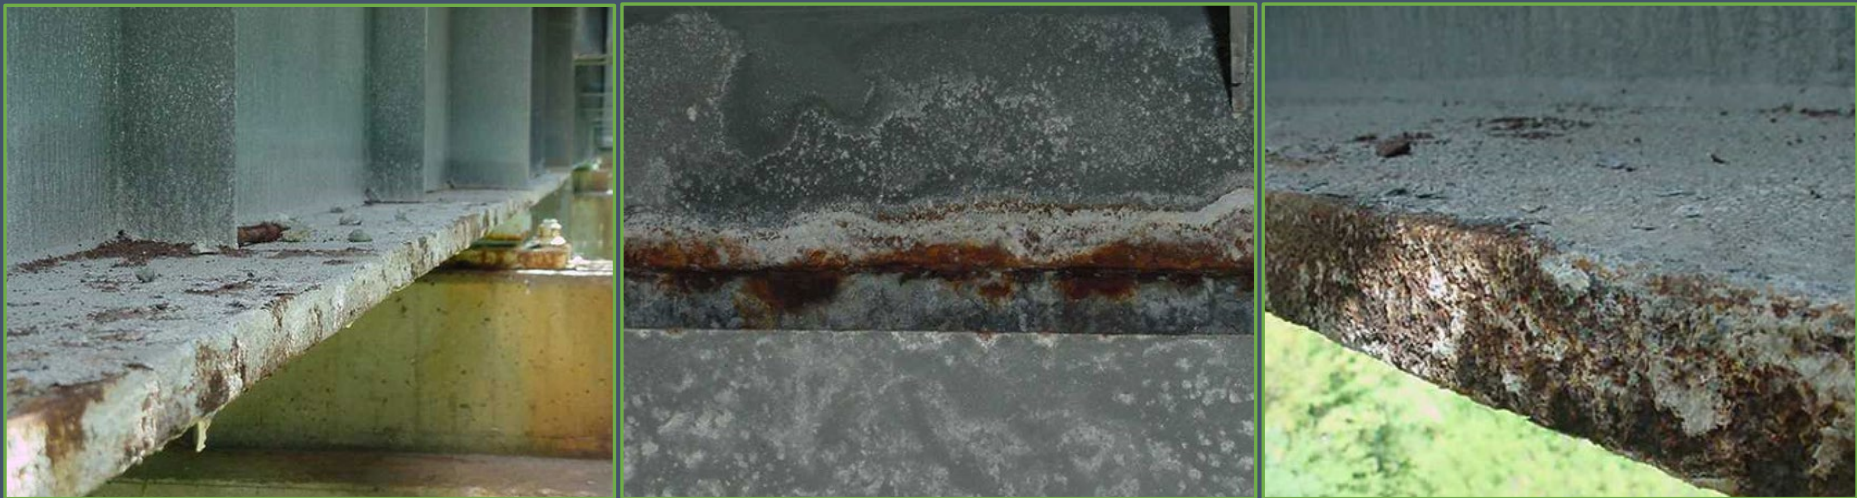
Castleton on Hudson Approach Spans

- The **un-sealed** metalizing was subjected to magnesium chloride deicing salts during the winters of 2001 and 2002.
- The metalizing deteriorated quickly.

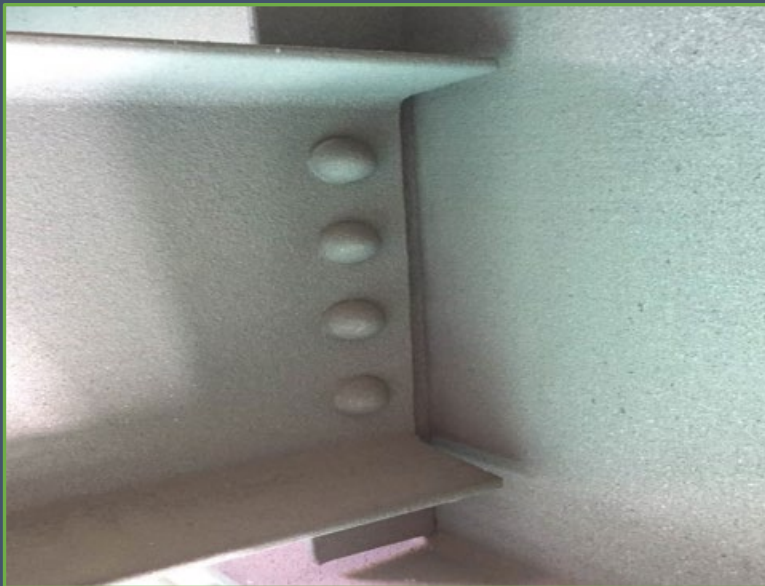
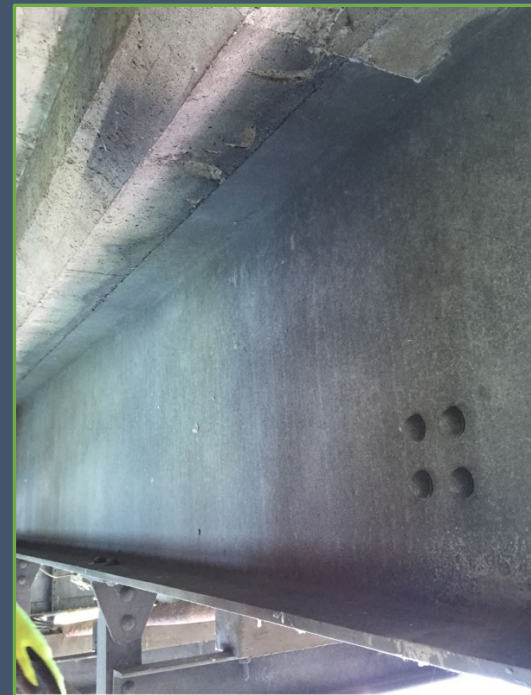
Rainbow Bridge, Niagara Falls, NY

- Metallizing performing well after 2 decades.
- A small number of problem areas isolated to areas of joint leakage.

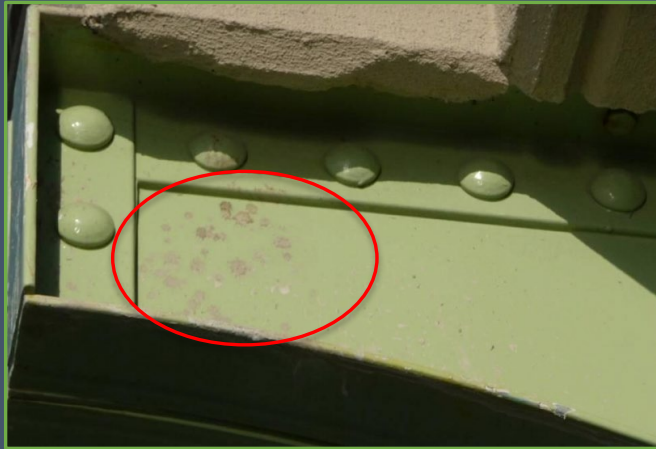
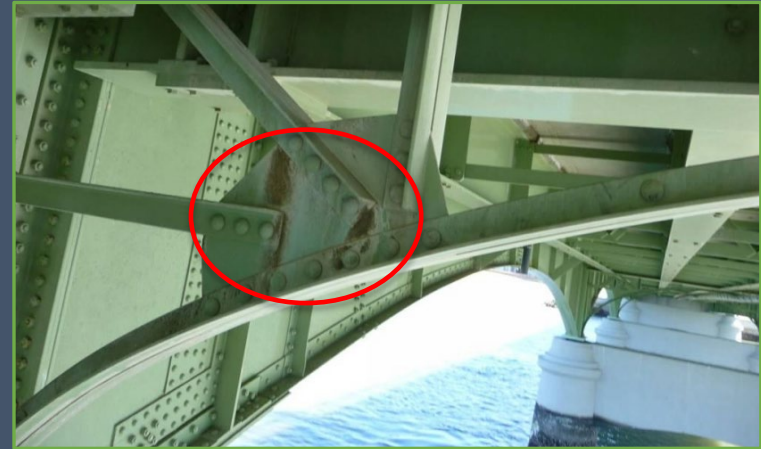
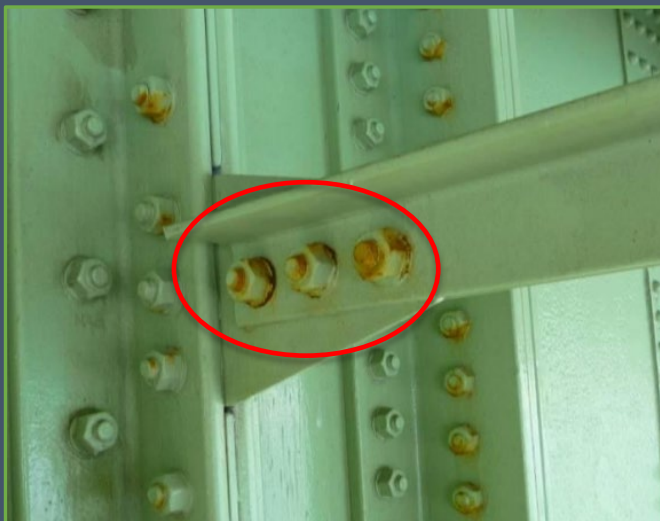
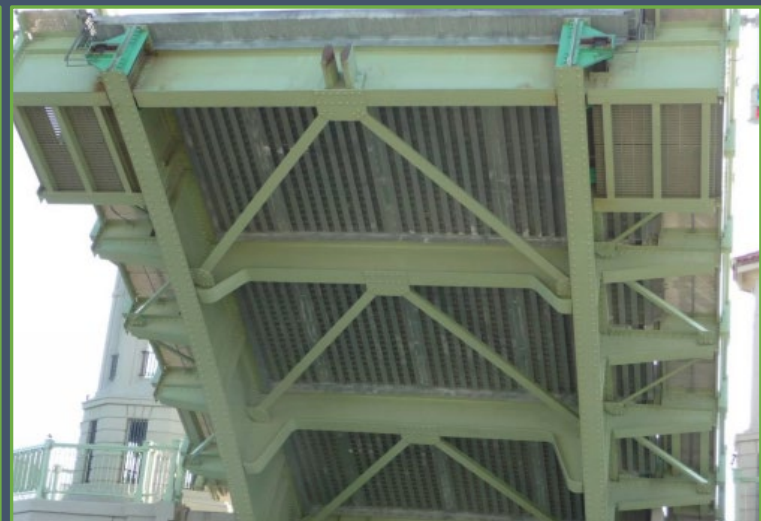
Bridge of Lions, St. Augustine, Fl.

- By 2012, after four years, areas of corrosion and delamination were observed.

- Detailed examination determined that localized failures were do to either localized application or preparation errors.
- Overall condition of the coating system was excellent.
- Localized repairs have been performed.... Its early in the estimated life-cycle - Stay tuned.

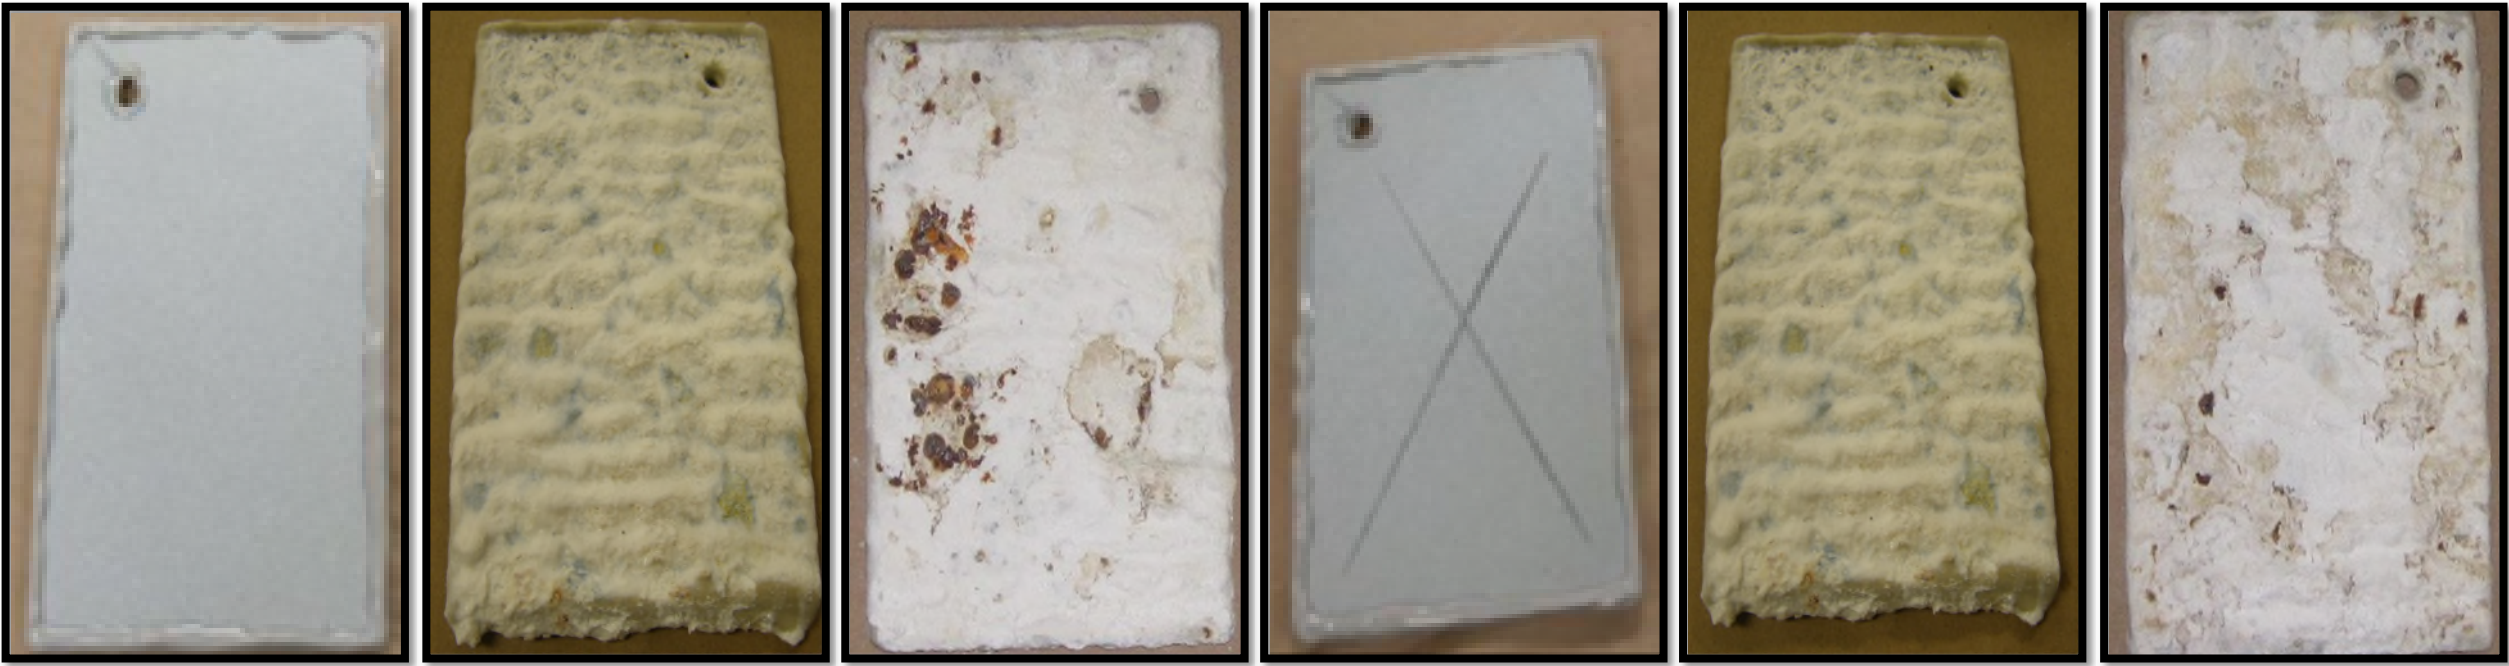
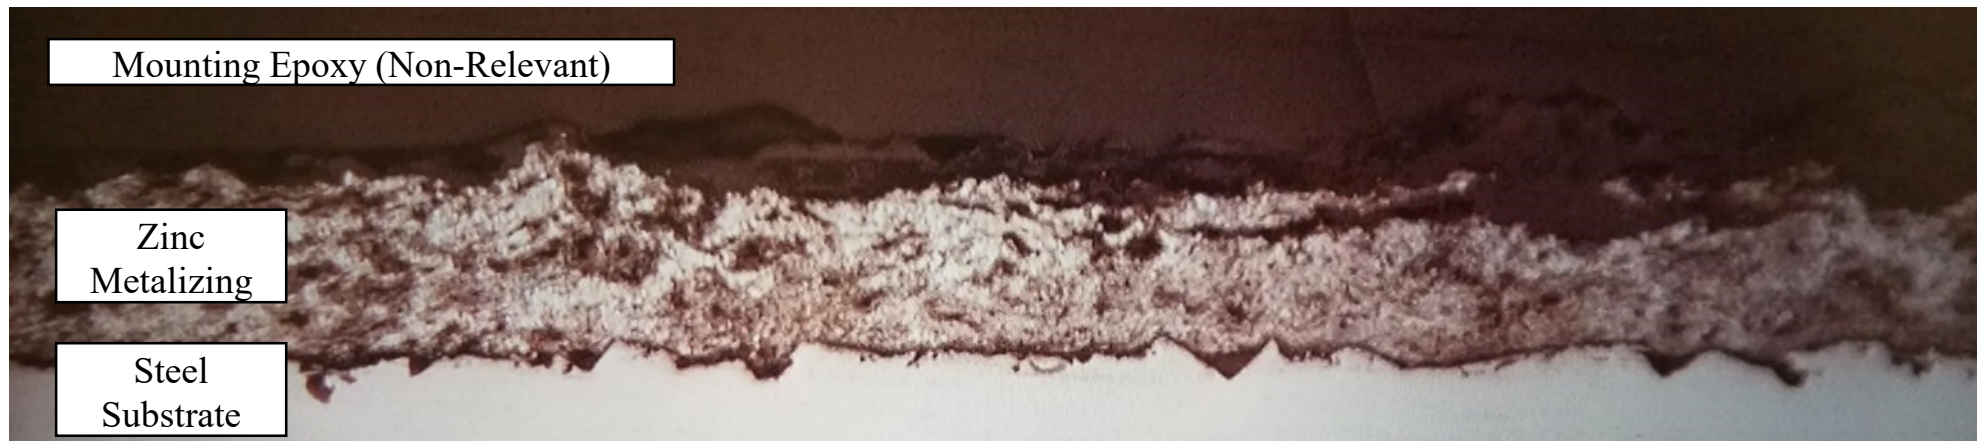
Zinc Metalizing (99% Zn)

Condition of the panels at 0 hrs., 30,000 hrs., 5 years; Left (Unscribed) & Right (Scribed)

Adhesion 834 psi

Image taken using Optical Microscope after 5-yrs. in the salt fog chamber (350x).

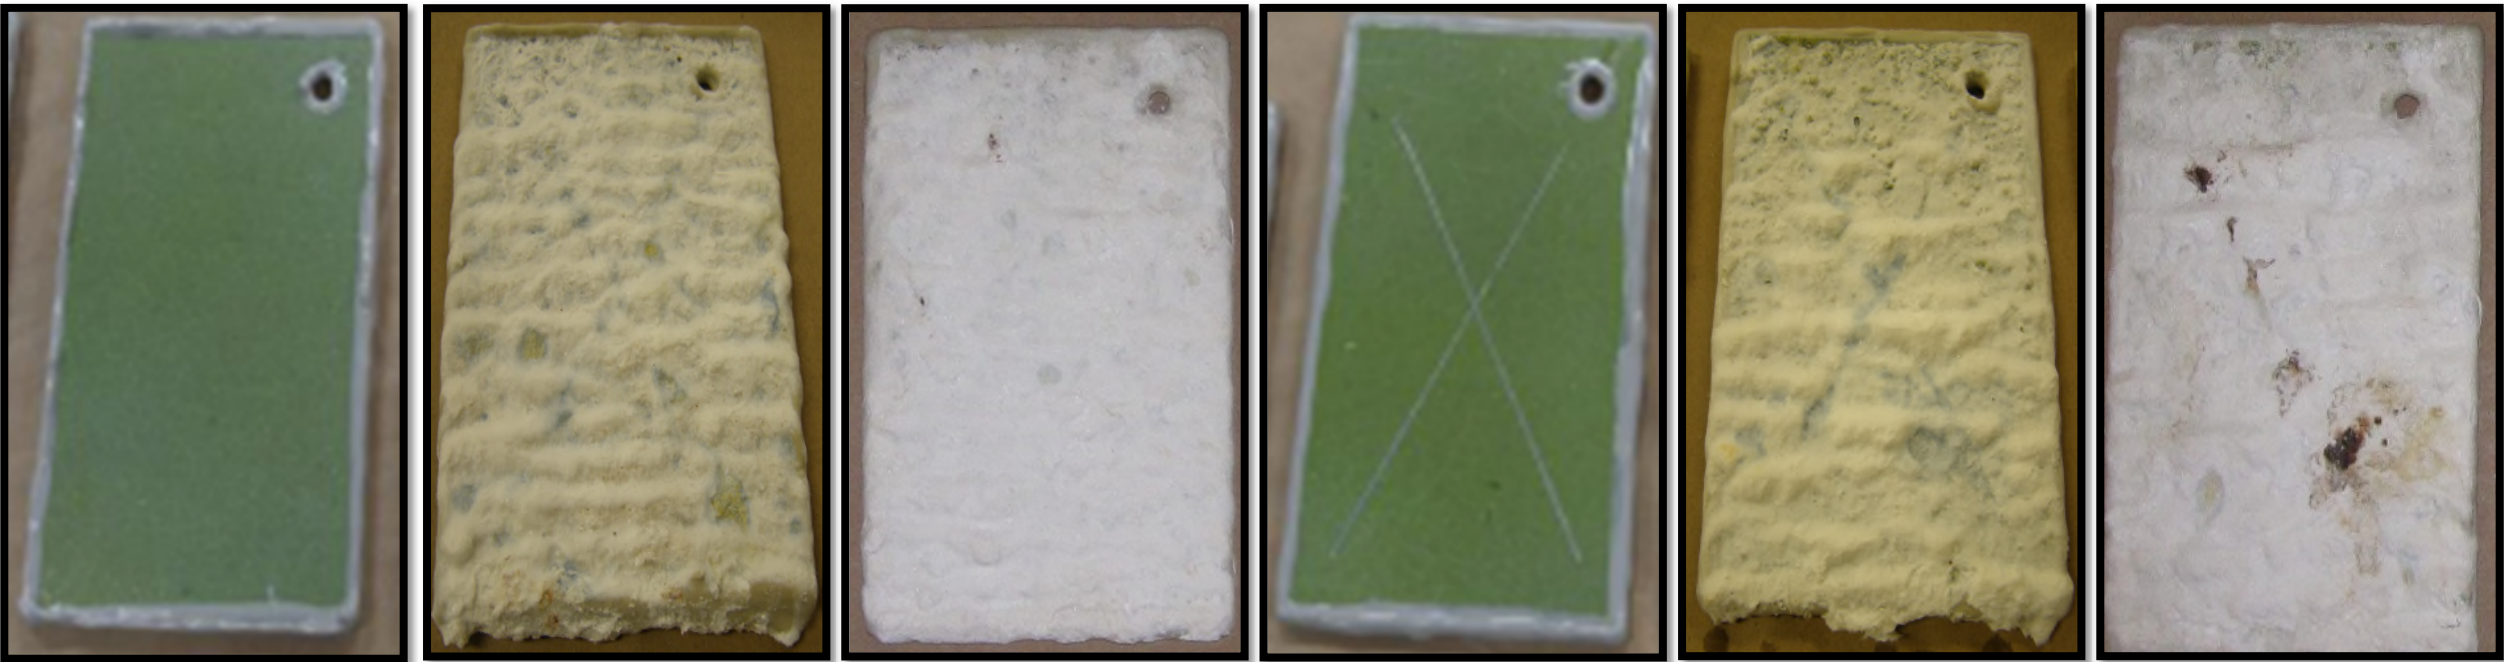
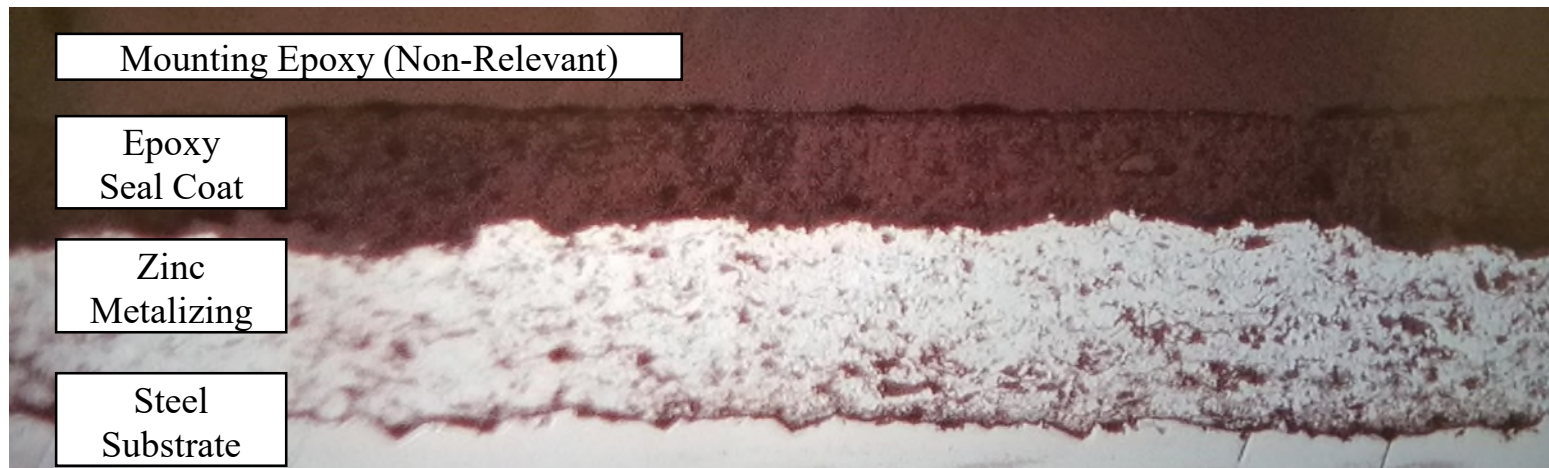
Zinc Metalizing (99% Zn) + Epoxy Seal Coat

Condition of the panels at 0 hrs., 30,000 hrs., 5 years; Left (Unscribed) & Right (Scribed)

Adhesion 837 psi

Image taken using Optical Microscope after 5-yrs. in the salt fog chamber (350x).

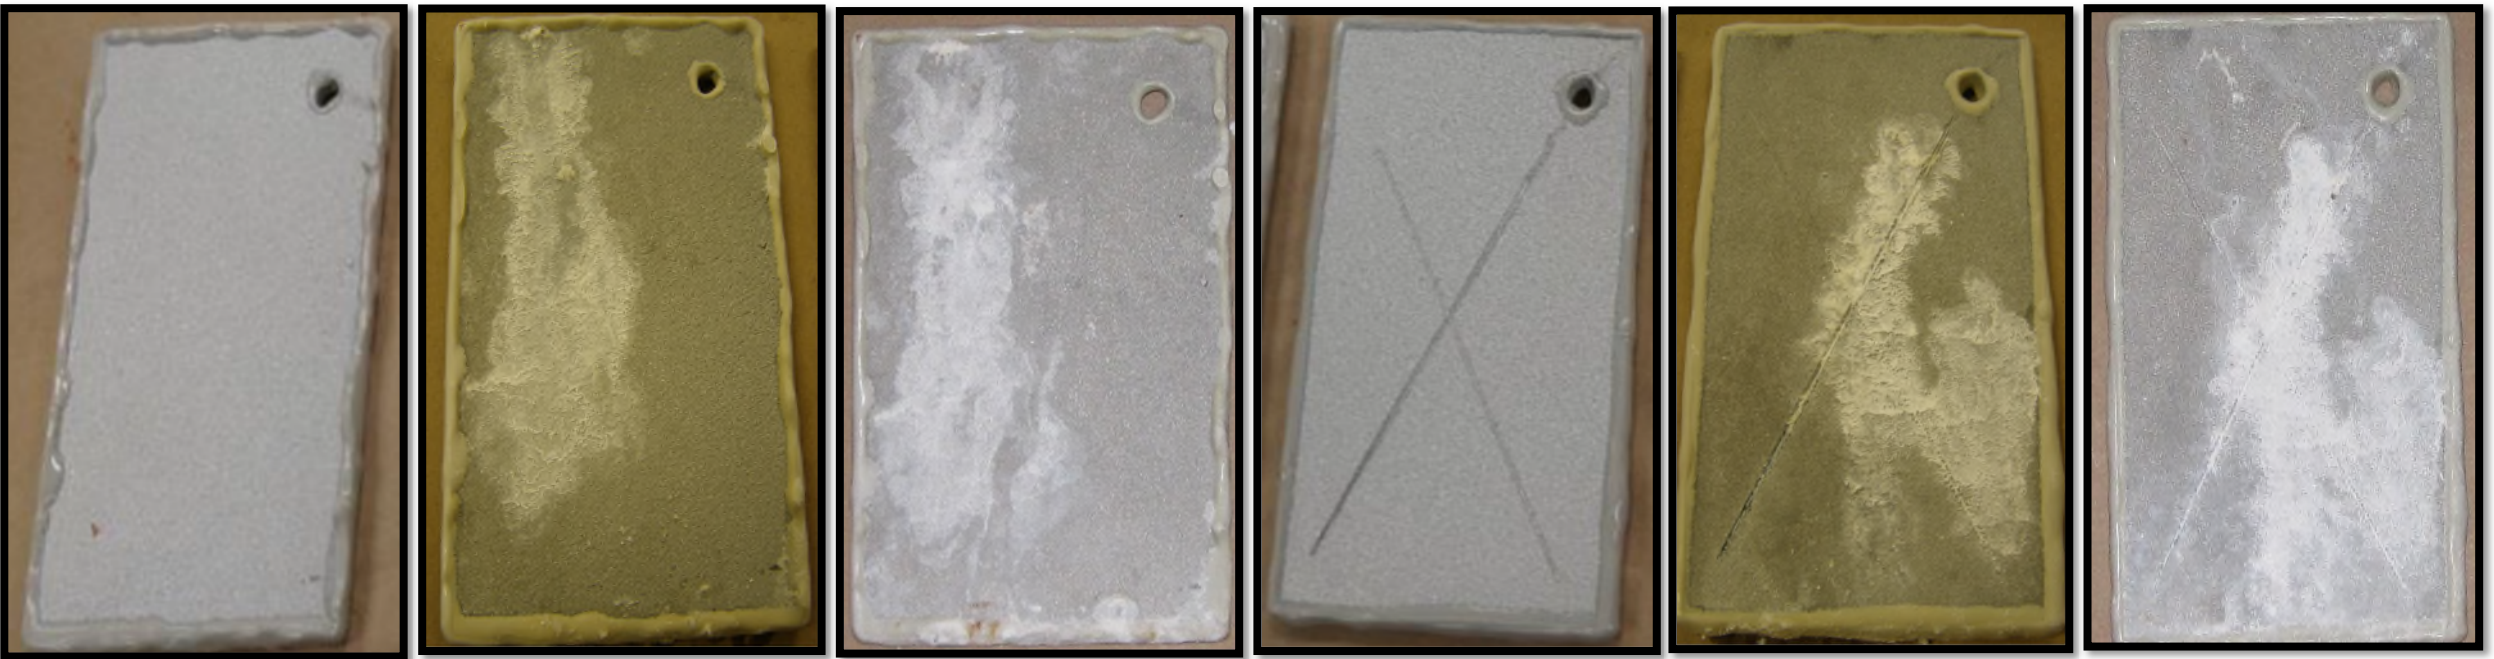
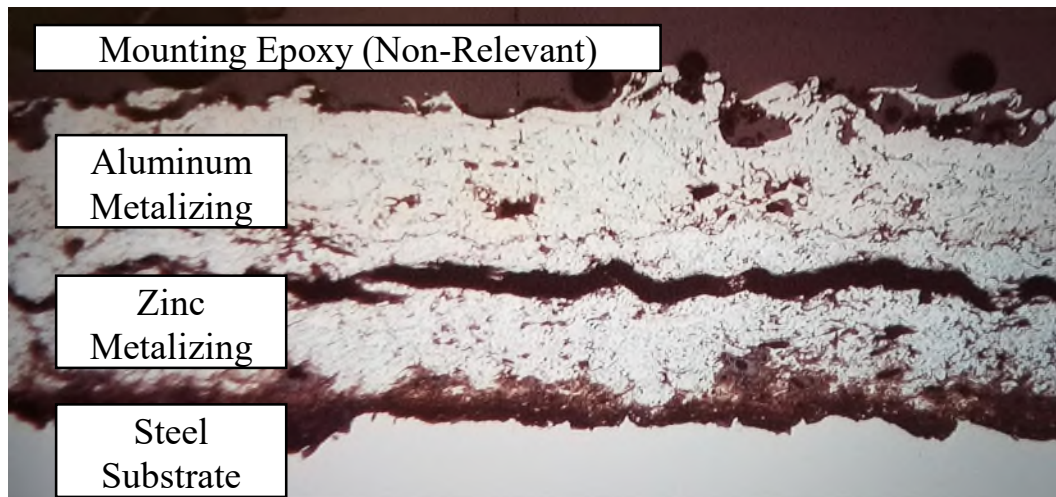
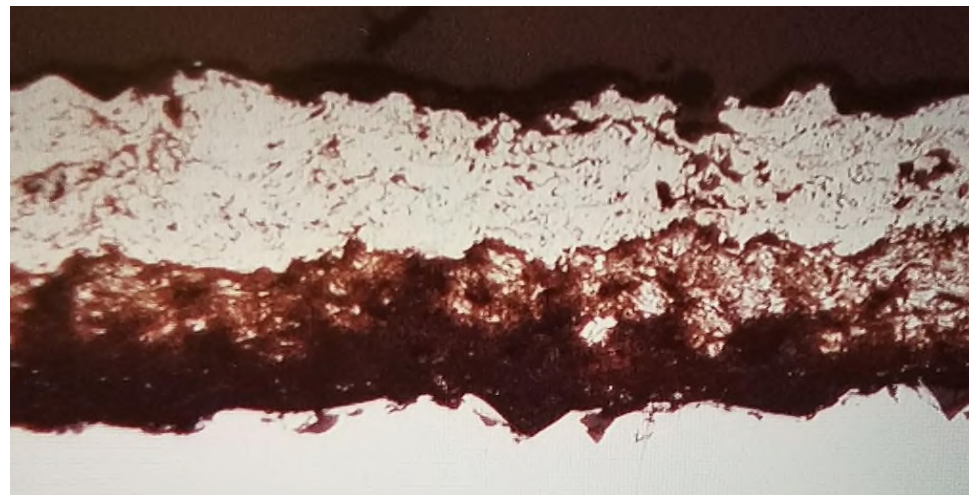
Zinc Metalizing (99% Zn) + Aluminum Metalizing (99% Al)

Condition of the panels at 0 hrs., 30,000 hrs., 5 years; Left (Unscribed) & Right (Scribed)

Adhesion 923 psi

Image taken using Optical Microscope after 5-yrs. in the salt fog chamber (350x).

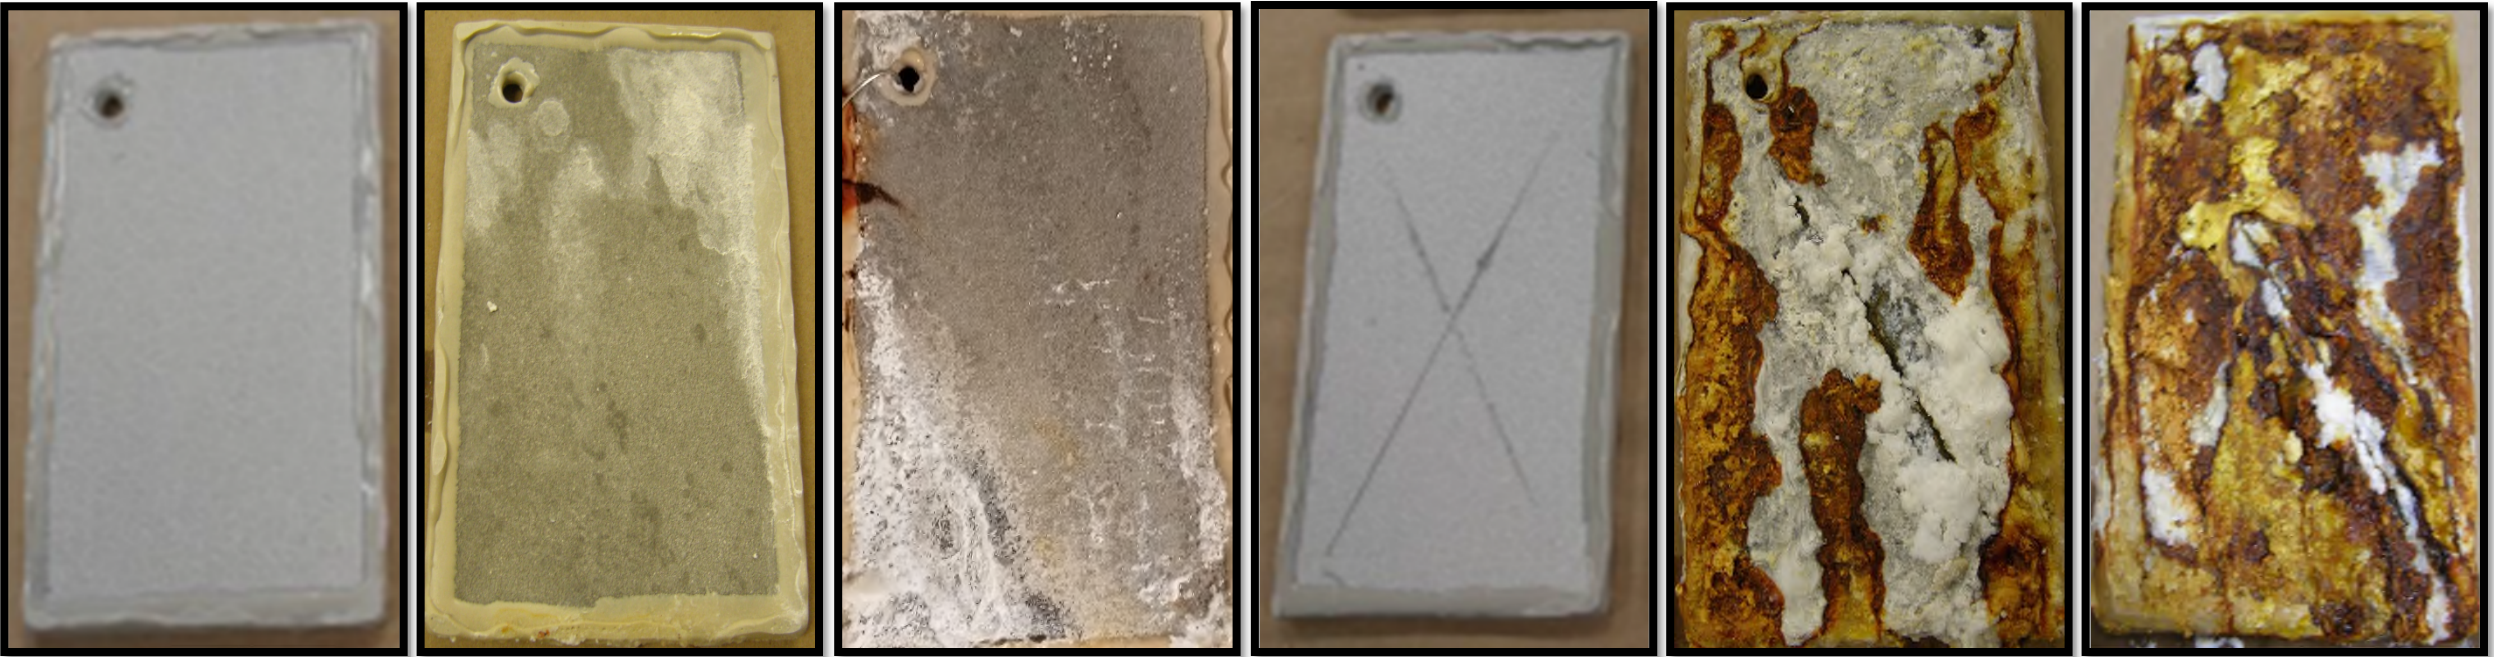
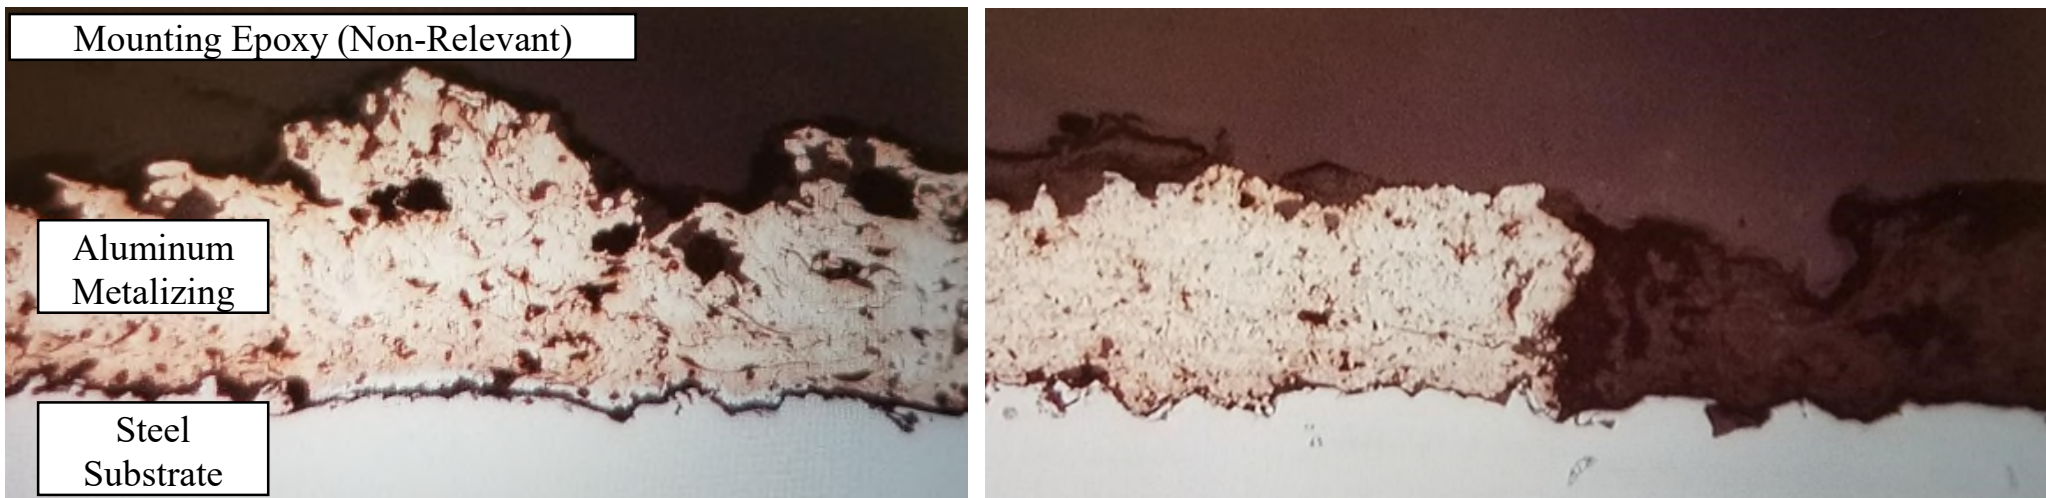
Aluminum Metalizing (99% Al)

Condition of the panels at 0 hrs., 30,000 hrs.*, 5 years; Left (Unscribed) & Right (Scribed tests ended at 20,000 hrs.)

Adhesion 450 psi

Image taken using Optical Microscope after 5-yrs. in the salt fog chamber (350x).

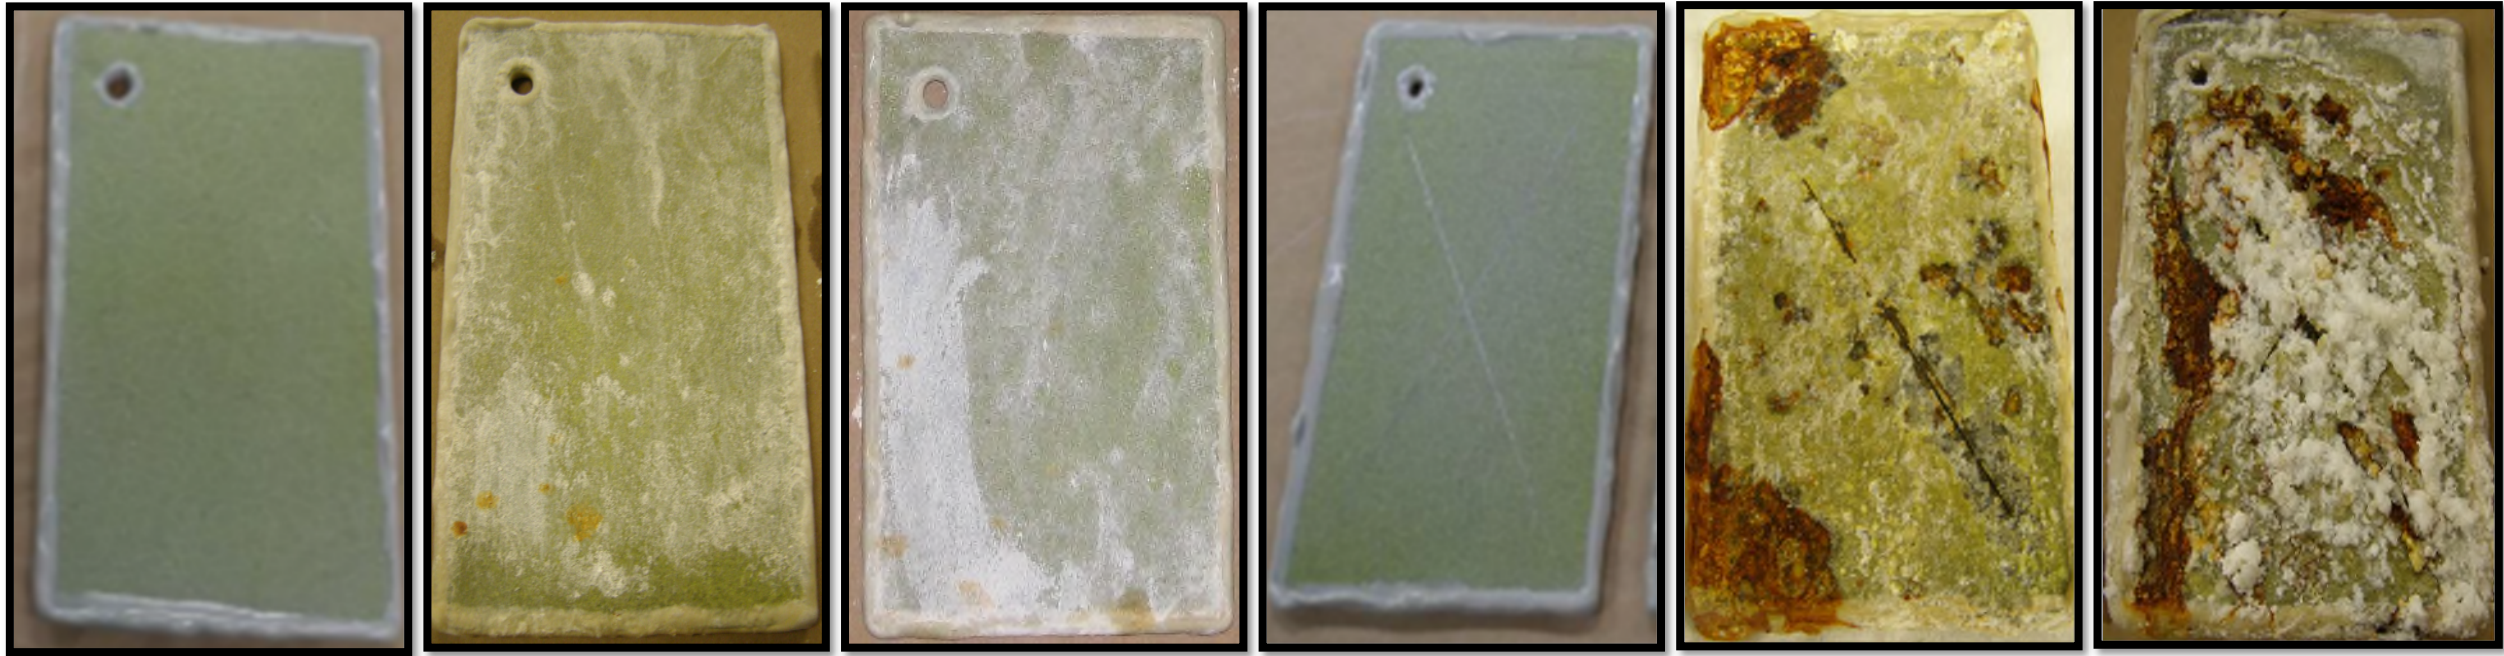
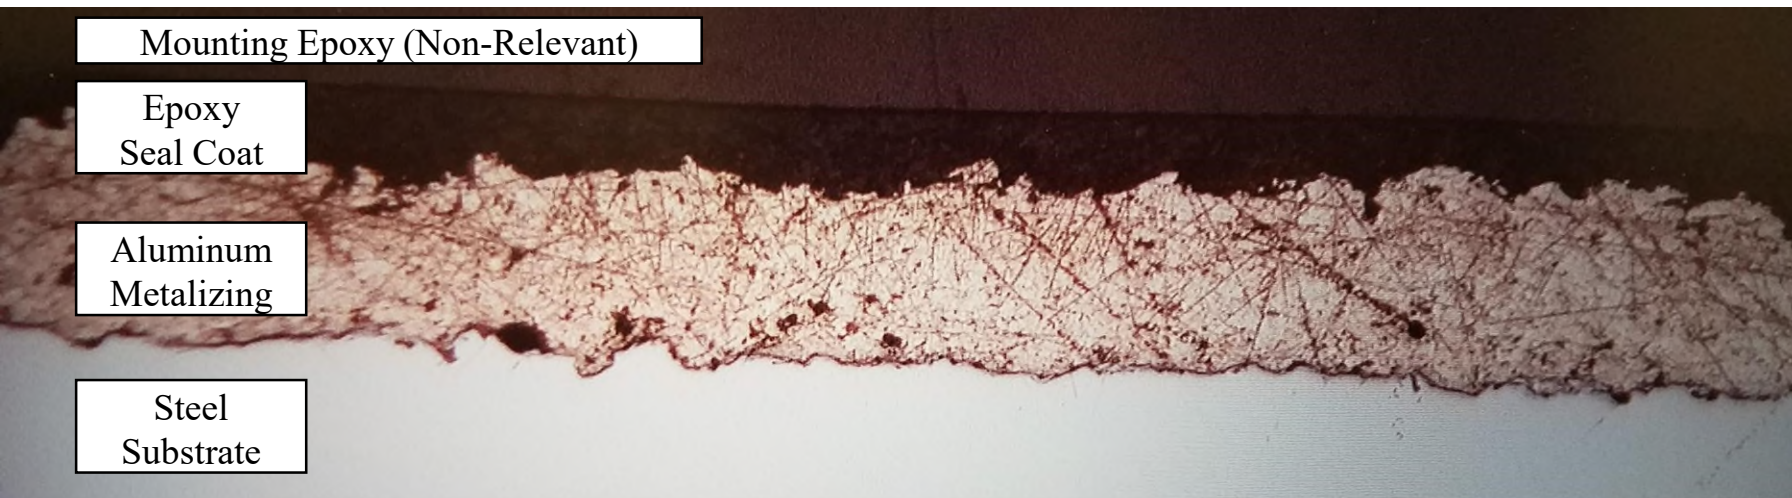
Aluminum Metalizing (99% Al) + Epoxy Seal Coat

Condition of the panels at 0 hrs., 30,000 hrs.*, 5 years; Left (Unscribed) & Right (Scribed tests ended at 21,000 hrs.)

Adhesion 1,532 psi

Image taken using Optical Microscope after 5-yrs. in the salt fog chamber (700x).

If the structure can be erected or coated without damage, a coating system made of 99% aluminum metalizing with an epoxy seal coat performed very well. Unfortunately, the coating did not perform well when damaged. It would become a critical step for the Owner to specify the repair of any damaged area.

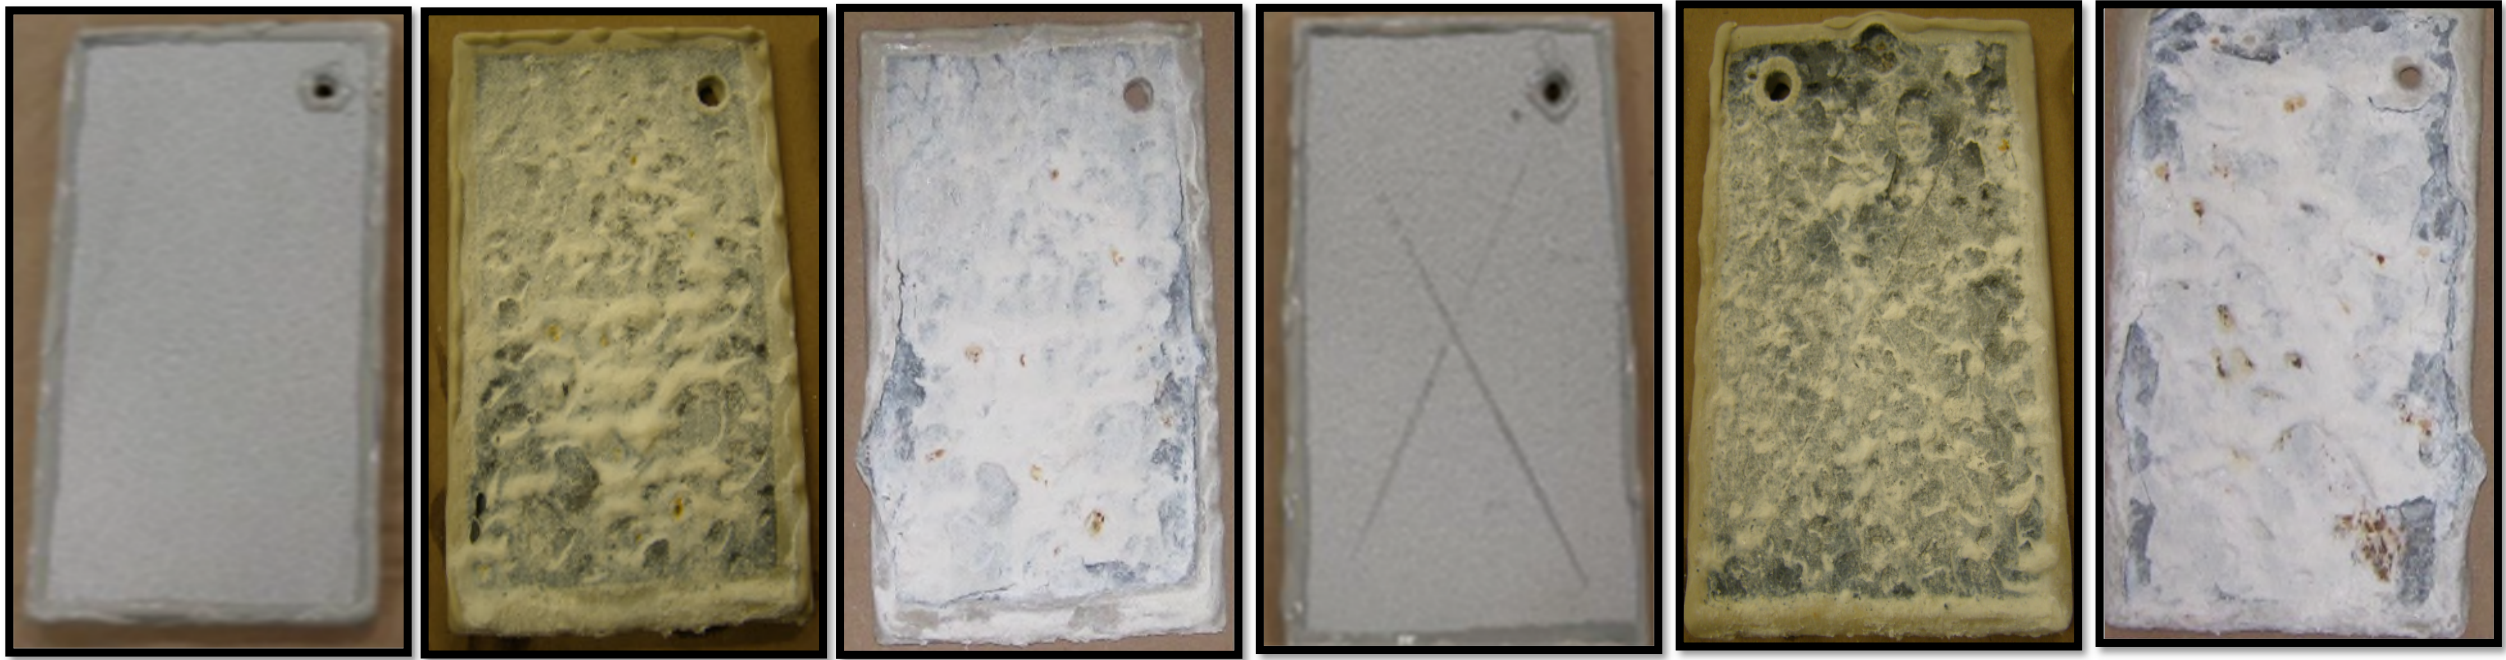
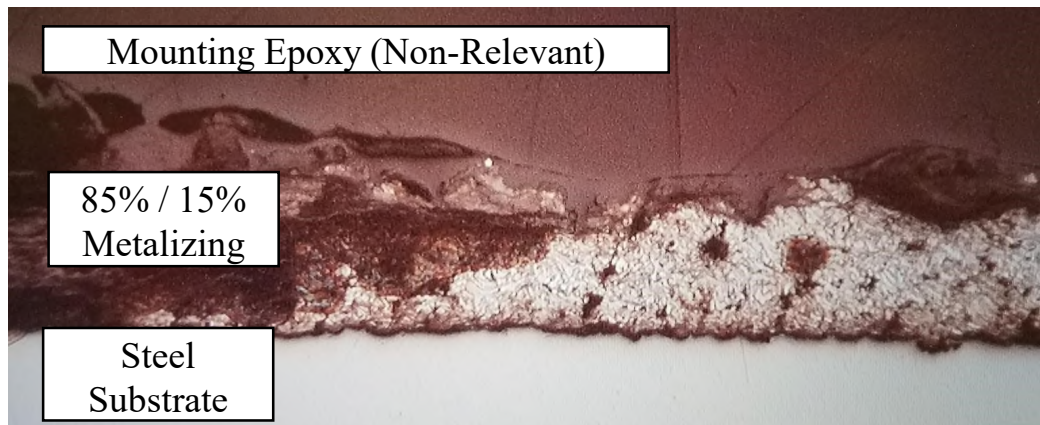
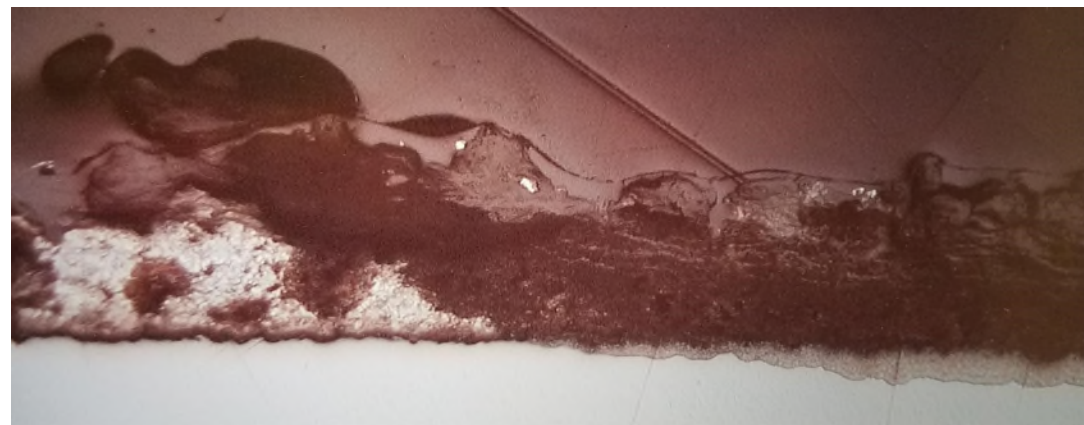
Zinc/Aluminum Metalizing (85% Zn / 15% Al)

Condition of the panels at 0 hrs., 30,000 hrs., 5 years; Left (Unscribed) & Right (Scribed)

Adhesion 522 psi

Image taken using Optical Microscope after 5-yrs. in the salt fog chamber (350x).

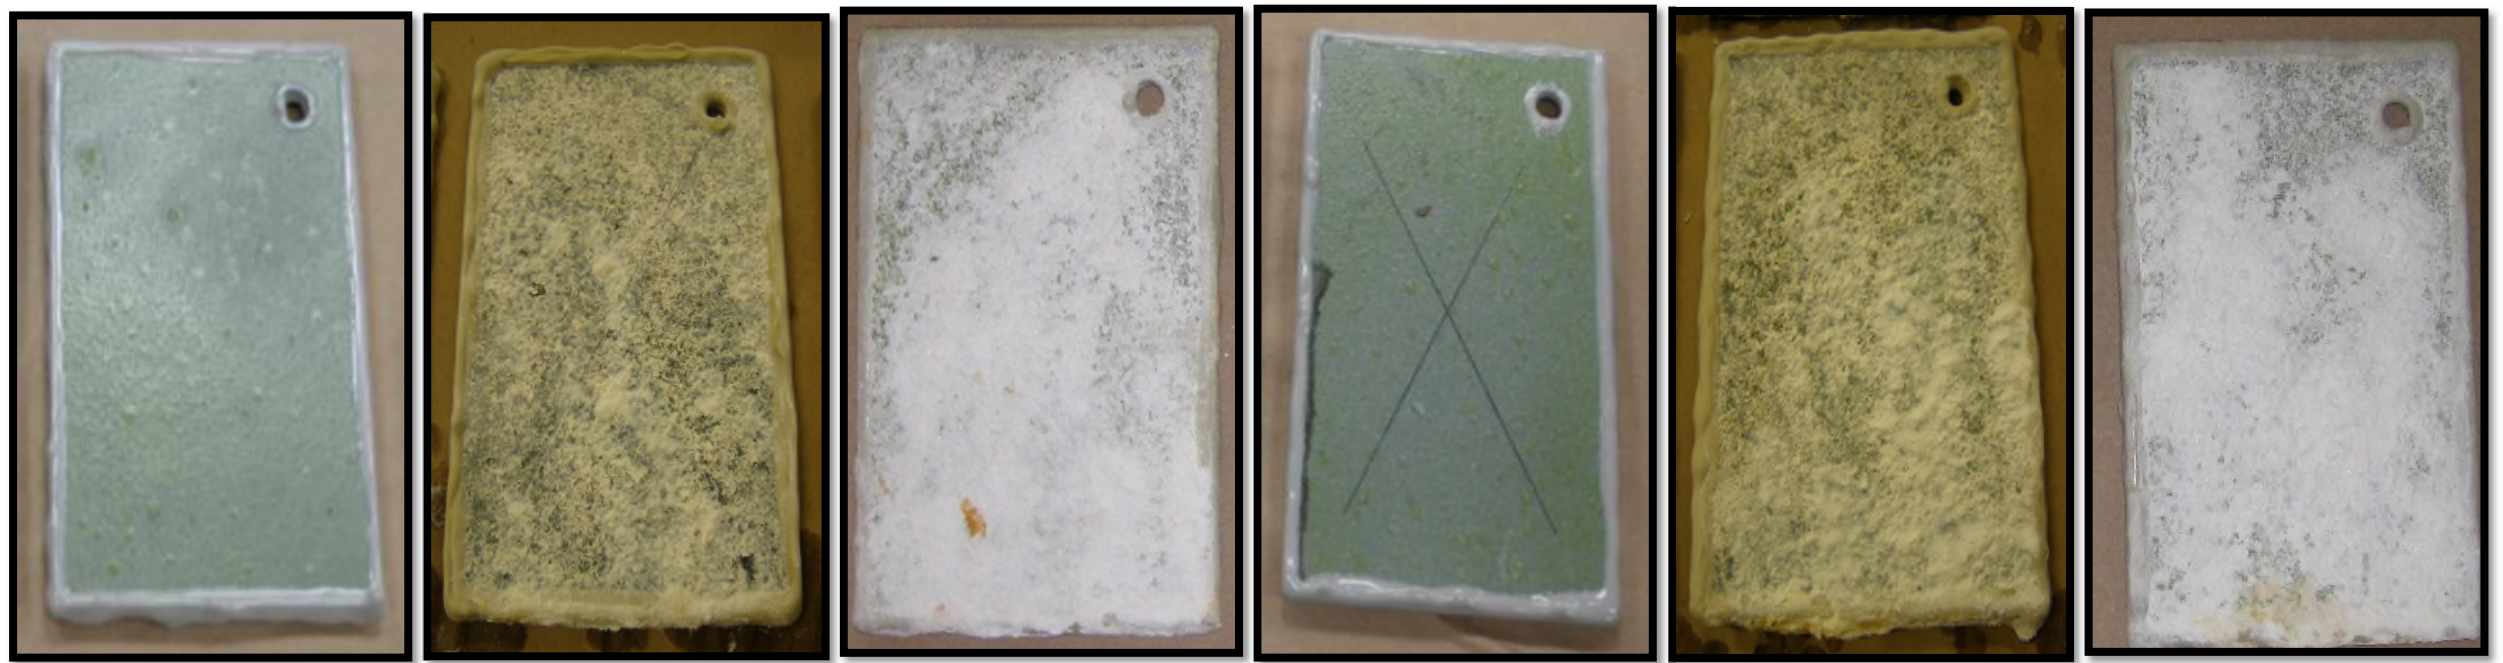
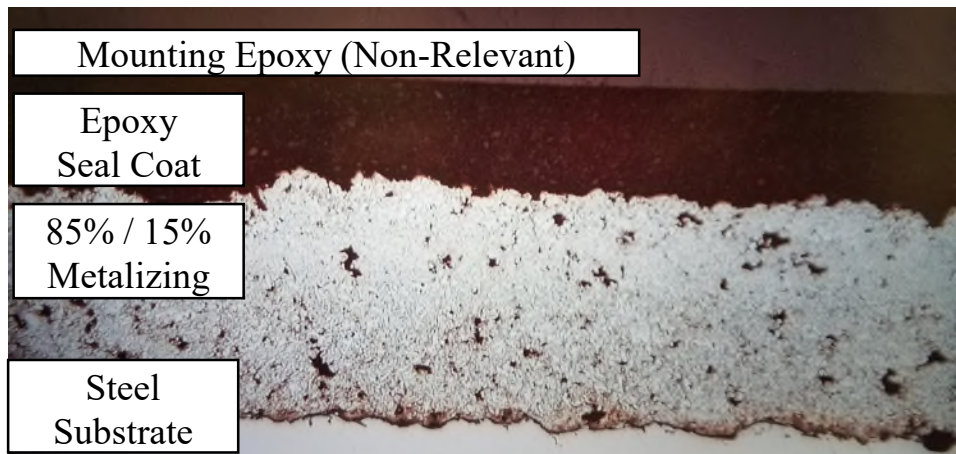
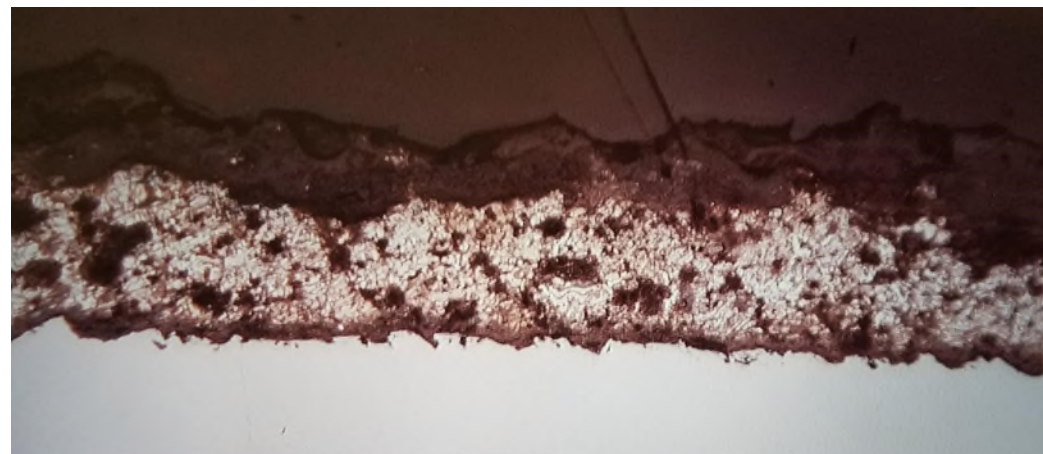
Zinc/Aluminum Metalizing (85% Zn / 15% Al) + Epoxy Seal Coat

Condition of the panels at 0 hrs., 30,000 hrs., 5 years; Left (Unscribed) & Right (Scribed)

Adhesion 765 psi

Image taken using Optical Microscope after 5-yrs. in the salt fog chamber (700x Left & 350x Right).

Zn/Al Metalizing (85% Zn/15% Al) Epoxy Seal Coat	Surface generates medium oxides and some corrosion over time. Microscopy shows confirms reactivity, surface break down near damaged areas; and excellent performance when left undamaged.
IOZ (Ethyl Silicates, min. 77% Zinc) Epoxy Seal Coat	Surface generates moderate oxides and some corrosion over time. Microscopy shows a fractured but functional underlying primer.
