TRANSPORTATION RESEARCH BOARD

Performance and Benefits of Metalizing and Duplex Coating

November 18, 2021

Using Metalizing to Enhance Durability of Steel Bridges

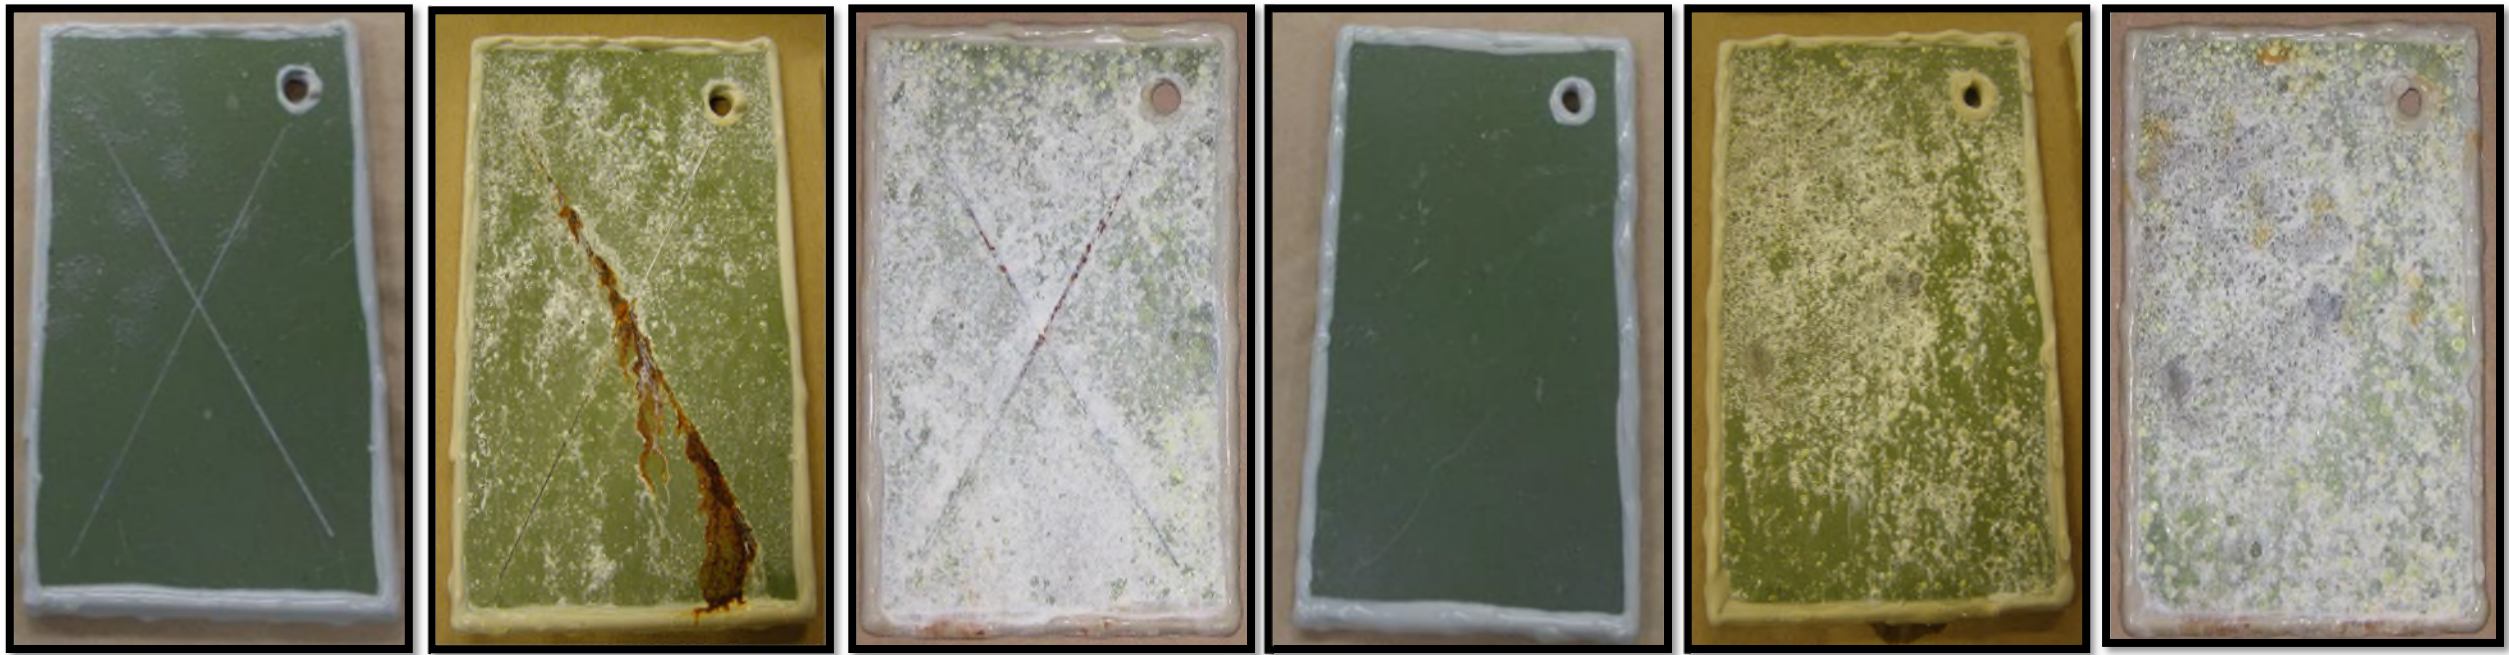
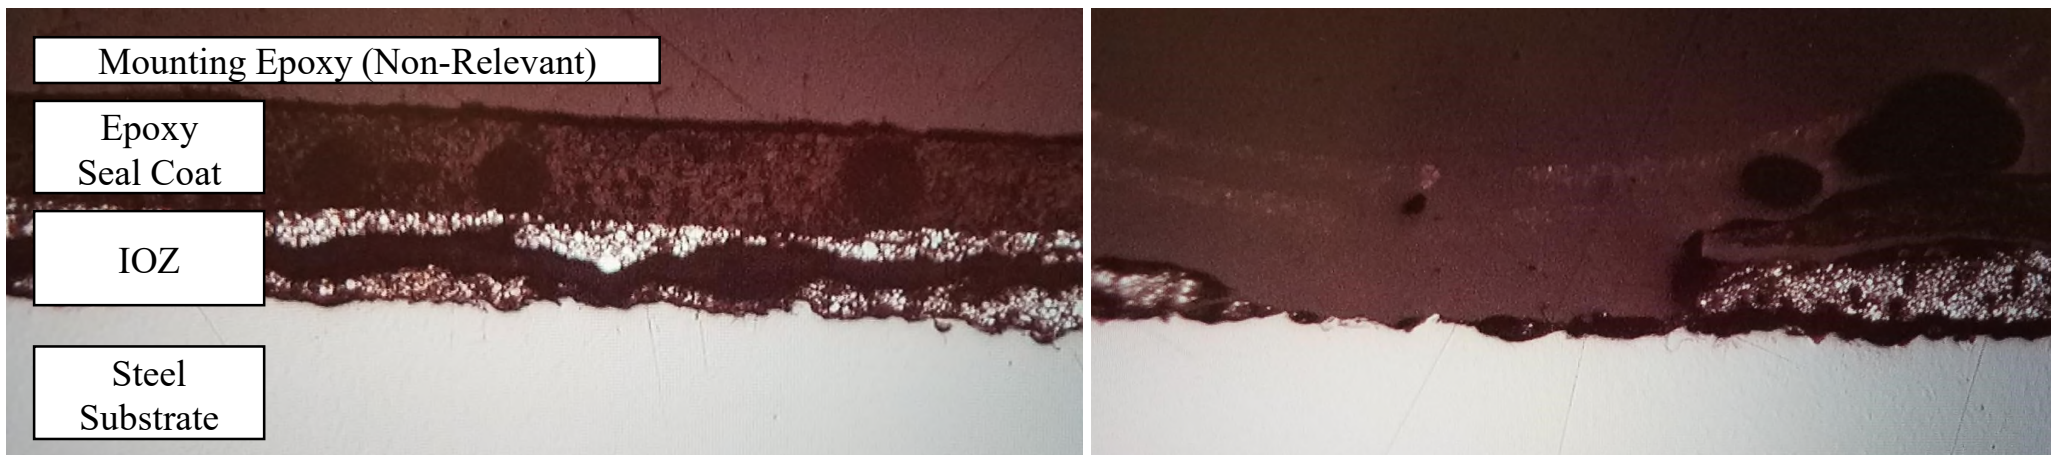
Inorganic Zinc (Ethyl Silicate, min. 77% Zinc) + Epoxy Seal Coat

Condition of the panels at 0 hrs., 30,000 hrs., 5 years; Left (Unscribed) & Right (Scribed)

Adhesion 927 psi

Image taken using Optical Microscope after 5-yrs. in the salt fog chamber (700x Left & 350x Right).

Inorganic zinc rich primer with epoxy seal coats performed well, however, the surface generated a moderate level of oxides, which may limit the ability to inspect during scheduled maintenance.

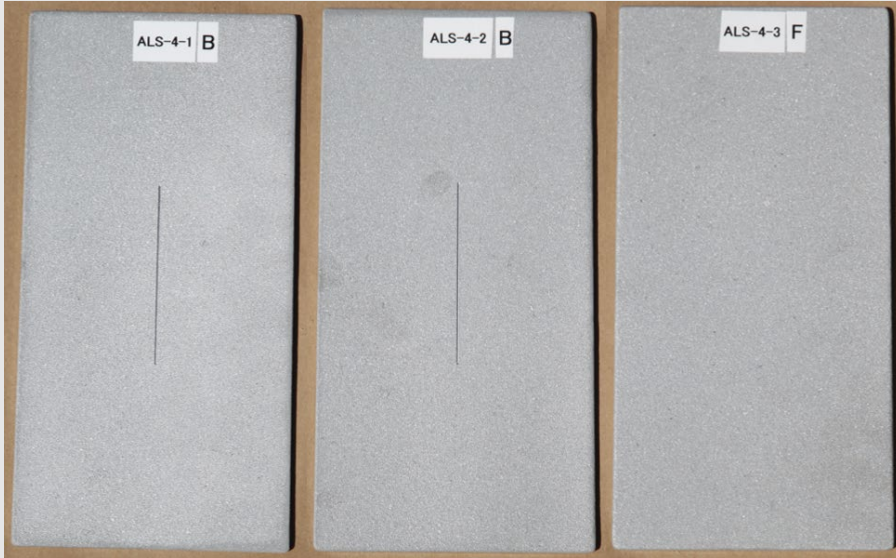
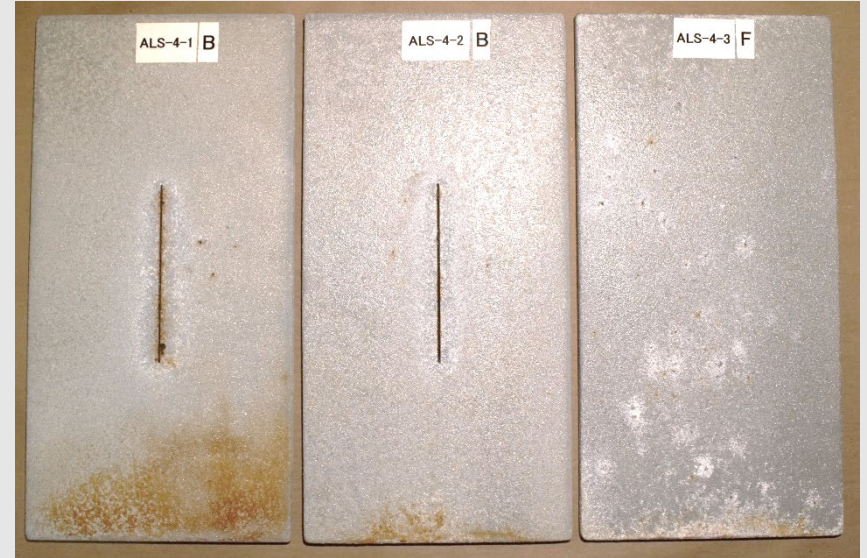
- 4 mil Aluminum, sealed

Seal degraded on 1, mostly intact on 2 and 3

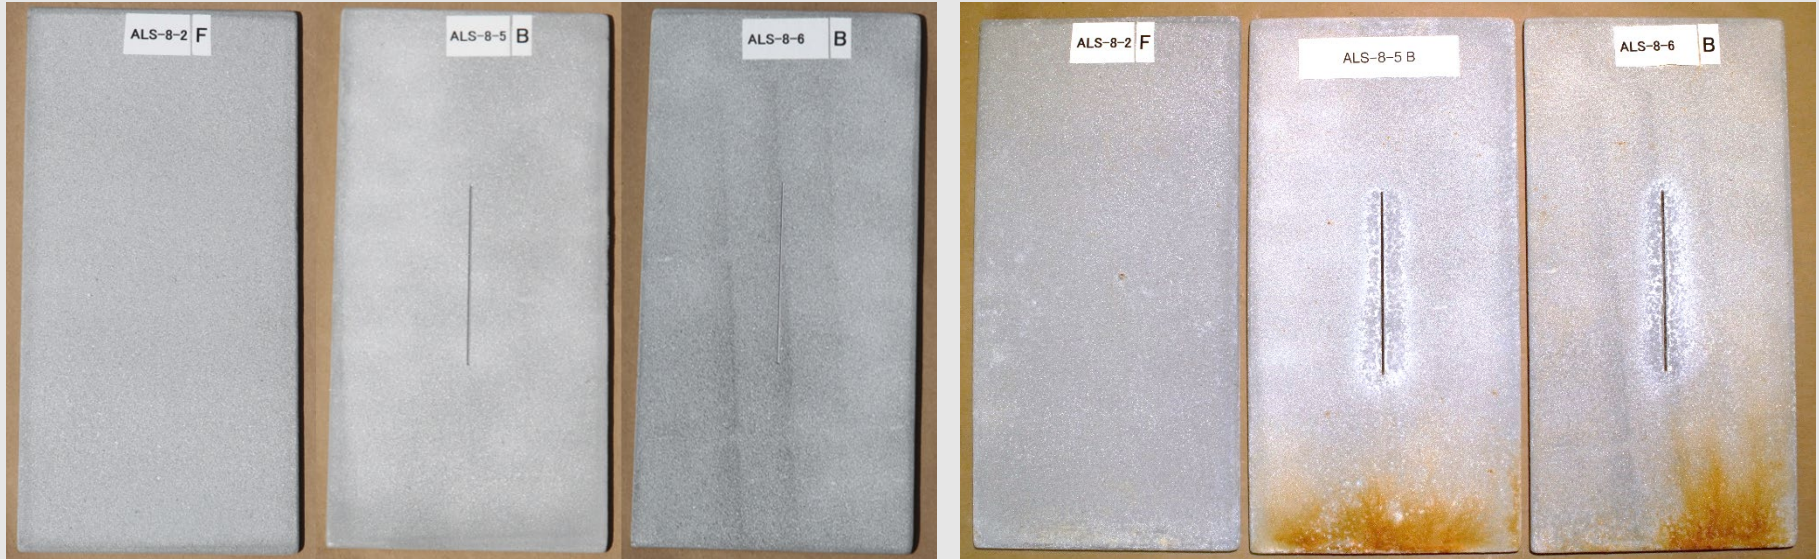
- 8 mil Aluminum, sealed

Seal degraded on all panels

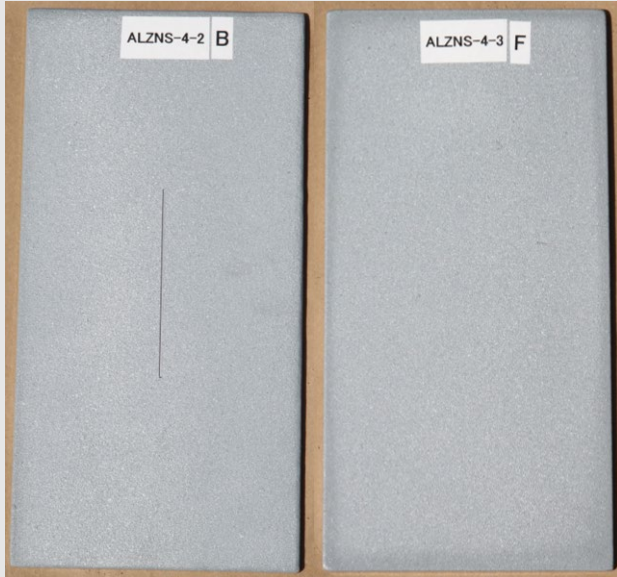
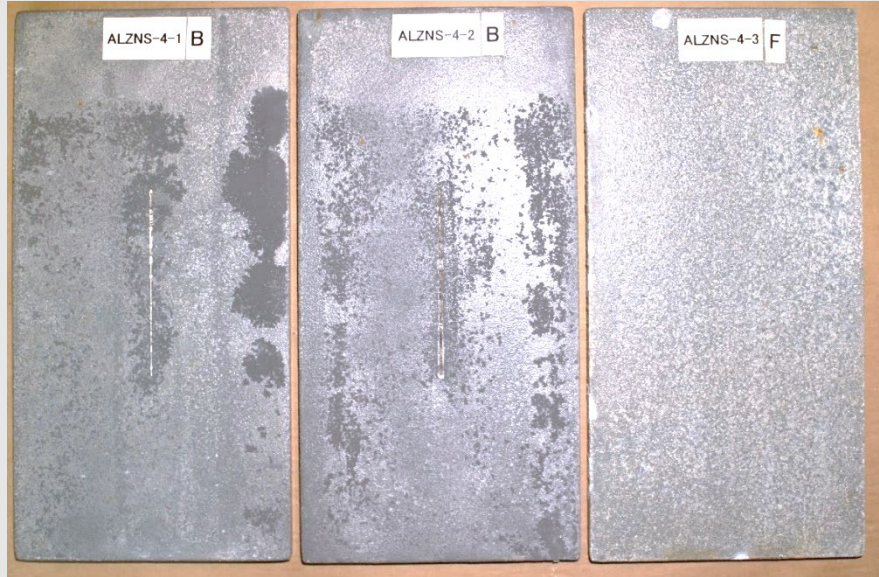
- 4 mil 85/15 Zinc/Aluminum, sealed

Seal is beginning to delaminate from panels 1 and 2

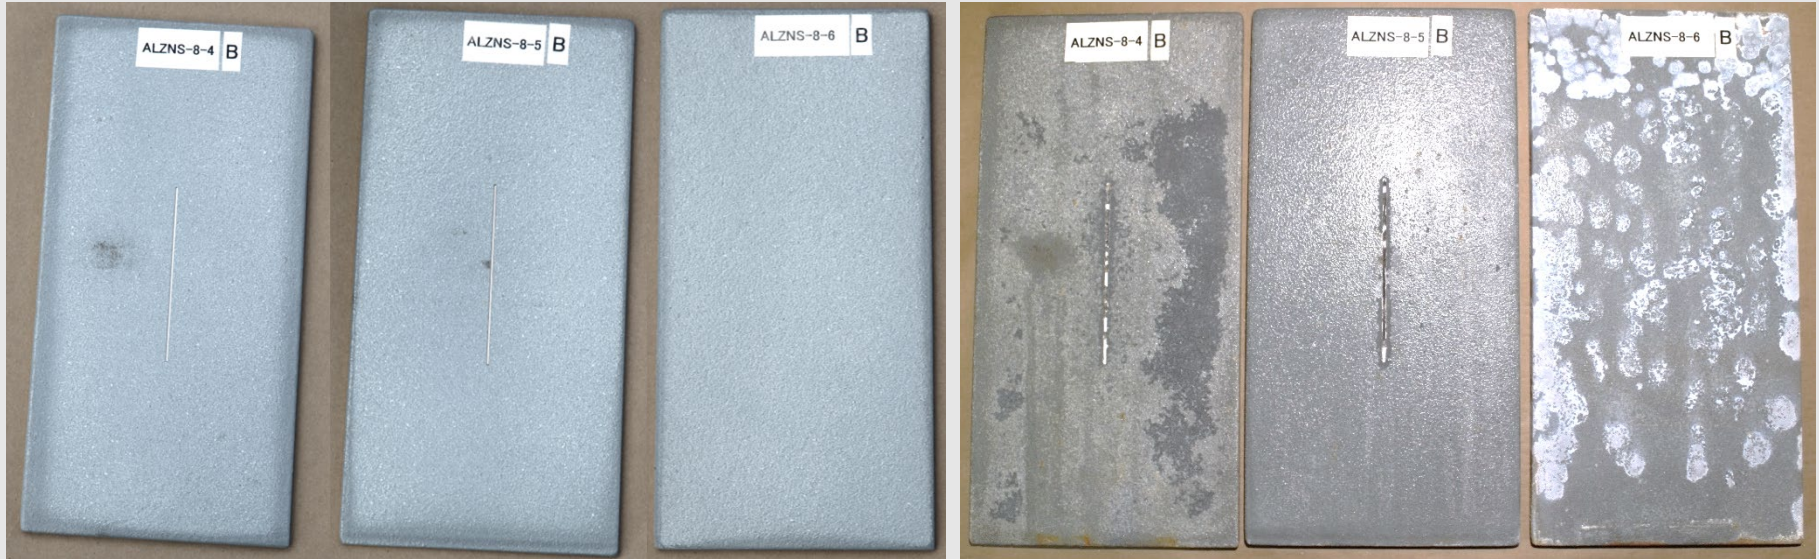
- 8 mil 85/15 Zinc/Aluminum, sealed

Seal is beginning to degrade from panel 4, intact on 5, and mostly degraded on 6

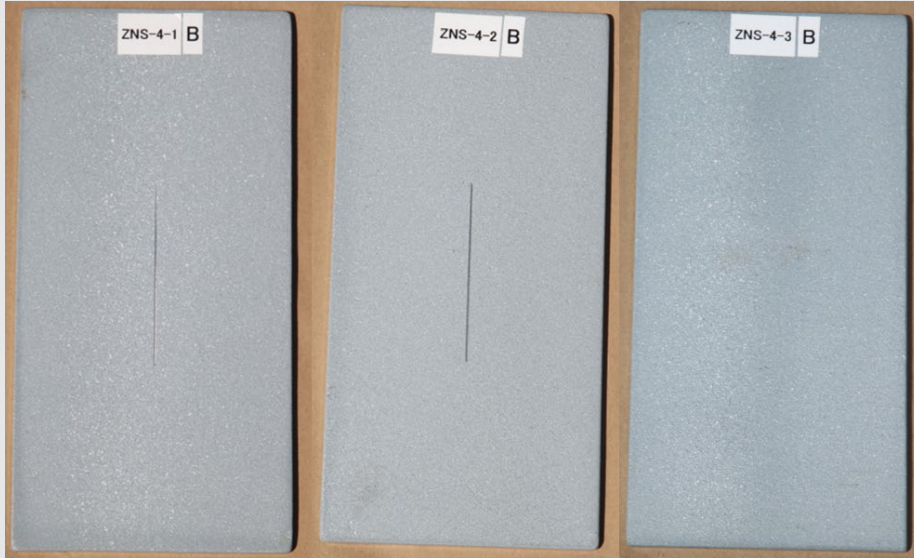
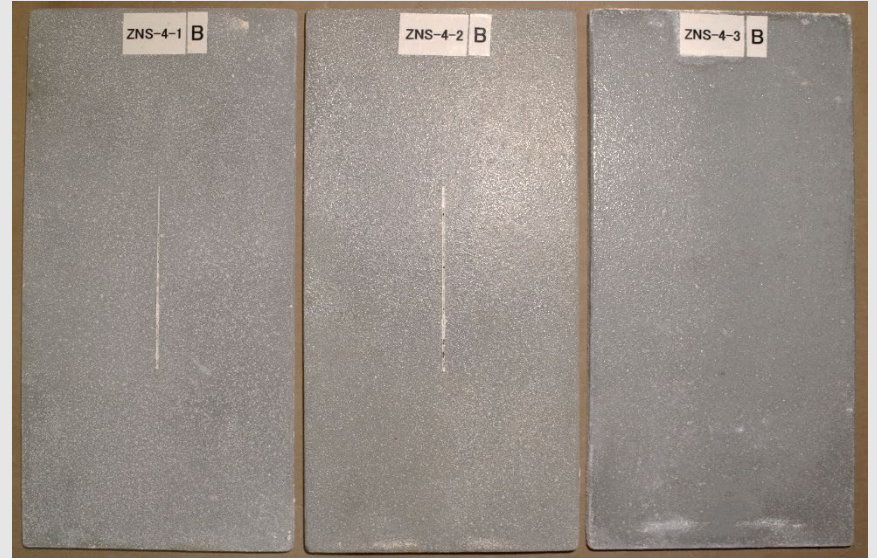
- 4 mil Zinc, sealed

Seal degraded on 1, mostly intact on 2 and 3

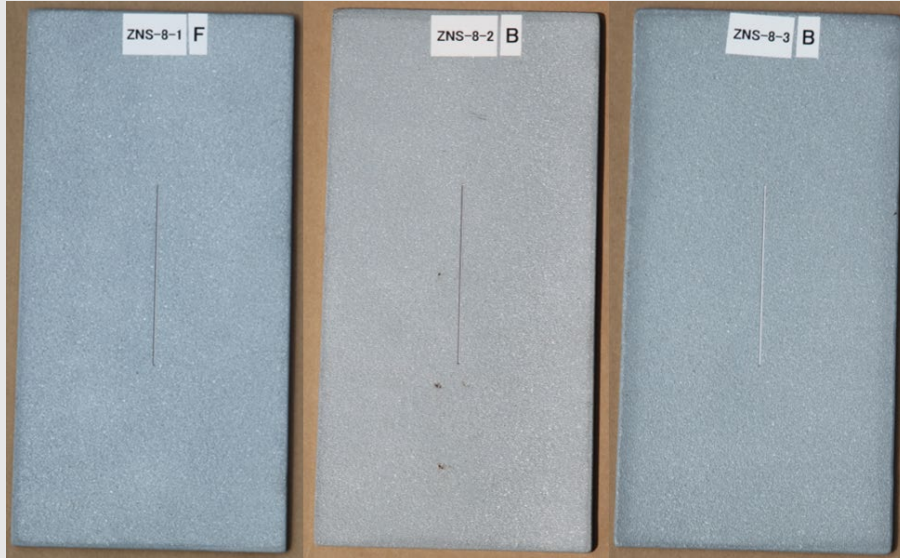
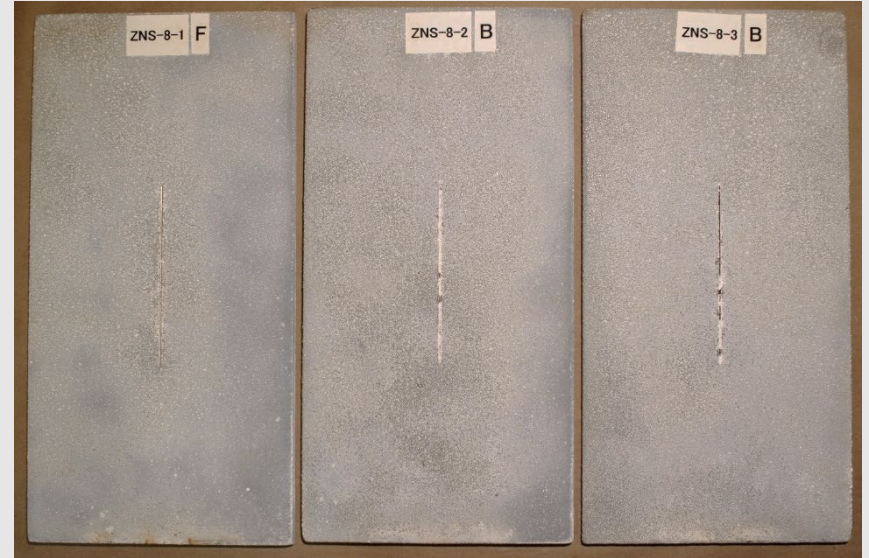
- 8 mil Zinc, sealed

All three panels mistakenly scribed. Silicone was used to fill scribe on panel 1.

Seal mostly degraded on all panels
